QUALITATIVE ASSESSMENT OF HABITAT IN EIGHT TRIBUTARIES TO UPPER CLARK FORK RIVER

June 2009

**Dennis Workman,
Natural Resource Consultant
5449 Prospect Dr.
Missoula, MT 59808**

**Montana Natural Resource Damage Program
P.O. Box 201425
Helena, MT 59620**

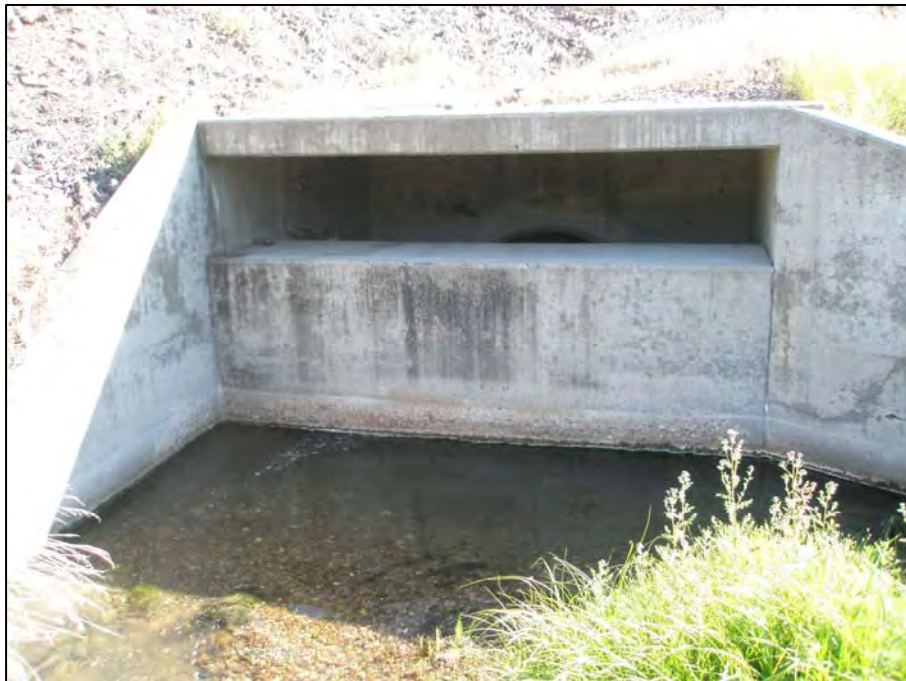
Photo C2 outlet of I-90 culvert looking at energy dissipater

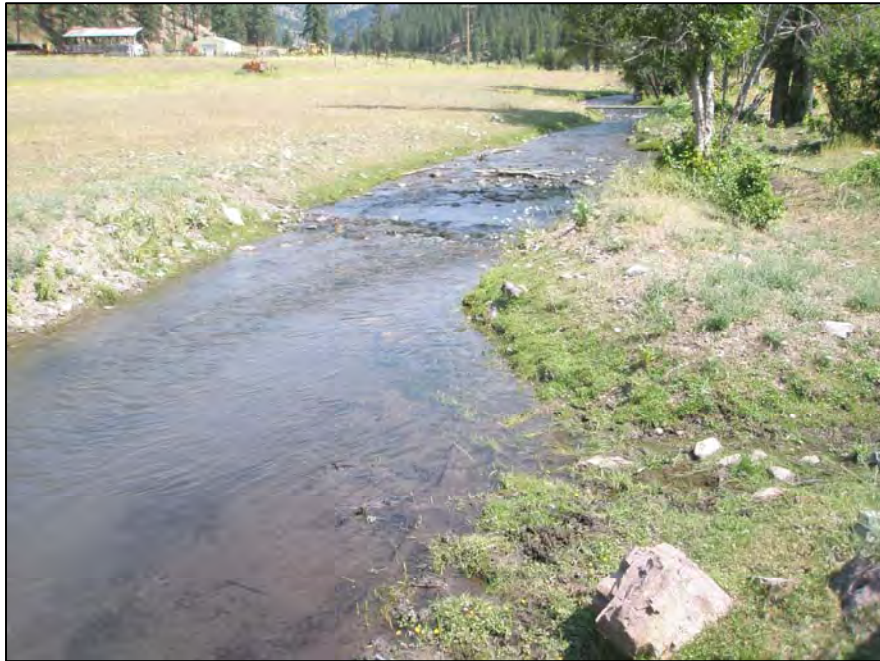
Photo C3 Cramer Creek above I-90

Photographs of the creek channel upstream of I-90 were taken from the county road (Photo C3). Stream restoration upstream of I-90 could improve conditions for fish in this section as well as downstream of I-90. Landowner contact would need to be made to determine the feasibility of doing restoration work on this property.

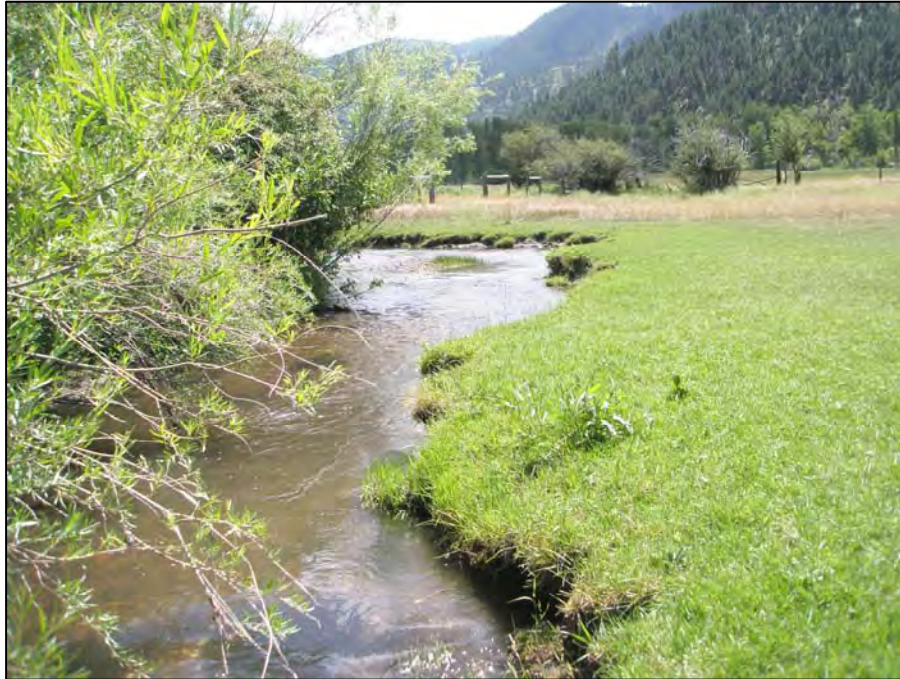
Photo C7 eroding bend

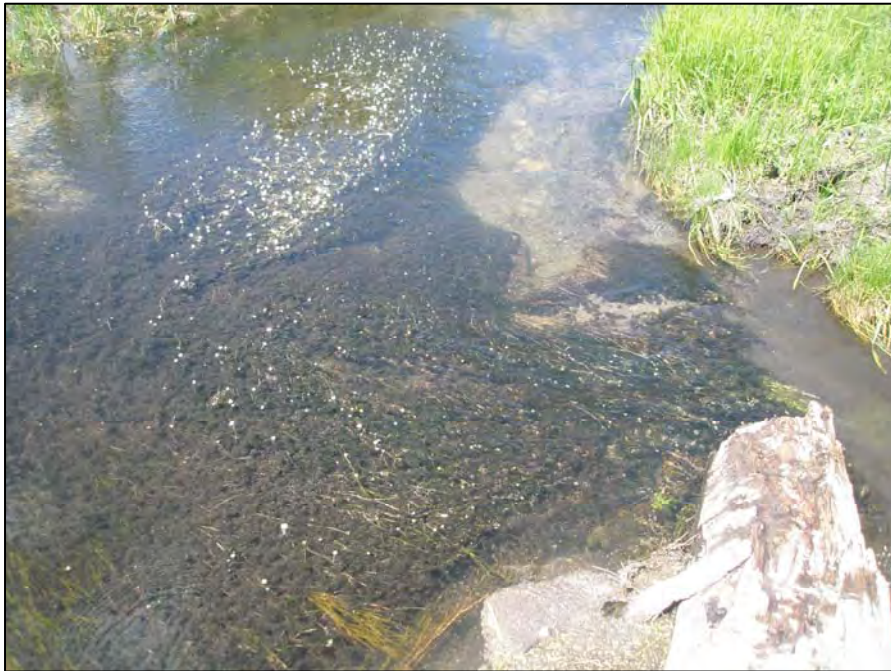
Photo C11 rooted aquatic vegetation in low gradient channel

Downstream of I-90 and railroad grades (Reach 4), the Creek flows approximately 600 feet in a low gradient channel. The creek bottom is dominated by fine silts and dense mats of rooted vegetation (Photos C11 and C12). Brown trout were observed in this section; however, it does not appear to offer habitat suitable for trout spawning. McFarland's culvert (Photos C13 and C14) may be set too high, creating a backwater during runoff and sediment accumulation in this reach.

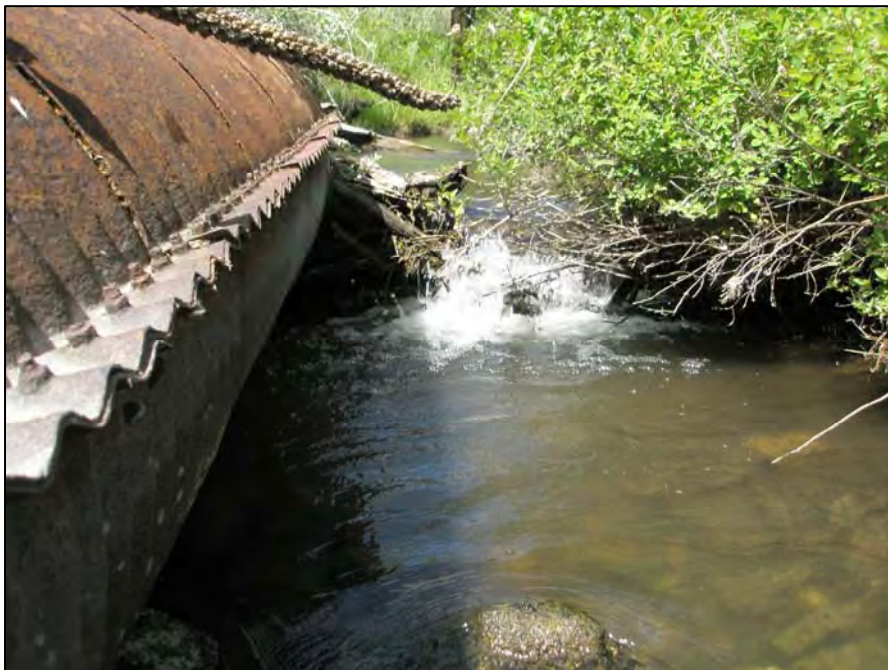
Photo C16 debris dam at mouth

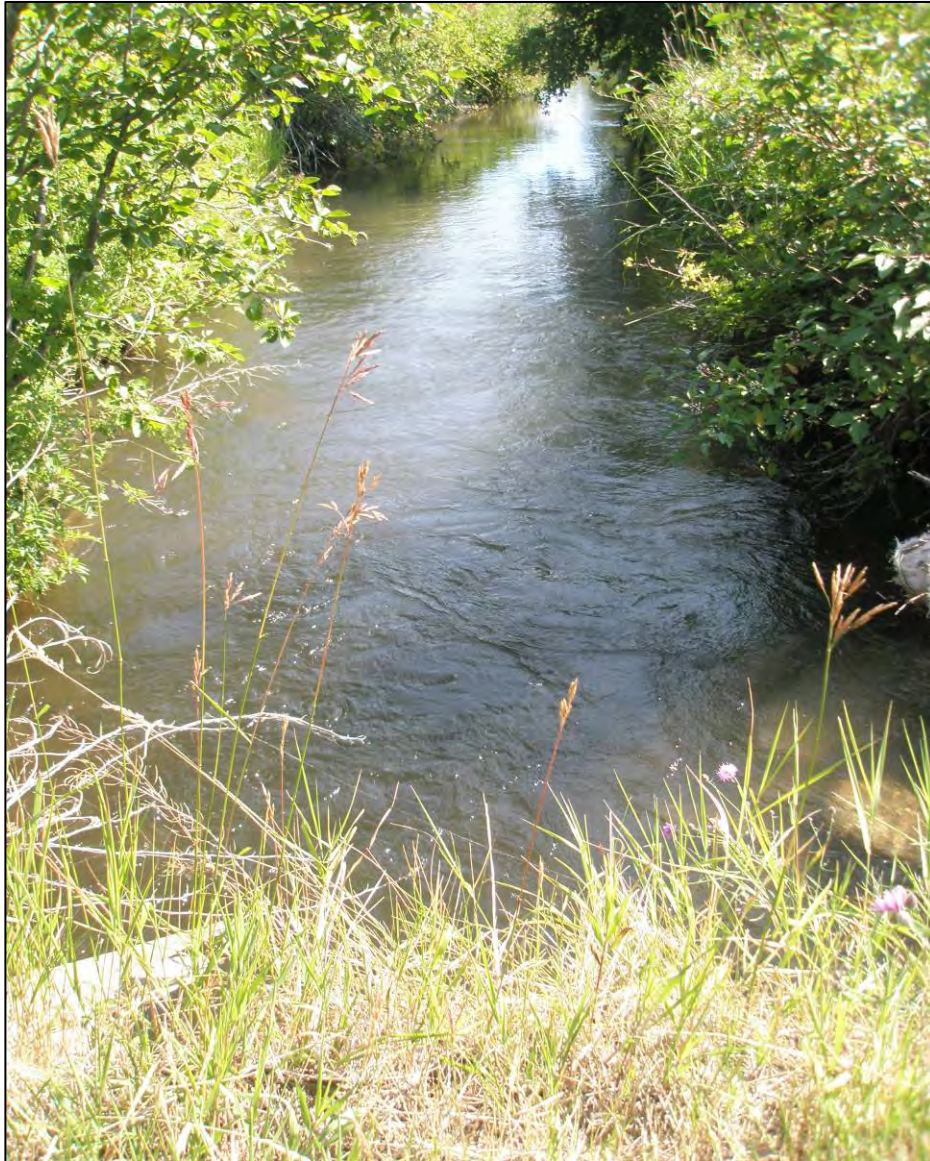
Photo 7

Approximately 780 feet downstream of the Highway 1 Bridge a small irrigation headgate and ditch were located on the right bank. Flow through the flume at that time was 1.9 cfs. This was the only irrigation system found in Reach 2 (Appendix D2, Photo 7).

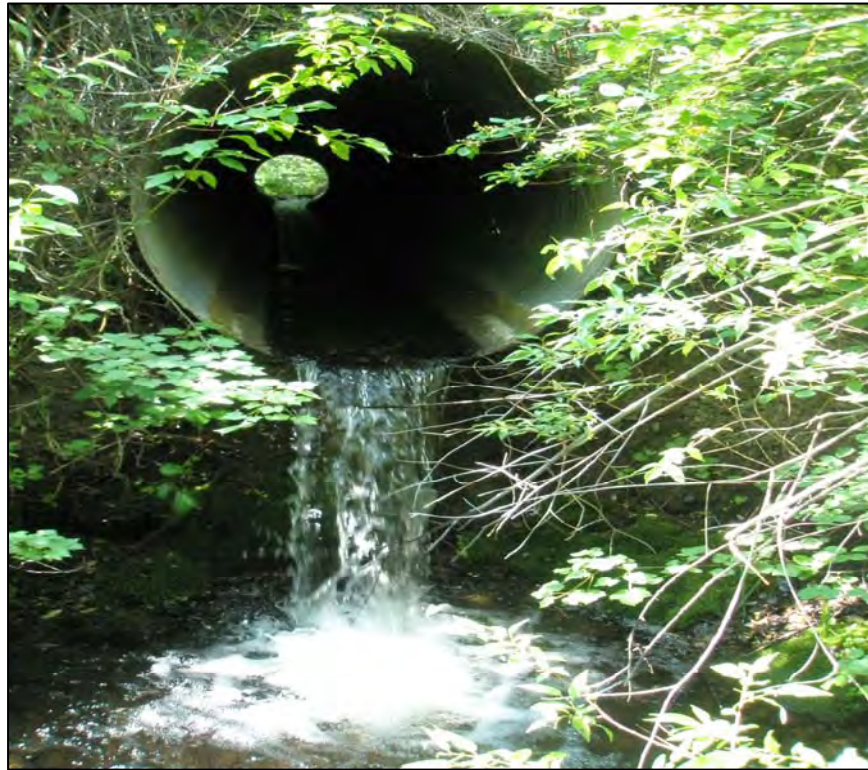
No fish were observed in the creek. There is some potential for a fish population in the stream above the barnyard, but it is isolated from the river. In addition, the culvert under forest road 354 is a fish barrier due to a perched outlet (Photo E1).

Photo E1. Gillespie Creek at forest road 354

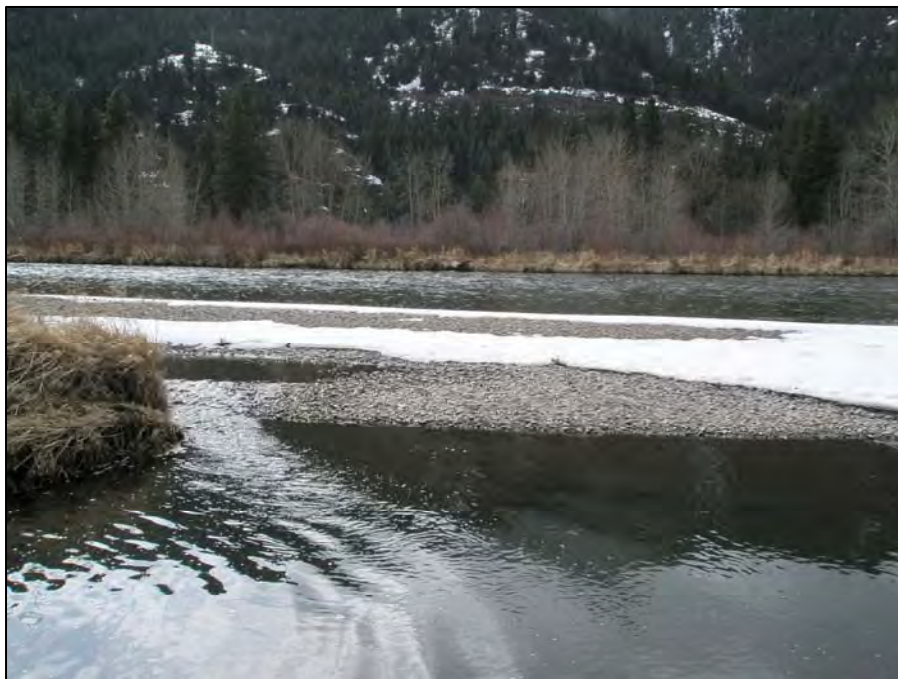
Photo G6

From the point at which Turah Creek crosses under the north frontage road of I-90 until it reaches the river it flows in a man-made channel for 0.62 miles. It is used in its entirety during the summer for flood irrigation of pasture land. The pasture land is heavily grazed and in poor condition. The creek channel is mostly straight and best described as an irrigation ditch – it has no habitat features (Map G2, Photo G1). It leaves the pasture land and flows into a small pond created by a gravel dike across the channel approximately 230 feet upstream from the mouth (Photos G2, G3, G4, G5). The pond and the remainder of the creek channel are surrounded by a mixture of woody shrubs and trees. Turah Creek drops into the CFR behind a point bar on the river (Photos G6 and G7).
