Silver Bow Creek – Balancing Competing Priorities and Lessons Learned

2012 Riparian Restoration in Contaminated Environments Conference

Presented By: Joel Gerhart. P.E.

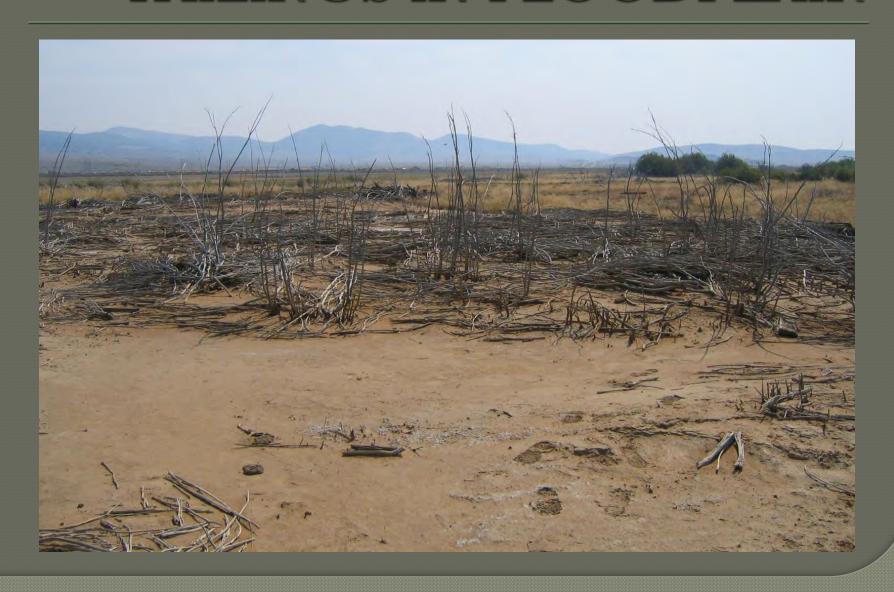
TAILINGS IN FLOODPLAIN

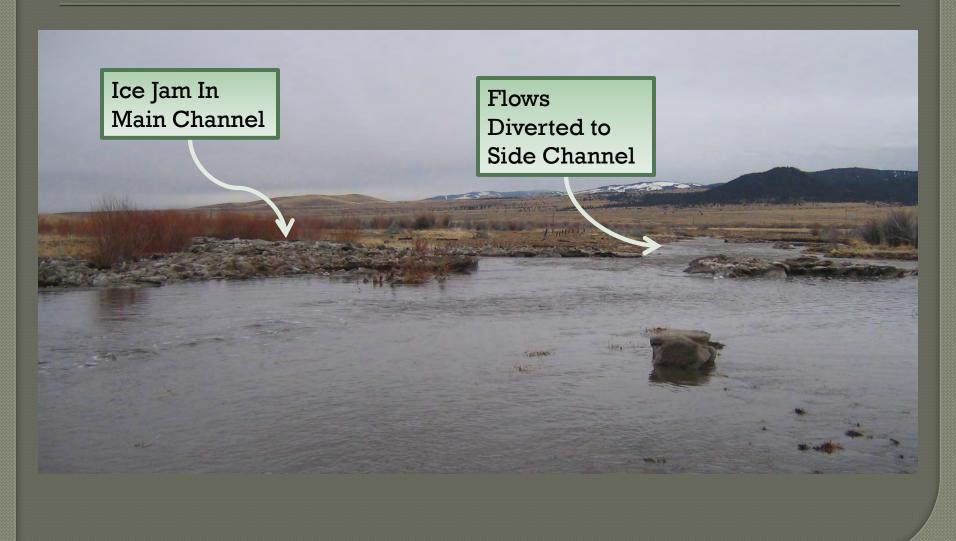
ICE JAMS

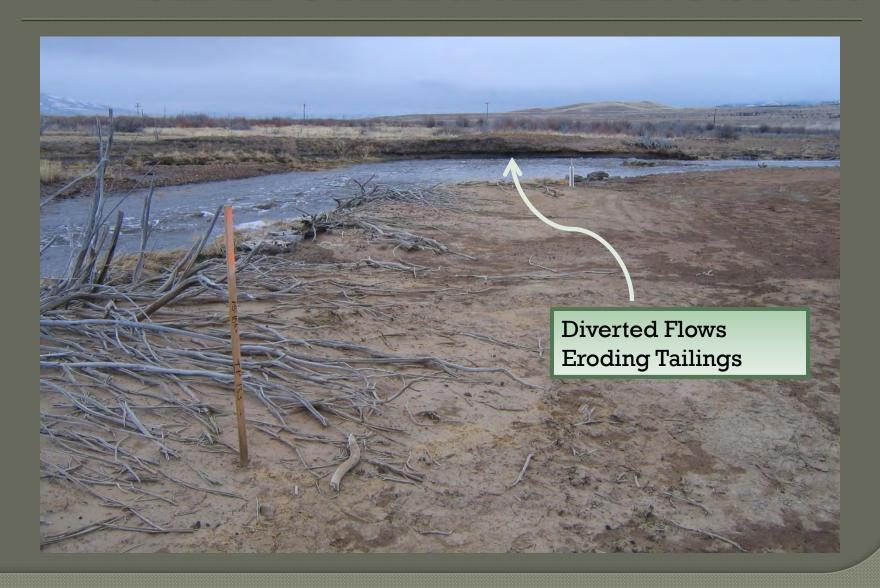
SIDE CHANNEL EROSION

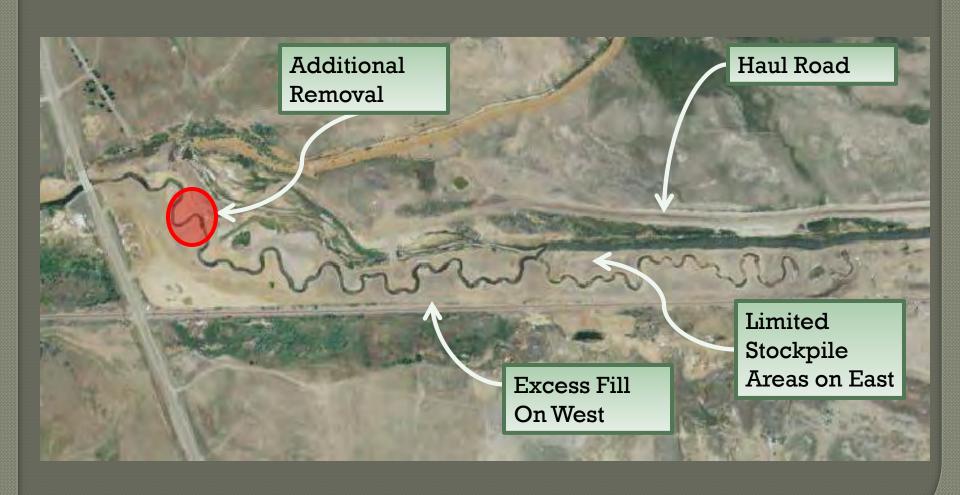
CONSTRUCTION ISSUES

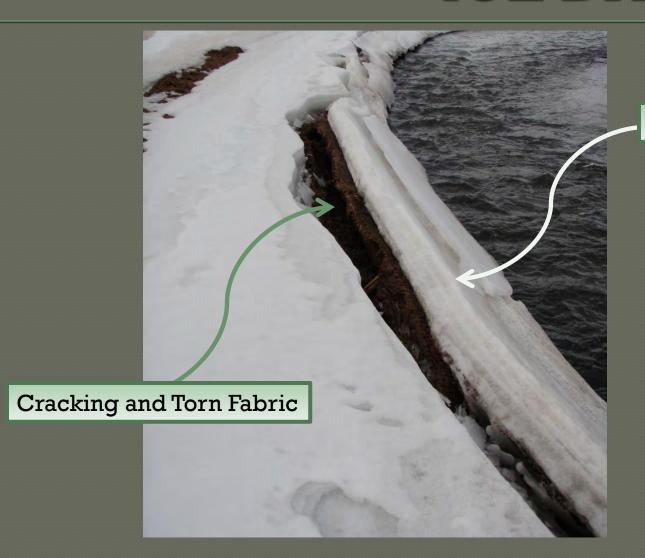
ICE DAMAGE

Ice Shelf

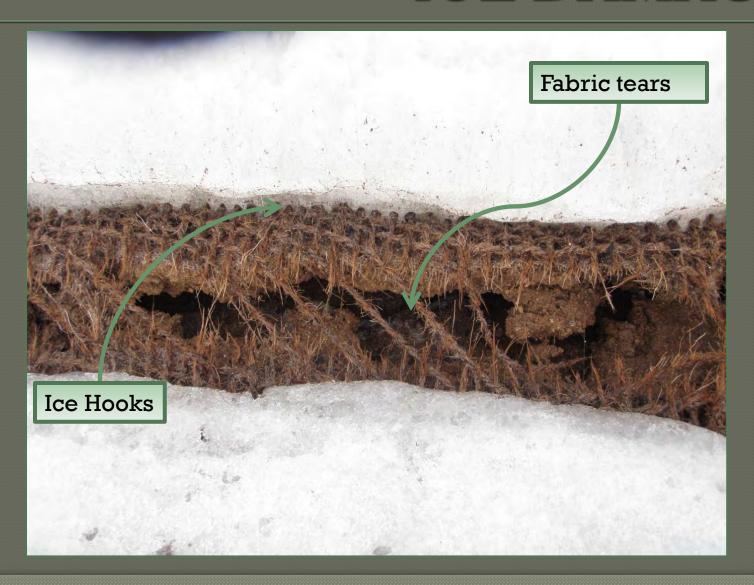
ICE DAMAGE

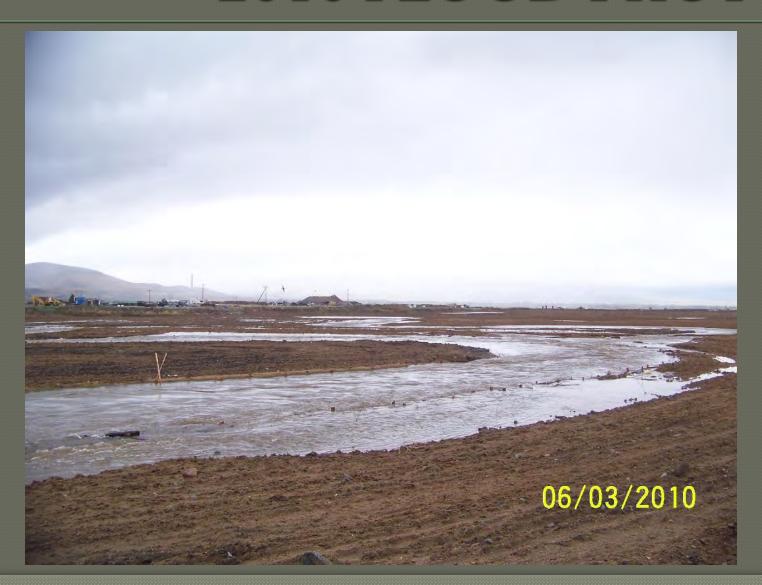
2010 FLOOD PHOTO

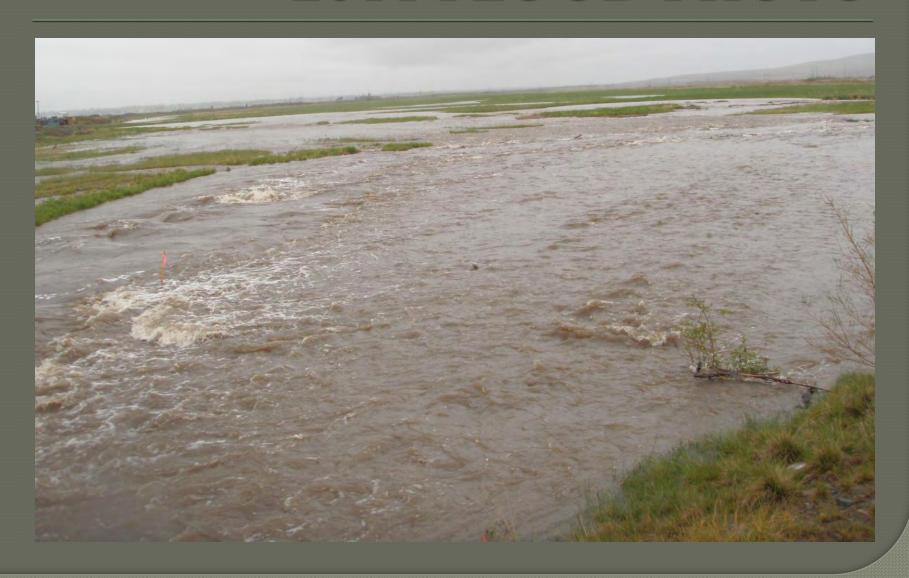
2011 FLOOD PHOTO
