# MILLTOWN RESTORATION

## Lessons Learned

Symposium on Riparian Restoration  
in a Contaminated Environment  
April 2012

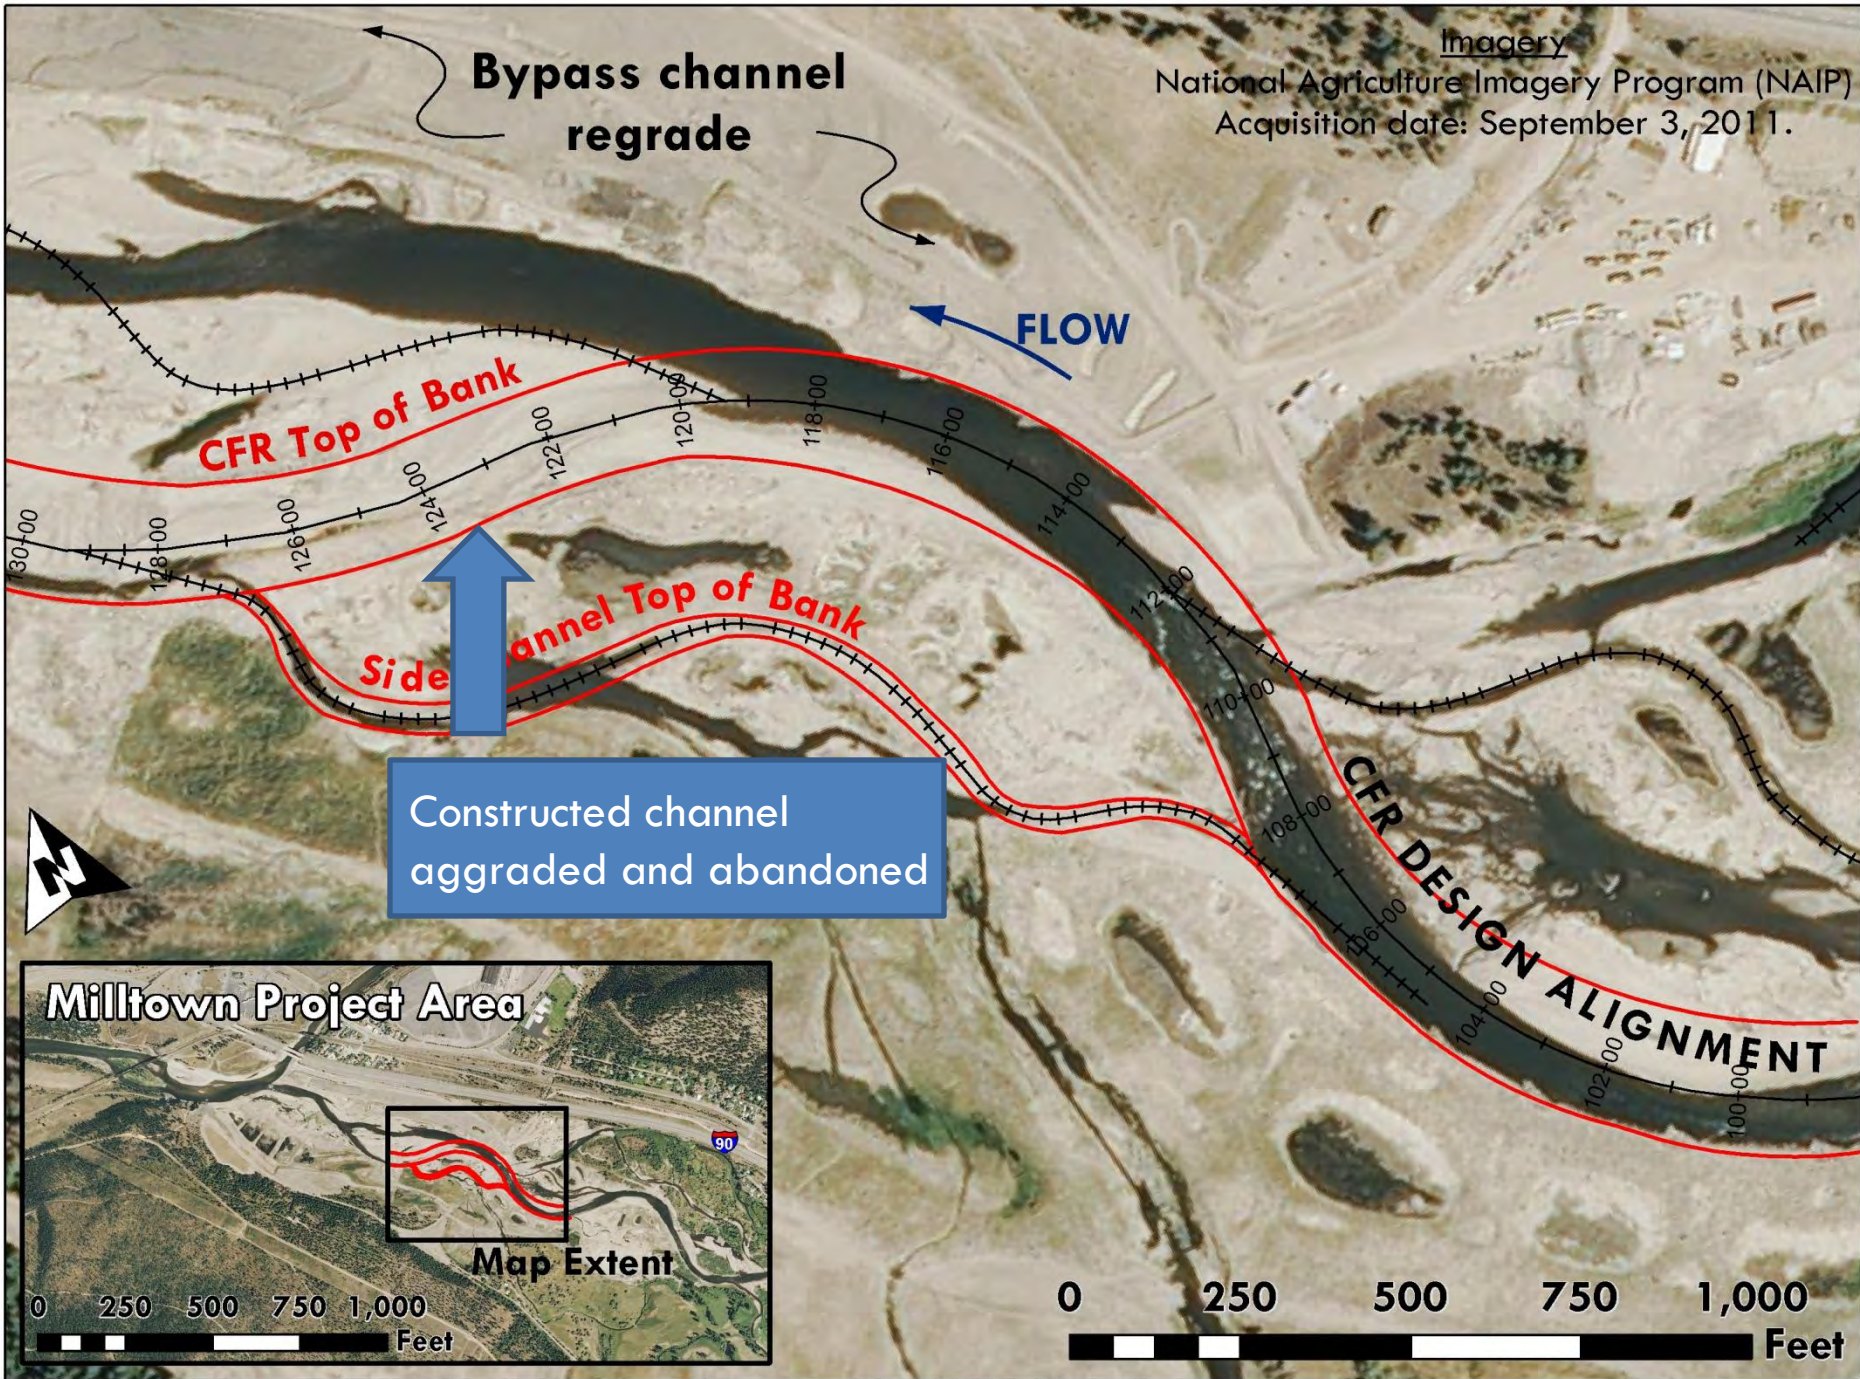
Constructed channel  
aggraded and abandoned

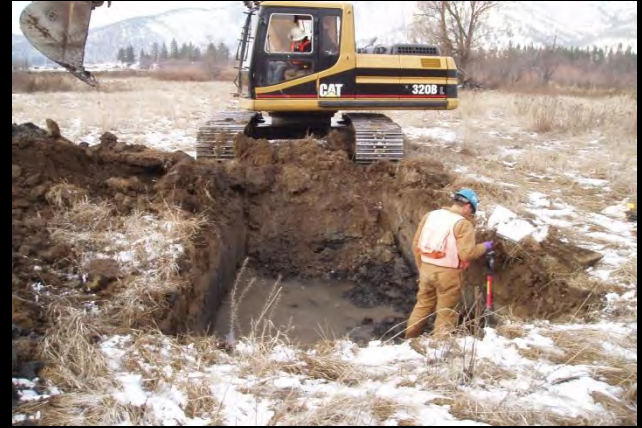
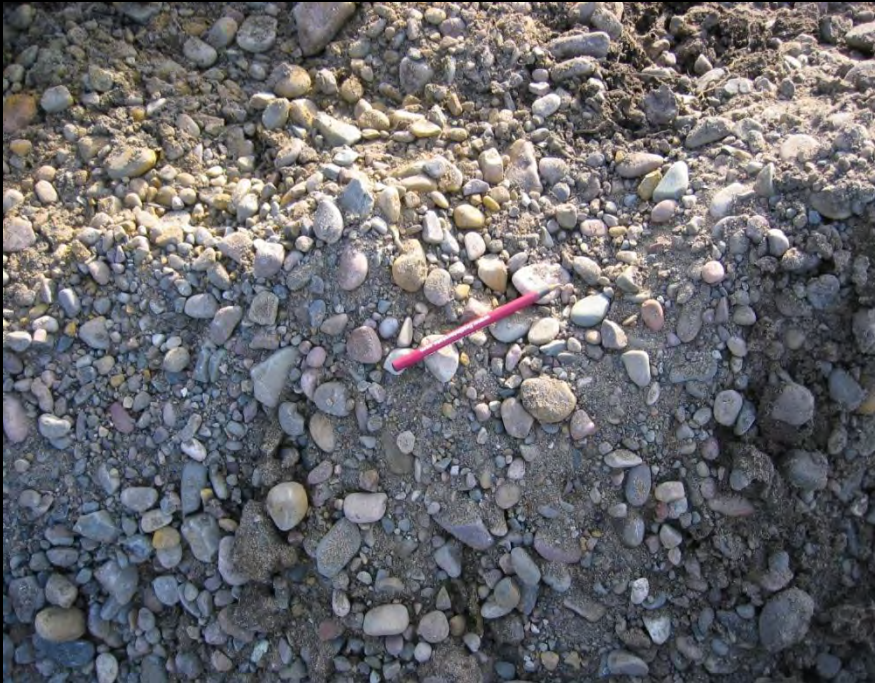
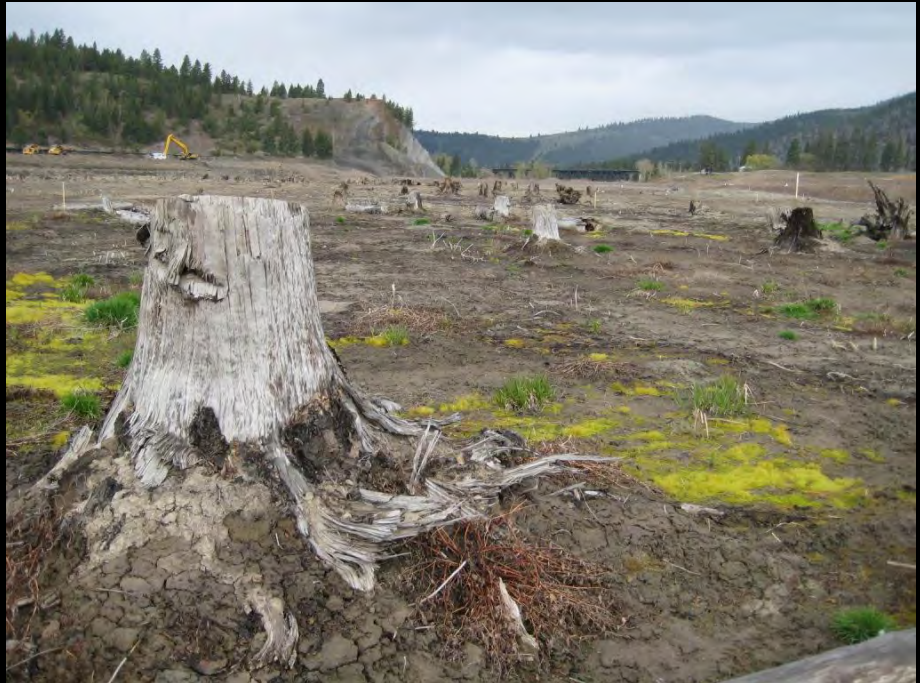
Stumps found at varying elevations

Alluvium characteristics variable

Unable to identify pre-dam channel

Groundwater correlated to river surface water

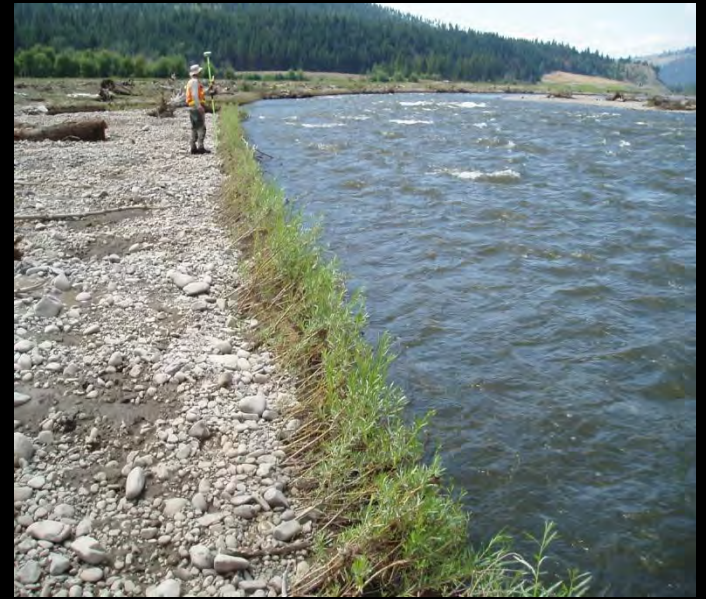
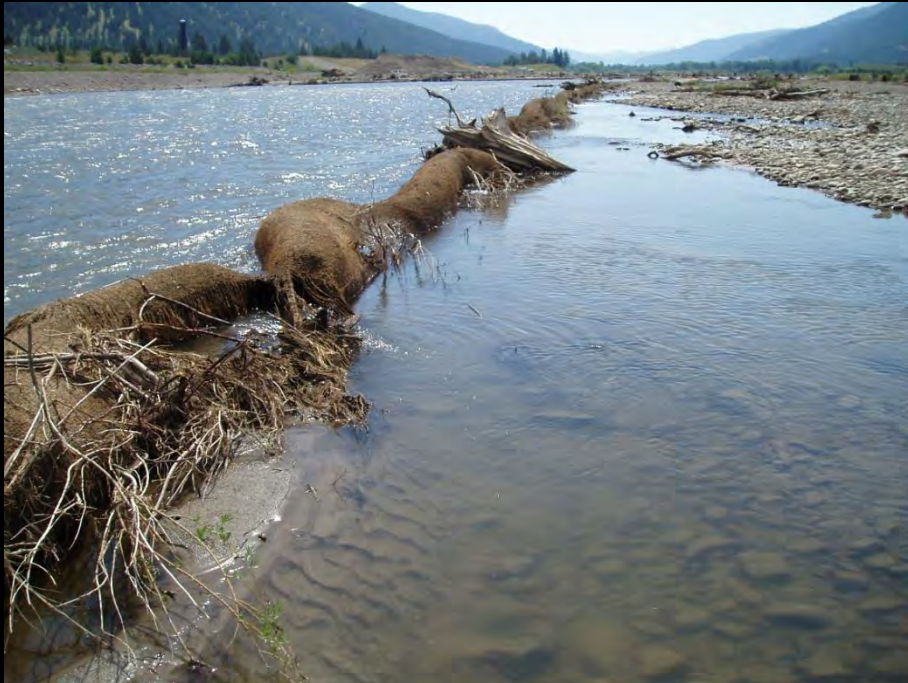
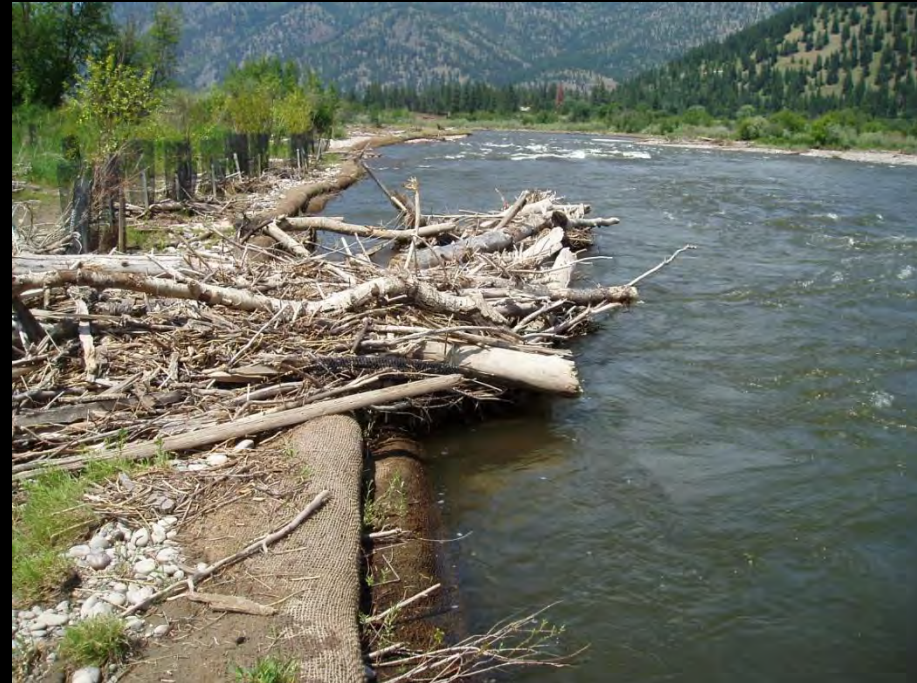
Discharge exceeded design criteria

Bioengineering and toe damage

Large Woody Debris structures intact

Engineered riffles damaged, but held grade

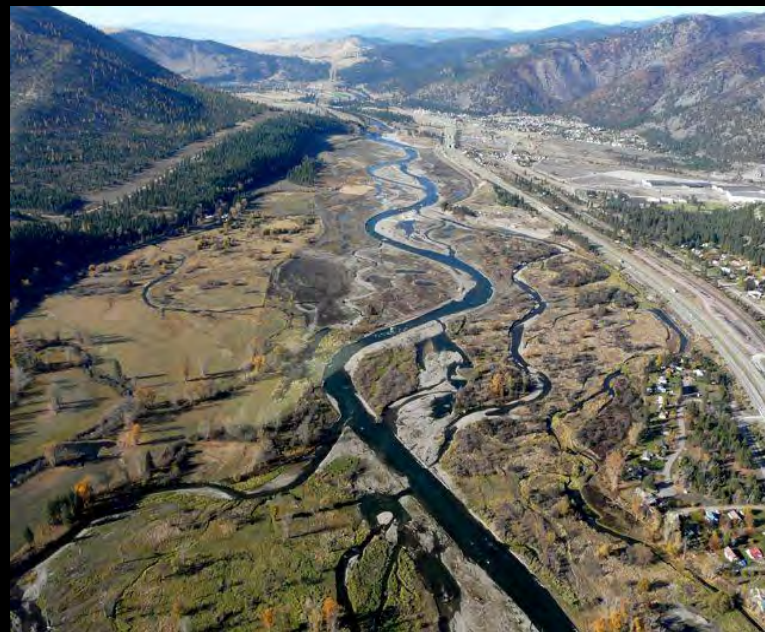
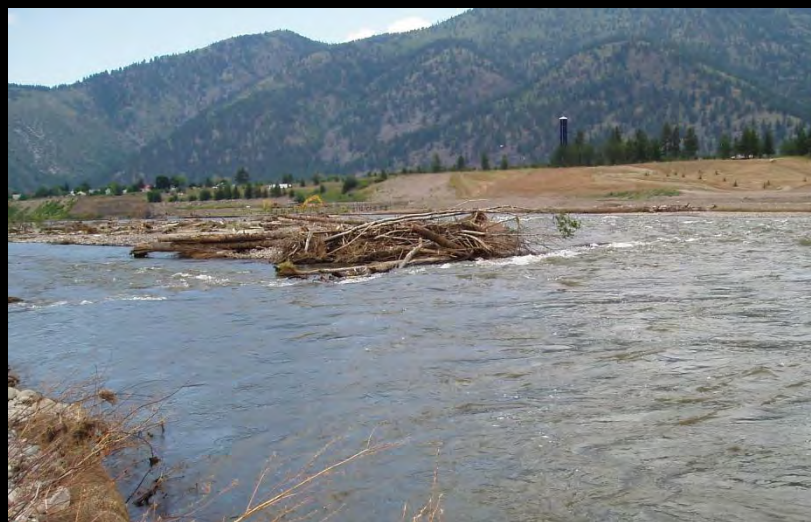
Discharge exceeded design criteria

Variable performance

Entrance damage and debris buildup

Conveyed more flow than expected

New side channels formed

Provided relief valves for main stem

Modified design criteria for  
maintenance

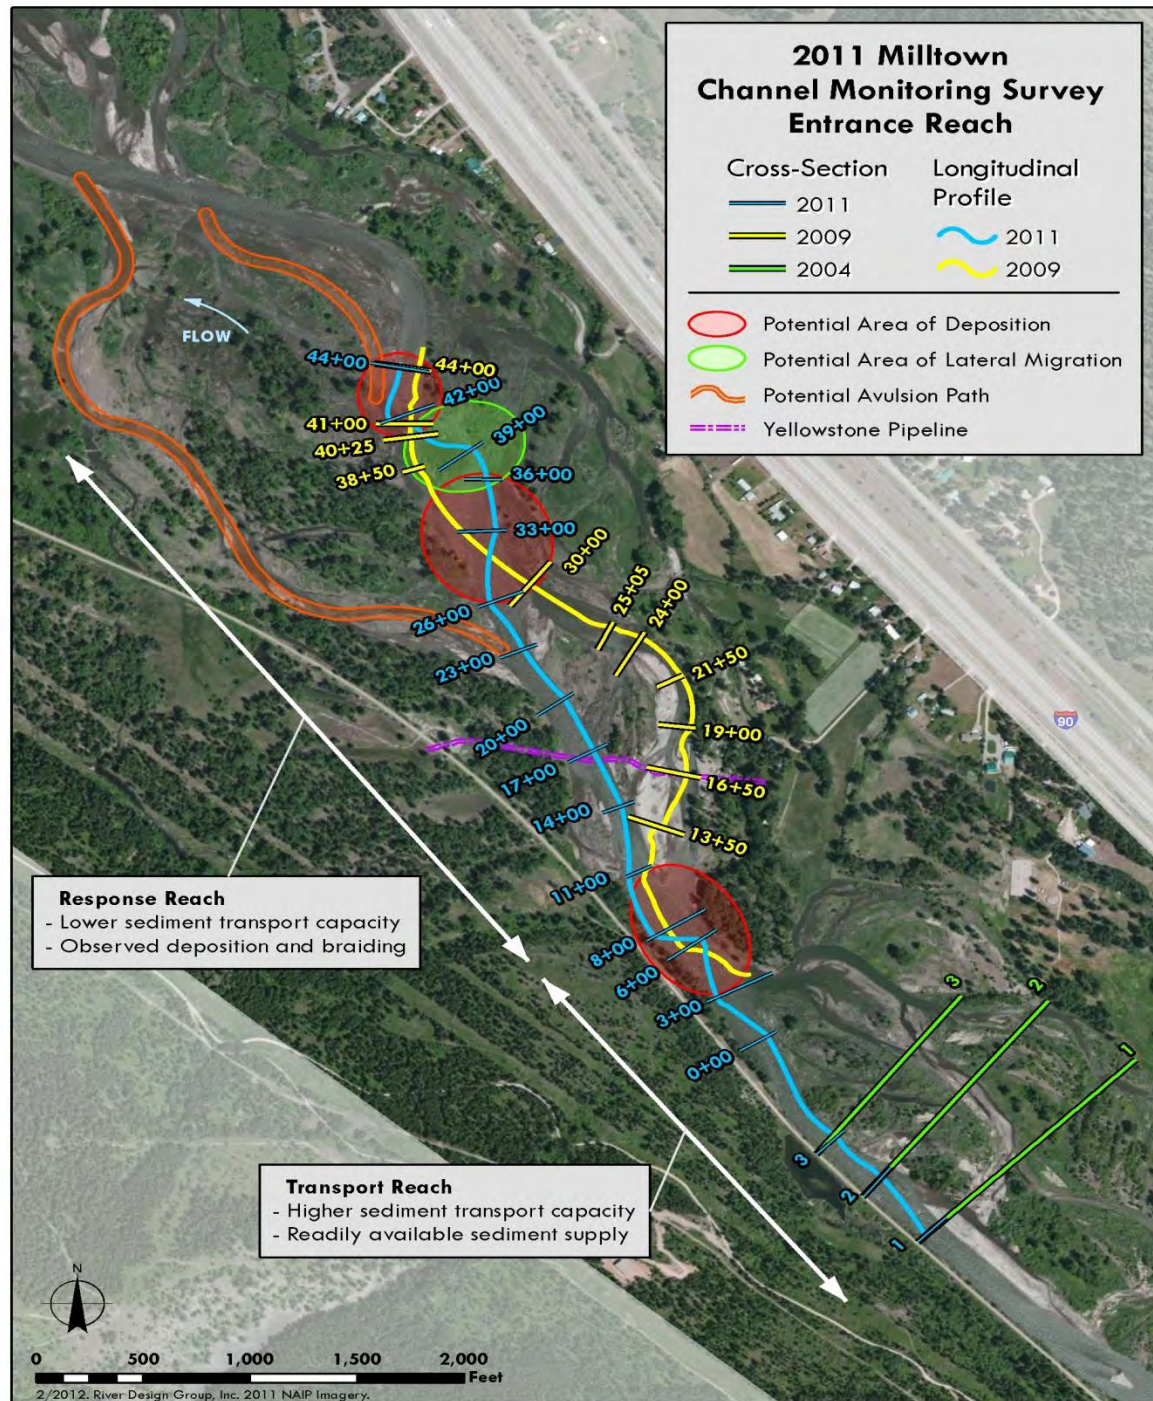
- Sediment transport discontinuity
- Avulsion
- Lateral migration
- Floodplain connection
- Habitat is adequate
- Wetlands present
- Navigable for recreation
