Qualitative Rapid Assessment

2023 Status Report

Milltown Reservoir / Clark Fork River NPL Site Clark Fork River Operable Unit, Reach A, Phase 1, Phase 2, and Phases 5 and 6

Geum Environmental Consulting, Inc.

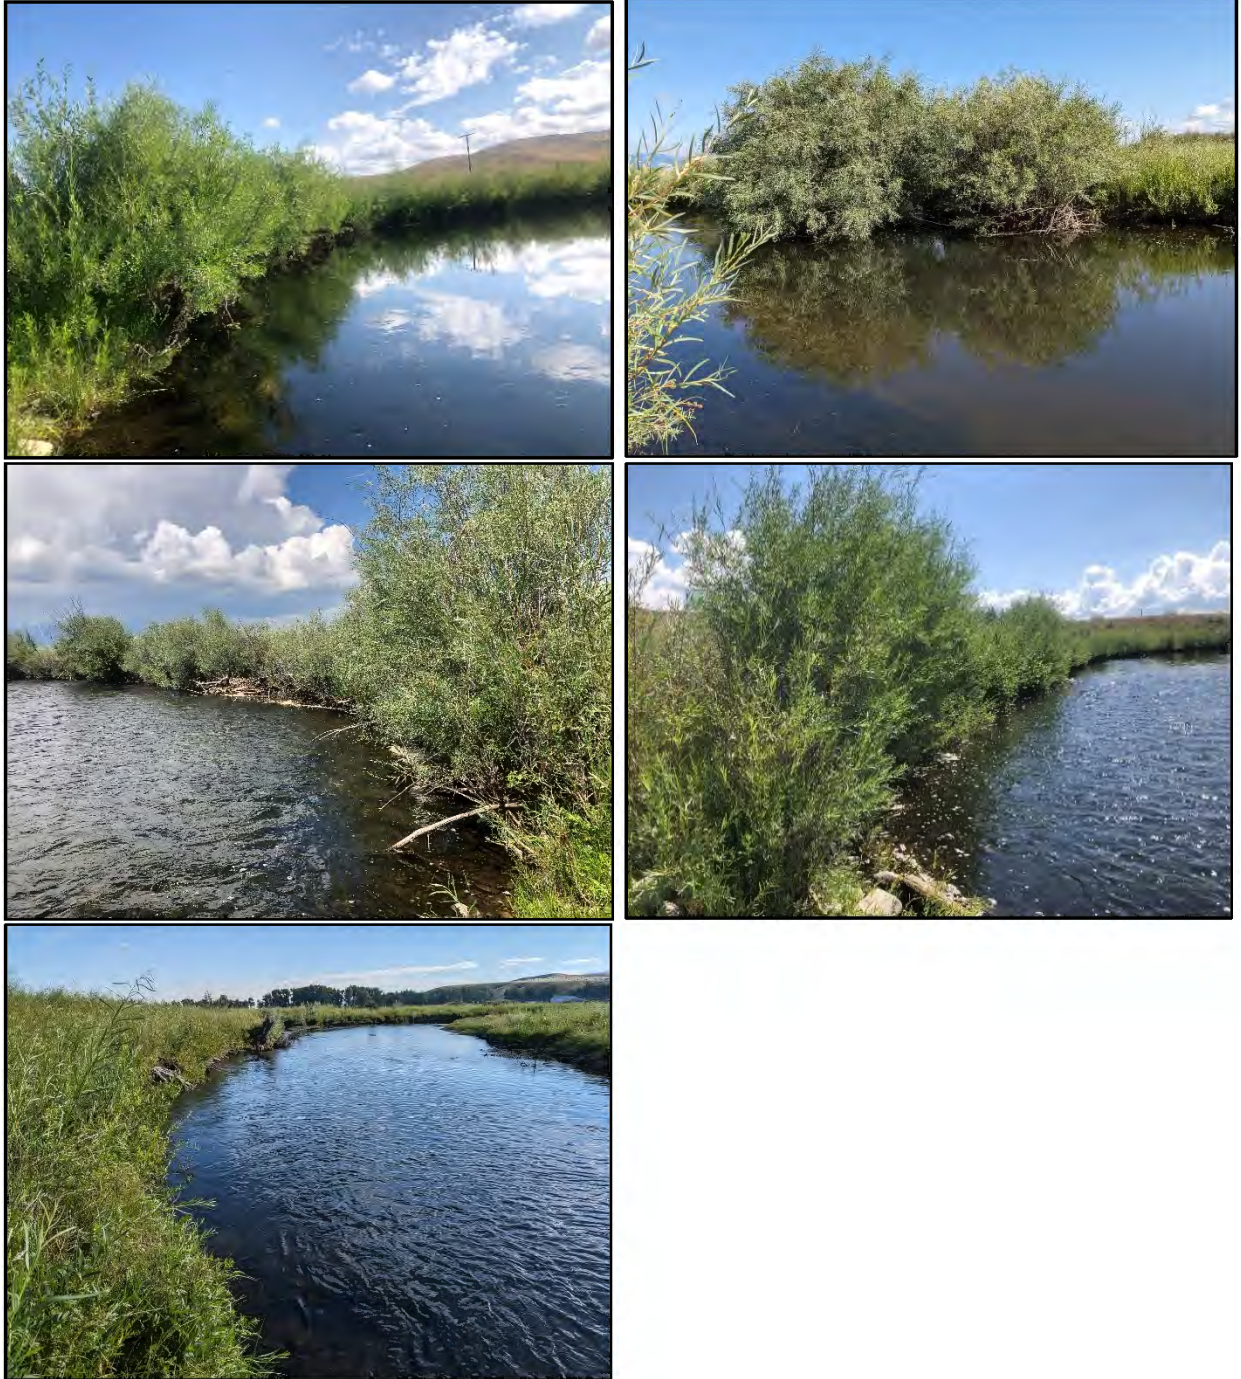
- In Phase 1 and 2 preserve vegetation streambanks typically consist of willow or birch that extend into the adjacent channel providing cover and roughness to the river (Figure 3). All preserve vegetation streambank treatments with woody vegetation continued to provide high cover in 2023. No erosion or bank instability was observed at these treatment types.
- Preserve vegetation streambanks with herbaceous remained intact and supported some new willow growth (Figure 4).
- Expansion of willows behind preserved streambanks with woody vegetation was typically wide and robust.
- One streambank in Phase 2 and several streambanks in Phases 5 and 6 were not treated because they are naturally high banks where contaminated sediments did not deposit in 1908 (No Treatment streambanks). These banks continue to erode and contribute clean sediment to the river (Figure 5)

Figure 3. Examples of preserved streambank treatments with woody vegetation in Phase 1 (top) and Phase 2 (bottom).

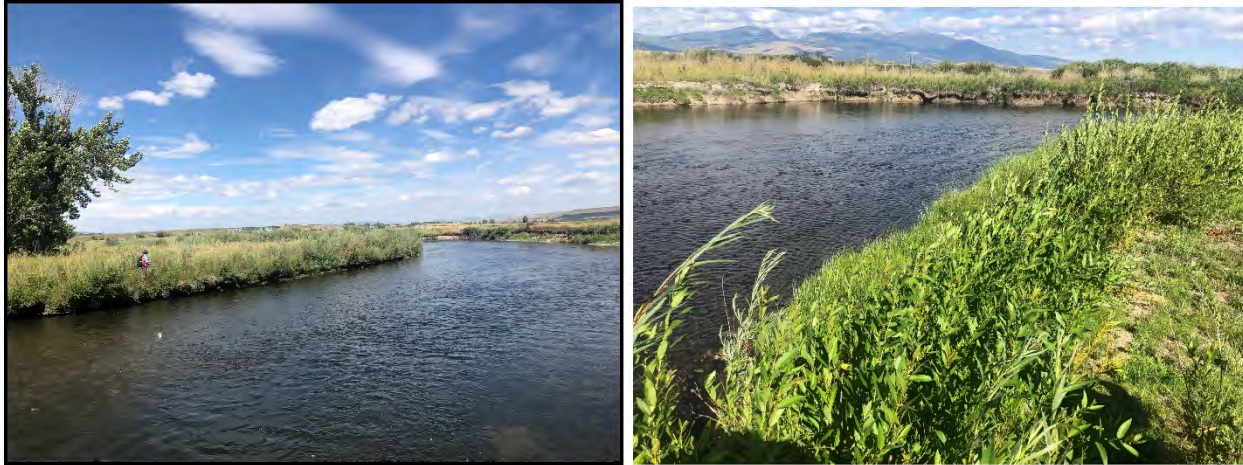
Figure 4. Left - Example of preserved streambank with woody vegetation in Phase 5. Right – Example of preserved streambank with herbaceous vegetation in Phase 6 with brush trench installed at the back edge of the preserved vegetation.

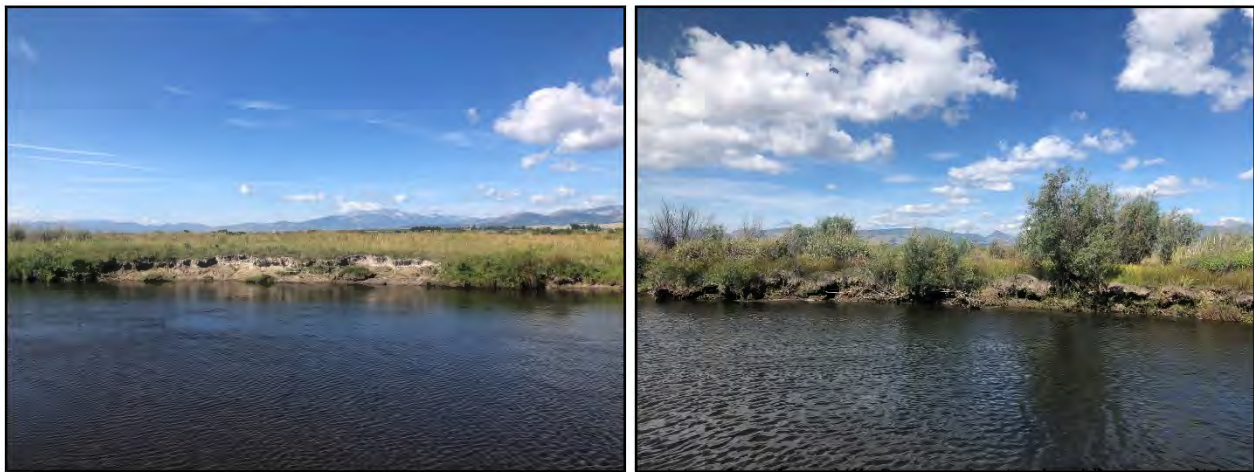
Figure 5. No Treatment streambanks in Phase 6.

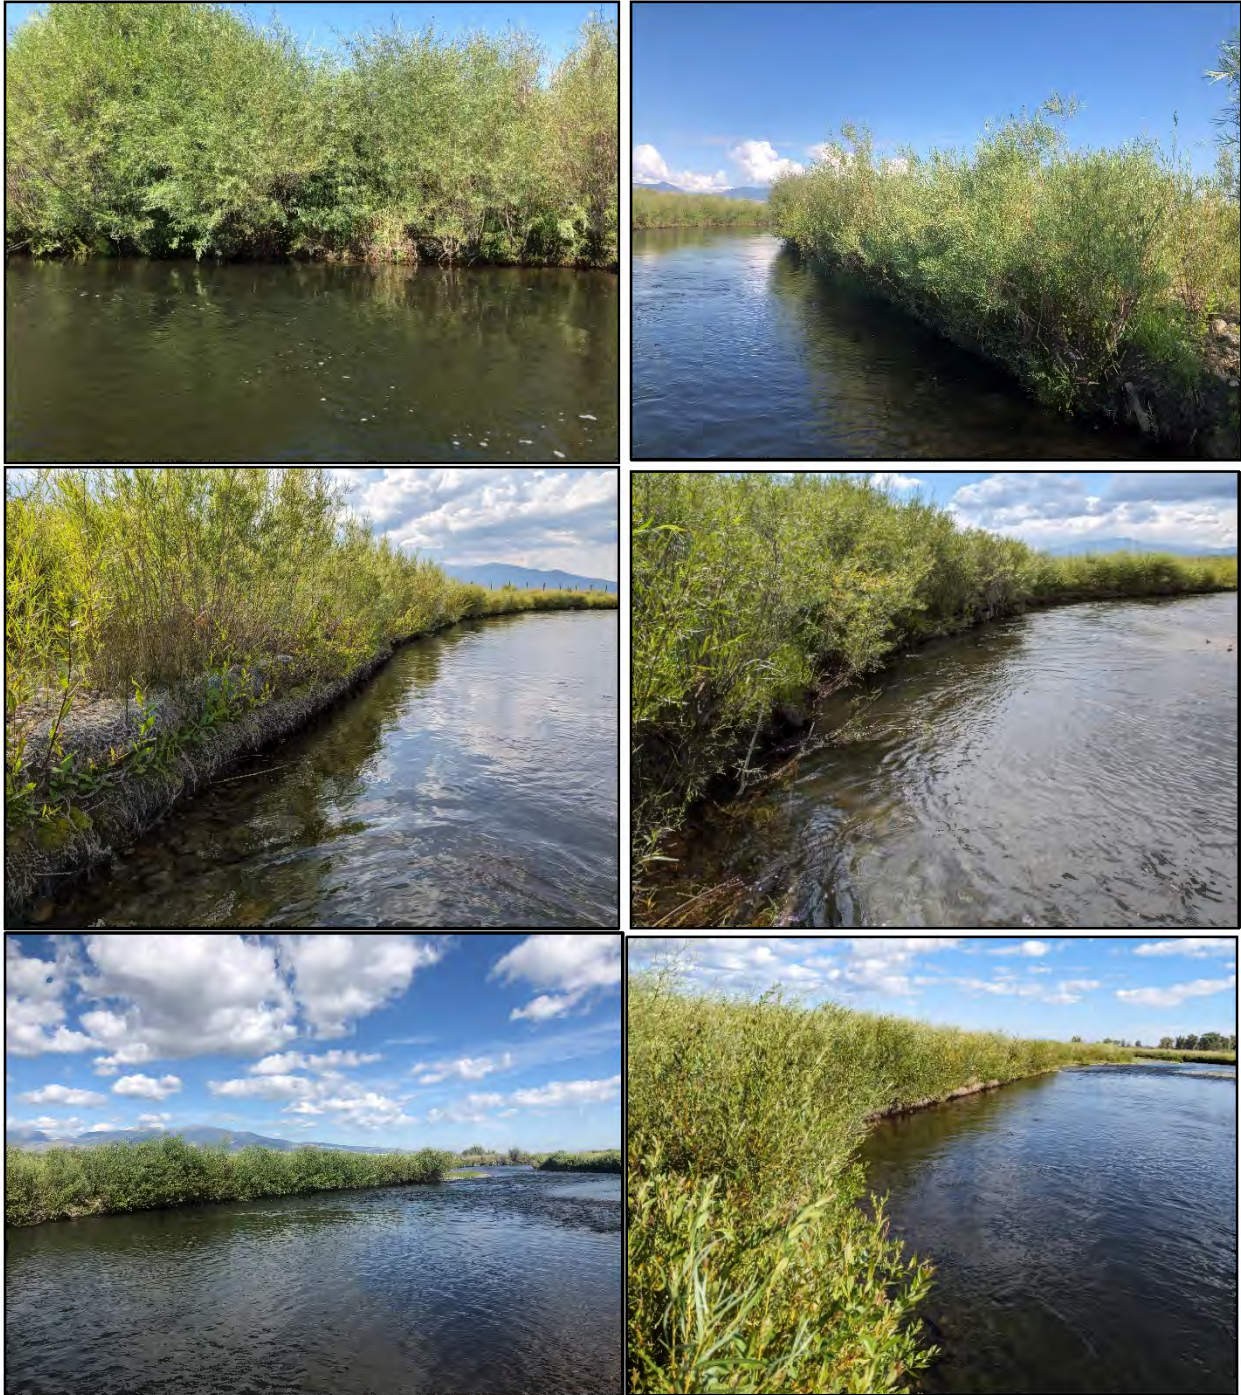
- Overall, vegetated soil lifts had high cover of willows and many of these treatments are beginning to establish overhanging woody vegetation cover and undercut features similar to preserve vegetation streambanks (Figure 6).
- Some banks with dense willow cover have not formed undercut banks in areas where cobble placed at the toe of the lifts has not eroded. Streambank toe material has been sized to resist 10-year return interval shear stresses (Figure 7).

Figure 6. Soil lifts with dense woody cover of willows starting to develop habitat features similar to preserved vegetation streambank treatments (top row Phase 1) (middle row Phase 2), bottom row Phase 5-6.

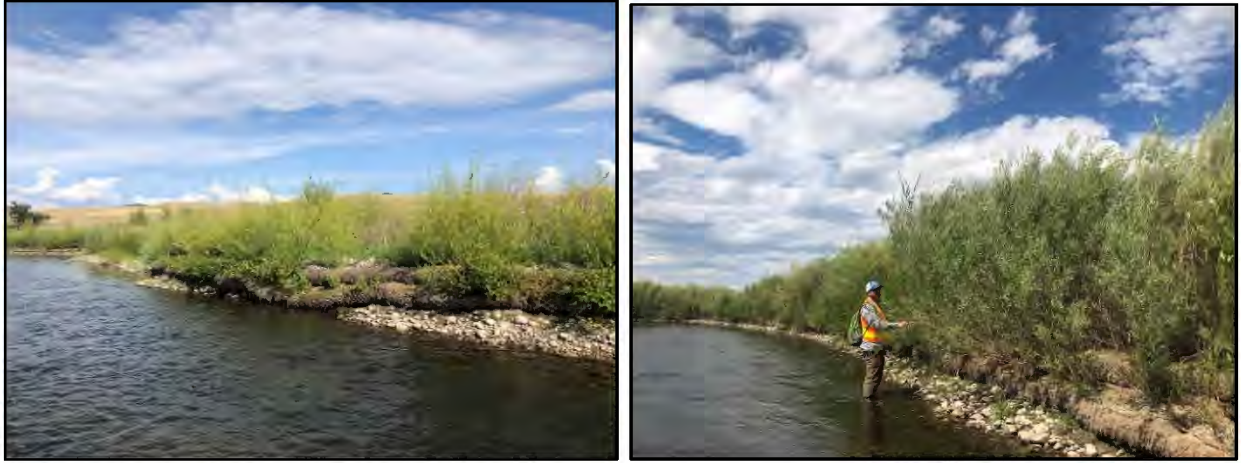
Figure 7. Soil lifts with cobble toe preventing undercut bank formation.

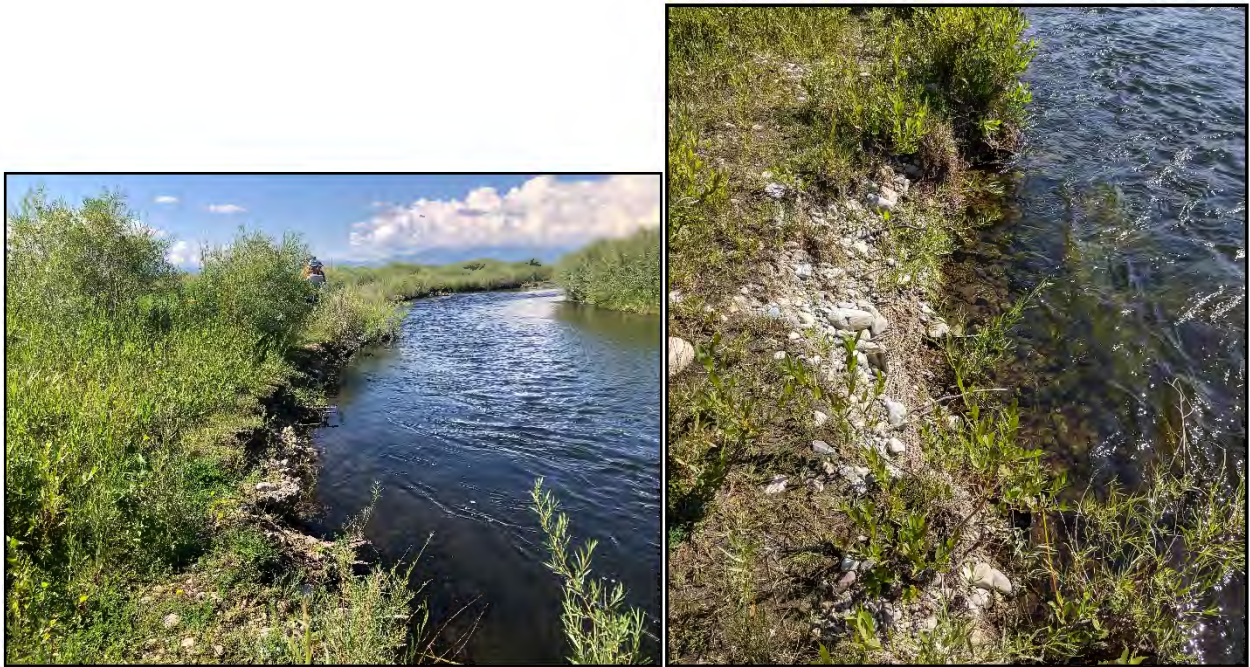
Figure 8. Examples of banks where soil lifts have been lost but willows are suckering out into bank face (photo right) or dense willows occur in the bank behind the lost soil lift (photo left).

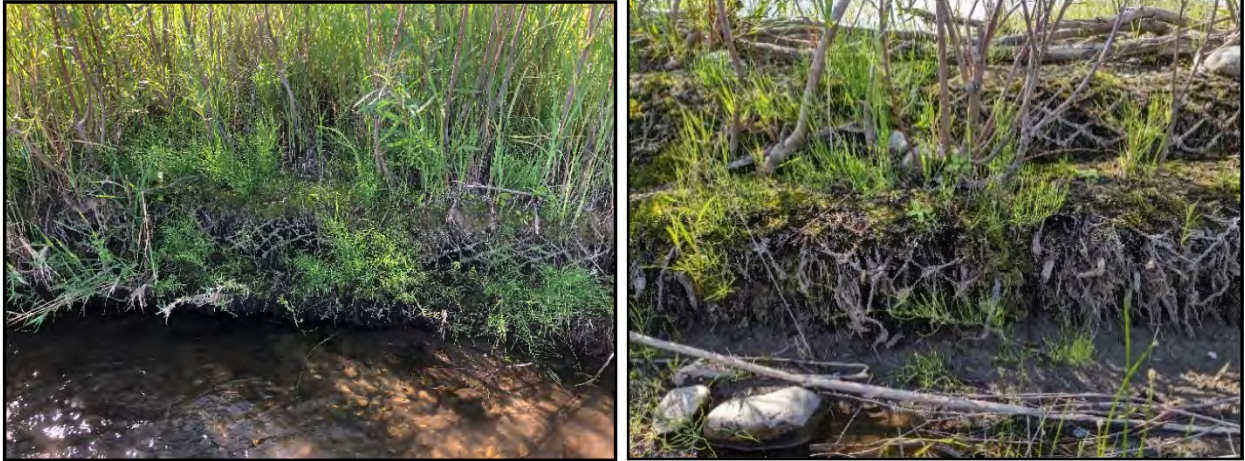
- Coir used in vegetated soils lifts is expected to begin degrading by year 5 and all phases monitored in the 2023 QRA had been in place for 6 years or longer (i.e. had been exposed to spring flows a minimum of 6 times). Coir fabric had degraded to varying degrees and on some streambanks the fabric had degraded enough to result in displacement of the coir log placed inside the fabric. Even in areas where a portion of the soil lifts were lost willow cover was generally high behind the bank and did not show signs of accelerated erosion although erosion is occurring at some of these banks (Figure 8).
- Herbaceous wetland species are colonizing coir logs in many locations and in some areas, deposition occurs at the base of the treatment where sedges or willows were colonizing and encroaching into the channel beyond the face of the bank treatment. See Figure 9, right photo below.

Figure 9. Left - Example of vegetated soil lift coir fabric and coir log being replaced with woody vegetation and colonized by herbaceous wetland vegetation.

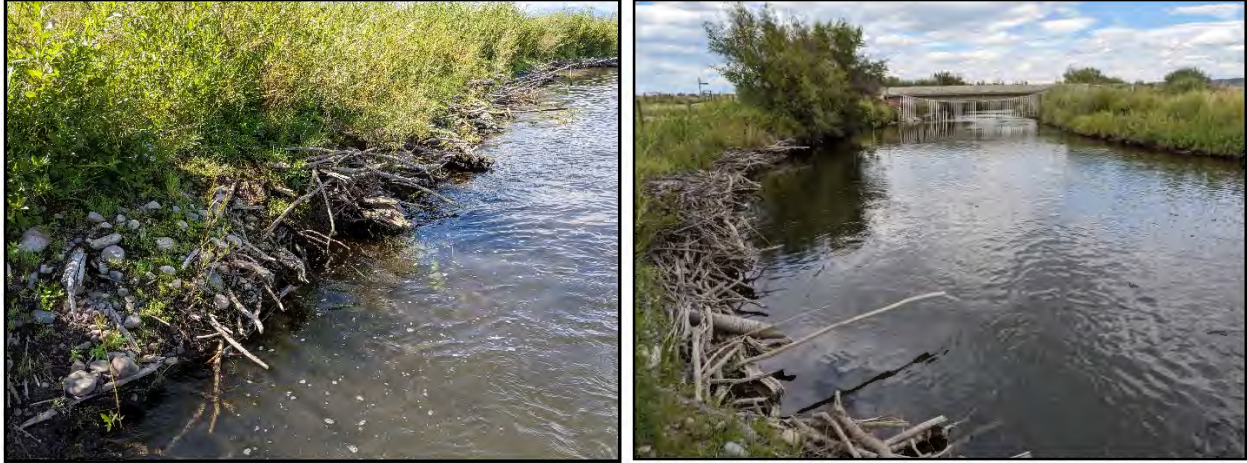
- Brush used to construct brush matrices was still intact at nearly all treatments.
- Willow growth and expansion was observed at nearly all treatments.
- Brush matrices located in more passive sections of the river included deposition at the base of the treatment where sedges or willows were establishing and encroaching into the channel beyond the face of the treatment.
- Brush matrices that had slumped (uncommon) provided a surface for willows to colonize on the face of the treatment. See left photo in Figure 10.
- Brush material in some brush matrices extends well into the channel providing overhanging cover. See right photo in Figure 10.

Figure 10. Left - Example of brush matrix providing overhanging cover and willows colonizing the face of the treatment (Phase 5). Right – Example of brush matrix with high woody cover behind bank and undercutting.

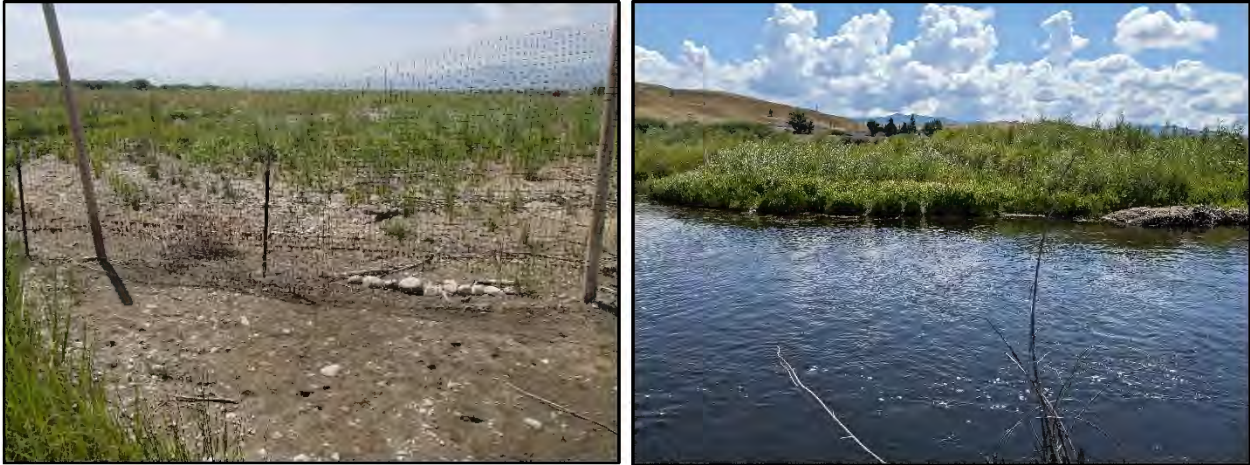
Figure 12. Phase 1 island right bank station 85+00 that has been frequently activated by high flow events in 2015 1 year after planting (left) and in 2023 (right).

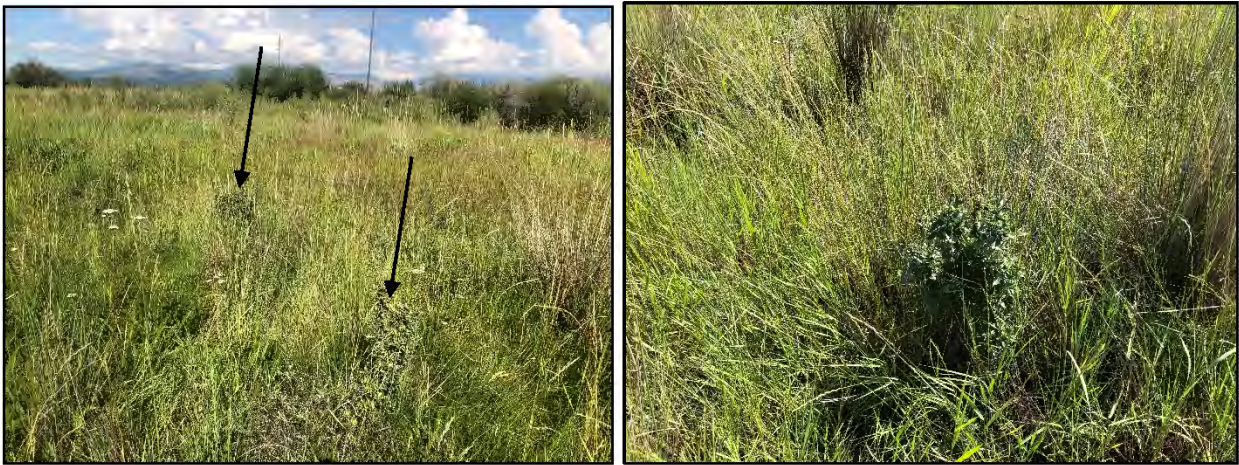
Figure 13. Heavy browse on silver buffaloberry planted in Phase 1. These plants are more than 10 years old and should be 10-15 feet tall.

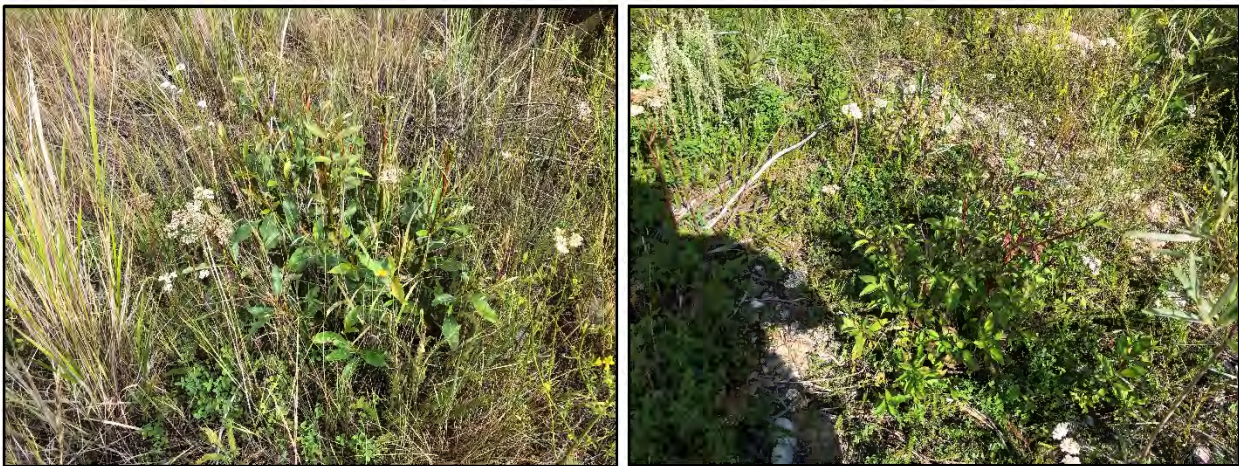
Figure 14. Ungulate browse on planted black cottonwood (left) and red-osier dogwood in Phase 2.

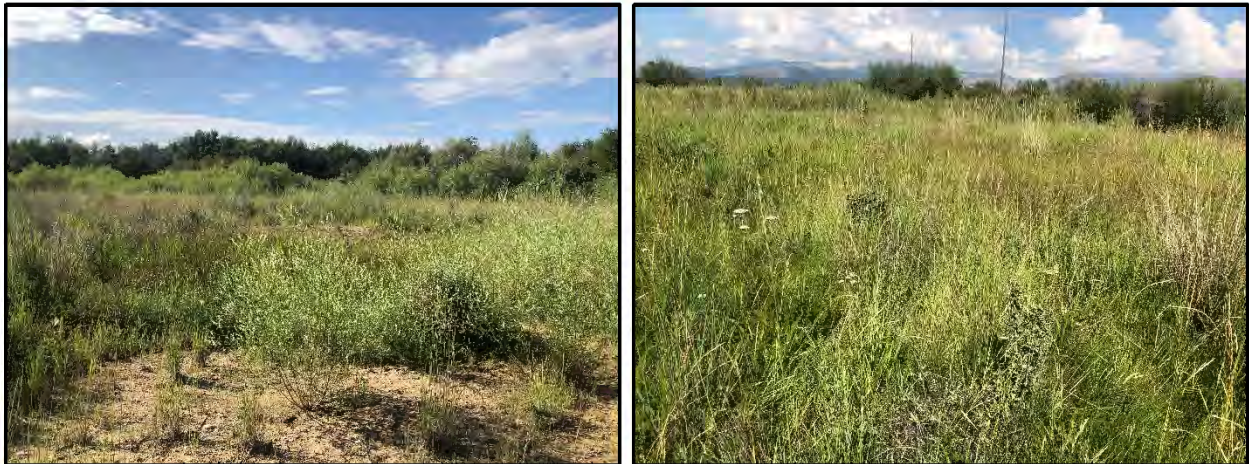
Figure 21. Left - Example of small area of bare ground and low cover in Phase 1. Right – Example of high cover of yarrow, Great Basin wildrye and slender wheatgrass in Phase 1 floodplain.

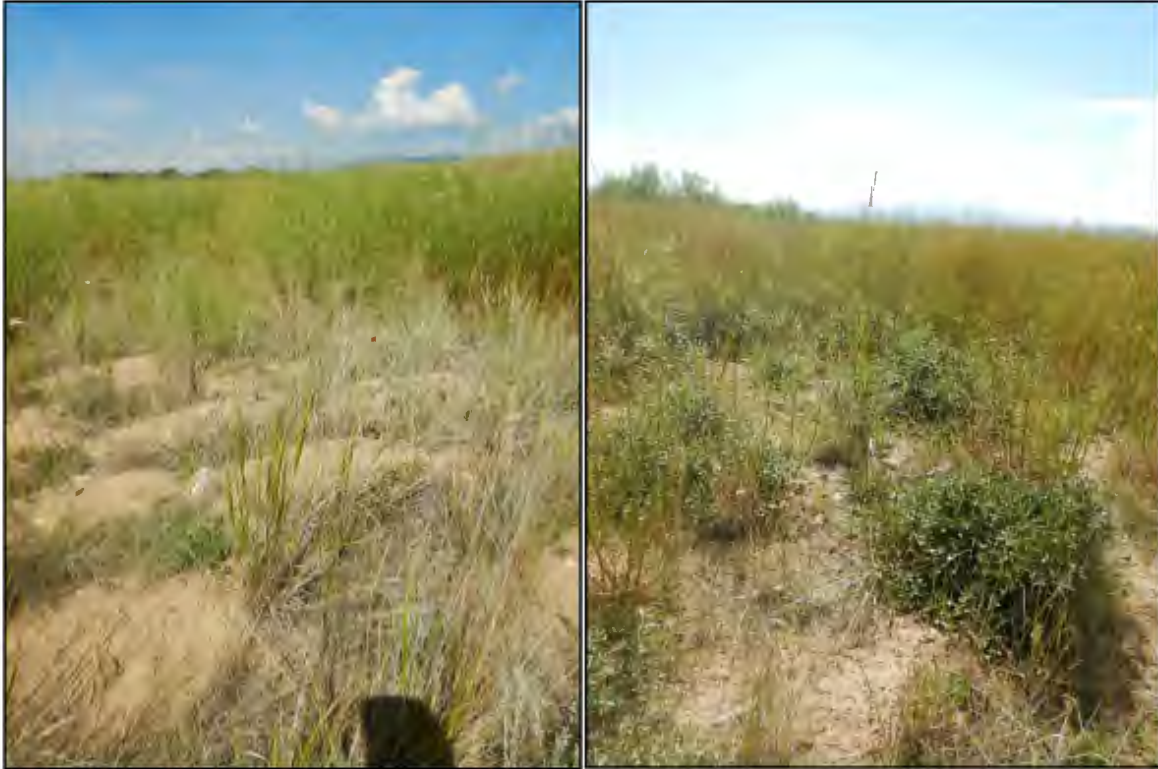
170+00 was constructed at a higher elevation compared to the rest of the floodplain. The dry conditions in this area have resulted in lower overall vegetation cover (Figure 22).

Figure 22. Area in Phase 2 with lower vegetation cover due to dry site conditions.

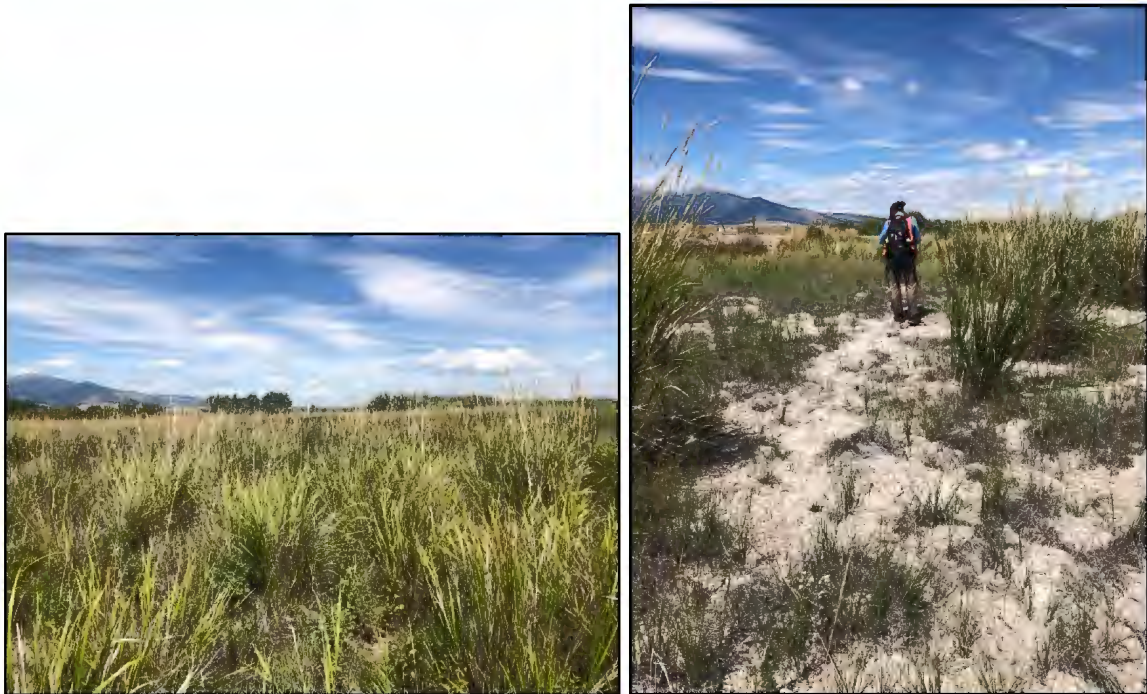
Figure 23. One of the largest areas of low cover observed in all phases is located in Phase 6.

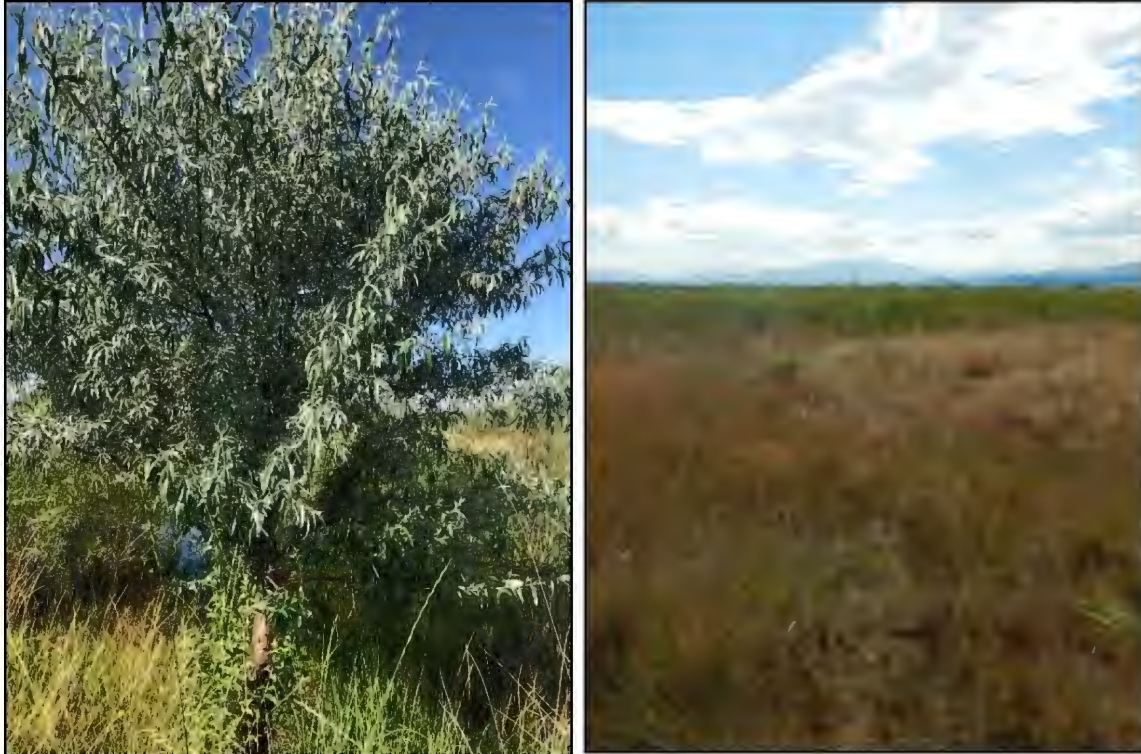
Figure 25. Russian olive tree in Phase 1 (left) and cheatgrass in Phase 2 (right).

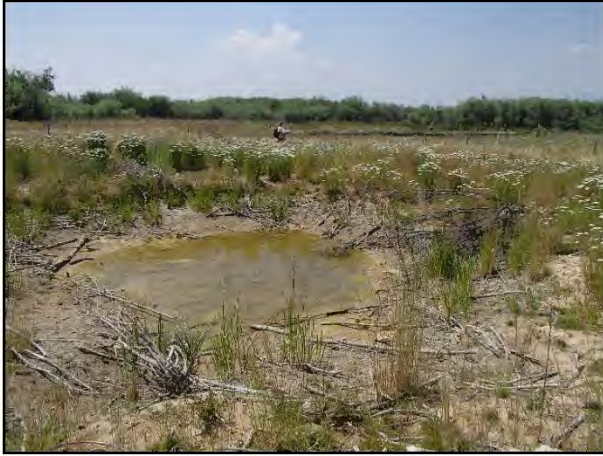
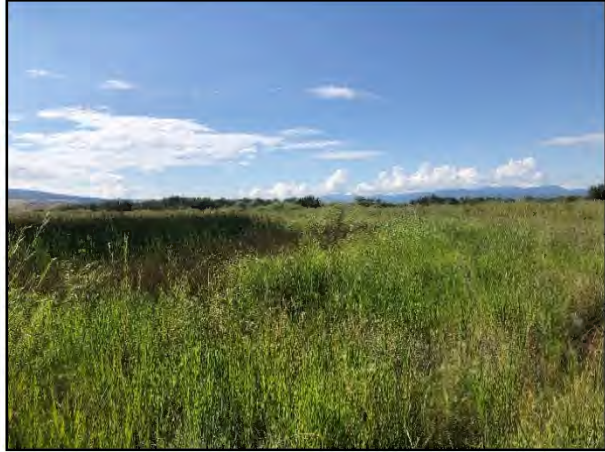
Figure 26. Phase 1 wetland feature in 2015 and in 2023.

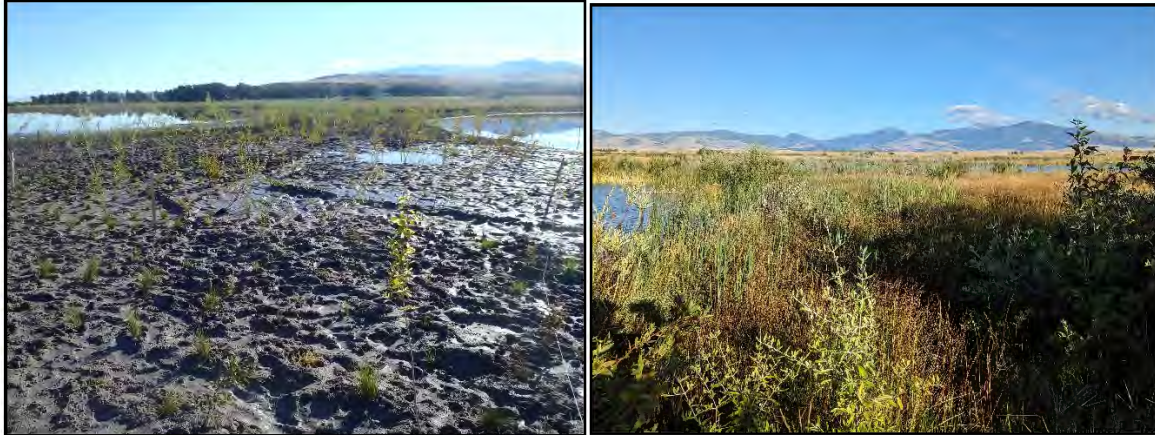
Figure 29. Phase 5 borrow area wetlands in 2017 and 2023.

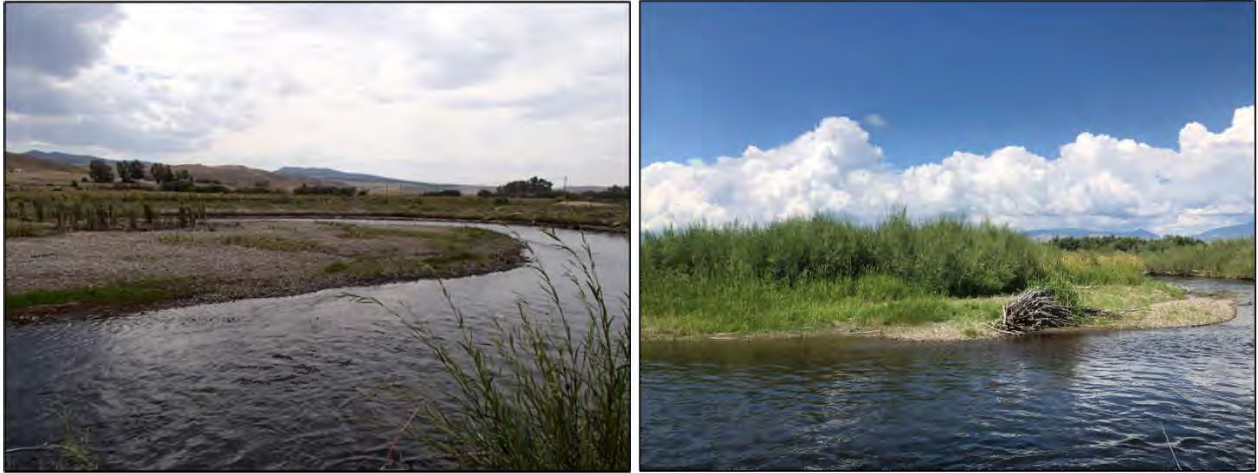
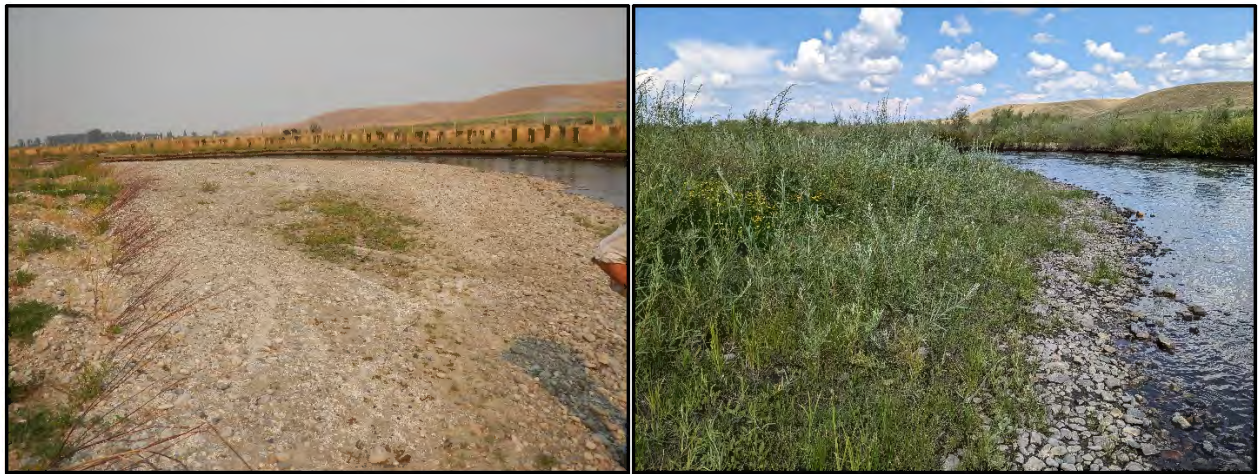
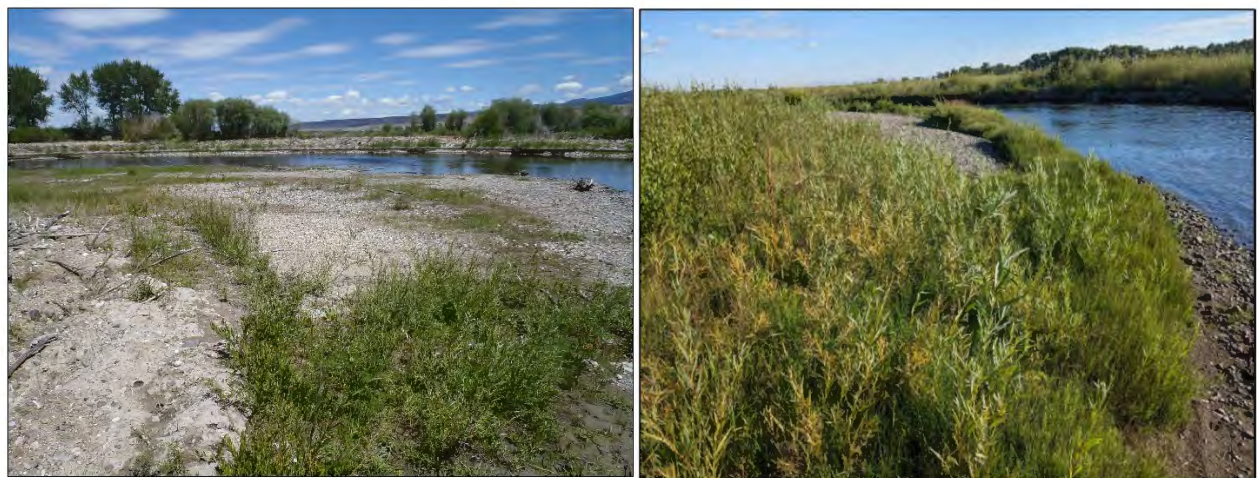
Figure 30. Phase 1 point bar in 2014 and 2023 (top). Phase 2 point bar in 2017 and 2023 (middle). Phase 5 point bar in 2016 and 2023 (bottom).

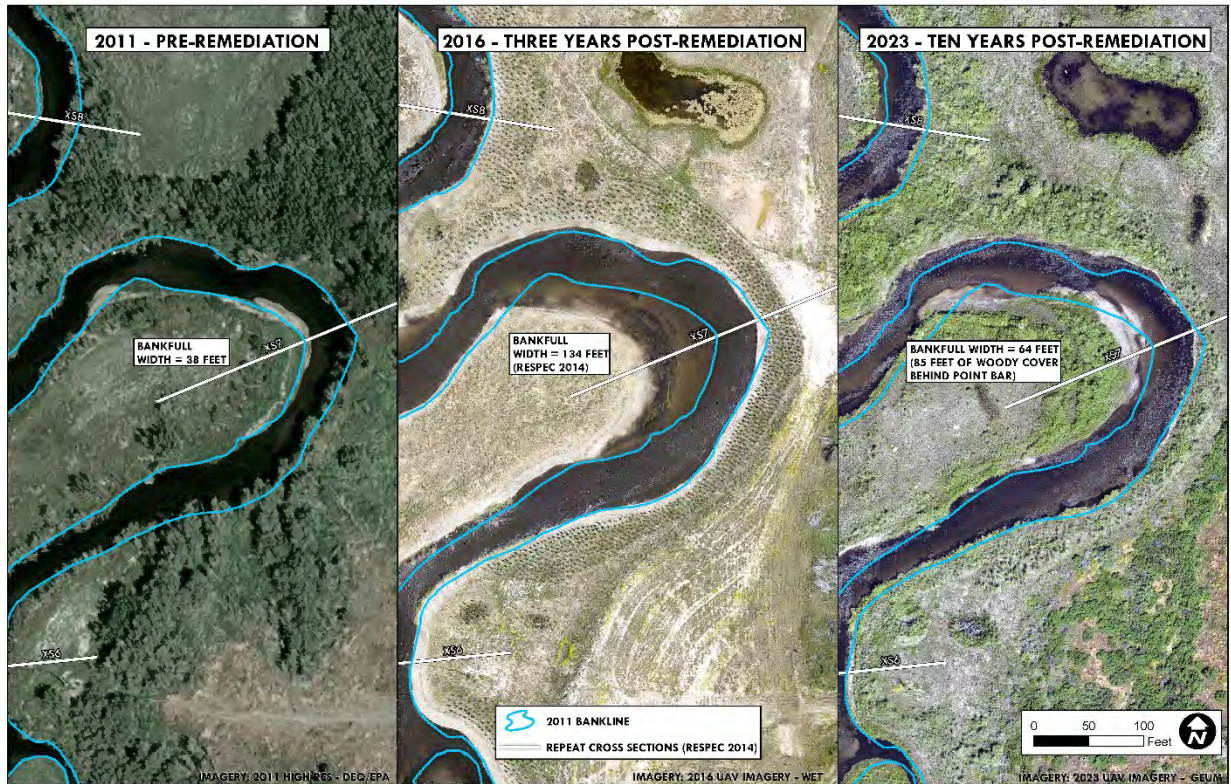
Figure 31. Point bar evolution in Phase 1. The left panel shows pre-remediation conditions, the middle panel shows conditions three years after remediation and the right panel shows the point bar ten years after remediation. The point bar was constructed wide to provide capacity for sediment storage and support natural colonization of willows and cottonwoods. The bankfull channel has narrowed 70 feet relative to 2016 conditions but is still wider than pre-remediation conditions.

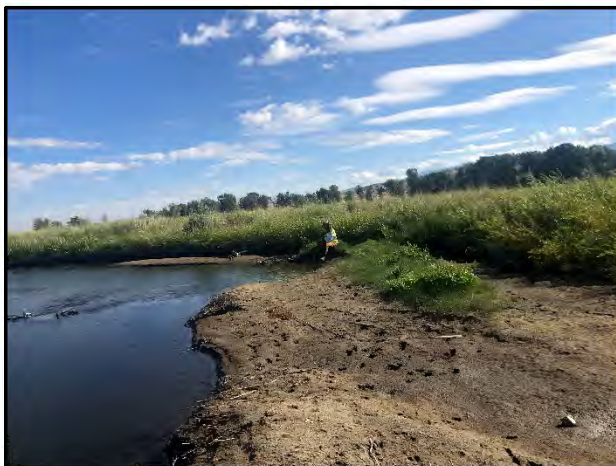
- Deposition at the downstream end of point bars was common along with raked wood recruited from the floodplain or streambank treatments (Figure 32).
- Point bars sometimes had dense patches of reed canarygrass, typically on more steeply sloped point bars, rather than on wide, shallow sloped point bars. Reed canarygrass establishment may also occur where fine sediment deposition occurs.

Figure 32. Fine sediment deposition on downstream end of point bar in Phase 5 creating diverse habitat that will likely support sedges or woody vegetation in the future. These areas of fine sediment deposition are also a risk for reed canarygrass colonization.
