MILLTOWN GREENLINE PHOTOS: 2010 - 2024

September 2024

Natural Resource Damage Program

Geum Environmental Consulting, Inc.

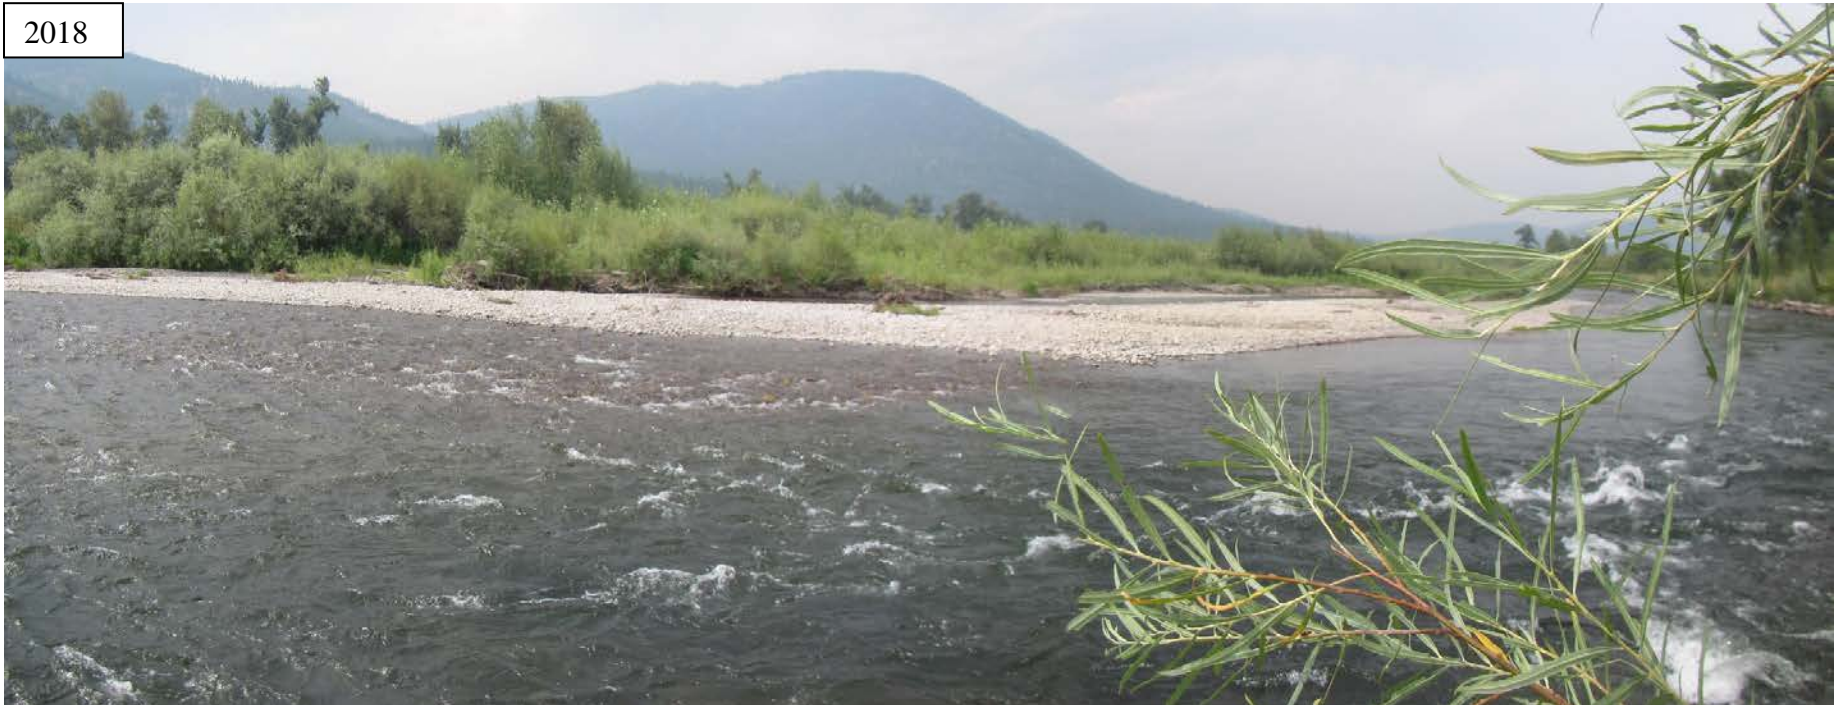
2018

Note: Willow growth and high water interfered with ability to capture downstream bankline.

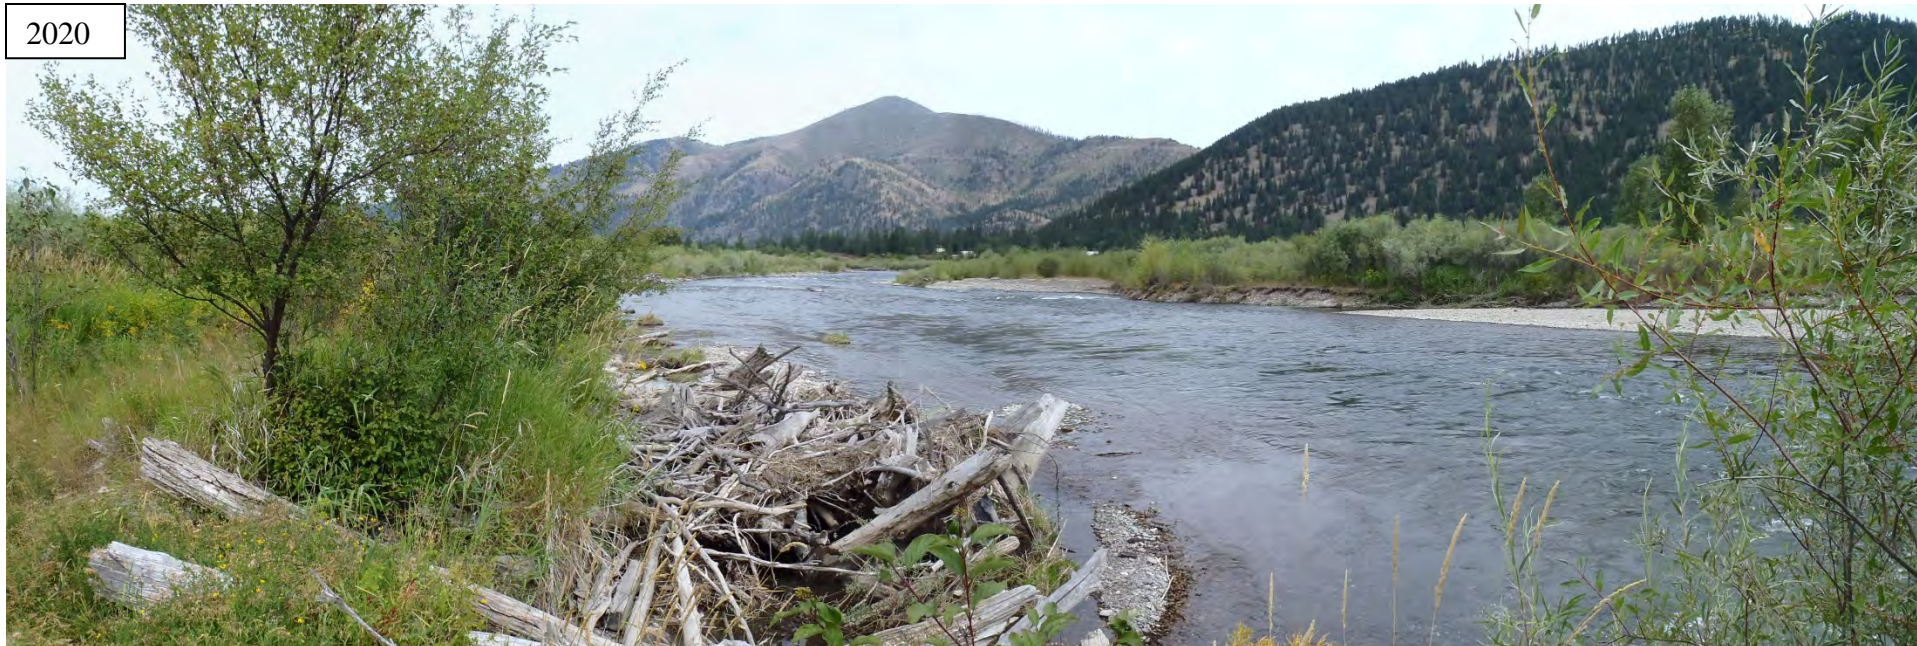
Note: Photopoint location moved to capture extents of bank erosion. Bank upstream of photopoint (including GL-10 photopoint location) is eroded to mature tree/shrubs.
