## Harvey Creek Fish Barrier and Culvert

## TECHINICAL MEMORANDUM

## Harvey Creek Fish Barrier and Culvert Mullan Trail

Trout Unlimited  
Granite County, Montana

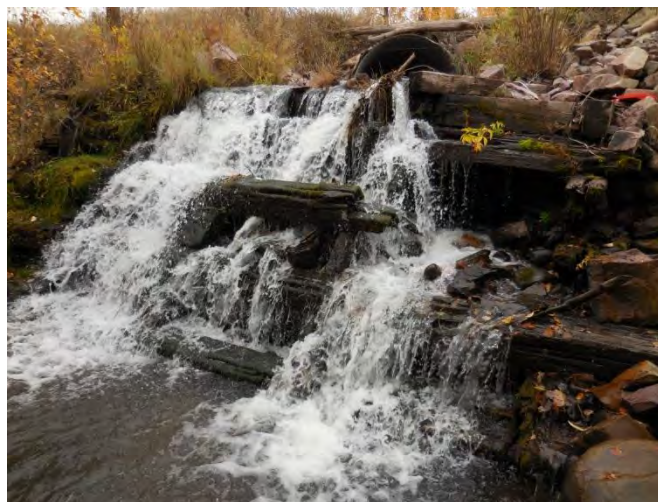
Overall, the structure is in poor condition. Sill #3 has experienced failure on the west side of the structure, with a significant portion of the member gone. The remainder of Sill #3 is tipping and structurally unsound. There are numerous areas of undermining throughout the structure, with the worst being under Sill #4 on the west face, with up to 4' of horizontal undermining. Additionally, Sills #1 and #2 are experiencing undermining (up to 2'-6" horizontal). The overall condition of the timber is poor-to-fair, with numerous areas of section loss, crushing, splitting and areas of decay. In general, 1/2" to 1" of surface decay is present with other areas of moderate to full decay. Timber borings were done in four locations throughout the structure. See the timber boring logs in Section 10. Vegetation and moss growth are present in numerous locations throughout the structure.

*Figure 4: Existing Fish Barrier*

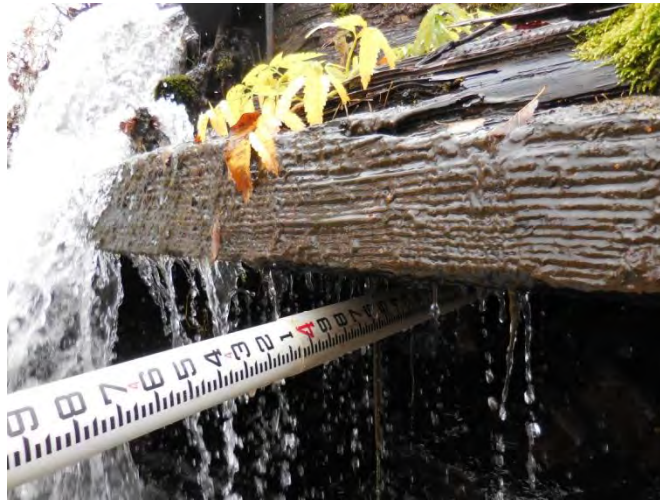
*Figure 5: 4' horizontal undermining under Sill #2*

The fish barrier structure is in poor condition. The primary structural concerns are timber structural member loss, significant undermining and condition of the timber materials. Currently, the undermining would likely yield failure more quickly than any other method. If undermining continues of the timber sills, members could fail, resulting in material loss, eventually leading to significant headcutting and potential roadway loss upstream. It is estimated that due to the undermining concerns and the timber structural concerns, this structure has approximately 5-10 years of useful life left before replacement.

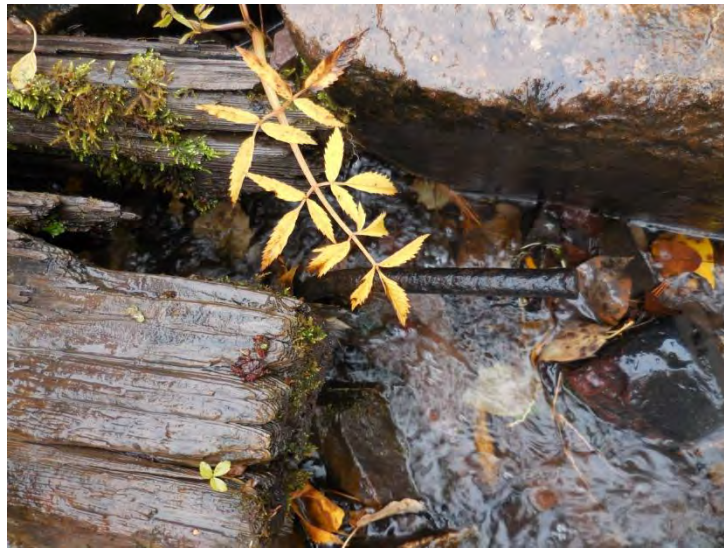
Repairs have been previously attempted on the existing structure and consisted of installing rebar into crib wall members to provide additional lateral and vertical support. The date of the repair is unknown. The repairs appear to be mostly cosmetic and likely do little to prevent the current stability issues of the wall.

*Figure 6: Previously attempted repair has failed*

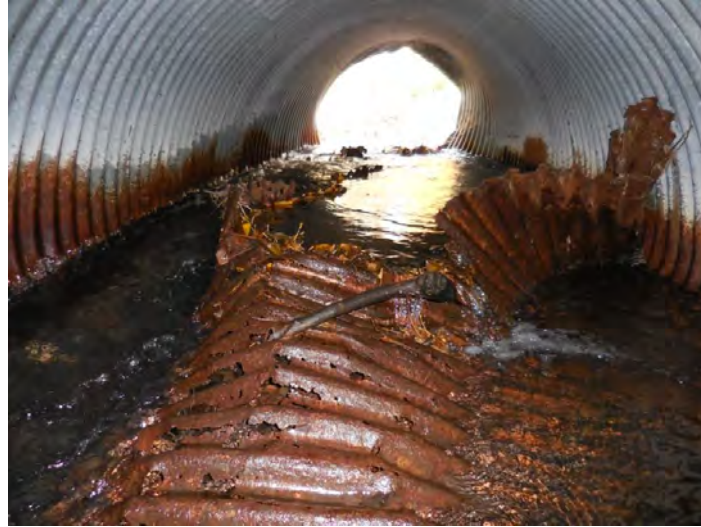
The culvert is in very poor condition and is currently in a stage of failure. The culvert invert is has completely failed for a length of 10' near the culvert inlet. The invert has complete section

loss and the bottom has ruptured. Because of the invert failure, some piping under the culvert is present. The bottom of the pipe has visible undulations, possibly a result of piping and differential settlement.

*Figure 7: Culvert failure near inlet*

As stated previously, the existing culvert structure is currently in state of failure. The culvert invert has completely failed for a length of 10' near the upstream inlet. Additionally, there are areas of deformation throughout the pipe and corrosion in the lower 18" of the pipe. The culvert invert provides significant structural support, and a culvert invert with full section loss results in areas of significant point loading, which can result in deformation. It appears the failure is located under the upstream roadway lane and due to the minimal cover over the culvert, will likely result in slow deformation (until complete failure). Estimating time to failure is challenging and especially so with a lightly used roadway with occasional high loads (log trucks, concrete trucks, etc.).

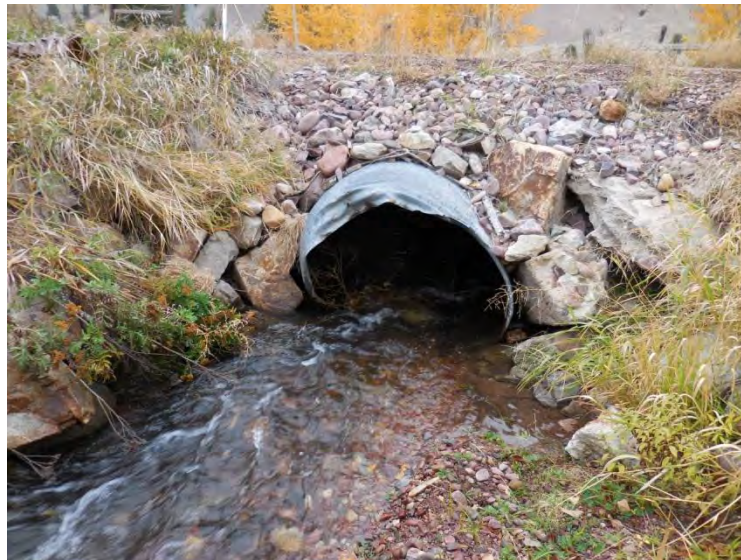
Additionally, minor to moderate deformation is present throughout the culvert on the walls and the top of the pipe. Moderate corrosion is present elsewhere in the culvert invert and sides extending 18" vertically from the invert. Both culvert ends exhibit moderate damage. The upstream end of the culvert is not aligned properly to the stream and should be moved to the west approximately 3' to 4' to promote better hydraulic efficiency. The existing length of the culvert appears sufficient, though downstream could be lengthened 4' to 5' to better retain road fill.

*Figure 8: View of existing culvert inlet*

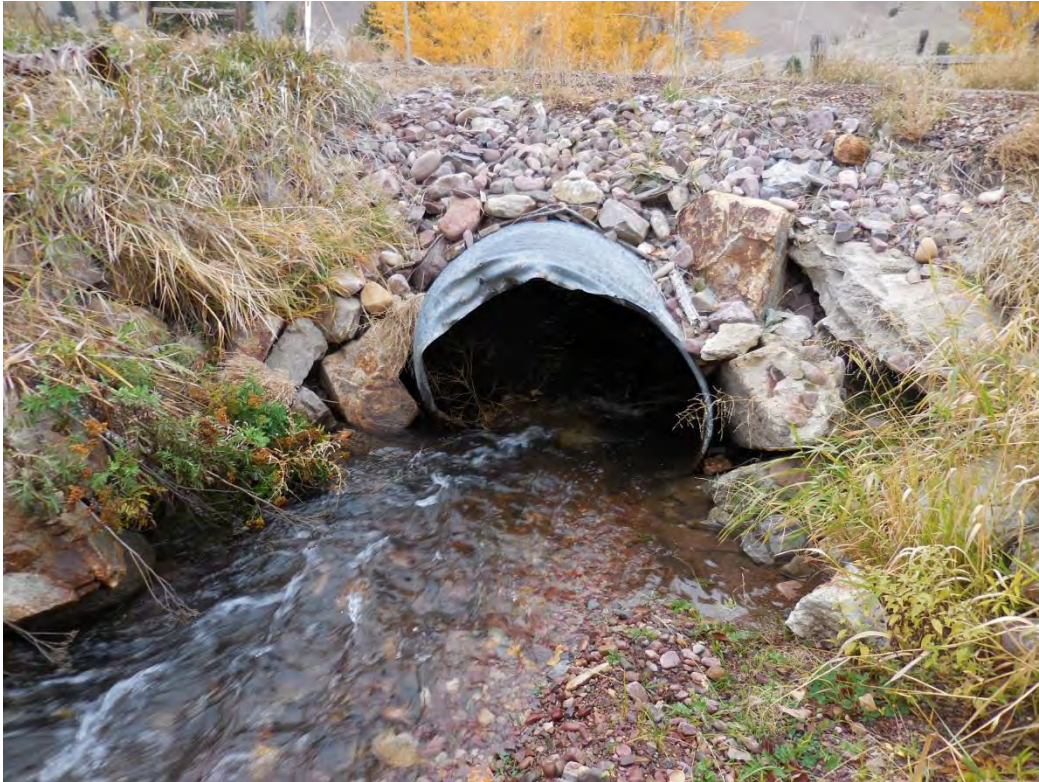
**Photo #3 – View of existing culvert inlet, note poor stream alignment and aggradation upstream.**

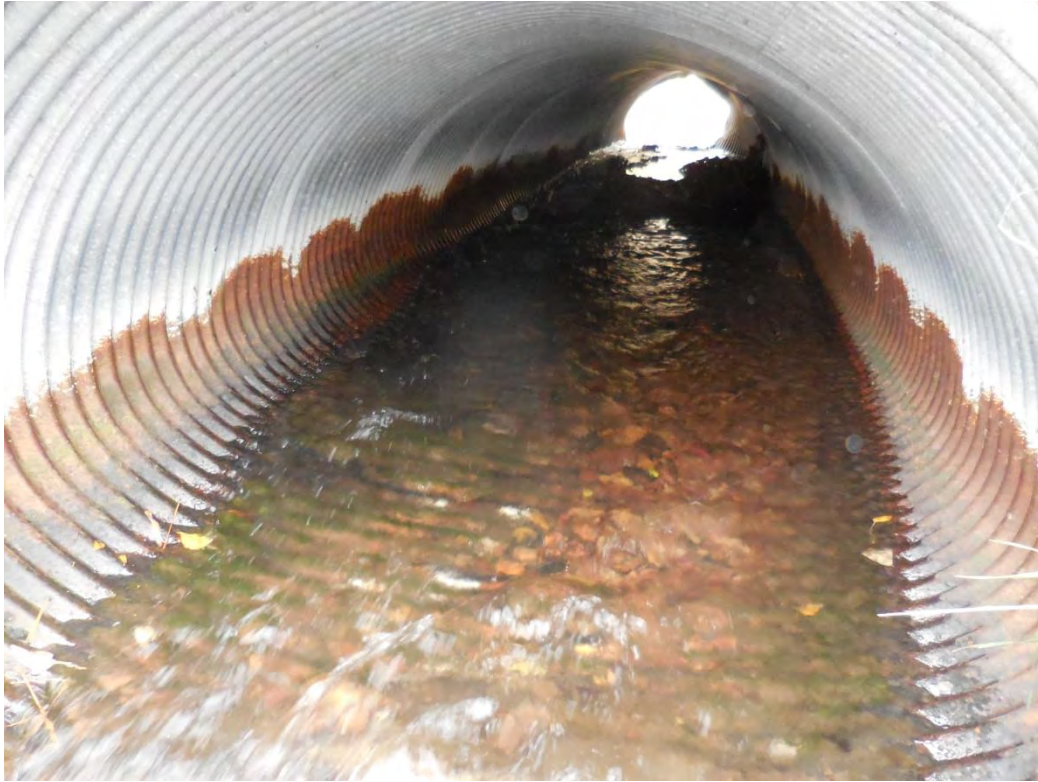
**Photo #7 – View of culvert condition near outlet. Note corrosion and deformation.**

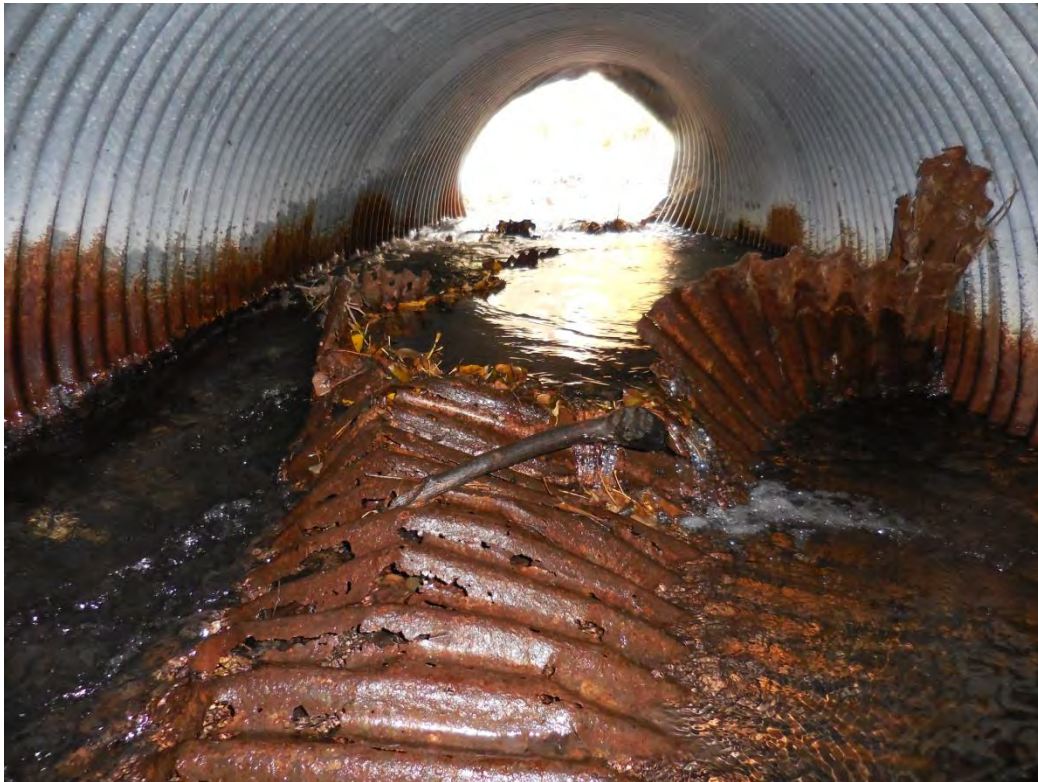
**Photo #8 – View of culvert failure approx. 15' from inlet. Note complete section loss and corrosion.**

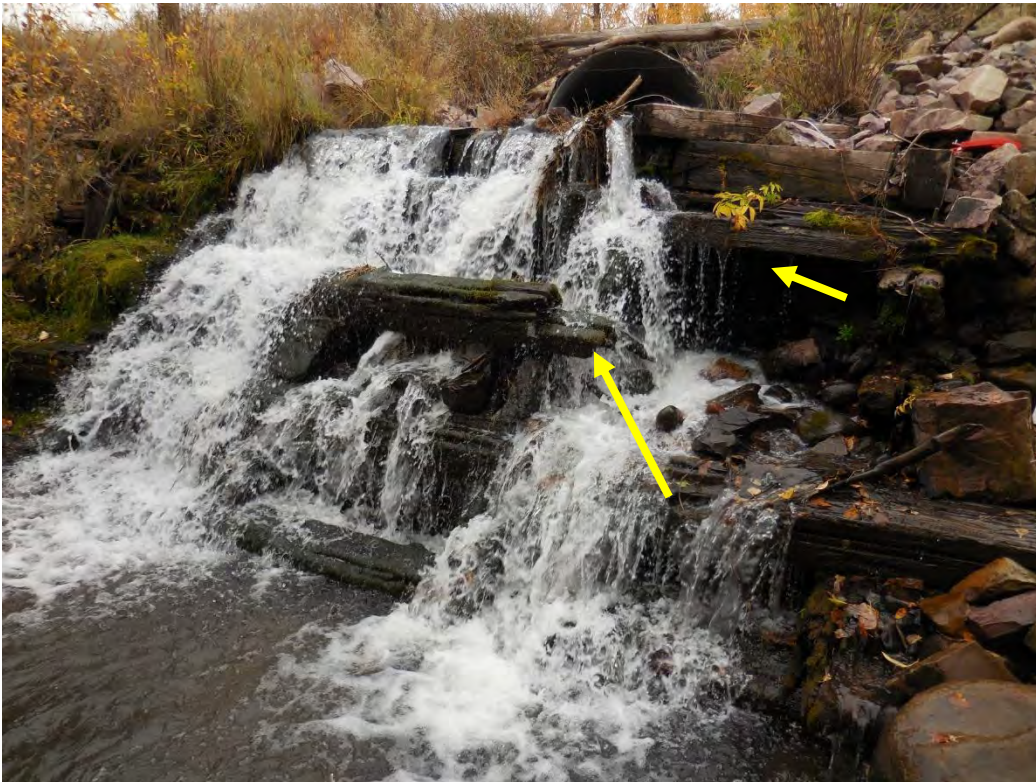
**Photo #10 – Another view of timber fish barrier. Note crib member loss at right and area of visible undermining.**

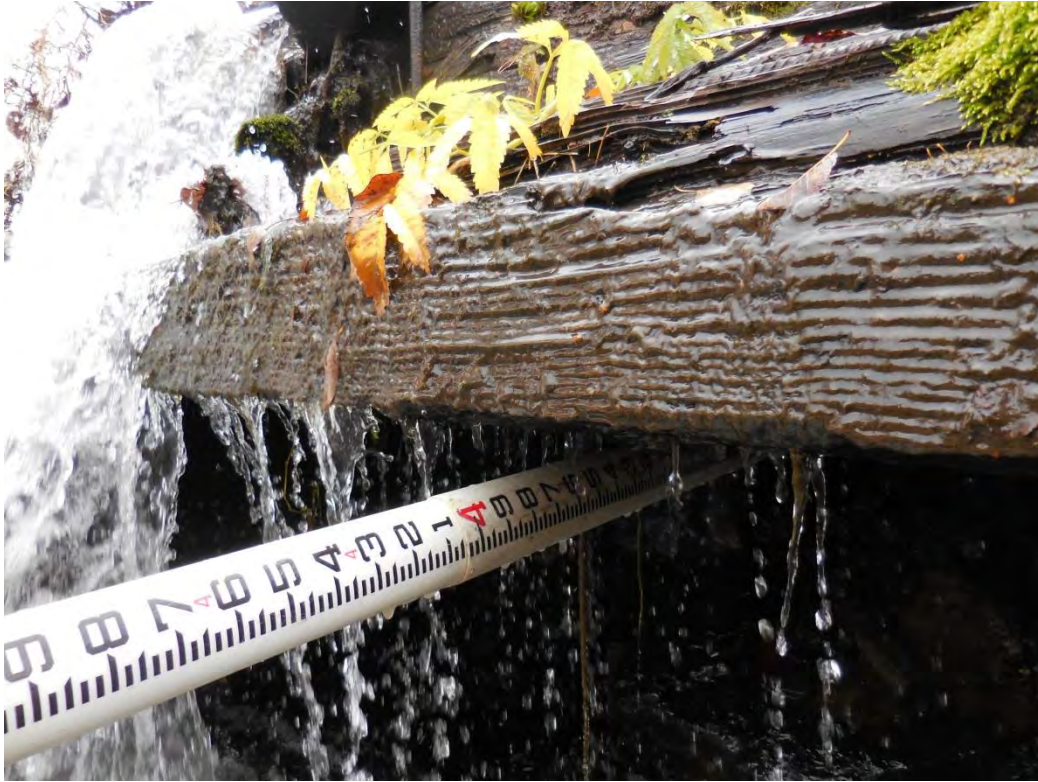
**Photo #11 – View of undermined (4') area under Sill #4 at west.**

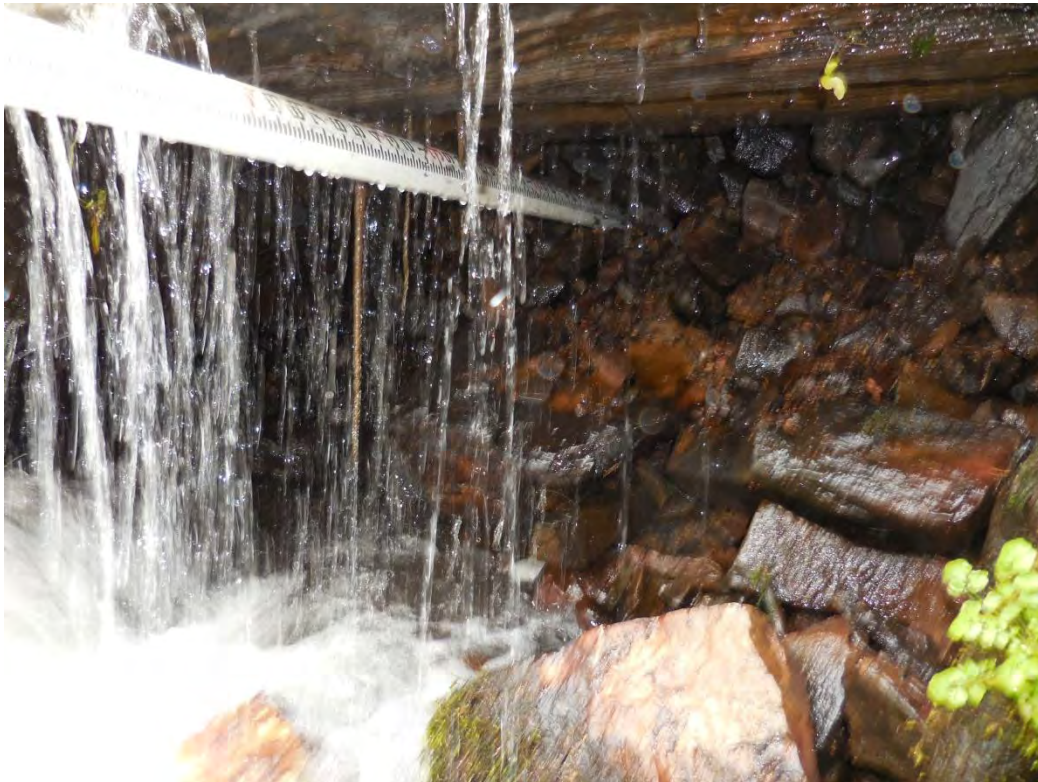
**Photo #12 – Another view of undermining under Sill #4.**

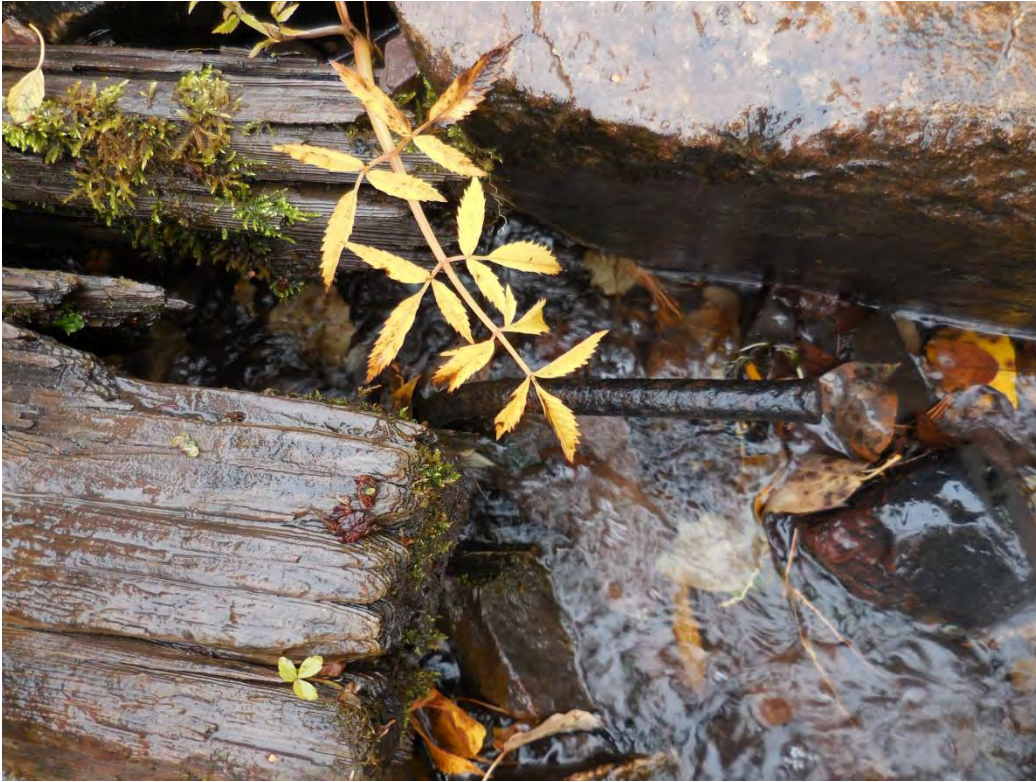
**Photo #13 – View of past repair efforts with rebar on wall members, note split and ineffectiveness of rebar.**
