2013

Blacktail Creek Assessment

Capri Gillam, Tom Waring, Seth Reedy

Department of Environmental Engineering

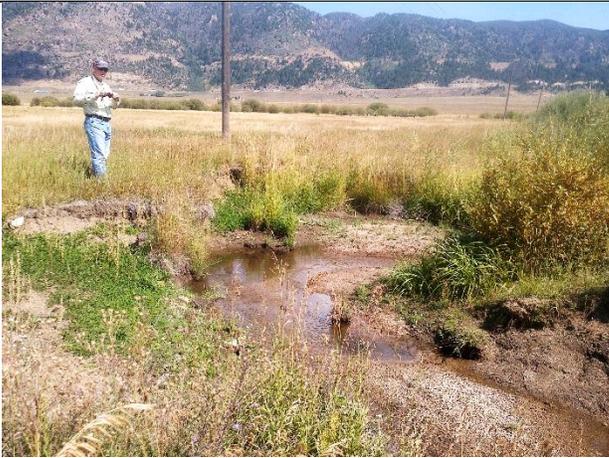
Photo 17

Possible Projects: The flow through the levy breach is causing some bank erosion immediately downstream (**Photo 17**). This erosion could be stemmed via construction of a new water control structure with an engineered outlet or through bioengineering treatment of the eroding banks. Further study and consultation with the landowner is recommended.

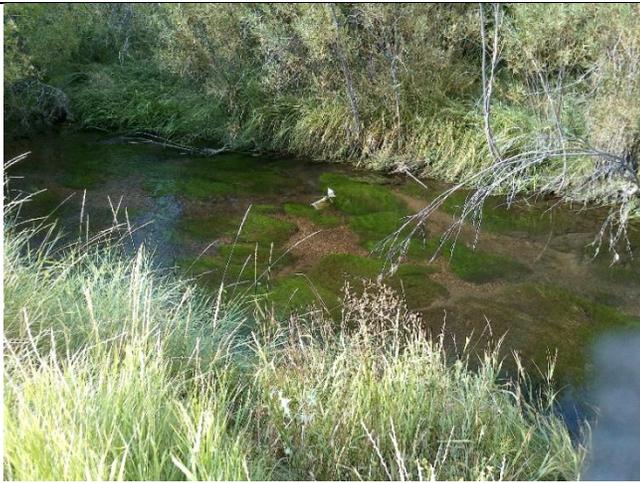
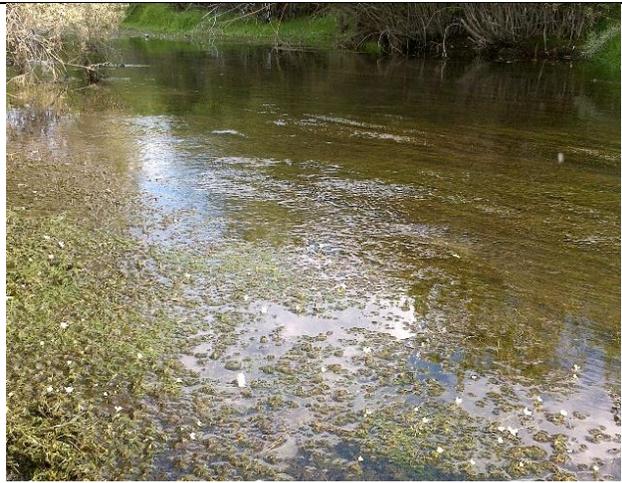
Photo 39

Riparian Vegetation: Vegetation along this reach is dominated by willows with five species being observed. Older generation cottonwoods are also present. Shallow rooted grasses planted in Father Sheehan Park provide little erosion protection for the banks. The willow zone in this reach is anywhere from 5 to 20 feet outside the channel. Some honeysuckle and rose bushes also grow on drier banks. In the riparian areas west of Harrison Avenue, the slower backwaters have an excessive amount of floating algae and rooted vascular aquatic plants are numerous. Abundant algae and rooted vascular aquatic plants suggest strong nutrient loading (**Photos 39 & 40**).

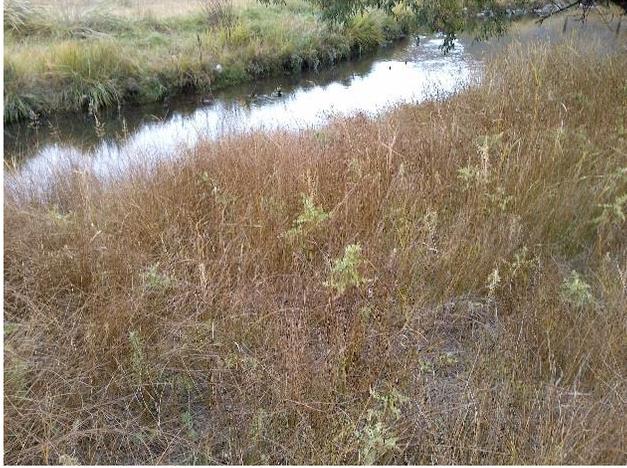
Photo 43

Overview: As the channel leaves the double culvert under Kaw Avenue it enters a gentle meander with a walking trail on the north side and I-90 on the south side of the channel bank. There is a large pool created by an older beaver dam below the double culvert. The channel then flows past the Butte Chamber of Commerce parking lot and a USGS monitoring station before it flows under the bridge at George Street. Below George Street large rock has been placed on both banks to help control erosion from past disturbances. Large patches of Canadian thistle were observed on the upper section of the reach (**Photo 43**).
