Riparian Habitat Assessment for Flint Creek and Boulder Creek Granite County, Montana

Environmental Services Contract #SPB-12-2177V

Task Order 1.28

January, 2015

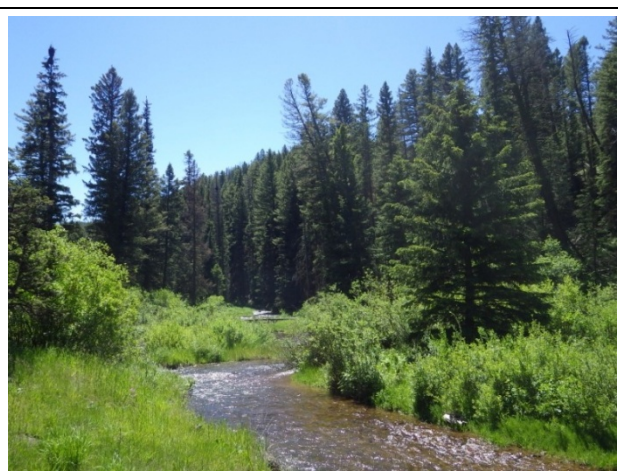
Conditions at downstream end of F02

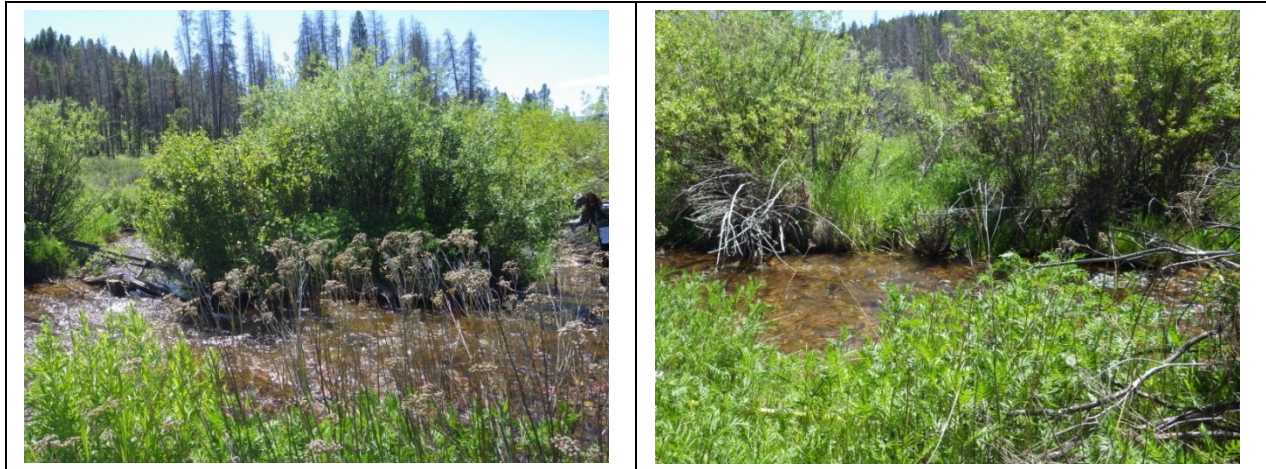
Conditions at upstream end of F03

- Weed control- common tansy is outcompeting and reducing regeneration of native riparian vegetation
- Revegetation of treated areas
- Riparian and floodplain restoration using bioengineering techniques to raise the stream level and reactivate some overflow channels, provided adjacent landowners can tolerate a higher water table
- Construction to increase channel sinuosity- potentially including three subreaches upstream

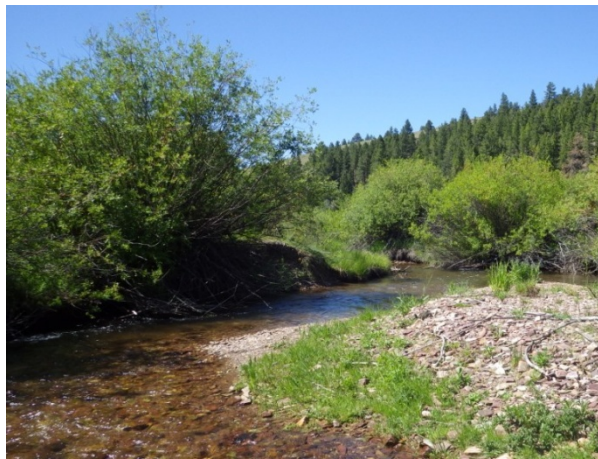
Conditions at upstream end of F04

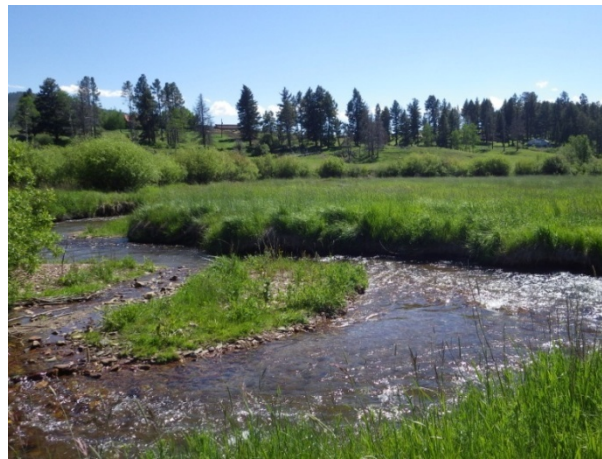
Grass-covered banks alternate with willow-dominated areas in F04

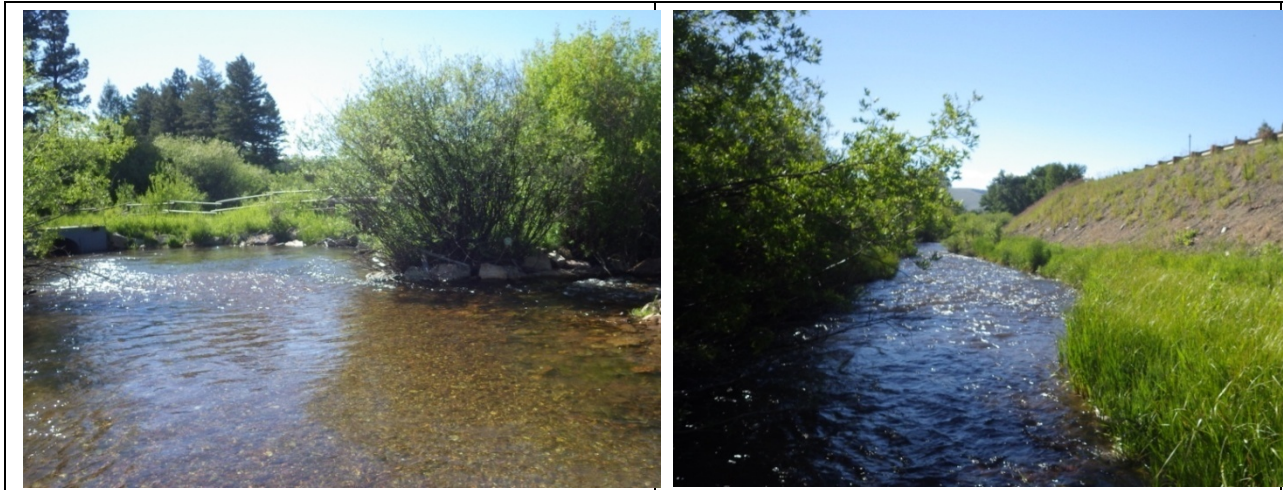
Channel conditions at large diversion mid-reach, F05

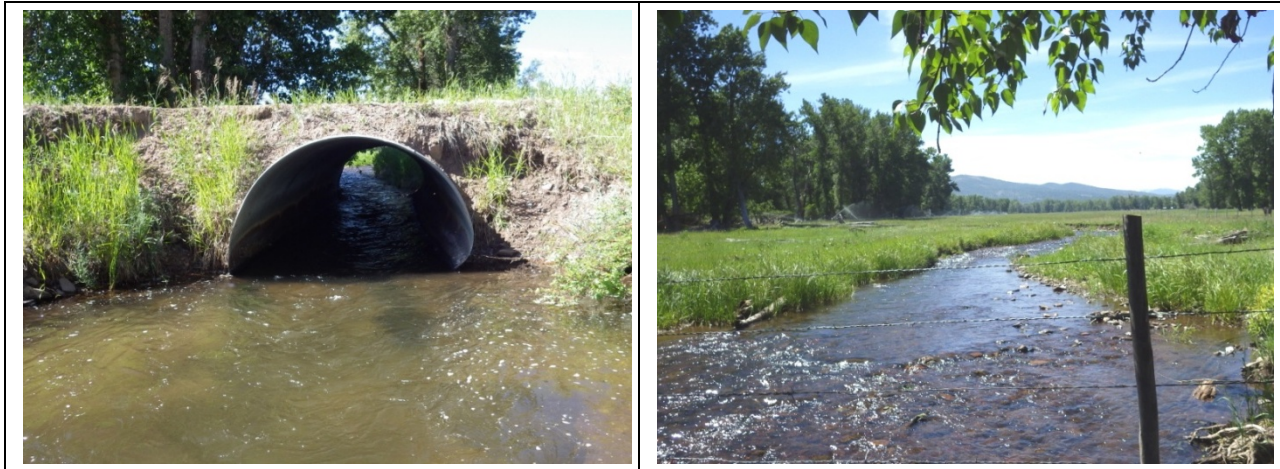
Undersized culvert with eroding road fill at Porters Corner Lane, F06

- Upgrade crossing at Porters Corner Lane to a bridge or large bottomless culvert that spans the natural channel width
- Riparian revegetation to stabilize areas disturbed by culvert replacement
- Review riparian grazing management and establish a new riparian fenceline to provide wider buffer. Could include temporary or long-term riparian fencing with water gaps, supplemented with riparian shrub planting in grass-dominated areas in downstream half of the subreach
- Bioengineering and riparian planting to stabilize high eroding streambank at the upstream end of the subreach
- Noxious weed control incorporated with restoration and fencing efforts

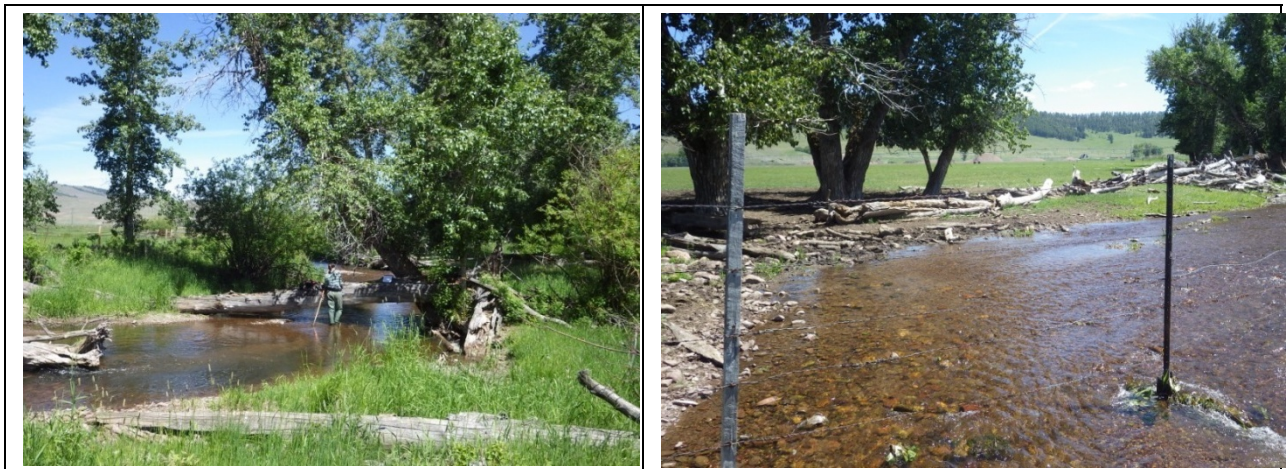
View toward upstream boundary of subreach F07ra. Mature cottonwoods are present but grasses dominate the riparian area

- Riparian planting and bioengineering to restore riparian vegetation to the floodplain, stabilize eroding banks, narrow the stream channel and improve aquatic habitat
- Outreach with landowner to develop a plan for mutually beneficial riparian grazing management

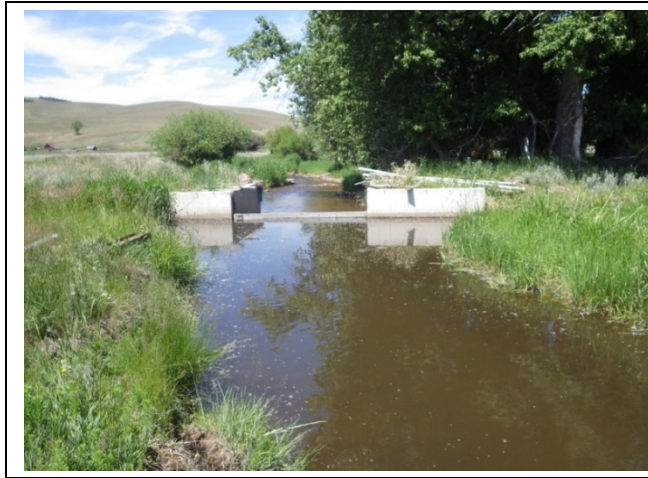
Diversion and eroding left bank at F07

- Re-establish cover of riparian shrubs along the stream, which would likely require active planting and temporary or long-term riparian fencing.
- Bioengineering techniques, such as brush fascines or post and woven branch structures would accelerate channel narrowing and improve aquatic habitat
- Upgrade current weir to improve fish passage and function and prevent fish entrainment, depending on interest by irrigators and partnering entities

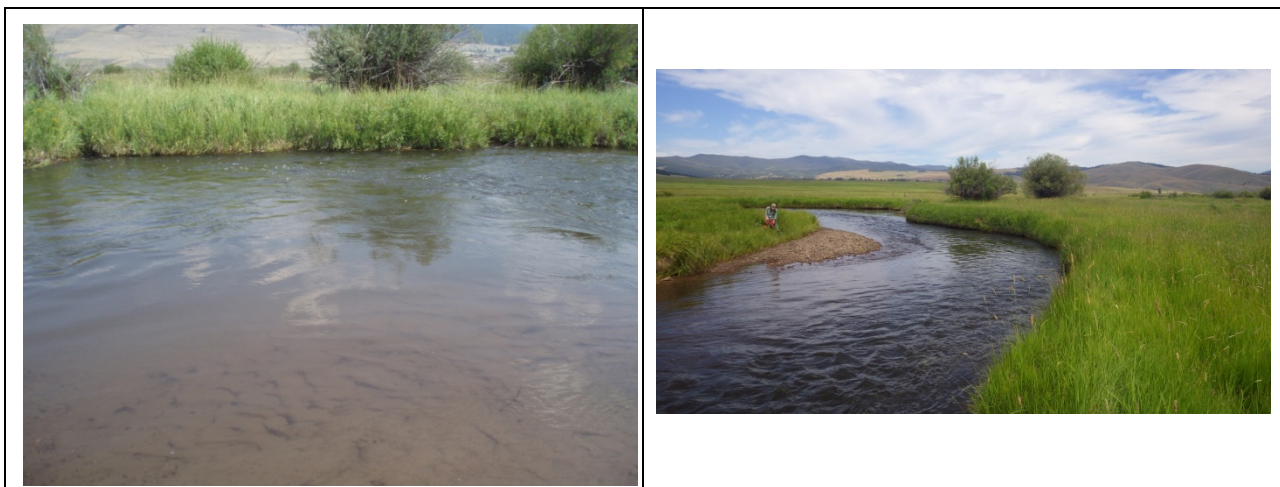
View across stream- sediment deposits and typical riparian vegetation in F10

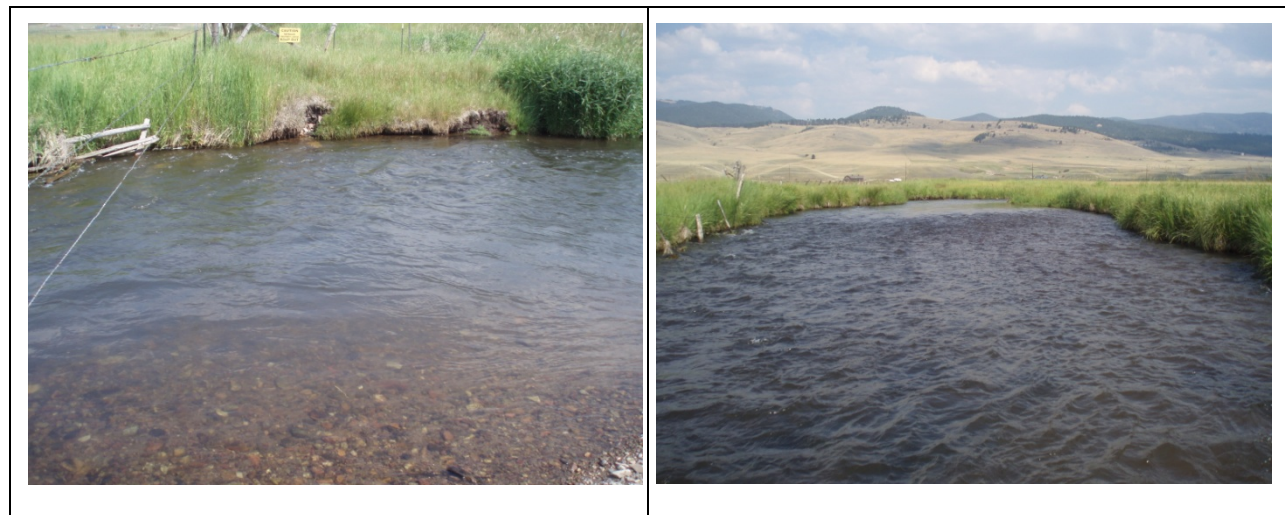
View across channel at downstream end of F11- bank conditions and gravel/fine substrate

- Planting of riparian vegetation or willow stakes with protection (may involve weed matting)
- Grazing management alternatives to remove cattle from banks at critical times

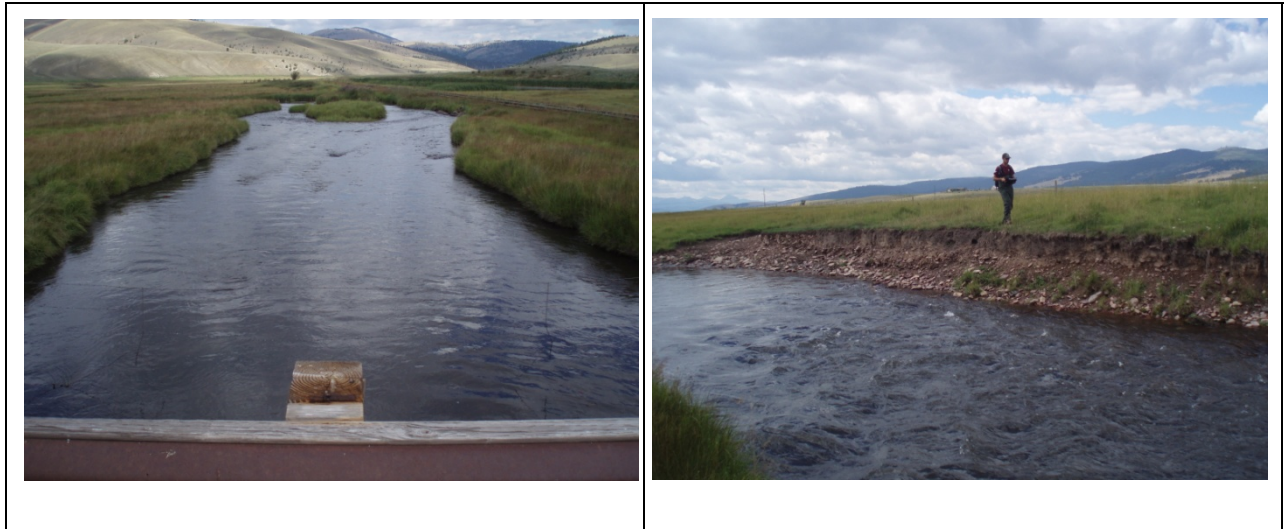
View downstream from top of subreach F13. Note railroad grade restricting floodplain access on river right

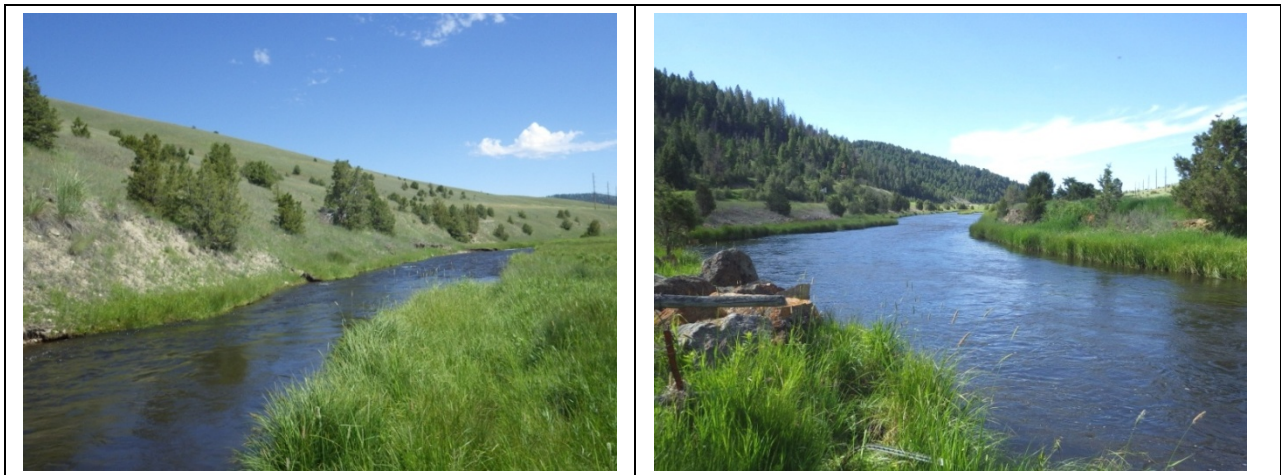
Limited riparian vegetation at the upstream end of the subreach F14

- Riparian shrub planting and browse protection
- Bioengineering of eroding banks
- Install hardened approaches for livestock
- Control of noxious weeds
- Restore meanders and floodplain connectivity in areas constricted by the historic railroad grade

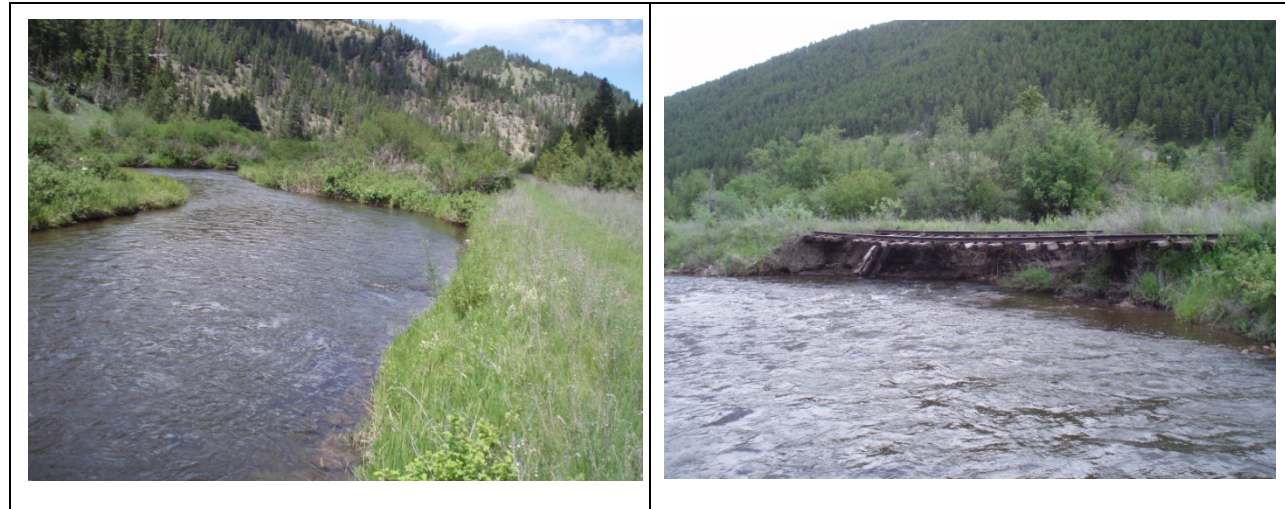
View downstream of typical bank conditions and weed incursions from old railroad bed in F18

- Connect stream to active floodplain- by removing railroad grade entirely or in specific locations
- Weed control along railroad grade and floodplain
- Enhance existing conservation land use practices

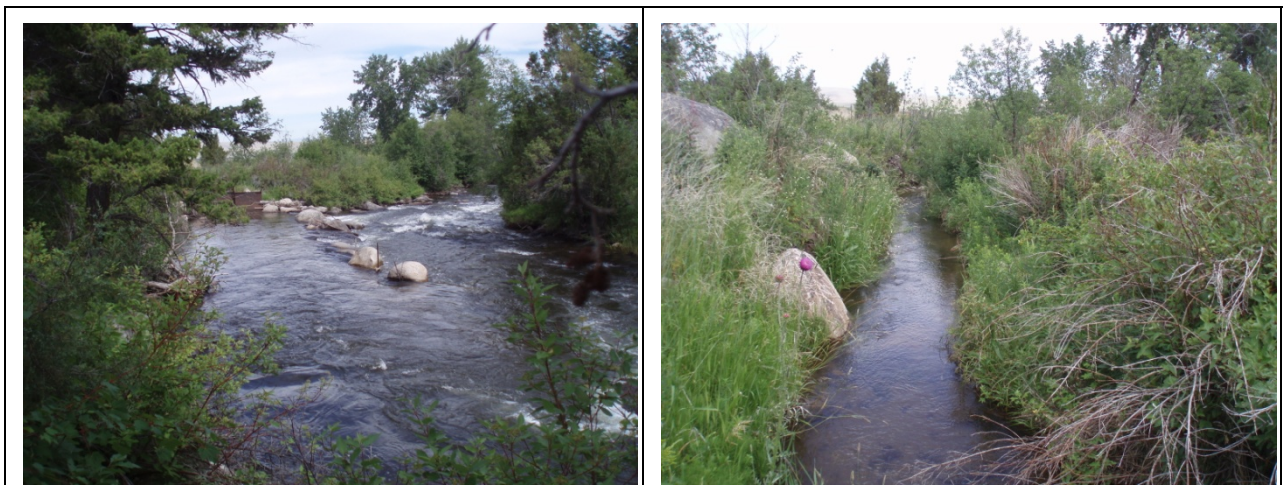
Stream diversion on river left in F21

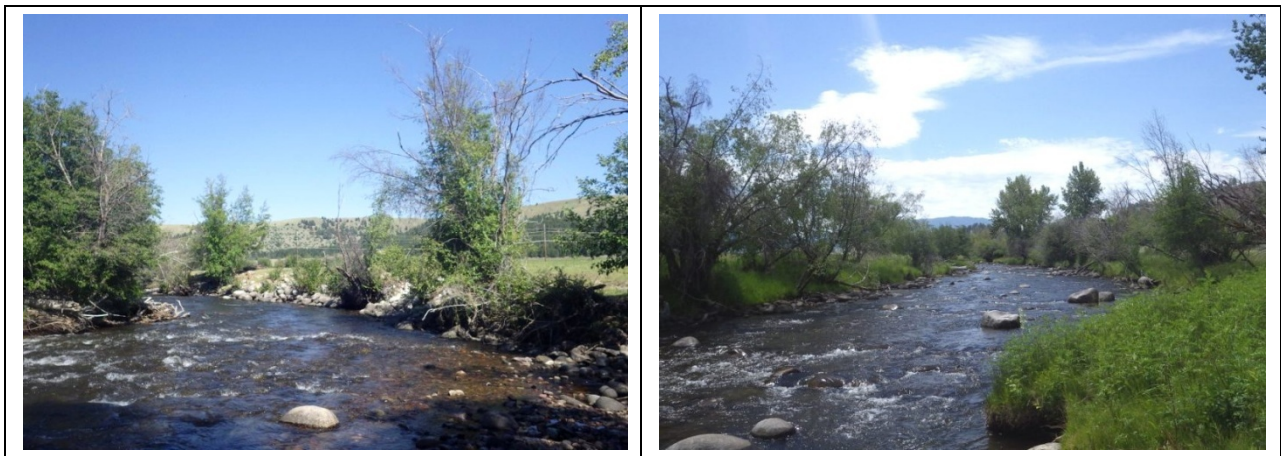
Wide channel and sparse riparian shrubs cover to hold banks along hay fields in F25

- Grazing management- rest the riparian area from livestock use for a few years
- Outreach with landowner to develop a revised grazing management approach before any active restoration
- Installing browse protection for riparian shrubs
- Addition of large wood and bioengineering banks to improve aquatic habitat
- Improve diversion at the upstream end of the subreach to improve fish passage

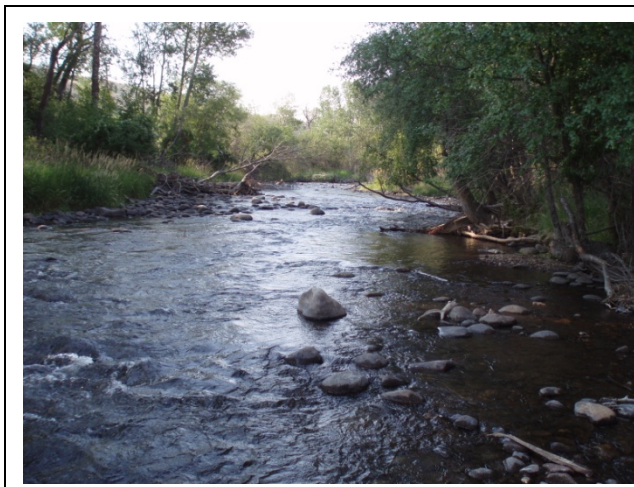
View upstream in subreach F26 showing desired vegetation and bank conditions on right and reed canary grass on left

- Weed matting on reed canary grass and riparian planting (after 2 seasons)
- Widen and increase density of riparian vegetation buffer in upper half of subreach

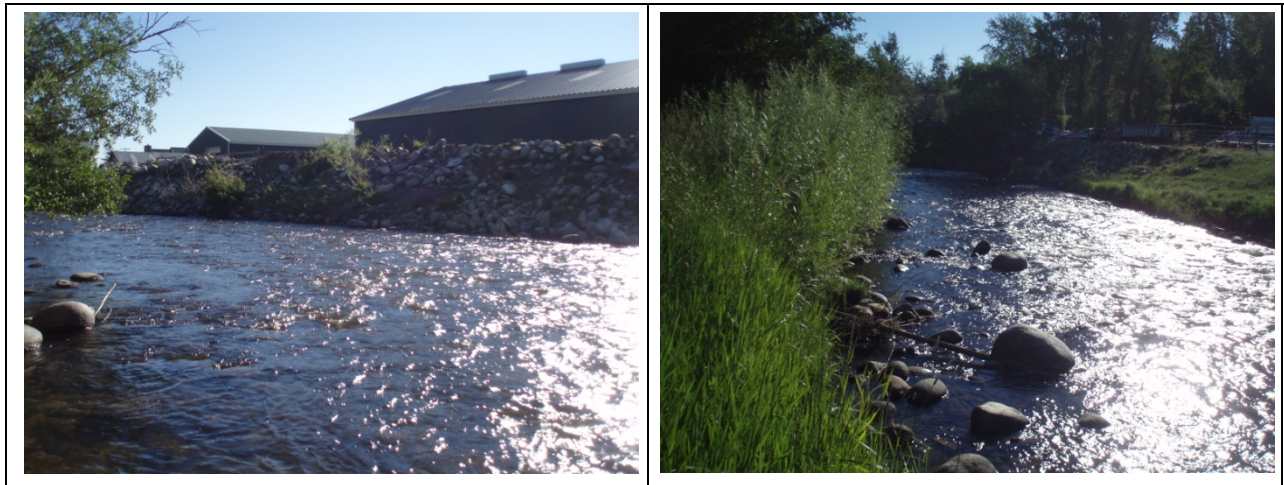
Armored bank on river right to protect property at F30.

- Conservation of streamside fencing
- Stabilization of high and bare banks on river right with bioengineering techniques, willow staking

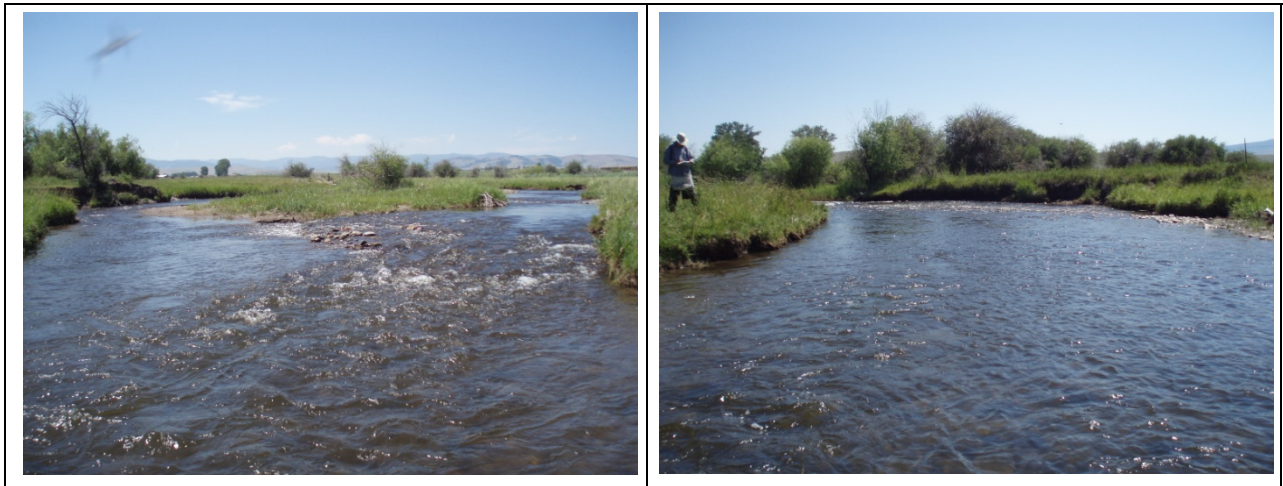
View upstream of typical stream conditions in F32: mid-channel bar, eroding banks, grass/sedge banks

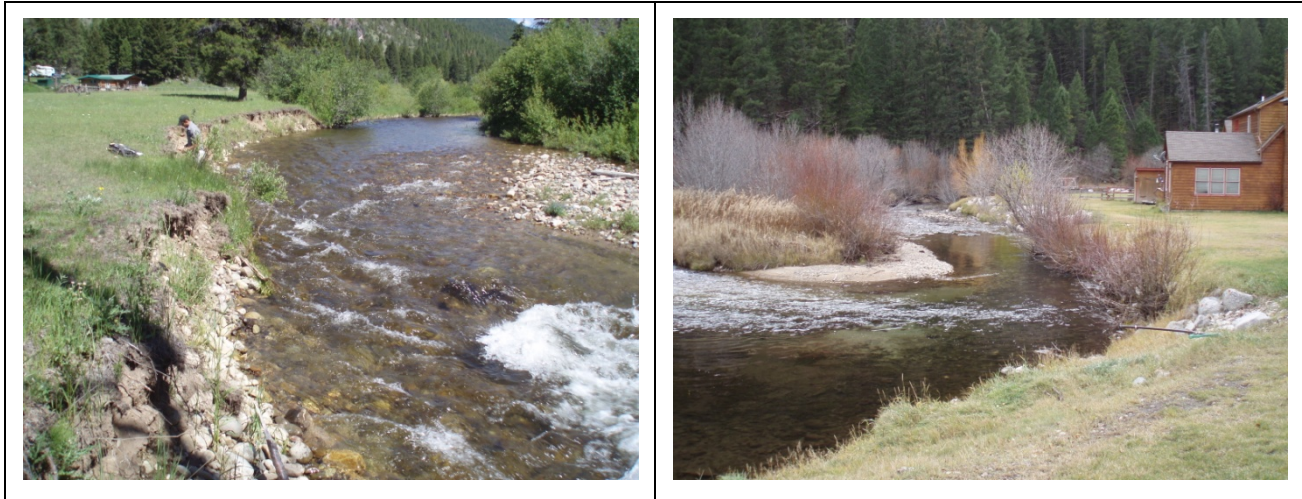
High bank erosion through meadow in B05

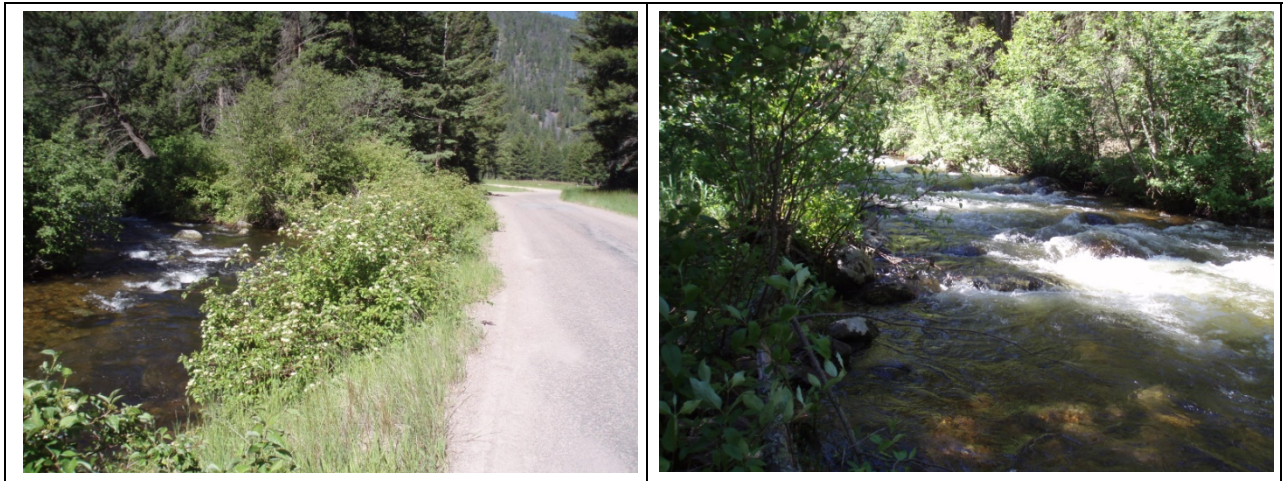
One of two areas where stream approaches road in
B06

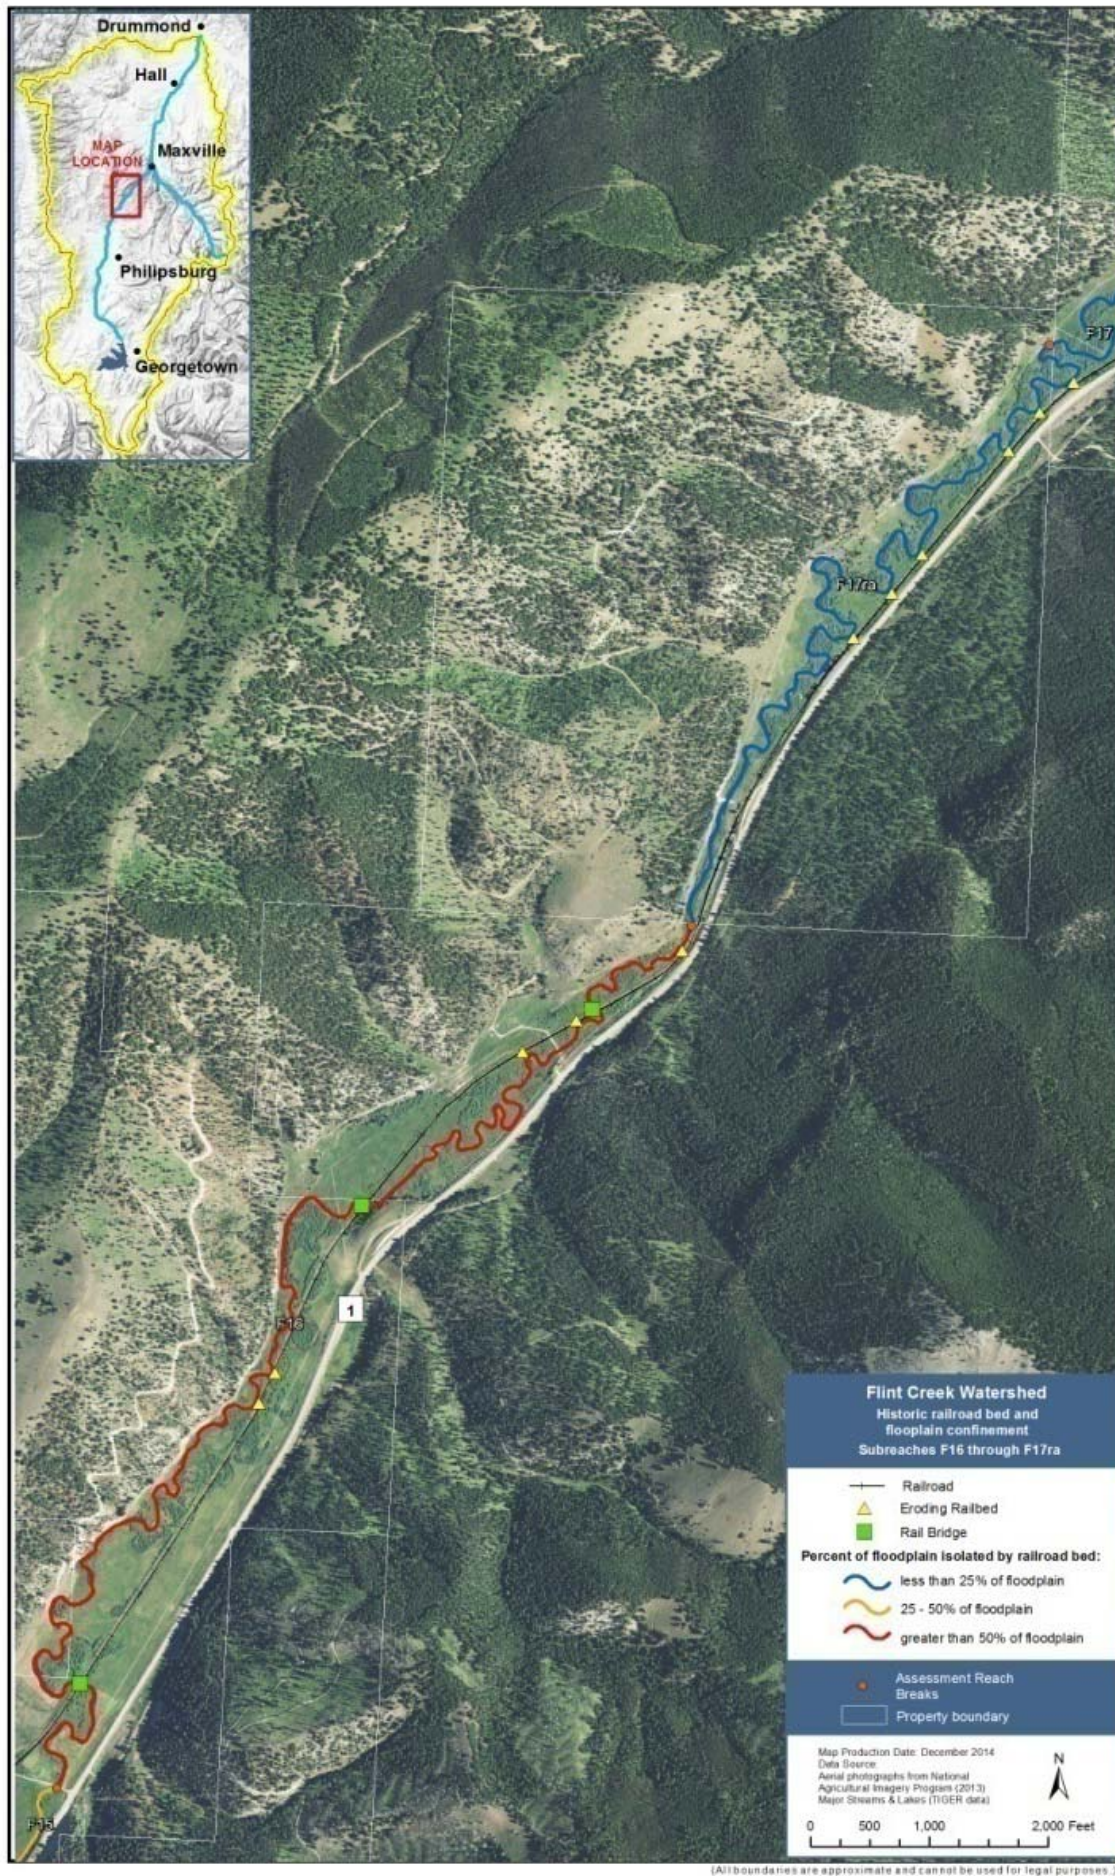
Figure 18. Railroad constriction of stream between F16 – F17

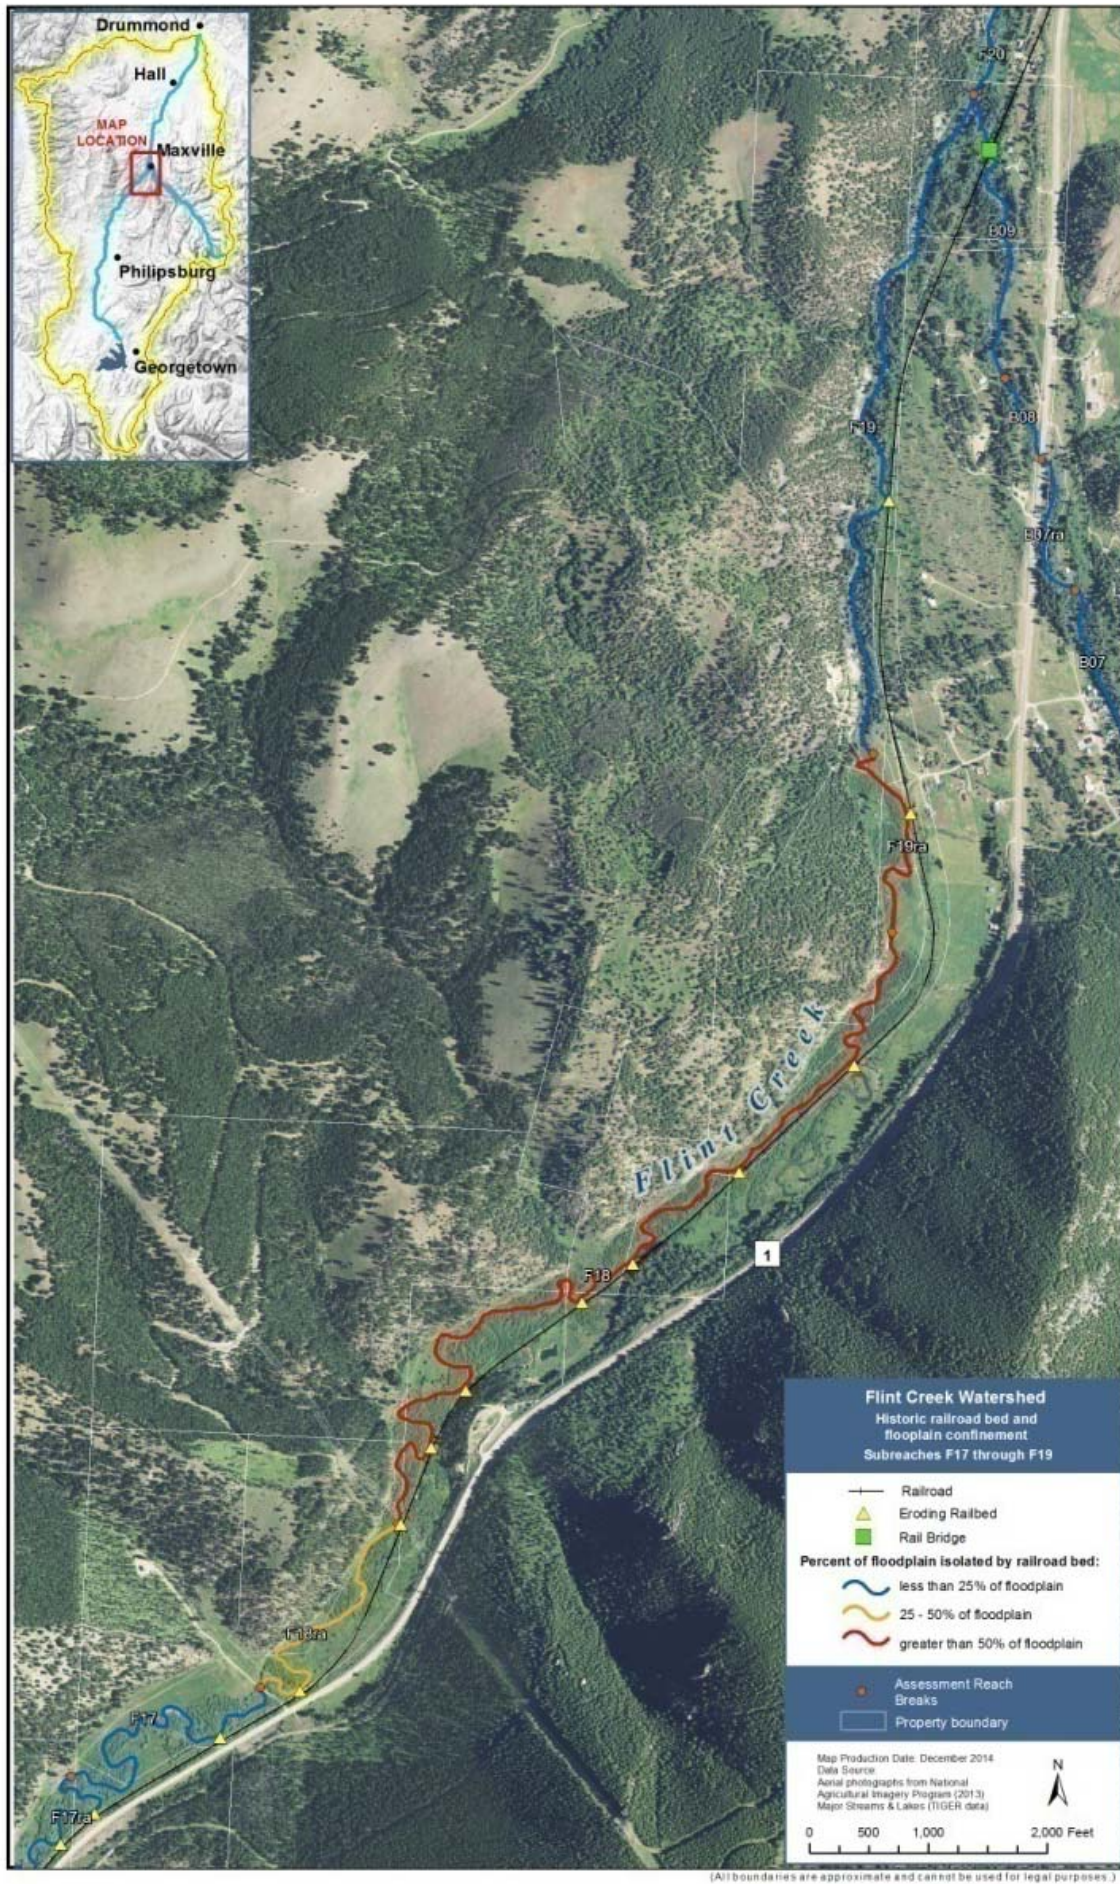
Figure 19. Railroad constriction of stream between F17 – F19
