APPENDIX D VALLEY AND FLOODPLAIN MORPHOLOGY ANALYSIS

D.1 INTRODUCTION

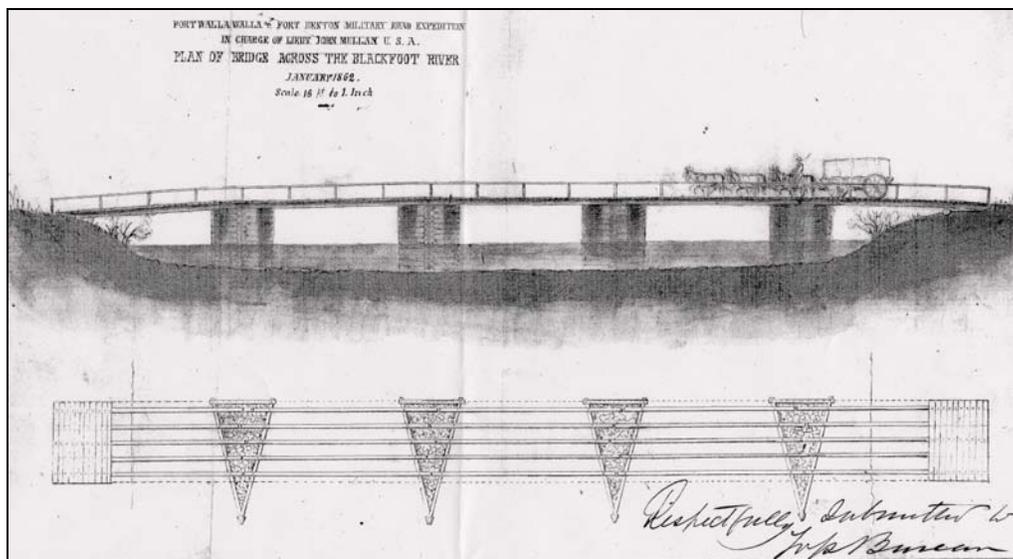
Figure D-1. The Military Road crossing on the Blackfoot River drawn under the guidance of Lieutenant John Mullan in 1862. Image provided by the National Archives (File: RG 77 Rds. 174-6).

The Mullan expedition established a camp at the CFR-BFR confluence in the winter of 1860 and 1861 during the construction of the Military Road. The Military Road (later called the Mullan Road) was to link Fort Walla Walla on the Columbia River, with Fort Benton on the Missouri River at distance of 640 miles. Reaching Cantonment Wright at the CFR-BFR confluence on November 22, 1860, Mullan divided his men into five groups. The first group remained at the confluence to construct a bridge over the BFR near the confluence (Figure D-1). The other groups were distributed in winter camps along the CFR from present-day Turah to Beavertail Rock (Kolecki, 1863) at locations where hill slope cuts were to be made in an effort to minimize the number of necessary river crossings (Mullan, 1863).

Construction of the Military Road impacted the CFR and BFR in addition to the many CFR tributary streams that were crossed. Timber removal, blasting of rocky outcrops, and stream and floodplain modifications were necessary to make the road passable for early miners, homesteaders, and other travelers. Although Mullan limited the number of crossings of the CFR, tributary stream crossings and road sections on the CFR floodplain typically necessitated corduroying wetland areas that were too soft for wagon travel. Mullan noted while in the Deer Lodge Valley, “I examined the side hills with a view of making a high water road, avoiding this and the next crossing. It will require 5,000 feet of heavy grading, part in rock, and 130 feet of corduroying to avoid marshy ground,” (Mullan, 1861).

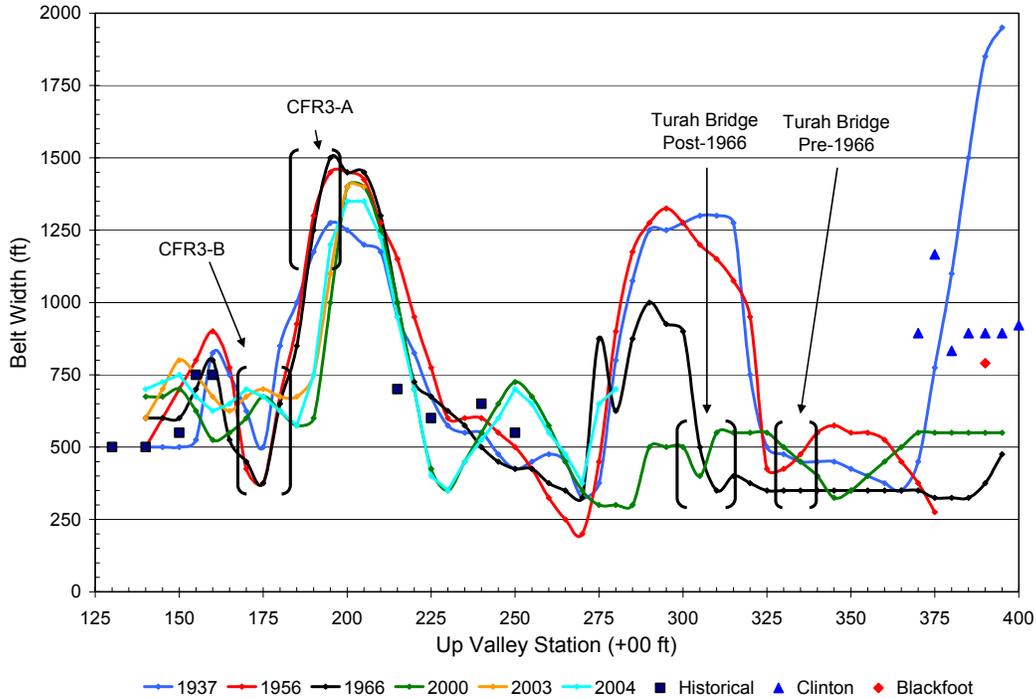
Figure D-2. Planform belt width by photograph series through the CFR3 study area. Comparative points are also presented for the Clinton Reach and the Ovando C Reach.

Historical meander scrolls identified in the CFR near Milltown Dam in the 1937 floodplain (station 215+00 through 250+00), likely represented a pre-disturbance condition and were found to have belt width dimensions similar to the CFR3-B reference reach. Additional abandoned meanders identified within the active 1937 floodway (station 130+00 through 150+00 and station 155+00 through 160+00), also displayed a range of intermediate belt width values.

Belt widths measured on the CFR near Clinton were found to have higher values than the downstream CFR3-B and historical meander values, but belt width values were less than the values measured in the braided reaches. The Ovando C reference reach also exhibited intermediate belt width values.

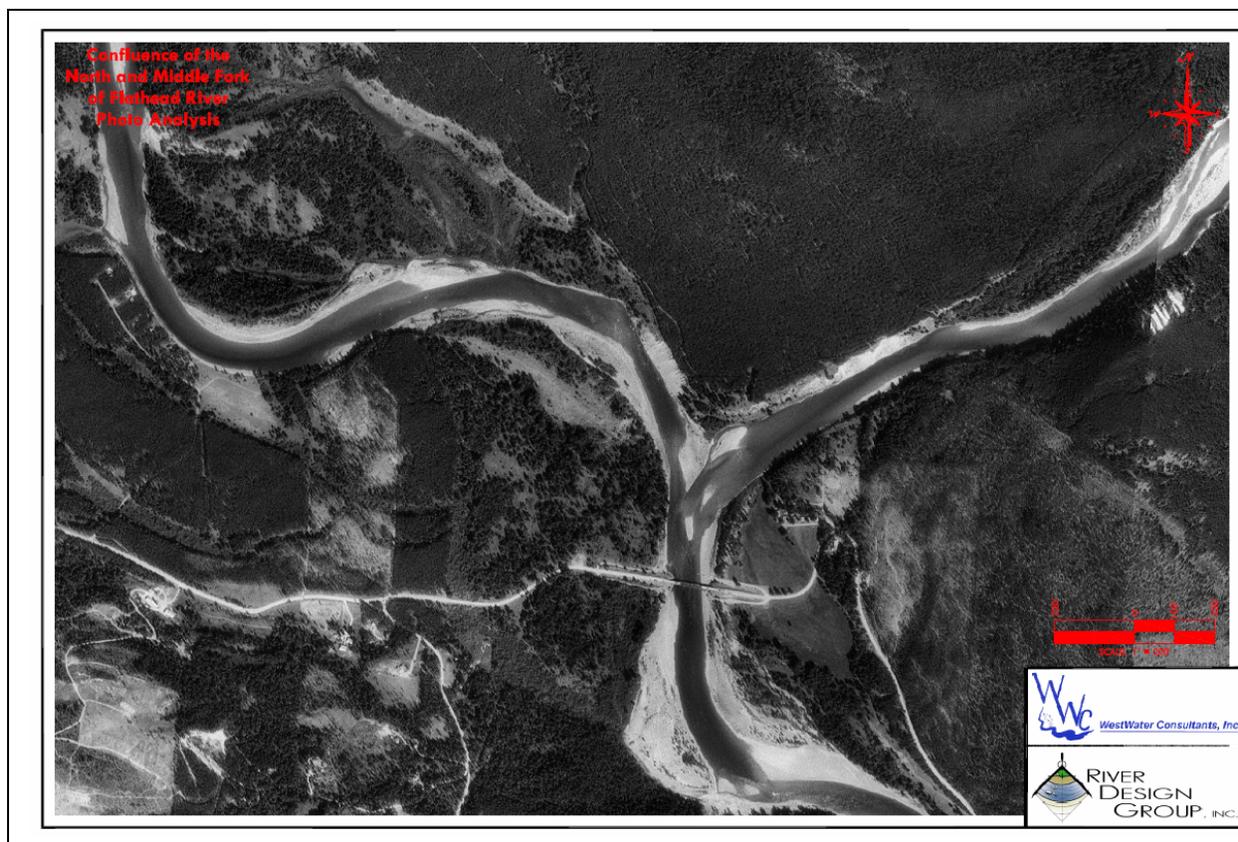
Figure D-3. Confluence of the North Fork Flathead River with the Middle Fork Flathead River near Columbia Falls, MT.

The North Fork Flathead River-Middle Fork Flathead River confluence is geomorphically similar to the CFR-BFR confluence. The North Fork Flathead is a Type VIII valley similar to the CFR upstream from the confluence. The Middle Fork Flathead is a Type II valley, similar to the BFR. Downstream from the confluence, both rivers transition into a more confined valley type. Both confluences are low gradient, alluvial, gravel bed rivers with numerous impacts and disturbances upstream. The Flathead system has had several large floods over the past four decades. As indicated in Figure D-3, both forks of the Flathead River currently have meandering morphology that continues downstream.

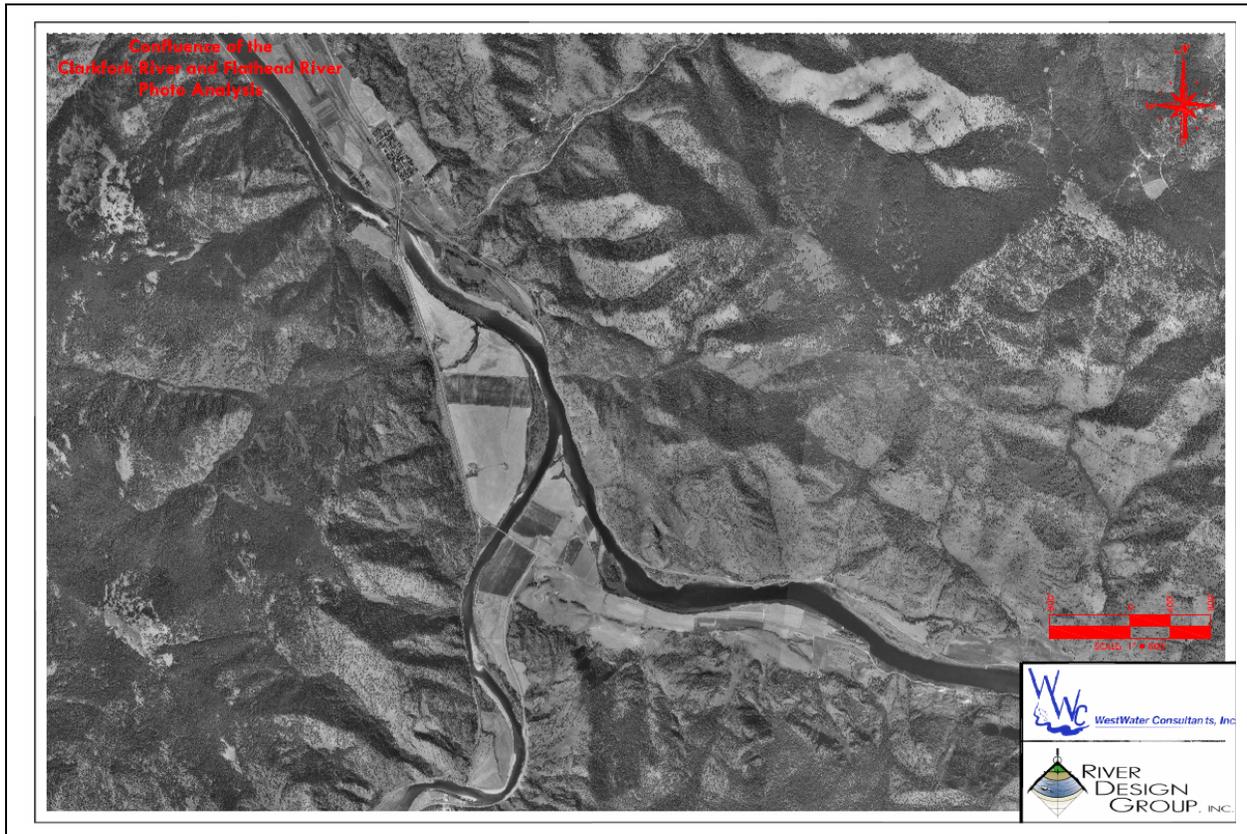
Figure D-4. The confluence of the Clark Fork River and Flathead River near Paradise, MT.

The confluence of the Clark Fork River with the Flathead River is another example of similar rivers converging without apparent braiding or anabranching (Figure D-4). Like the previous example, both rivers are low gradient systems with the Flathead River located in a large, unconfined valley while the CFR is moderately confined. Downstream of the confluence, the CFR transitions to a moderately confined valley type. Both rivers have numerous impacts upstream and have experienced large floods over the last several decades.

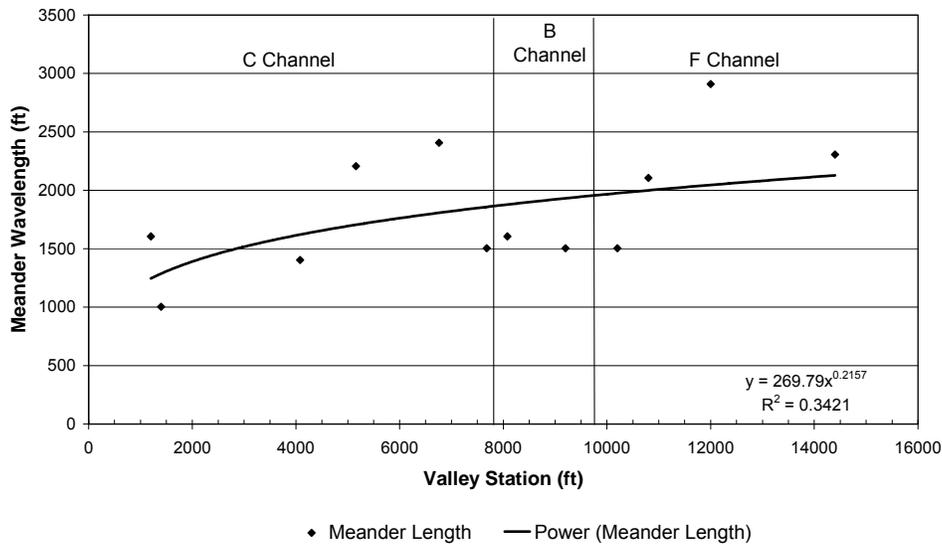
Figure D-5. Meander wavelength relative to valley stationing and stream type for the BFR Ovando reference reach.

The meander wavelength generally increased in a downstream direction from the C stream type to the F stream type (Figure D-5). While the BFR in the C channel reach was free to laterally migrate, the F channel reach was structurally controlled. The distance between consecutive meanders increased as the channel was increasingly confined by the valley as the valley transitioned from a Type VIII valley a Type II valley to a Type IV valley.

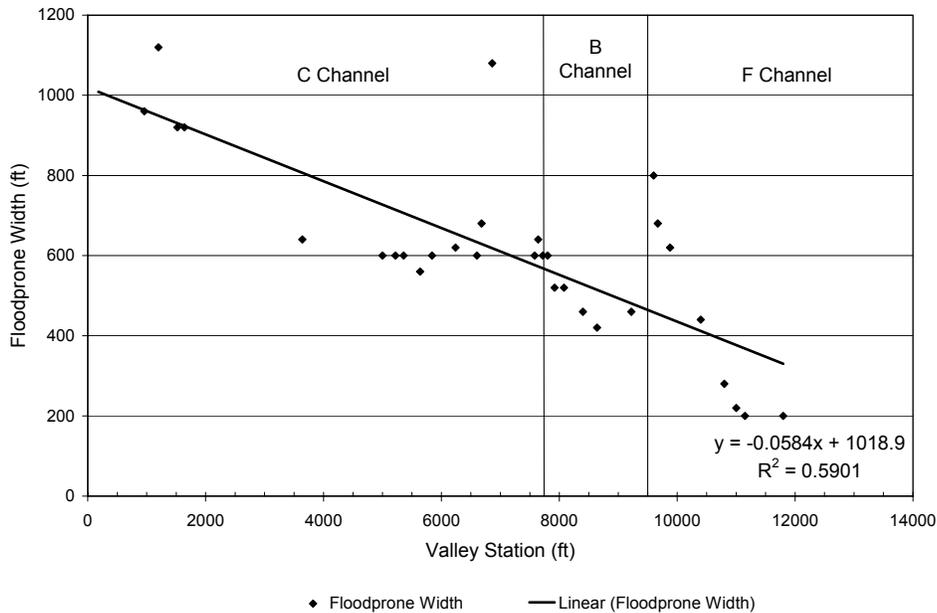
Figure D-6. Floodprone width relative to valley stationing and stream type for the BFR Ovando reference reach.

The floodplain area as measured by the floodprone width also exhibited a down-valley trend. As the BFR transitioned from the unconfined Type VIII valley in the C reach to the structurally controlled Type II valley in the F reach, the floodprone width narrowed. This morphological trend was expected based on the valley types. However, instead of a smooth, consistent narrowing of the floodplain through the B transition reach and into the entrenched F reach, the floodplain widens substantially at the beginning of the B and F reaches (Figure D-6). The data

points illustrate this condition with a momentary increase in floodplain width at each transition, then narrowing again in the downstream direction. Meanders occur at each of these transitions and may encourage flooding of the opposite bank during high flows.

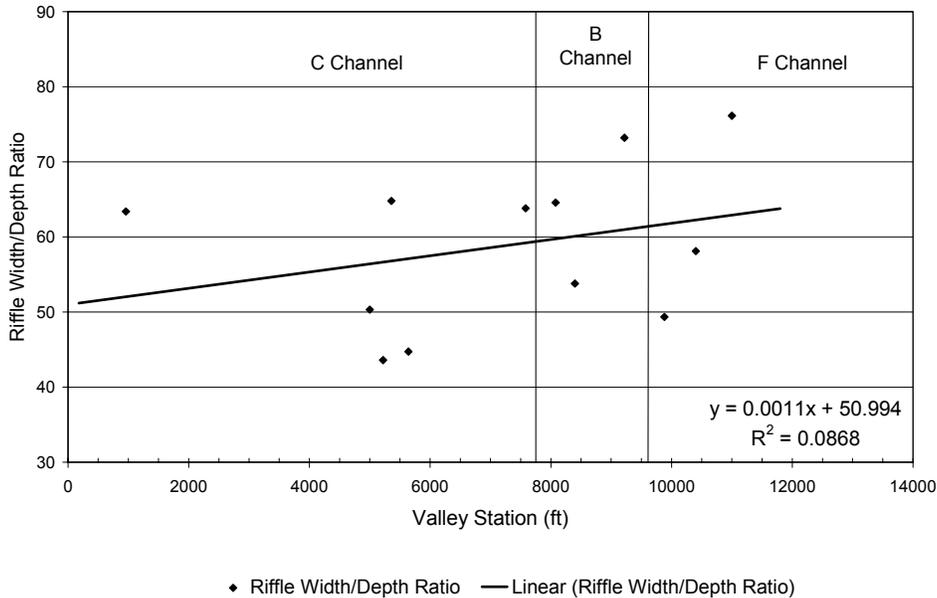
Figure D-7. The riffle width-to-depth ratio relative to valley stationing and stream type in the BFR Ovando reference reach.

There was also a notable increasing trend in the riffle width-to-depth ratio in a down-valley direction (Figure D-7). As the floodplain narrows width-to-depth ratios increase. Lower values occur upstream in the C reach and maximum values occur downstream in the F reach. The transitioning B reach was characterized by intermediate width-to-depth ratio values. Although a relatively strong trend was detected, substantial variation in width-to-depth ratio exists within each reach. The channel width-to-depth ration likely relates to the influence of flood flows that scour the channel. In the slightly confined C reach, flood flows access the adjacent floodplain and the stream energy is dissipated. In the entrenched F reach, flood flows are maintained within the active channel and there excess stream energy available to scour the channel.

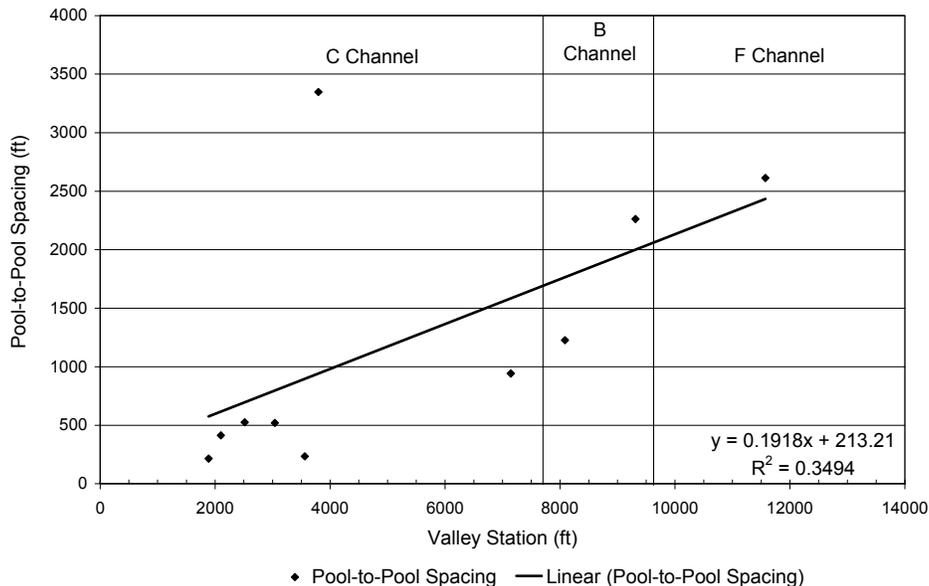
Figure D-8. The pool-to-pool spacing as measured by the distance between pools, relative to valley stationing and stream type in the BFR Ovando reference reach.

Pool spacing increased in the downstream direction through the valley transition suggesting greater stream energy in the confined F reach (Figure D-8). The shortest spacing was observed in the upstream meandering C reach where nine pools occurred, and minimum values obtained in the downstream F reach where two pools exist. Within the transition B-reach, one pool was noted.
