Milltown Revegetation Data Summary Report

November 2, 2006

Geum Environmental Consulting, Inc.
307 State Street
Hamilton, MT 59840

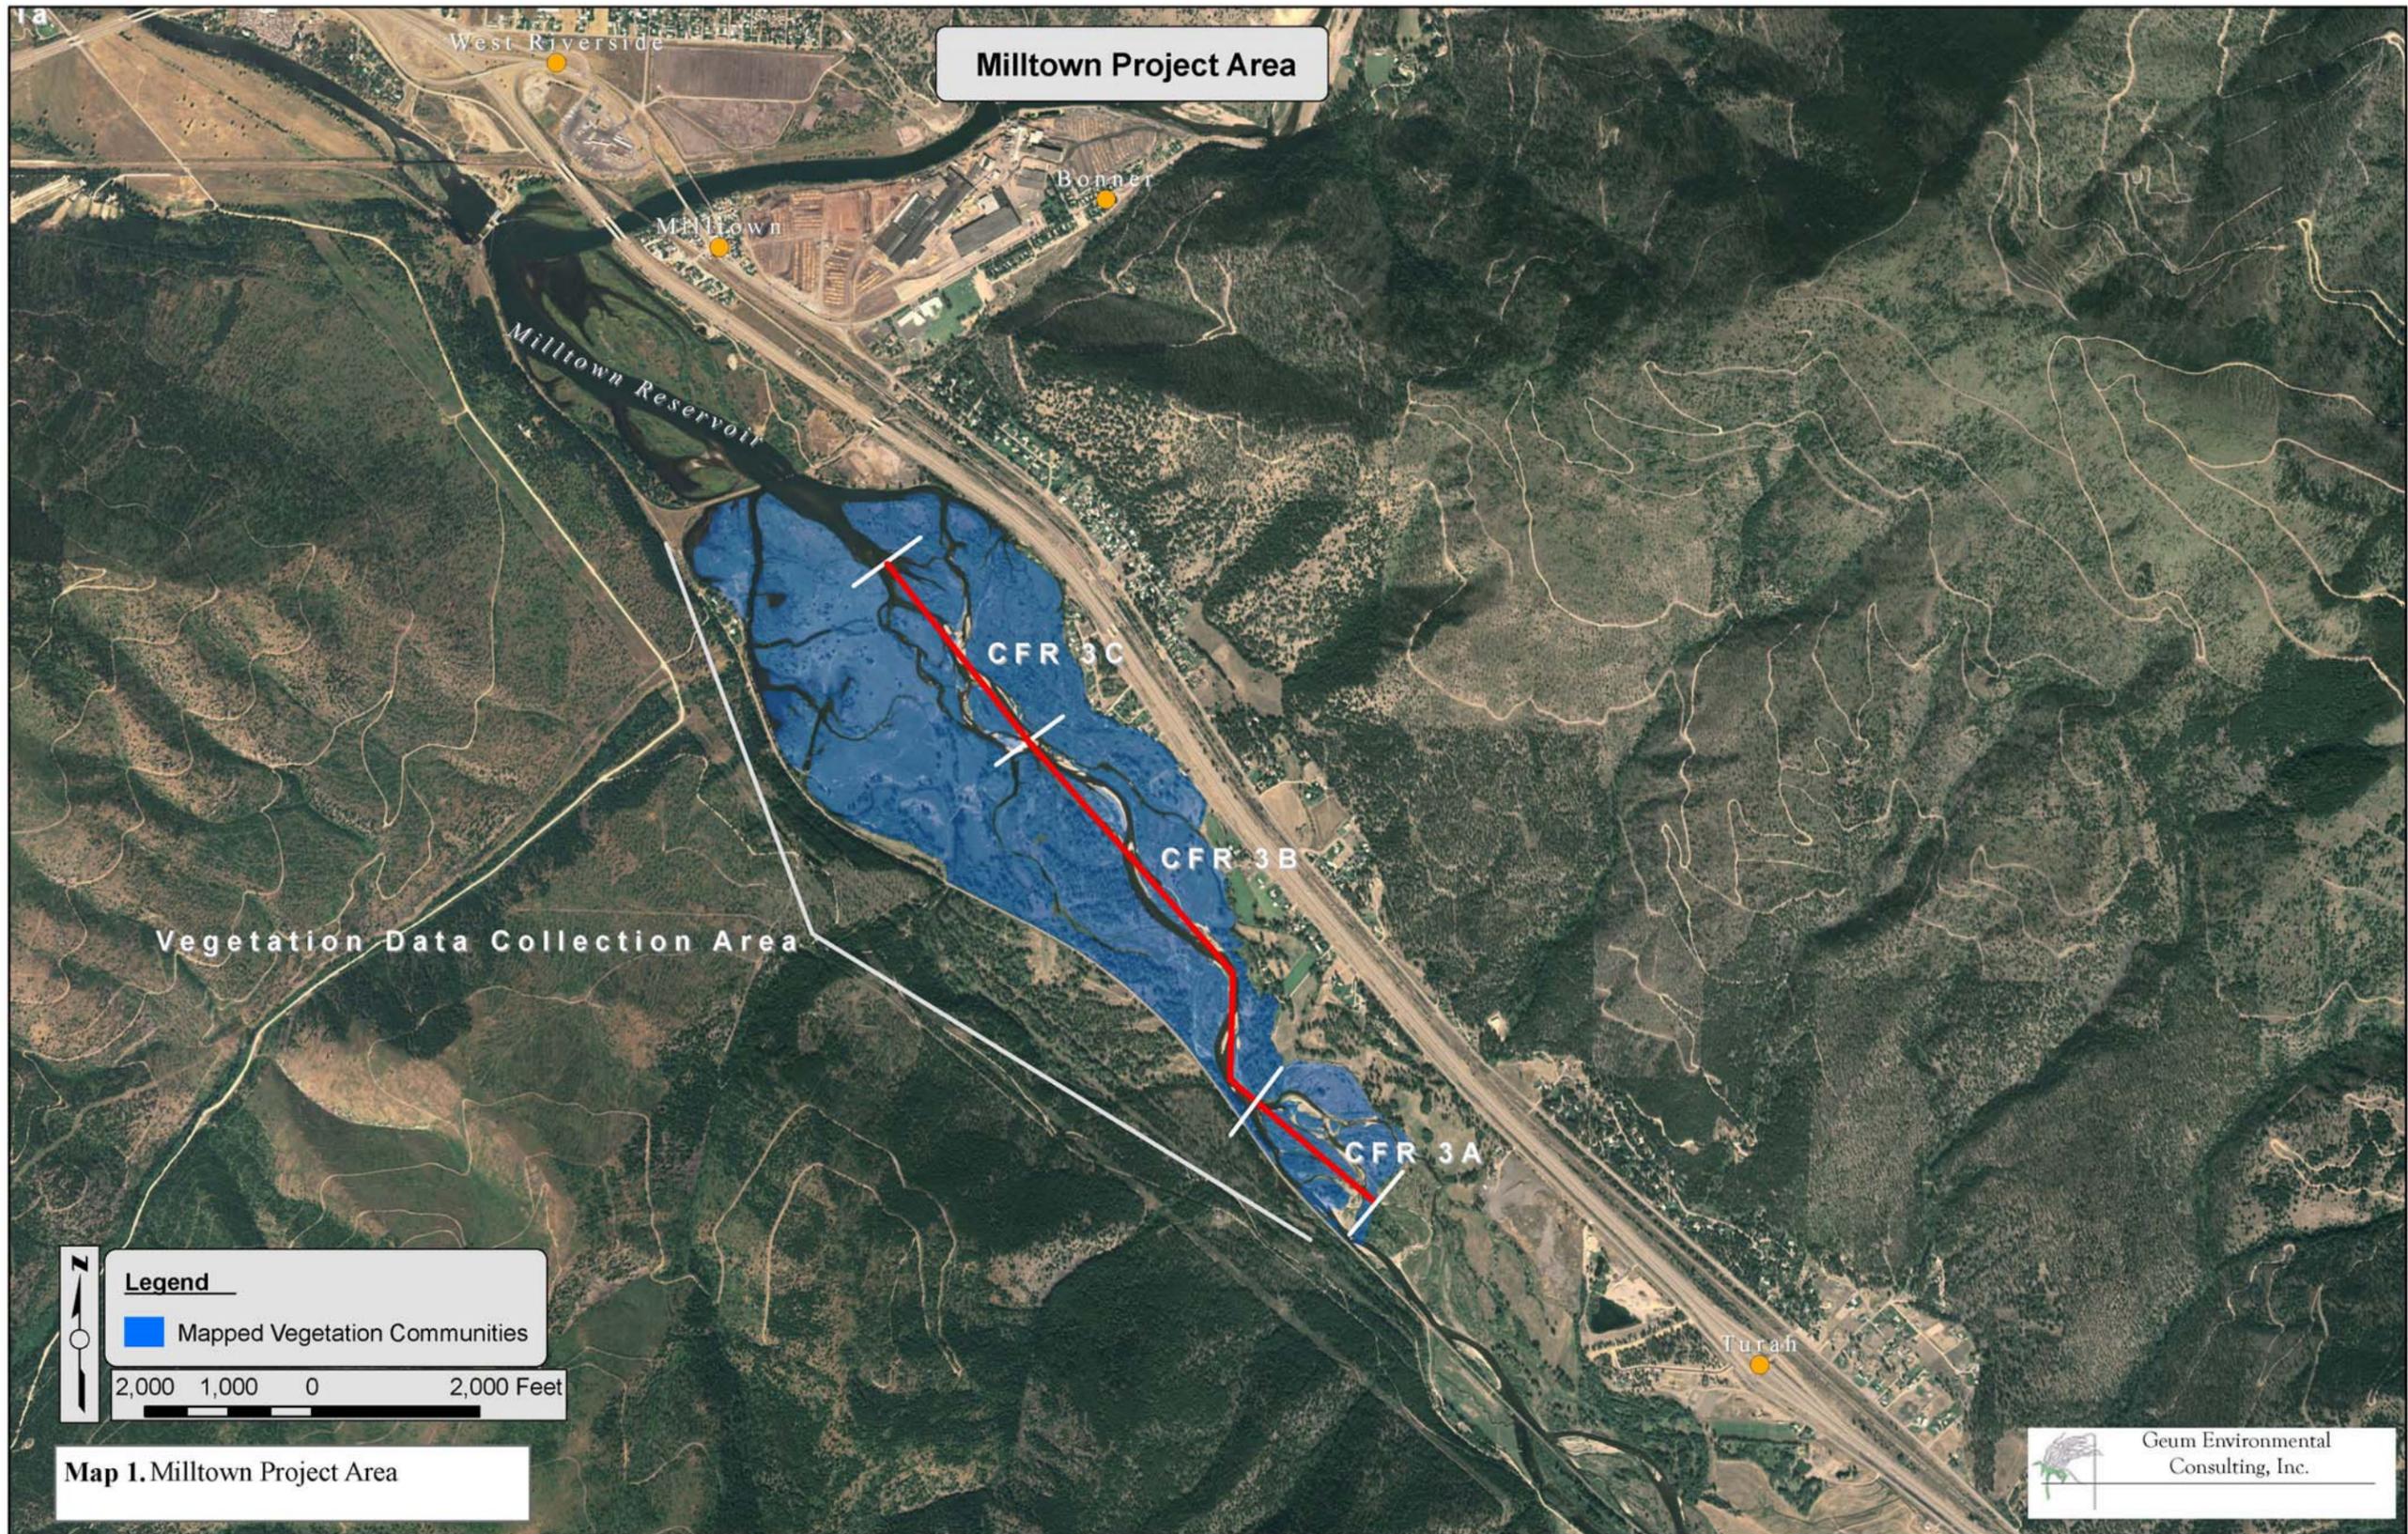
A total of 26 plant communities were mapped within the assessment area (Appendix A, Map 1). Data were collected for one additional plant community located in the CFR-3 Upstream Study Area, for a total of 27 described plant communities. A description of each plant community/dominance type, corresponding Hansen habitat or community type if applicable, geomorphic location within the floodplain, dominant plant species, presence of hydrologic indicators, weed species, potential for salvage, restoration, or enhancement and a photograph is provided in Appendix B. Complete species lists for

³ Specific salvage areas identified in this column (e.g. S1-S11) are shown as points on Map-1 in Appendix A.

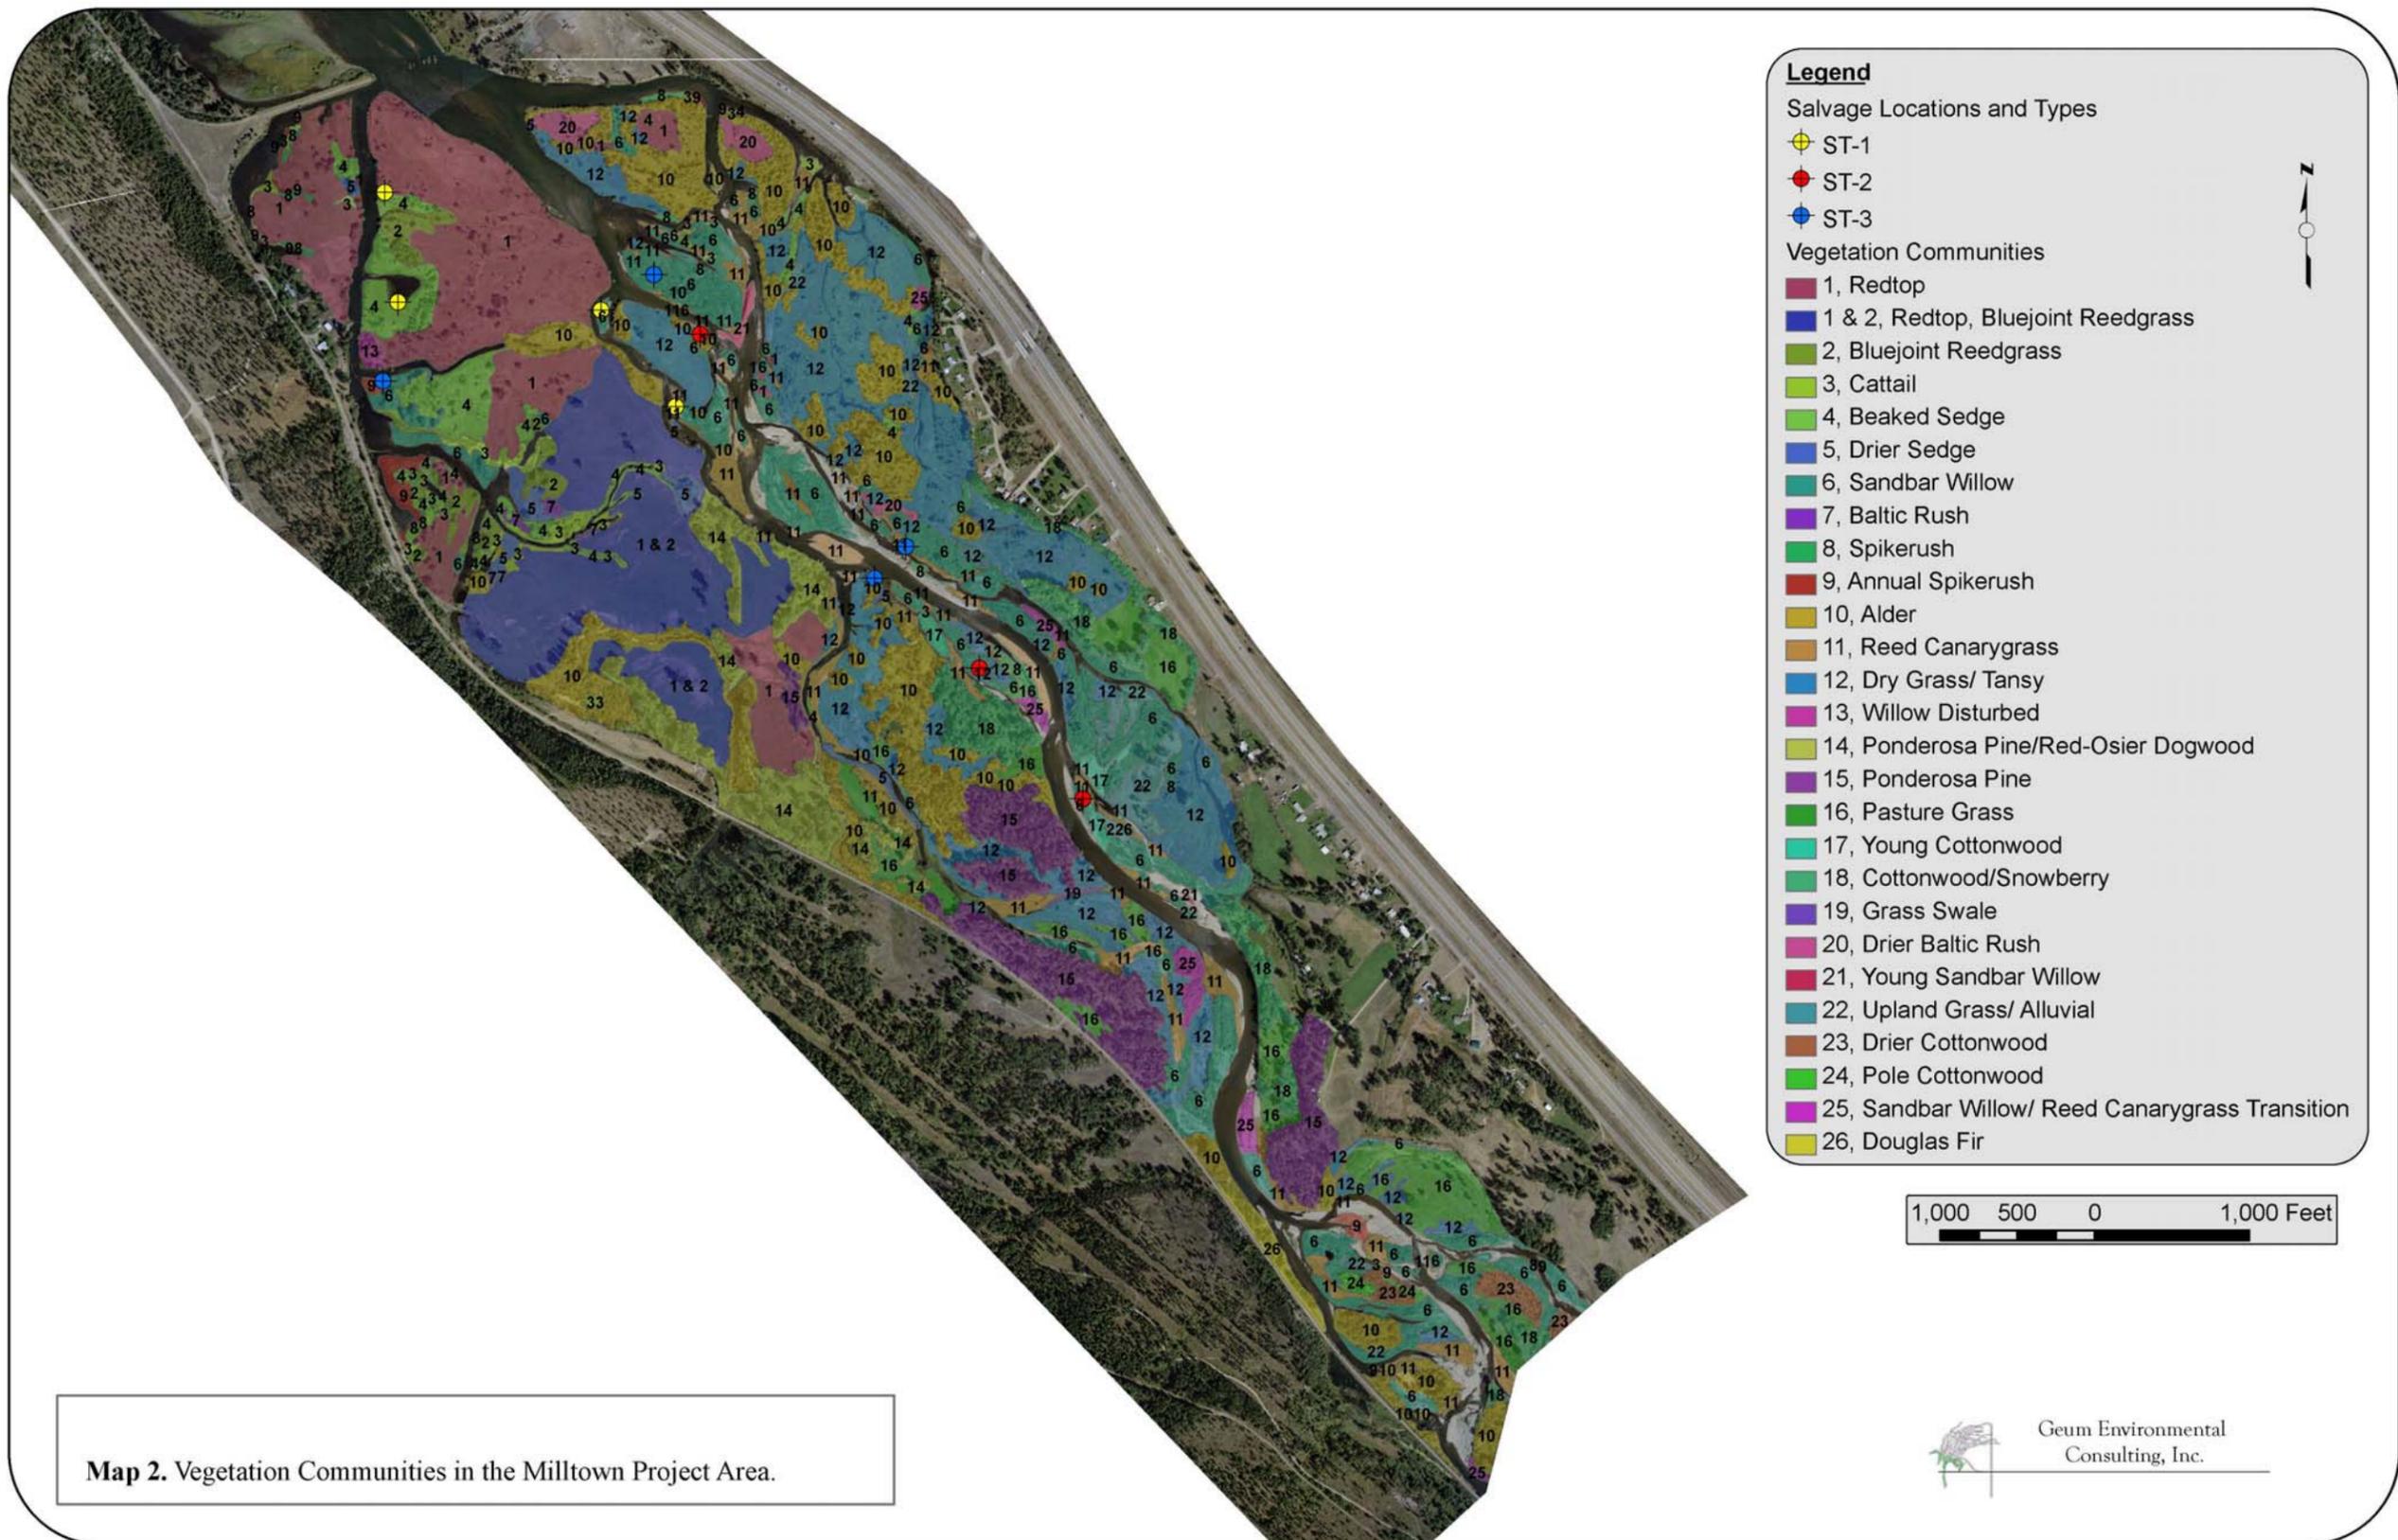
Weeds dominate large areas of the assessment area. The downstream end of the assessment area (SAA IV and V) is influenced by the backwater effect of the dam and has large amounts of reed canarygrass and smaller infestations of Canada thistle and musk thistle. The upstream end of the assessment area (CFR 3a-c) has areas with high cover of weedy species adapted to drier conditions. Weeds and invasive species within these drier areas include tansy, leafy spurge, Dalmatian toadflax, spotted knapweed, and cheatgrass. Monotypic stands of reed canarygrass are common along channel margins and mid-channel bars throughout the assessment area. As described earlier, some infestations were mapped as separate dominance types due to the extent of their infestations. These types include PHAARU (11) and DRY GRASS/TANVUL (12) and are shown on the plant community map (Appendix A, Map 1). These weed infestations, along with other weed concern areas, are also shown on a separate map (Appendix A, Map 2).

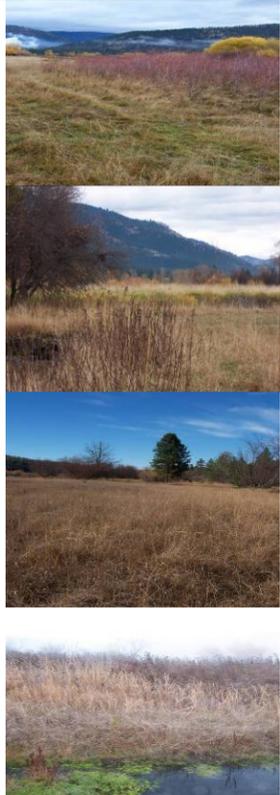
ID	Vegetation Community	Hansen Type ¹	Description	Floodplain Location	Hydrologic Indicators	Dominant Plant Species ²	Weeds and Invasive Species	Salvage Potential ³	Photographs
6	SALEXI <i>Salix exigua</i> (Sandbar willow)	Sandbar willow C.T.	Sandbar willow communities along the main channel are typically early to mid-successional. Late successional communities occur outside the main channel in areas of the floodplain that are not regularly disturbed by seasonal flooding.	Occur on point bars, mid channel bars, and other recent alluvial deposit areas. Also occur in some wetter areas of the floodplain.	Sediment deposits, debris accumulation typical with saturated soils occurring in some floodplain communities.	Sandbar willow and Redtop.	Reed canarygrass and Common tansy cover ranges from 80% to 100% in some places along channels. Floodplain communities have Canada thistle, common tansy, common mullein, climbing nightshade, Common hound's tongue, Musk thistle in small amounts.	Live willow cutting potential in areas with dense mid to late successional stands. Mature shrub salvage potential in areas with low weed cover.

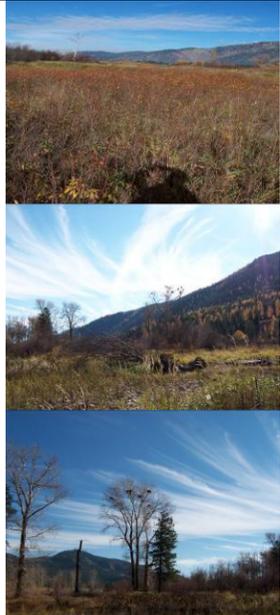
ID	Vegetation Community	Hansen Type ¹	Description	Floodplain Location	Hydrologic Indicators	Dominant Plant Species ²	Weeds and Invasive Species	Salvage Potential ³	Photographs
18	POPTRI/ SYMOCC <i>Populus trichocarpa/Symphoricarpos occidentalis</i> (Black cottonwood/ Western snowberry)	Black Cottonwood / Western snowberry C.T.	Drier cottonwood communities typically outside the active floodplain with mostly mature cottonwood.	Drier, better drained, higher topographic locations, ranging from near the bank of the main channel to the outside edge of the active floodplain.	None present, occur at higher topographic locations.	Black cottonwood, Common tansy, and Western snowberry.	Common tansy, Canada thistle, Smooth brome, and Reed canarygrass.	No potential for salvage was observed.
