**Preassessment Screen:  
Smurfit-Stone/Frenchtown Mill Site  
Frenchtown, Montana**

***Prepared for:***  
**Montana Natural Resource Damage Program**  
P.O. Box 201425  
Helena, MT 59620-1425

***Prepared by:***  
**Abt Associates Inc.**  
1881 Ninth Street, Suite 201  
Boulder, CO 80302

April 30, 2018

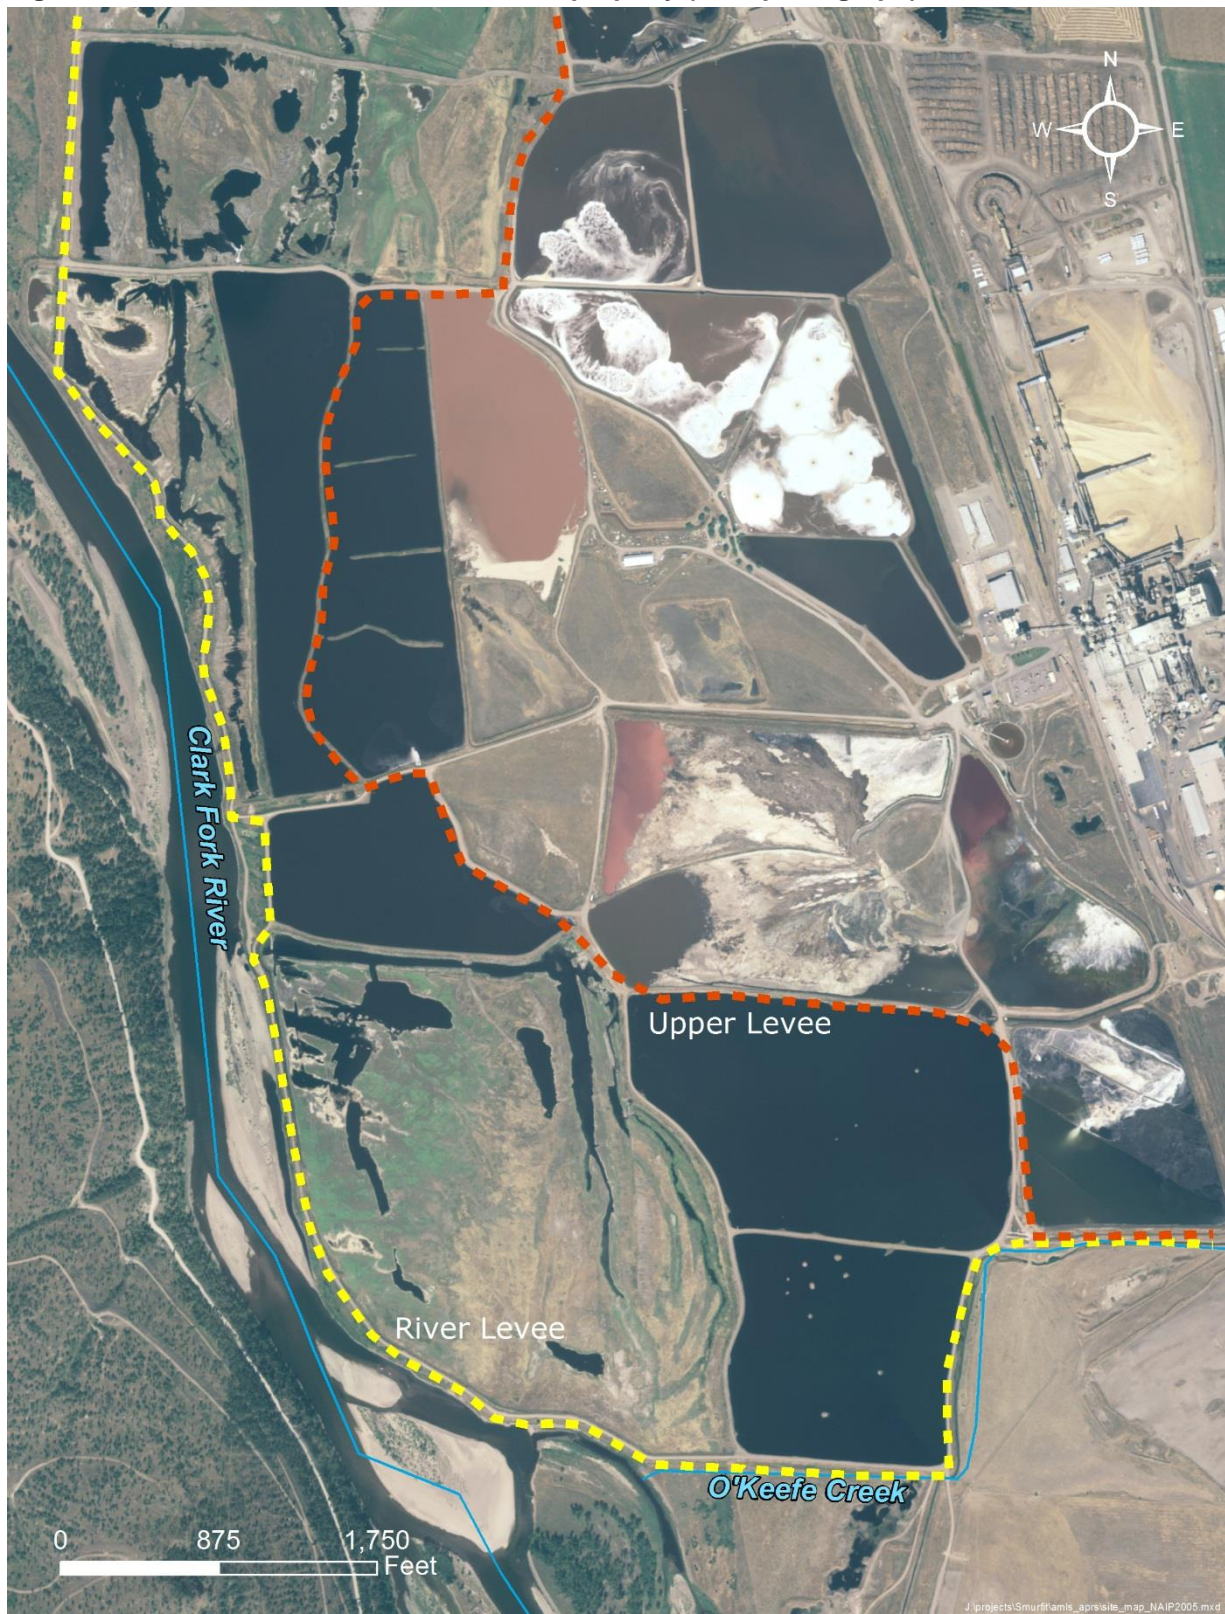
Figure 2. Levees at the south end of the mill property (2005 photograph).

The mill property covers 3,150 acres, with approximately 3.6 miles of river frontage (URS, 2012). A 15-foot-wide levee separates wastewater holding ponds from the Clark Fork River (Figure 2). The levee is 3.7 miles long and ranges from 2 to 25 feet in height above the ground surface. This levee provides flood protection under “seasonally normal flows” (NewFields, 2015, p. 7).

There is also a higher internal levee at the mill property, with a distance from the river that varies from approximately 0.5 to 2 miles (Figure 2). This upper levee was not breached on May 18, 1997, when the Clark Fork River discharge was 55,100 cubic feet per second (cfs), the largest flood event to occur since 1930 (NewFields, 2015; USGS, 2018).
