Natural Resource Damage Assessment Work Plan

Reed Point Bridge Derailment – Draft

June 10, 2024

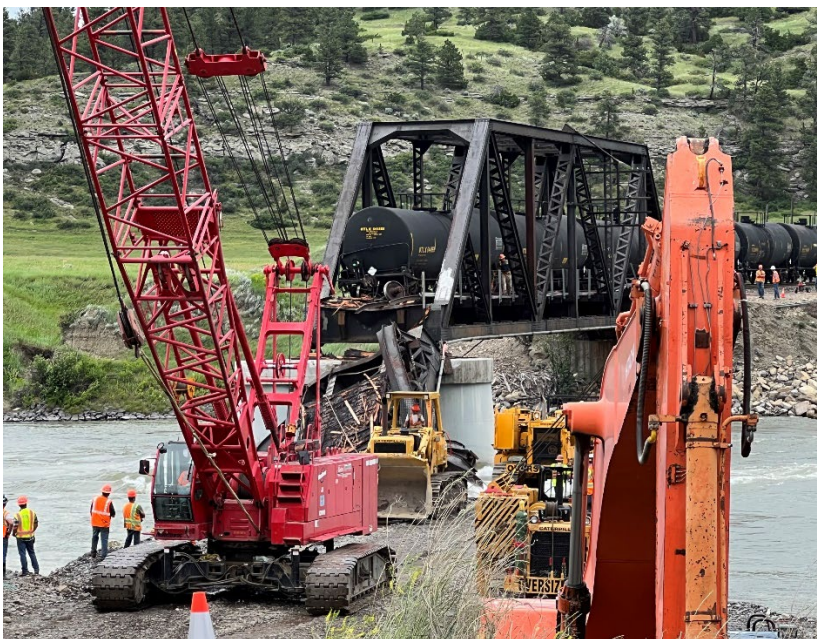
Exhibit 1-1. The Twin Bridges Road railroad bridge after the derailment.

On June 24, 2023, a train operated by Montana Rail Link, Inc. (“MRL”) traversing the Twin Bridges Road railroad bridge approximately 40 miles west of Billings, Montana, derailed (Exhibits 1-1, 1-2, and 1-3). A total of 17 railcars derailed, 10 of which entered the Yellowstone River. Of those entering the river, 6 contained asphalt liquified petroleum (“asphalt”), 3 contained molten sulfur, and 1 contained scrap aluminum. The incident also involved the partial collapse of the railroad bridge.

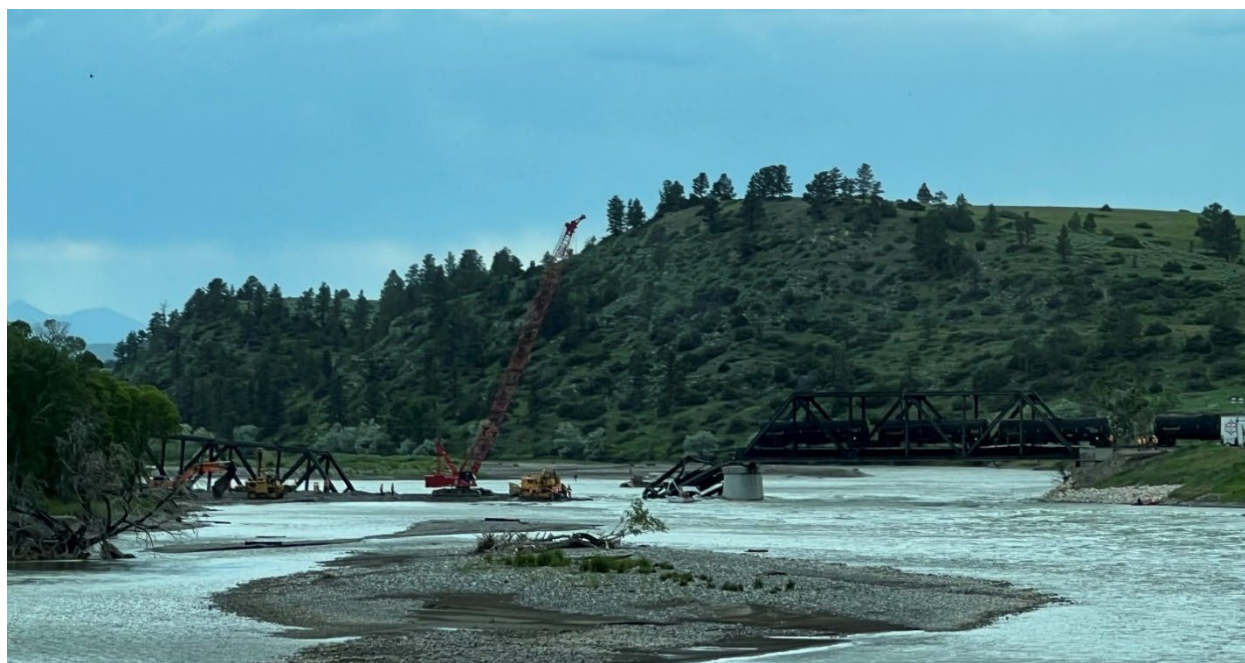
Exhibit 1-2. Side view of the Twin Bridges Road railroad bridge after the derailment.

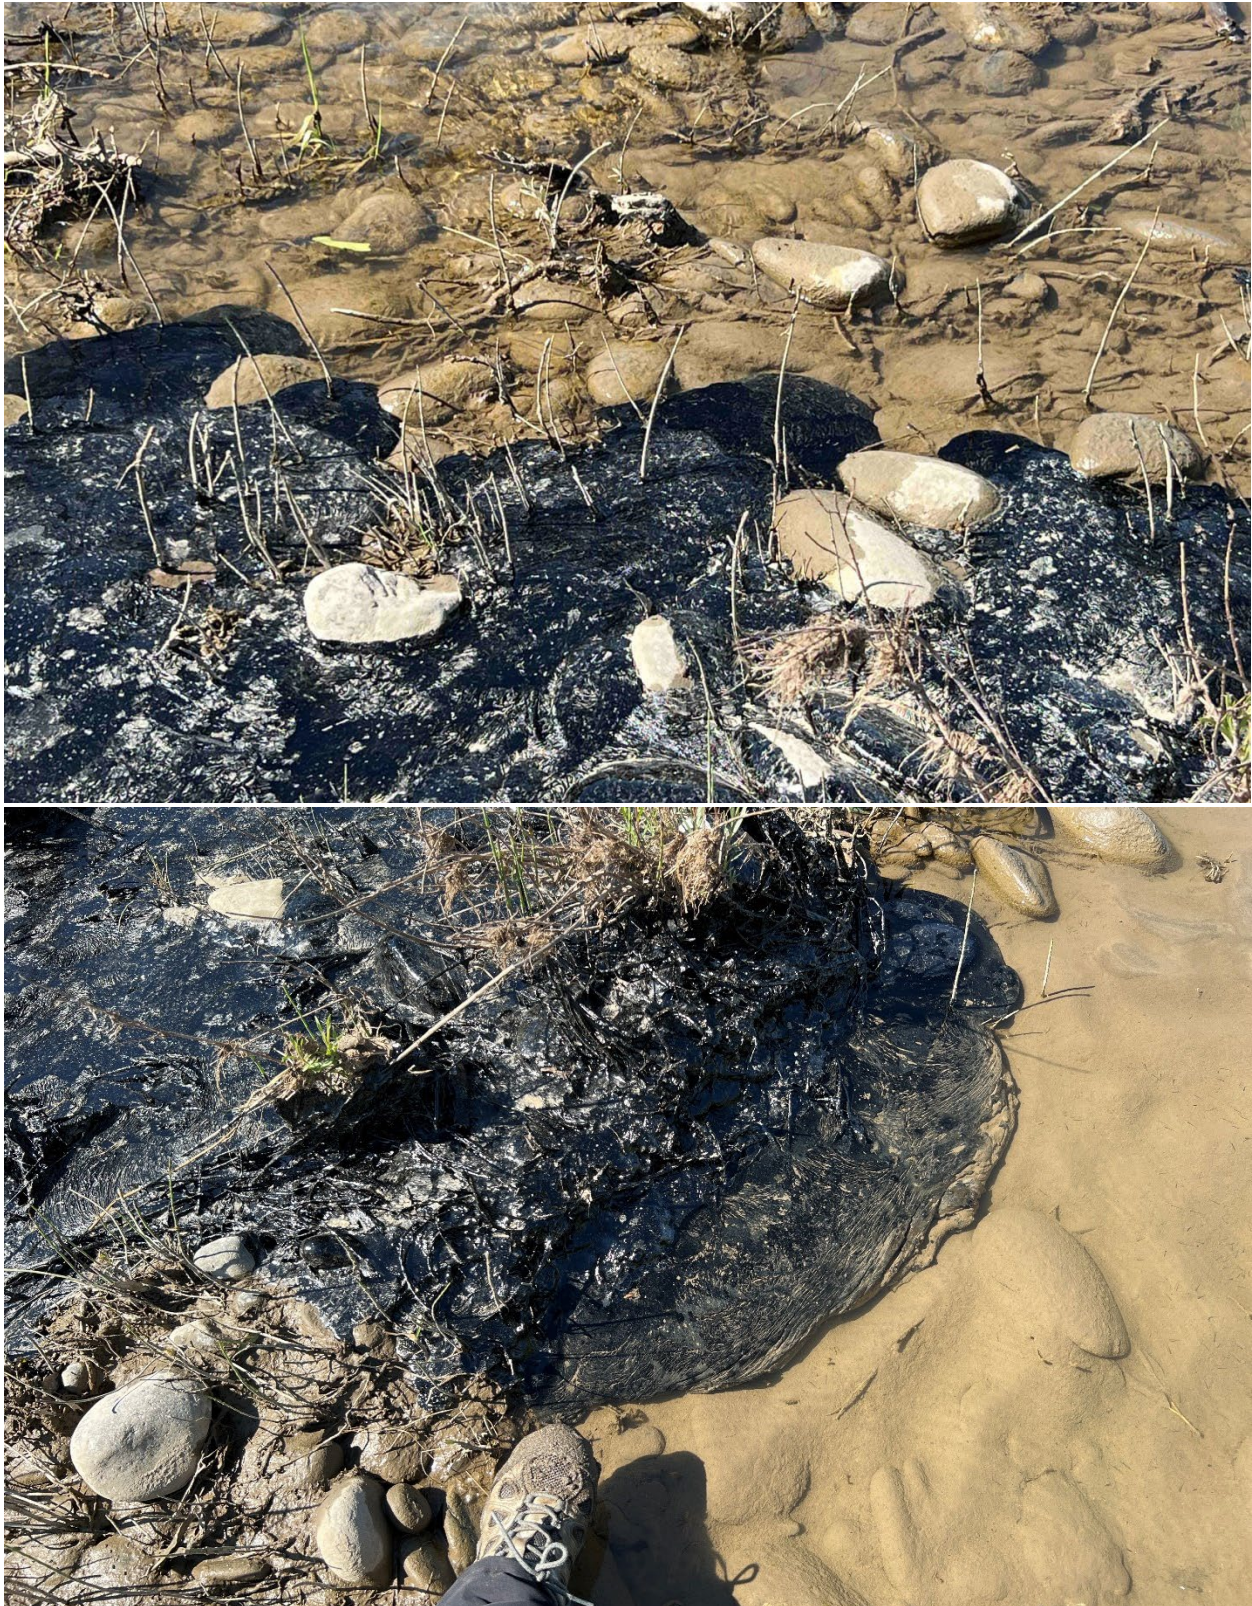
Exhibit 2-1. Asphalt deposits along shoreline. Photos taken approximately 1.5 miles downstream of the train derailment site, on the lee side of an island.

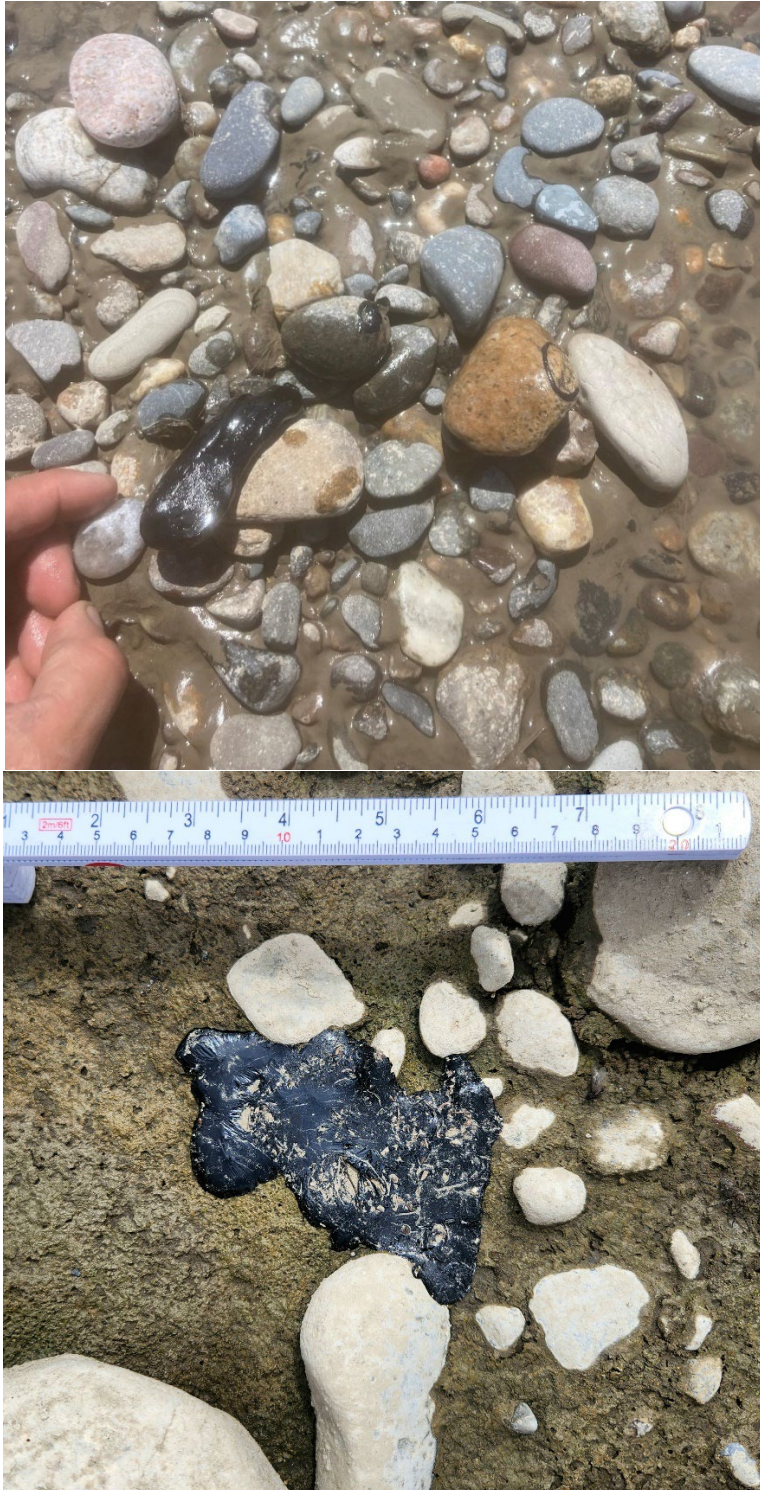
Exhibit 2-2. Asphalt deposits a few centimeters in diameter. Top photo taken near Worden, Montana (coordinates 45.97984 N, 108.23328 W); bottom photo taken at Dover, Montana.

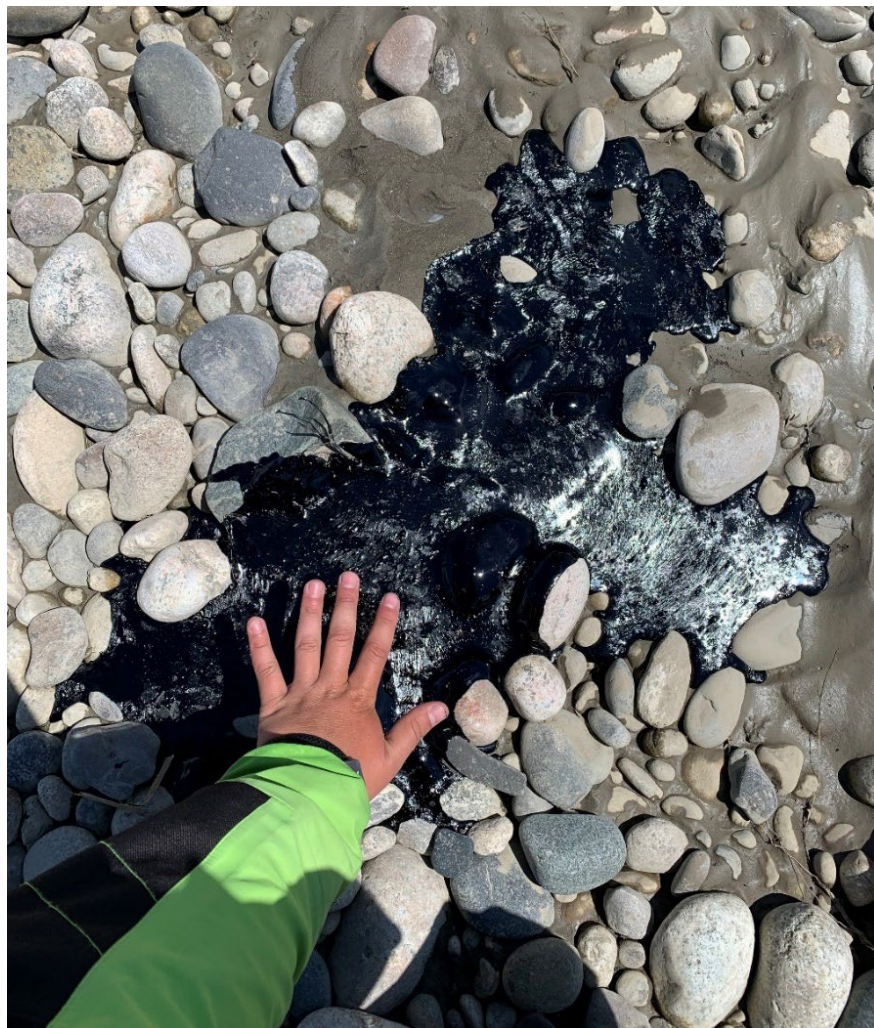
Exhibit 2-3. Asphalt deposits along rocky shoreline. Photo taken near Worden, Montana (coordinates 45.97984 N, 108.23328 W).

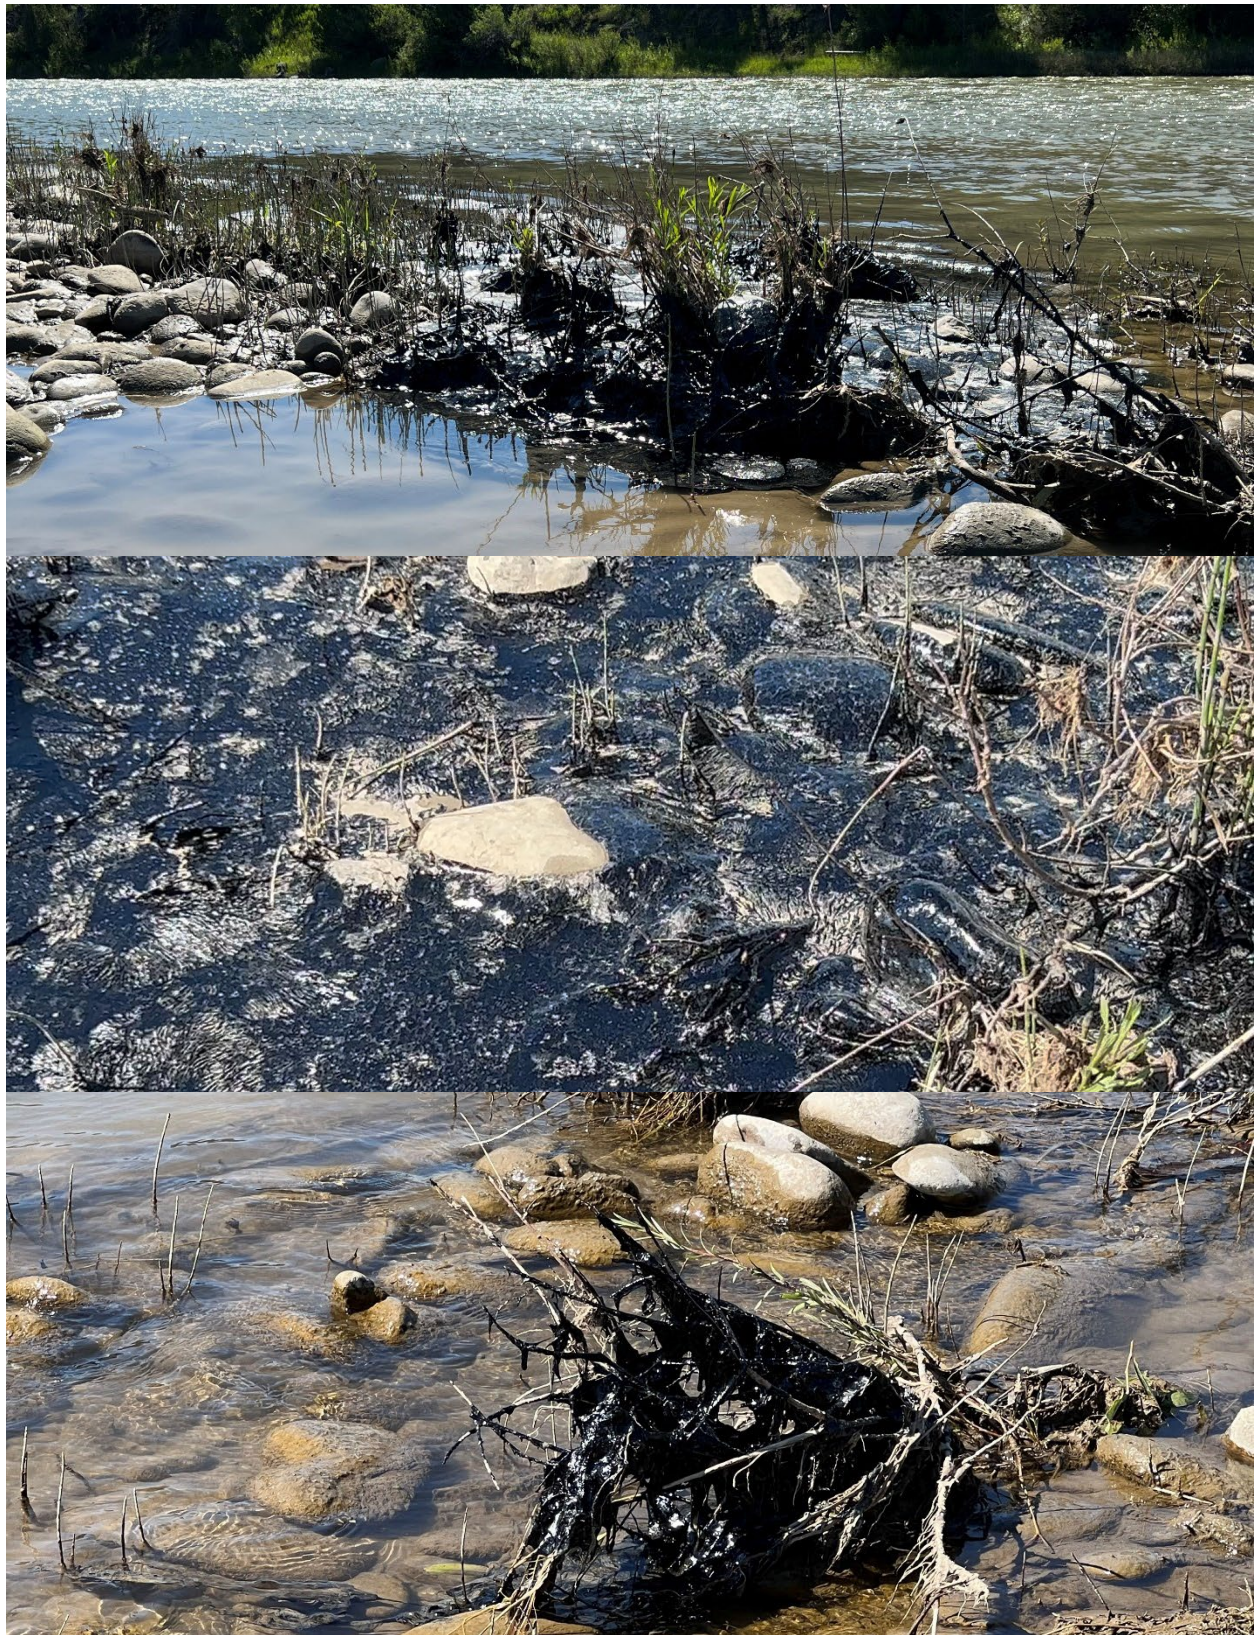
Exhibit 2-4. Asphalt deposits along riparian vegetation.

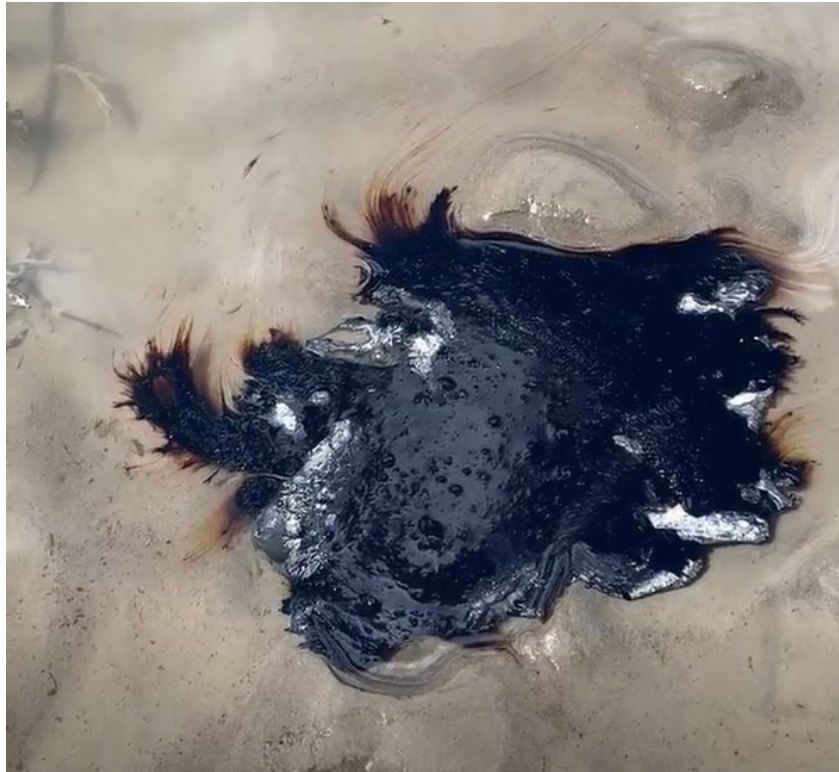
Exhibit 2-5. Asphalt deposits in water. Image displays the asphalt breaking into small pieces and spreading downstream. Photo taken near Worden, Montana (coordinates 45.97984 N, 108.23328 W).

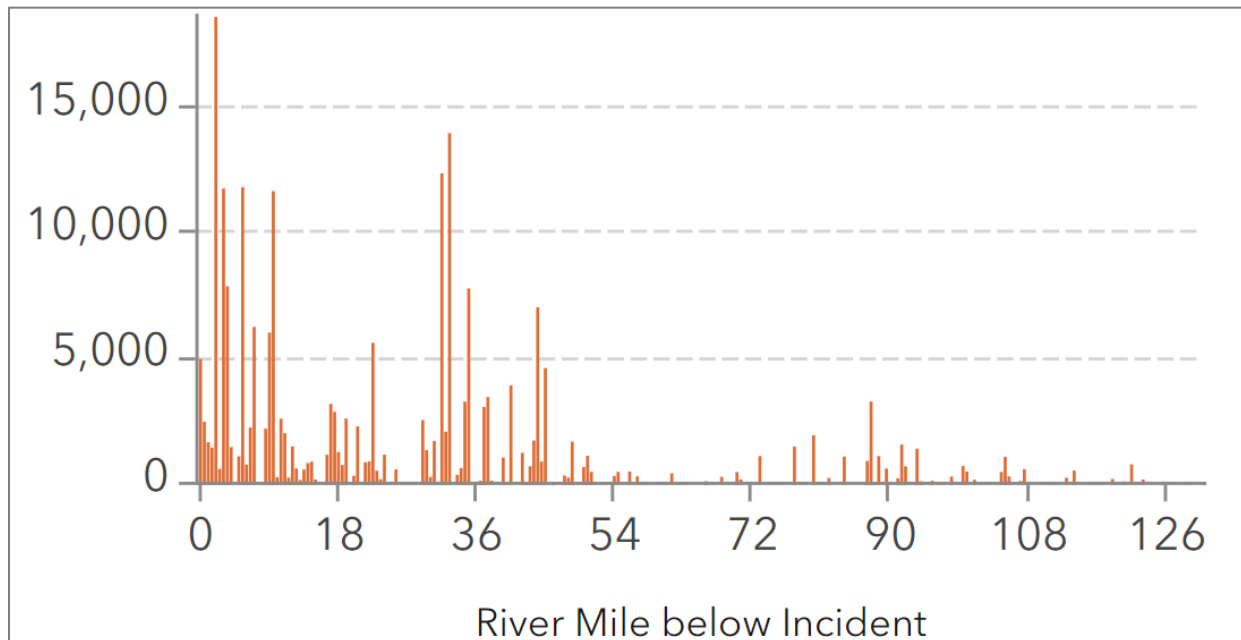
Exhibit 2-8. Cumulative weight of collected asphalt (in pounds) by river mile.

By completion of 2023 cleanup activities, an estimated 236,385 pounds of asphalt were recovered, from ~136 river miles (Exhibit 2-8; EPA, 2024a,b; MRL, 2023a). This represents an approximate 60% recovery of the estimated 420,000 pounds spilled into the Yellowstone River at the time of the incident with more than 40% unrecovered at the end of cleanup activities in 2023. This asphalt may represent a combination of observed asphalt that did not meet “actionable” criteria, asphalt that was present within the 136 river miles but not observed by cleanup crews, and any asphalt that may have been transported even farther downstream. The weight of the collected asphalt was estimated by weighing bags of asphalt, followed by visually inspecting the material in the bags to determine a percentage of various debris (e.g., wood, rocks, etc.) in the bags (EPA, 2023d). This percentage was deducted from the overall weight to account for the weight of the various debris that was not asphalt (EPA, 2023d).

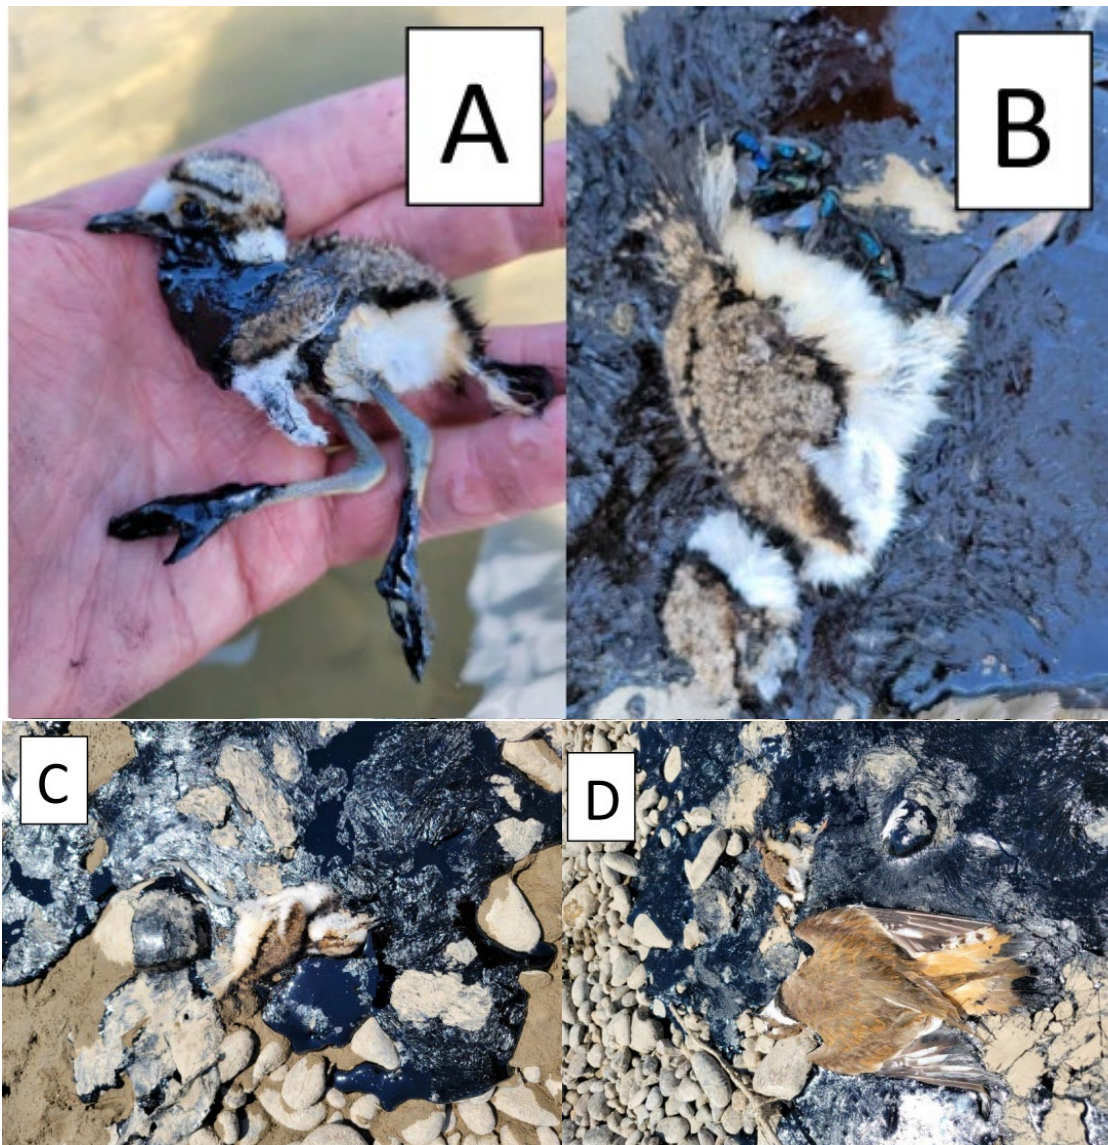
Exhibit 2-9. (A) Asphalt coated alive, (B and C) Asphalt coated deceased killdeer chicks, and (D) Asphalt coated deceased killdeer adult.

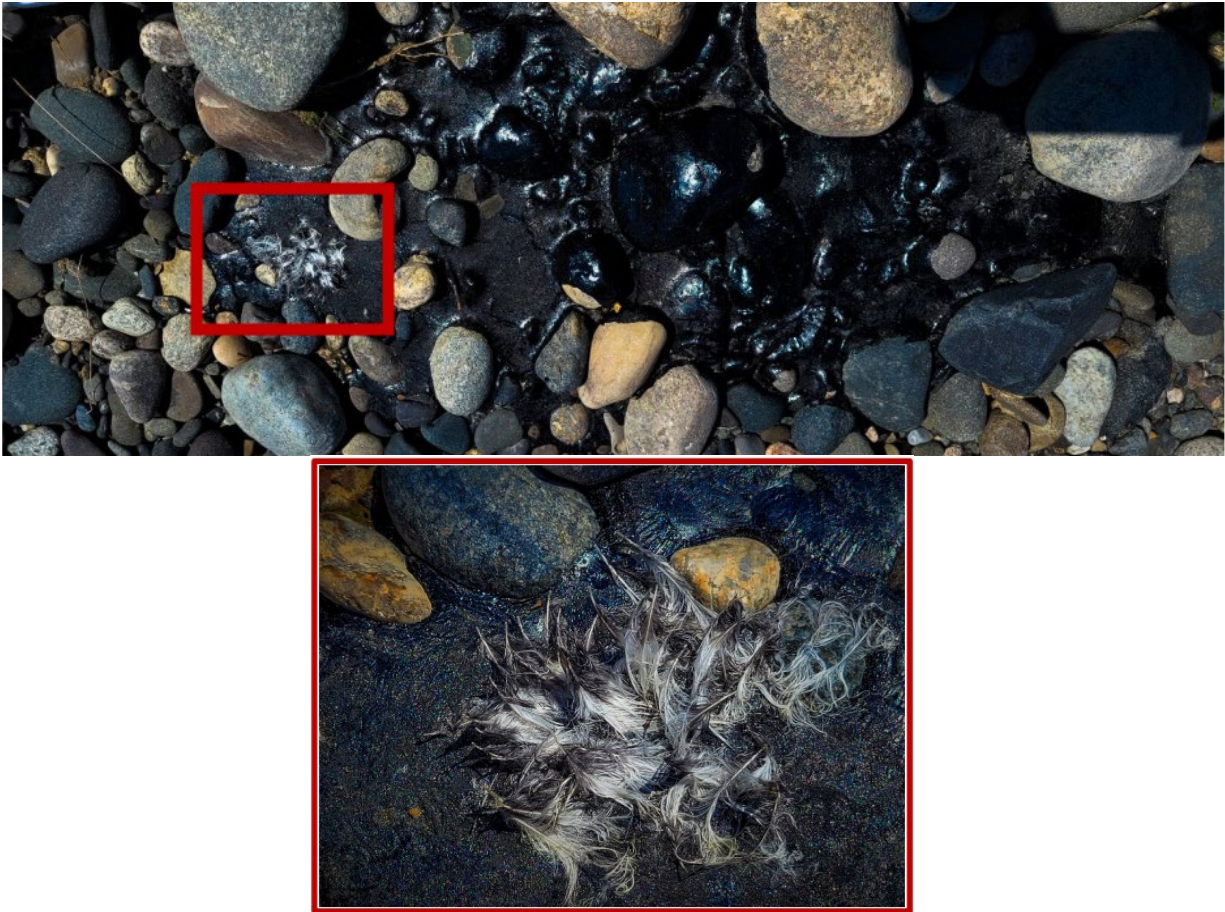
Exhibit 2-10. Tar mat with potential spotted sandpiper mortality/scavenging. The top image displays the tar mat, and the bottom image displays a zoomed in view of the remaining feathers. Location 45.705518, -108.603698 was on a gravel bar southwest of Billings, Montana, on the Yellowstone River.

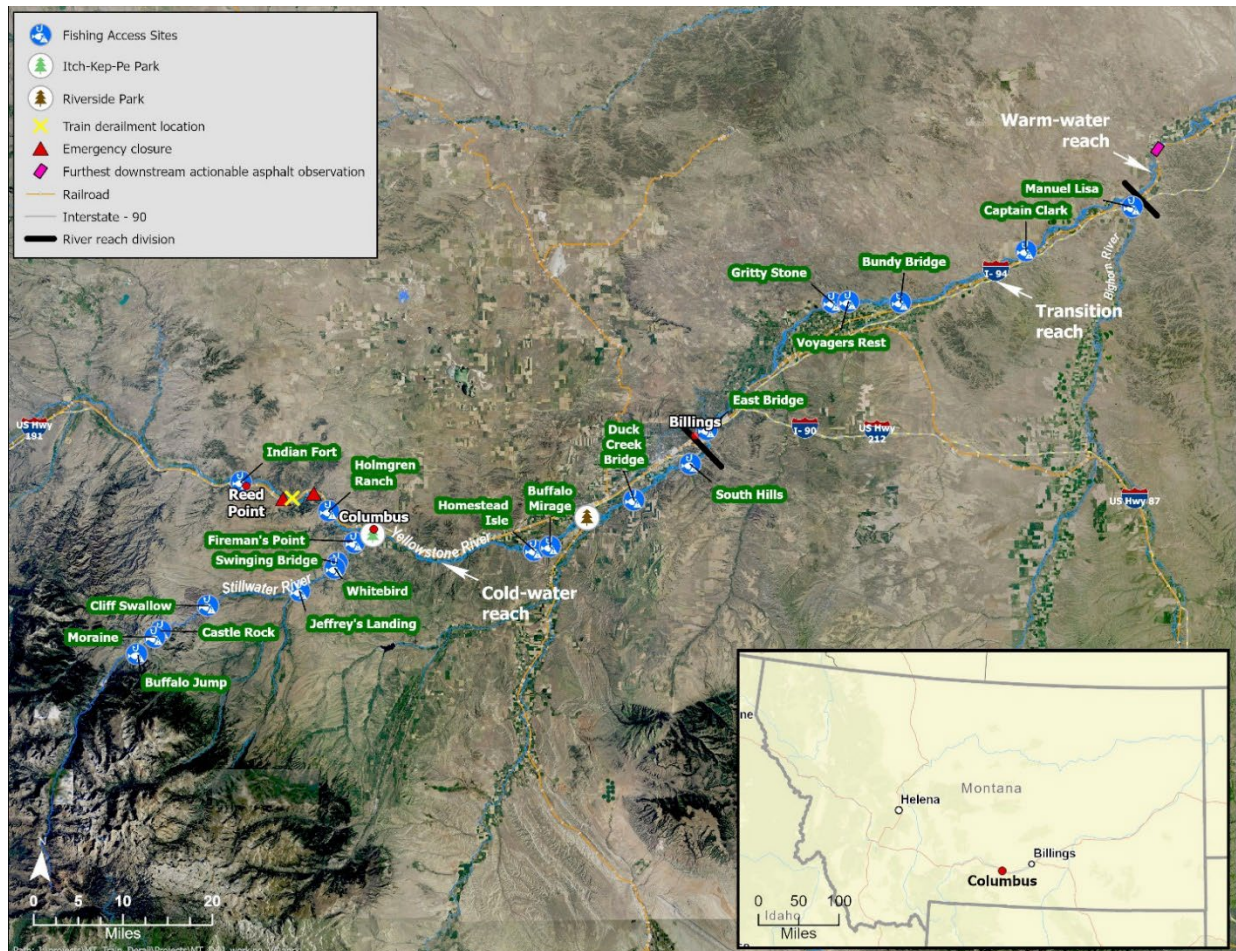
Exhibit 3-1. Incident location and furthest downstream observation of asphalt.

This chapter provides an overview of the Assessment Area. For the purposes of this Work Plan, the Assessment Area is defined by where asphalt (oil) released as a result of the incident may have come to be located and response activities have caused injuries and service losses. This includes upstream areas that were affected by river closures, the location of the incident, and downstream areas affected by the spilled asphalt and response activities, potentially extending approximately 136 miles, and potentially including tributaries, such as the Stillwater River (NRDP, 2023a; MRL, 2023a; DES, 2024; Exhibit 3-1).

136 miles downstream, extending into the middle reach of the river (NRDP, 2023a; MRL, 2023a; Exhibit 3-1). Below, we describe the reaches where asphalt was observed.
