Natural Resource Damage Assessment Work Plan

Reed Point Bridge Derailment

September 20, 2024

Prepared by:
Abt Global
Tabor Center
10th Floor
Denver, CO 80202

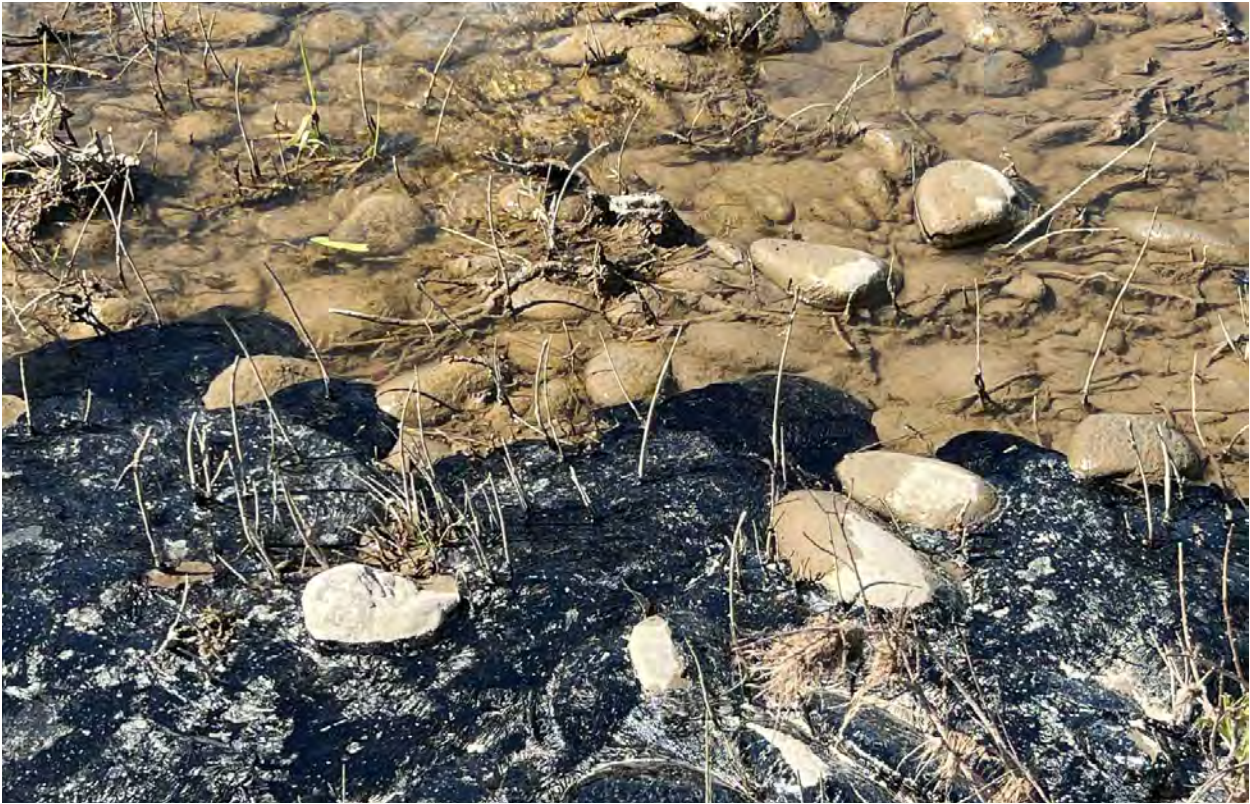
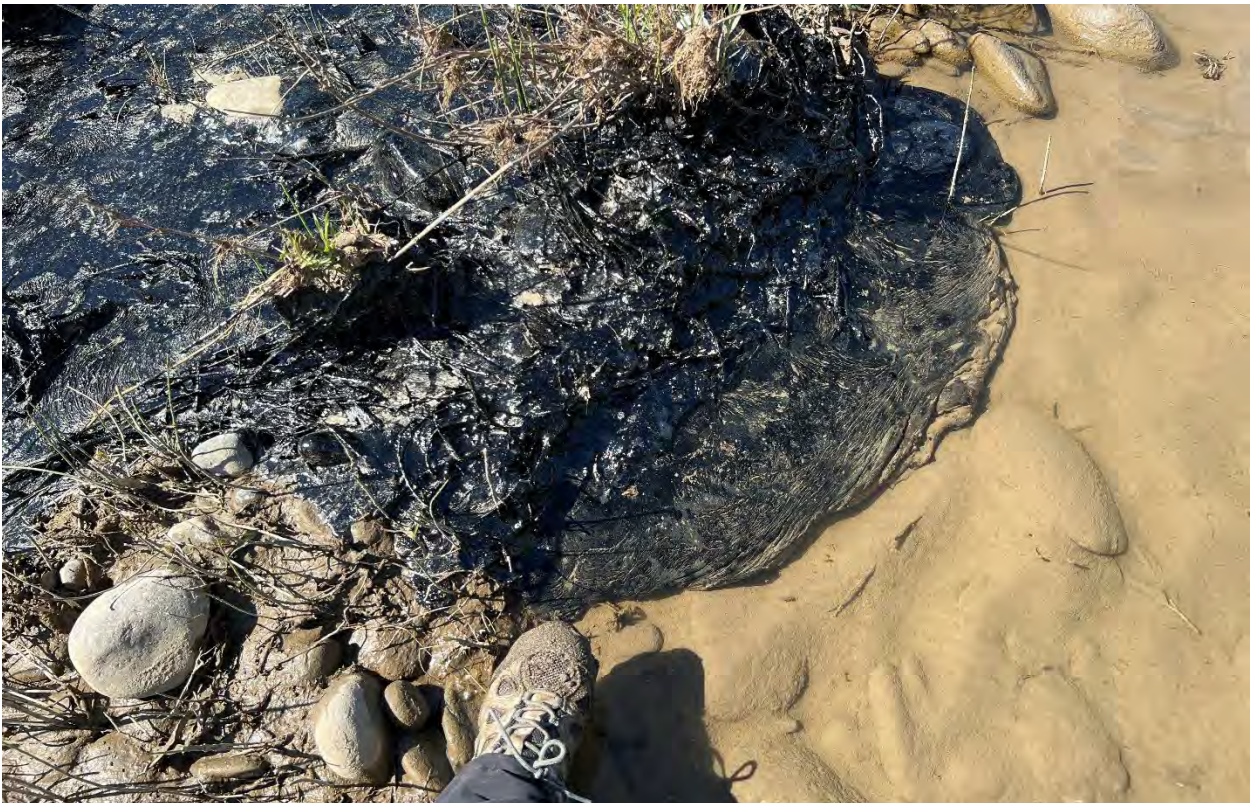
Exhibit 2-1. Asphalt deposits along shoreline. Photos taken approximately 1.5 miles downstream of the train derailment site, on the lee side of an island.

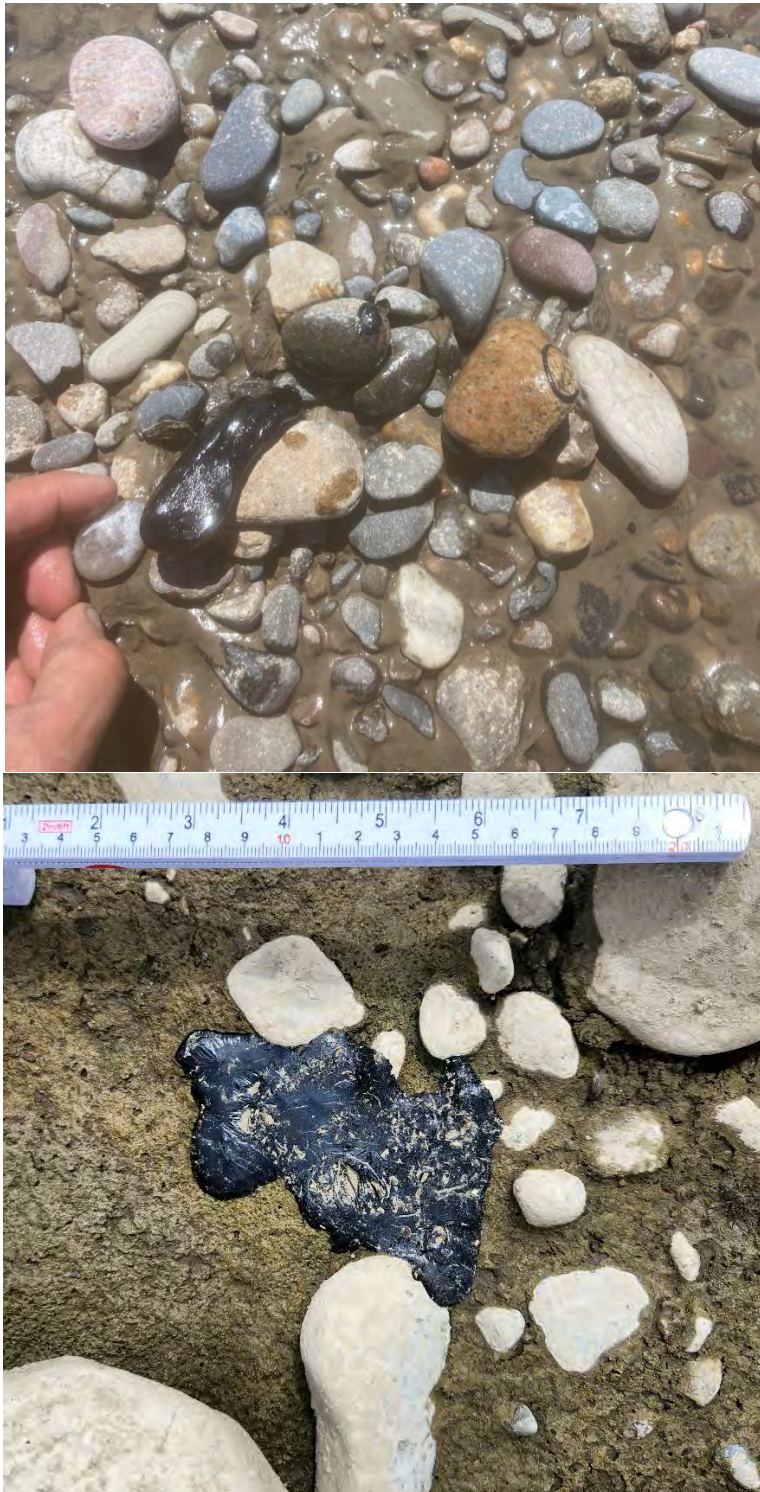
Exhibit 2-2. Asphalt deposits a few centimeters in diameter. Top photo taken near Worden, Montana (coordinates 45.97984 N, 108.23328 W); bottom photo taken at Dover, Montana.

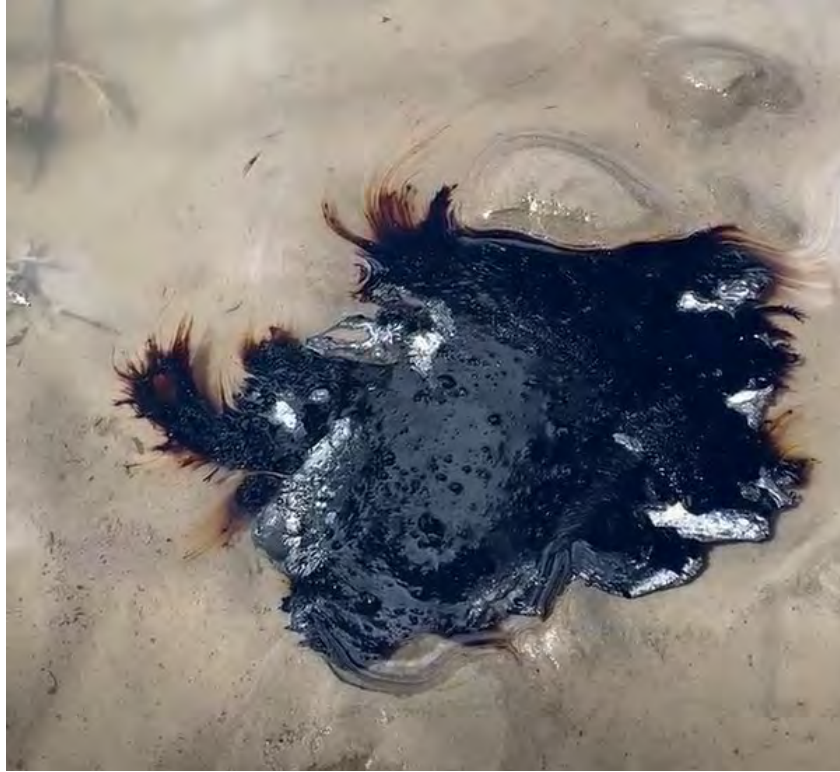
Exhibit 2-5. Asphalt deposits in water. Image displays the asphalt breaking into small pieces and spreading downstream. Photo taken near Worden, Montana (coordinates 45.97984 N, 108.23328 W).

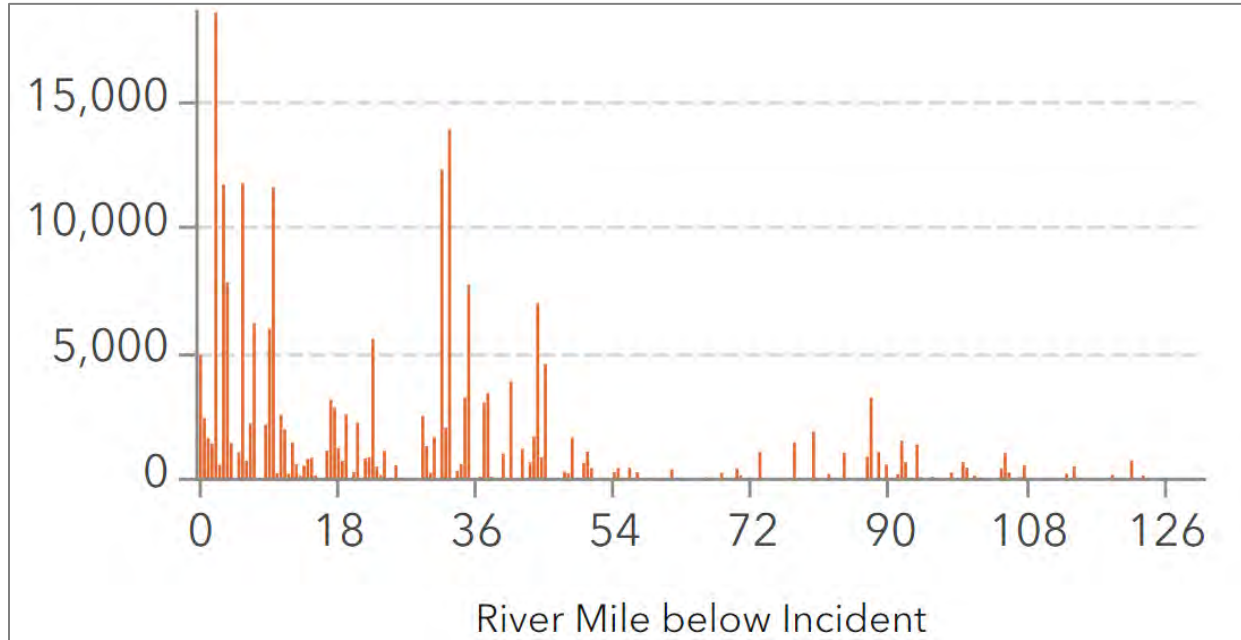
Exhibit 2-8. Cumulative weight of collected asphalt (in pounds) by river mile.

By completion of 2023 cleanup activities, an estimated 236,385 pounds of asphalt were recovered, from ~136 river miles (Exhibit 2-8; EPA, 2024a,b; MRL, 2023a). This represents an approximate 60% recovery of the estimated 420,000 pounds spilled into the Yellowstone River at the time of the incident with more than 40% unrecovered at the end of cleanup activities in 2023. This asphalt may represent a combination of observed asphalt that did not meet “actionable” criteria, asphalt that was present within the 136 river miles but not observed by cleanup crews, and any asphalt that may have been transported even farther downstream. The weight of the collected asphalt was estimated by weighing bags of asphalt, followed by visually inspecting the material in the bags to determine a percentage of various debris (e.g., wood, rocks, etc.) in the bags (EPA, 2023d). This percentage was deducted from the overall weight to account for the weight of the various debris that was not asphalt (EPA, 2023d).

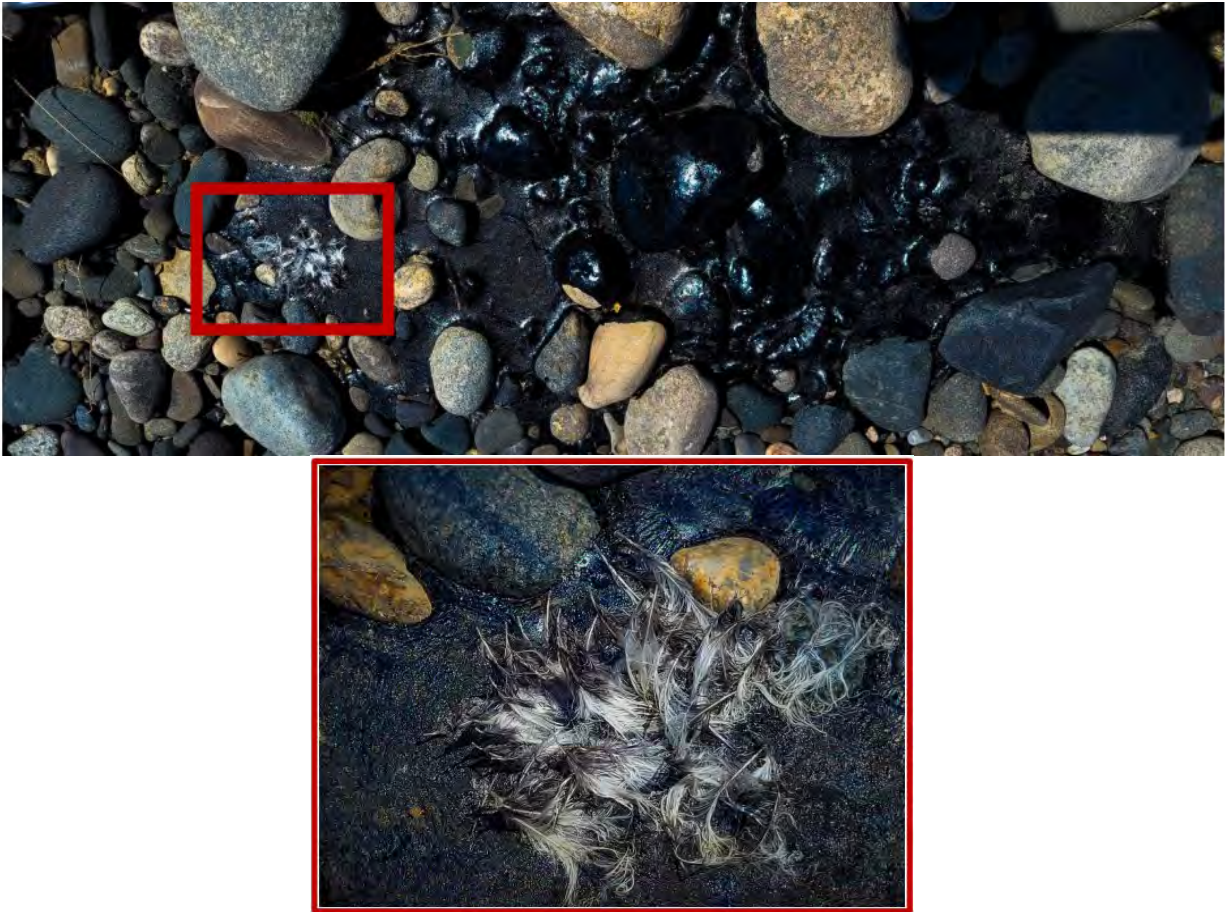
Exhibit 2-10. Tar mat with potential spotted sandpiper mortality/scavenging. The top image displays the tar mat, and the bottom image displays a zoomed in view of the remaining feathers. Location 45.705518, -108.603698 was on a gravel bar southwest of Billings, Montana, on the Yellowstone River.

Hundreds of tiger beetles, stoneflies, spiders, crayfish, and other invertebrates were found entrapped in the asphalt mats (Ostovar, 2023). Spiny softshell turtles use the same gravel/sandbar habitat as killdeer and spotted sandpipers. Because the incident and response occurred during the nesting season for spiny softshell turtles, MRL retained Professor Kayhan Ostovar to conduct rapid on-the-ground assessments to identify and mark nesting habitat of turtles to mitigate potential negative impacts of cleanup activities. There were no observations of turtles entrapped in asphalt. Four dead turtles were found downstream of the incident site. However, there were no visual observations of asphalt on the turtles (Ostovar, 2023).

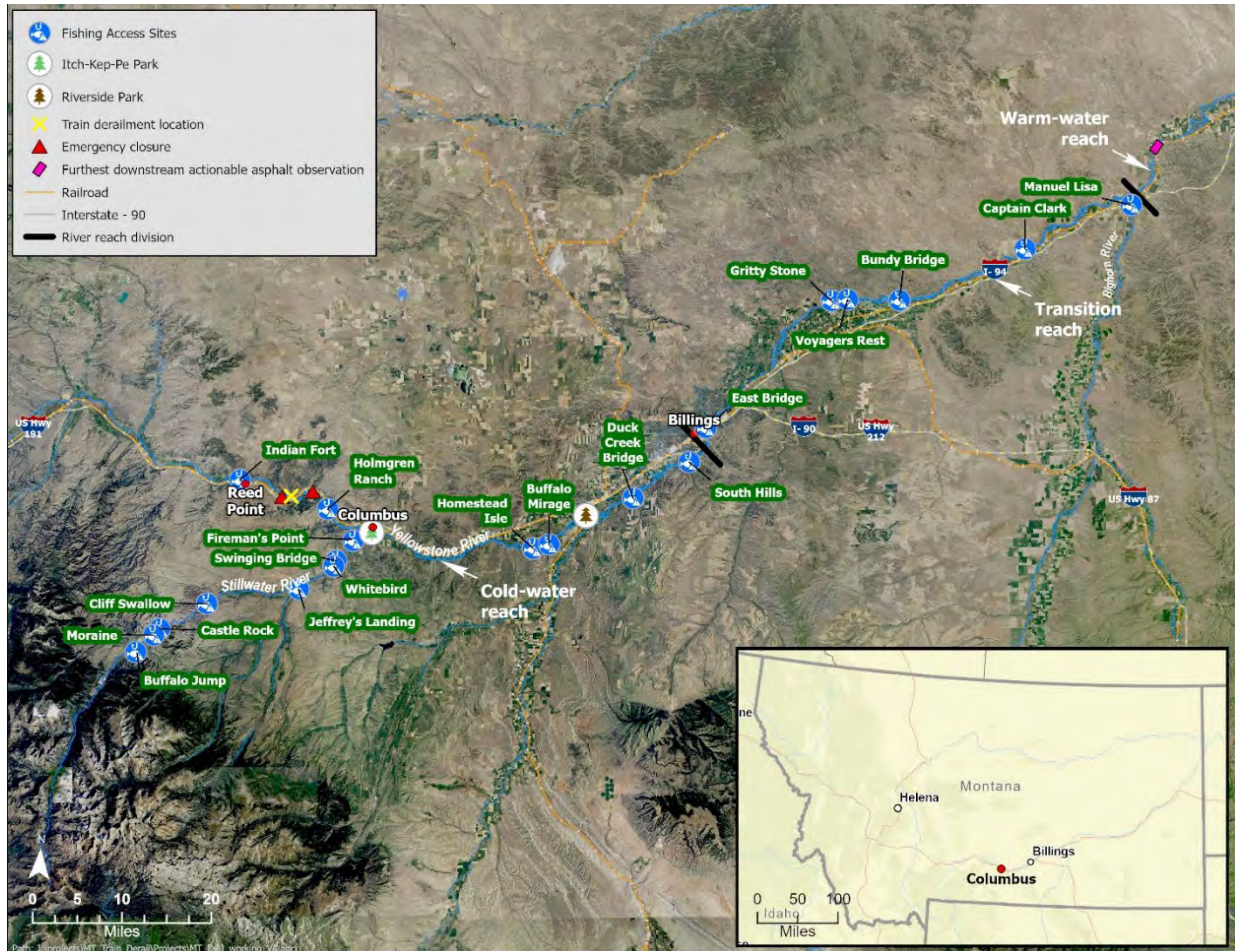
Exhibit 3-1. Incident location and furthest downstream observation of asphalt.

This chapter provides an overview of the Assessment Area. For the purposes of this Work Plan, the Assessment Area is defined by where asphalt (oil) released as a result of the incident may have come to be located and response activities have caused injuries and service losses. This includes upstream areas that were affected by river closures, the location of the incident, and downstream areas affected by the spilled asphalt and response activities, potentially extending approximately 136 miles, and potentially including tributaries, such as the Stillwater River (NRDP, 2023a; MRL, 2023a; DES, 2024; Exhibit 3-1).

136 miles downstream, extending into the middle reach of the river (NRDP, 2023a; MRL, 2023a; Exhibit 3-1). Below, we describe the reaches where asphalt was observed.

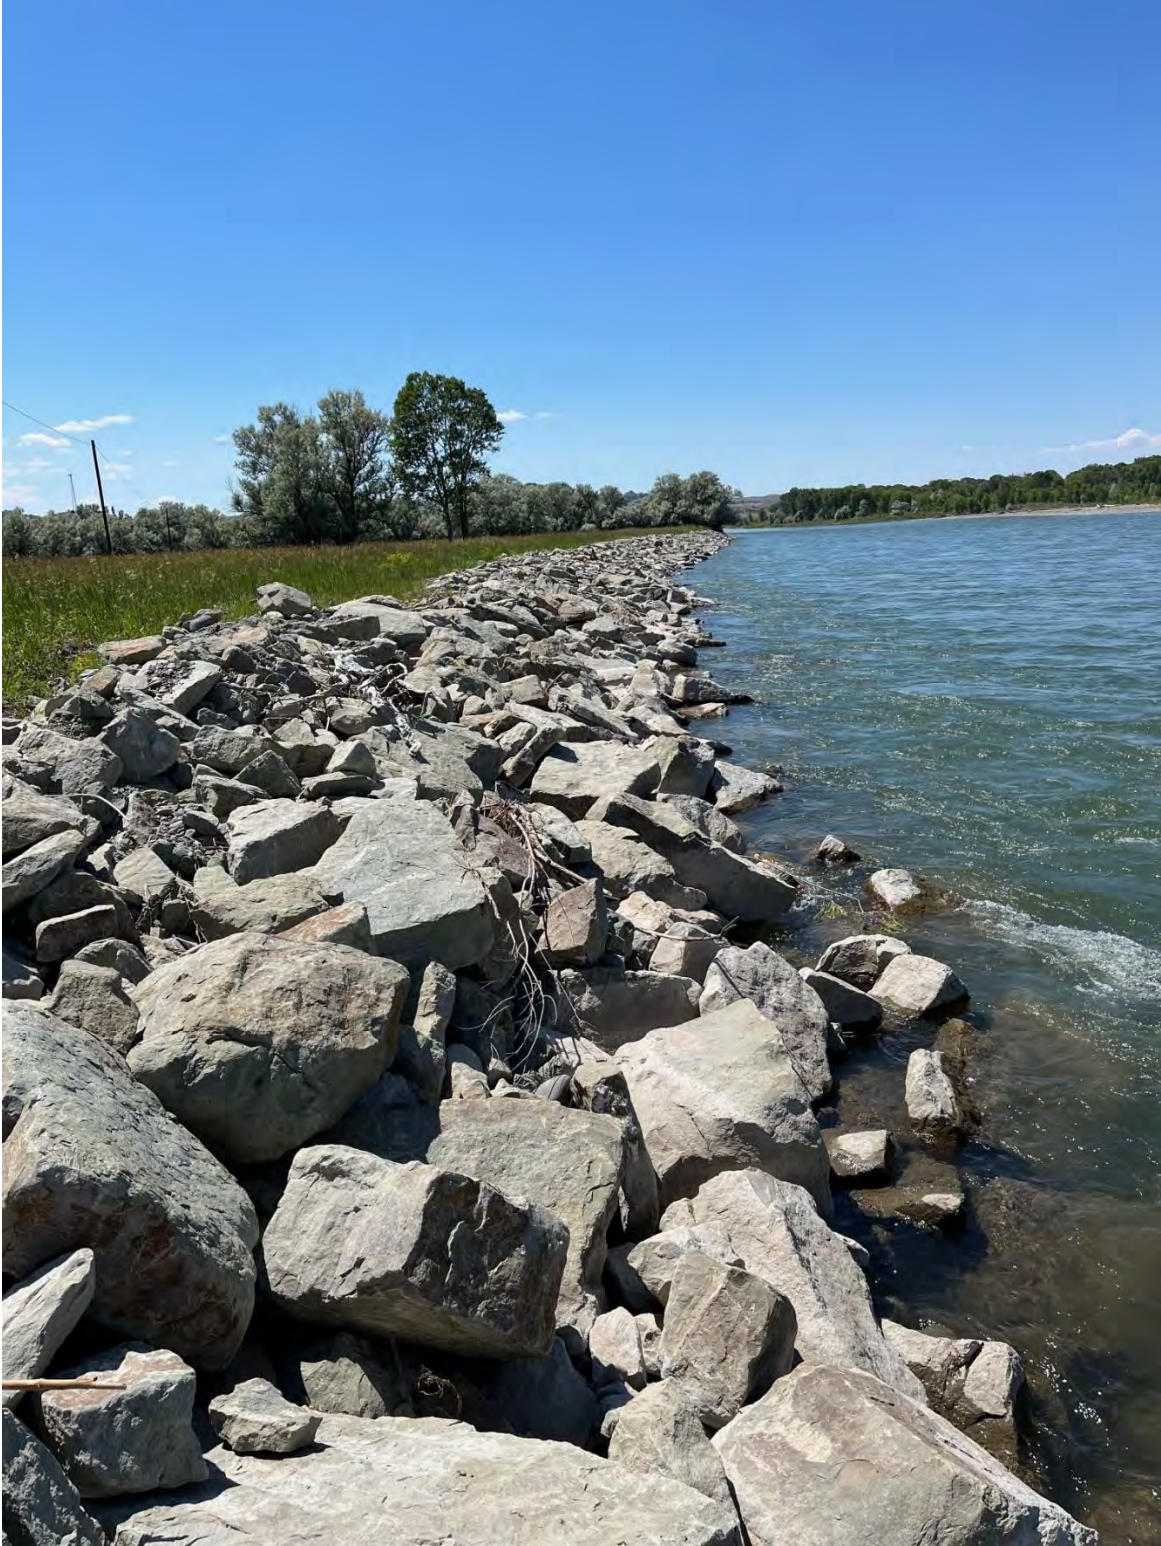
Bridge 51 riprap facing upstream (north-west) July 9, 2024.

Additionally, after the derailment, extensive riprap was placed on approximately 1,000 feet of riverbank above the derailment site; it contained materials that are not allowed in riprap, such as metal from the incident and rebar (FWP, 2024a). MRL is working with the Stillwater Conservation District to remove the metal and meet 310 permit conditions, though final approval from the Conservation District has not yet been issued. As part of the assessment, the Trustee will review appropriate documentation and information to determine how response actions may have resulted in additional injuries to ecological resources.

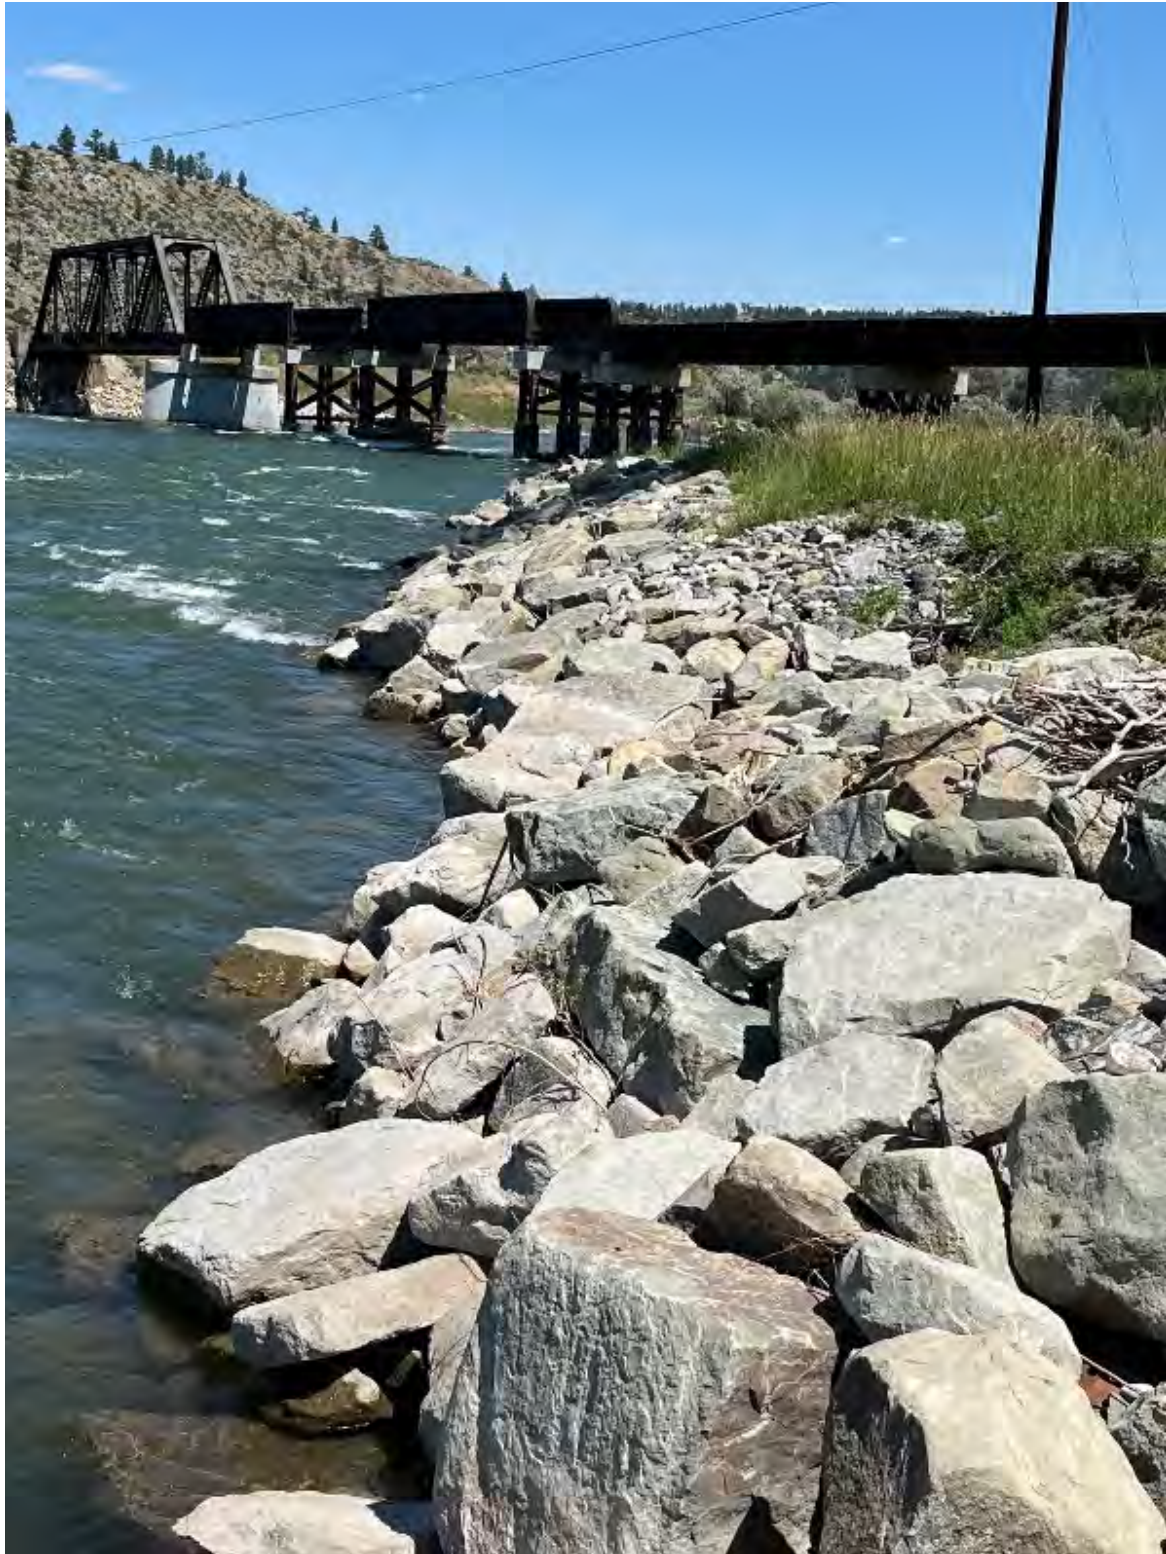
Bridge 51 riprap facing downstream (south-east) July 9, 2024.
