TO: Doug Martin, Montana Natural Resource Damage Program
FROM: Amy Sacry and Gabi Poupart, Geum Environmental Consulting, Inc.
DATE: March 28, 2025
RE: Milltown 2024 Soil Treatment Evaluation Summary

This document summarizes observations made in July 2024 of the Milltown Dam Soil Treatment Project (Project, Project Area) completed between November 2017 and October 2019 at the Milltown Dam Project Site by the Montana Natural Resource Damage Program (NRDP). The Project is described in detail in *Milltown Soil Treatment Project Manual State of Montana – Department of Justice Natural Resource Damage Program* (Geum, 2017) and *Milltown Dam Soil Treatment Project – Construction Completion Report* (Geum, 2020). Monitoring of the Project began in August 2020 and was repeated in July 2021, and July 2024. There were two main areas of soil treatment work completed – one in the Bypass Channel Area (Bypass Channel Soil Treatment Area) and one in the Posse Ground Area along the south slope (Posse Ground Soil Treatment Area) (Figure 1 and Figure 2). In the Posse Ground Soil Treatment Area, work included: ripping the soil surface, applying lime, applying cover soil amended with compost, construct

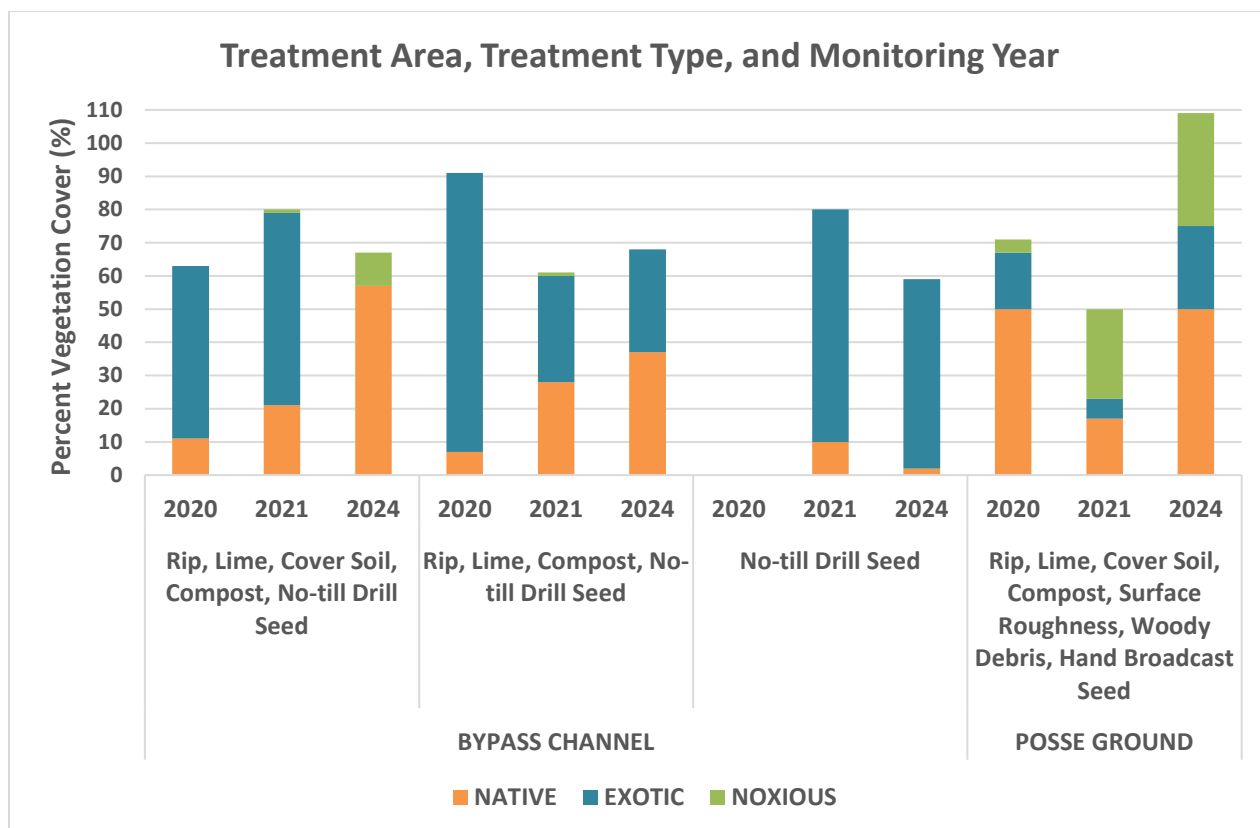
Figure 5. Total percent vegetation broken out by native, exotic and noxious species and by treatment area, treatment type and monitoring year.

In 2024, native species made up most of the total cover for all treatments (Figure 5). The native species with the highest average cover for all plots were western wheatgrass (*Elymus smithii*, 33%), bluebunch wheatgrass (*Pseudoroegneria spicata*, 50%), Nevada bluegrass (*Poa nevadensis*, 23%), slender wheatgrass (*Elymus trachycaulus*, 23%), and Idaho fescue (*Festuca idahoensis*, 16%). Exotic species with the highest cover included black medic (*Medicago lupulina*, 60%), redtop (*Agrostis stolonifera*, 49%), smooth brome (*Bromus inermis*, 15%), and tall tumble mustard (*Sisymbrium altissimum*, 14%). Noxious weed species occurred in all plots in the Posse Ground Soil Treatment Area and in two plots in the Bypass Channel Soil Treatment Area. In the Posse Ground Soil Treatment Area, cheatgrass (*Bromus tectorum*) had an average cover of 34% and occurred in all four plots, and Japanese brome (*Bromus japonica*) had an average cover of 30% and occurred in Plot 3. In the Bypass Channel Soil Treatment Area, cheatgrass had an average cover of 25% and occurred in Plots 1 and 2 in the rip, lime, cover soil, compost, and no-till drill seed treatment area. Japanese brome had an average cover of 5% and occurred in Plot 2 in the rip, lime, compost, no-till drill seed treatment area. Cheatgrass and Japanese brome are not Montana listed noxious weeds but are categorized as noxious for monitoring purposes because they are highly invasive and have significant management implications.

Table 3 and Figure 5 compare average cover for all plots between 2020, 2021, and 2024 by treatment area, treatment type, and species status – native, exotic, or noxious weed. In the Bypass Channel Soil Treatment Area, plots where the only treatment was no-till drill seeding were only observed in 2021 and 2024. Bypass Channel Soil Treatment Area plot cover decreased from 76.6% in 2020 to 73.1% in 2021 and 65.7% in 2024. In 2024, cover decreased in the 'rip, lime, cover soil, compost, no-till drill seed' treatment in the Bypass Channel Soil Treatment Area (2021= 62.2%, 2021= 79.0%, 2024=67.0%) and increased in the 'rip, lime, compost, no-till drill seed' (2021= 91.0%, 2021= 60.3%, 2024 =72.0%). Native cover increased in all plots in the Bypass Channel Soil Treatment Area except in the 'no-till drill seed' treatment area where cover went from 10% in 2021 to 2% in 2024. Exotic species decreased in 'rip, lime, cover soil, compost, no-till drill seed' plots (2021= 51.6%, 2021= 58.0%, 2024= 0.0%) and continued to decrease in 'rip, lime, compost, no-till drill seed' plots (2021= 84.0%, 2021= 32.3%, 2024= 31.0%). Noxious weed cover increased in the 'rip, lime, cover soil, compost, no-till drill seed' from 1.0% to 10.0% between 2021 and 2024. In the Posse Ground Soil Treatment Area, cover remained nearly the same

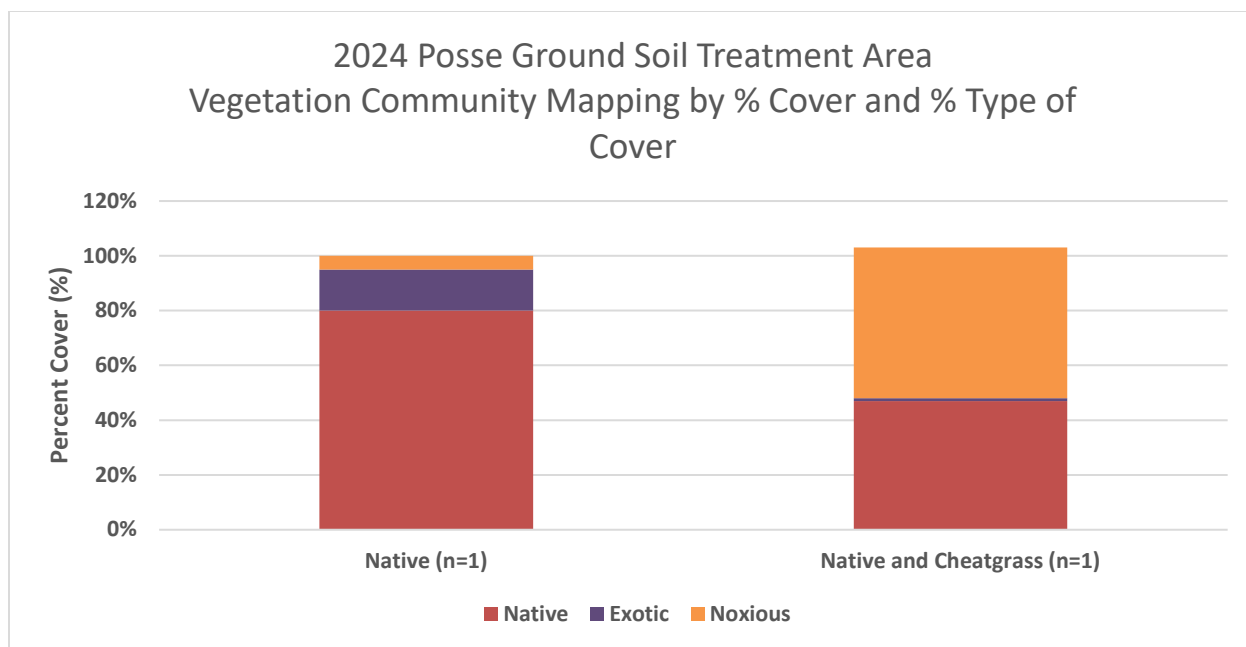
Figure 11. 2024 vegetation community mapping for the Posse Ground Soil Treatment Area by % cover and % of type of cover – native, exotic, or noxious.

by species and type of cover for each individual plot for the Posse Ground Area. Figure 11 shows percent cover by type of cover for vegetation communities in the Posse Ground Soil Treatment Area.

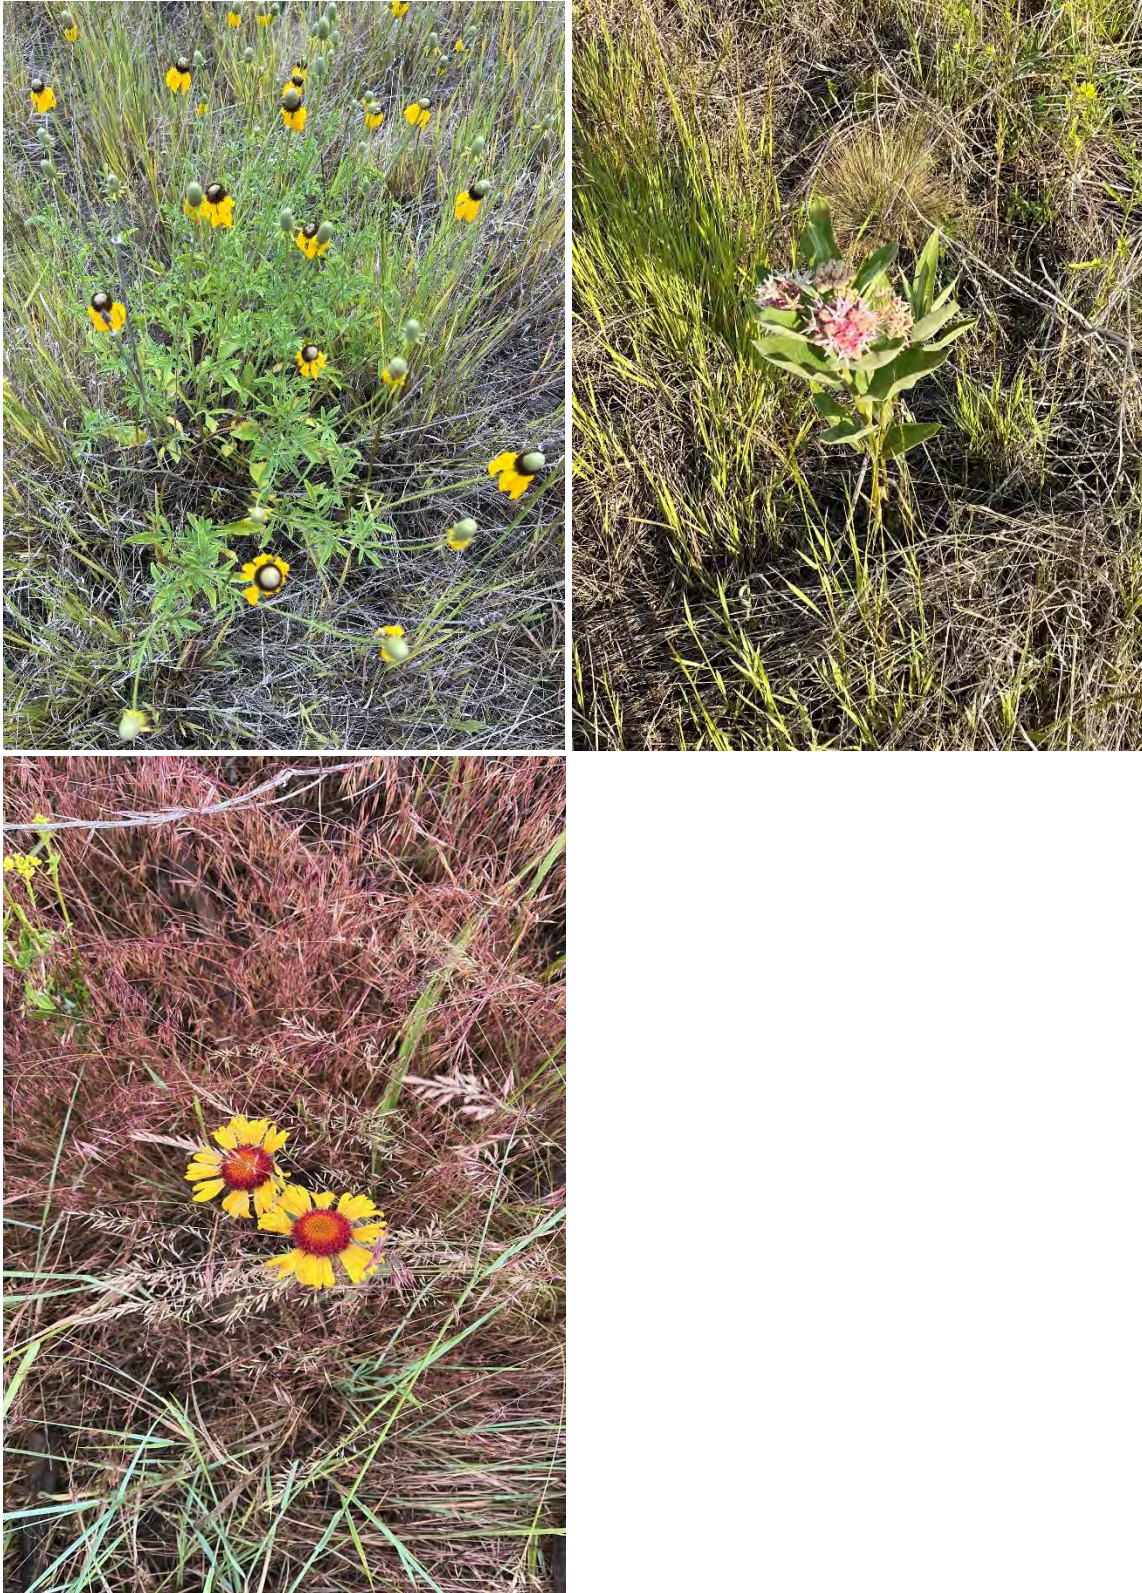
Figure 17. Forb species present in the Project Area (from top left - prairie coneflower, showy milkweed and blanketflower.

- Similar to 2020 and 2021 observations, several other seeded species were observed in the treatment areas, particularly in the Posse Ground Soil Treatment Area. These species included: common yarrow (*Achillea millefolium*), white sagebrush (*Artemisia ludoviciana*), Lewis flax (*Linum lewisii*), blanketflower (*Gaillardia aristata*), and fuzzy-tongue penstemon (*Penstemon eriantheus*) (Figure 17). Common yarrow cover was much lower in 2024 compared to 2021.
