DRAFT Environmental Assessment Racetrack Pond Fishing Access Site and Habitat Improvement Project

August 3, 2017

Racetrack Pond Restoration Project

Wetland Delineation Report

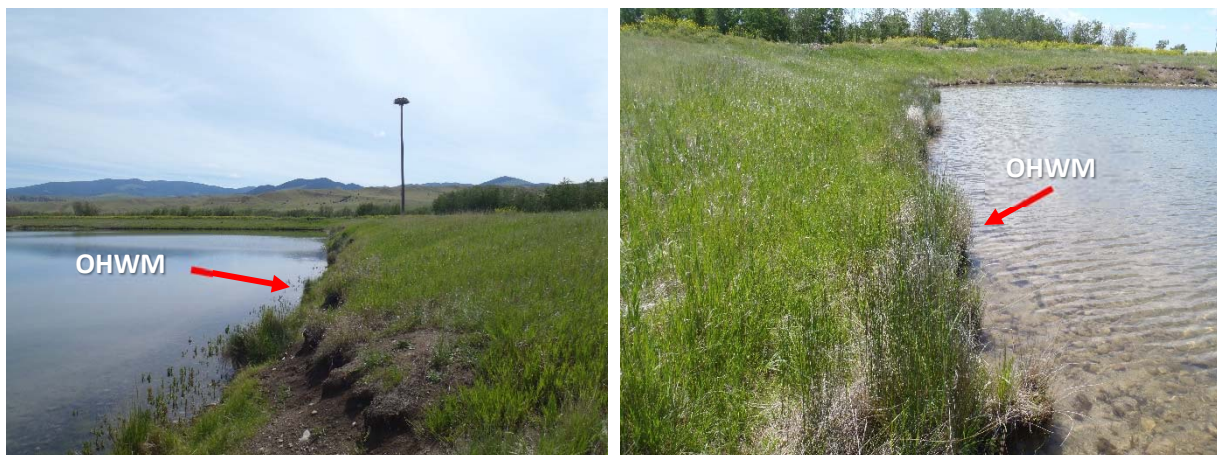
Figure 11. The line of perennial vegetation on shorelines of Racetrack Pond indicates the OHWM. Steep slopes of the south side of Racetrack Pond (left photo) and more gradual slopes of the northwest side of Racetrack Pond (right photo).

Surface water is present in Racetrack Pond throughout the year. Groundwater is the primary water source for the pond. The pond water elevation is controlled by an outlet culvert and channel located near the northeast corner of the pond. Water depth of the pond averages 8 to 10 feet, and substrate is generally cobble and small gravel. The OHWM, indicated by a line of perennial vegetation around the pond, defines the boundary of the lacustrine wetland. The slope of the shoreline is variable around the pond (Figure 11). Palustrine wetlands described in the following sections, occur adjacent to the lacustrine wetlands in the pond.

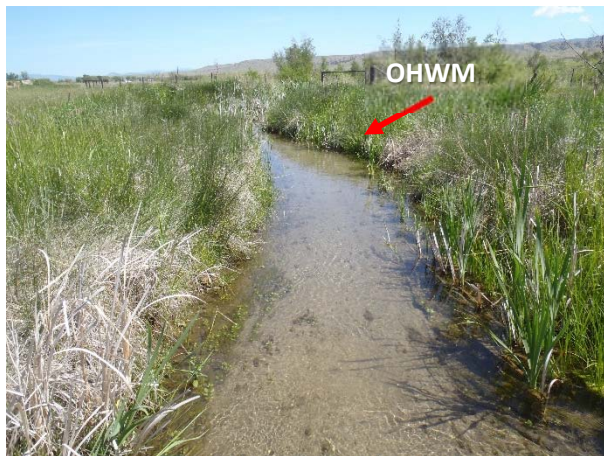
Figure 12. Racetrack Pond outlet channel on the east side of the pond.

An outlet channel on the northeast side of Racetrack Pond flows through culverts under a gravel access road, through a sand bottom channel, and then through another culvert into a side channel of the Clark Fork River (Figure 6, Figure 12). The straight outlet channel has a gradual slope from the road towards the side channel of the Clark Fork River. Small areas of patchy emergent vegetation encroach into the channel. The OHWM, indicated by a line of perennial vegetation along the outlet channel, is the boundary of this riverine wetland. Palustrine wetlands, described in the following sections, occur adjacent to the outlet channel.

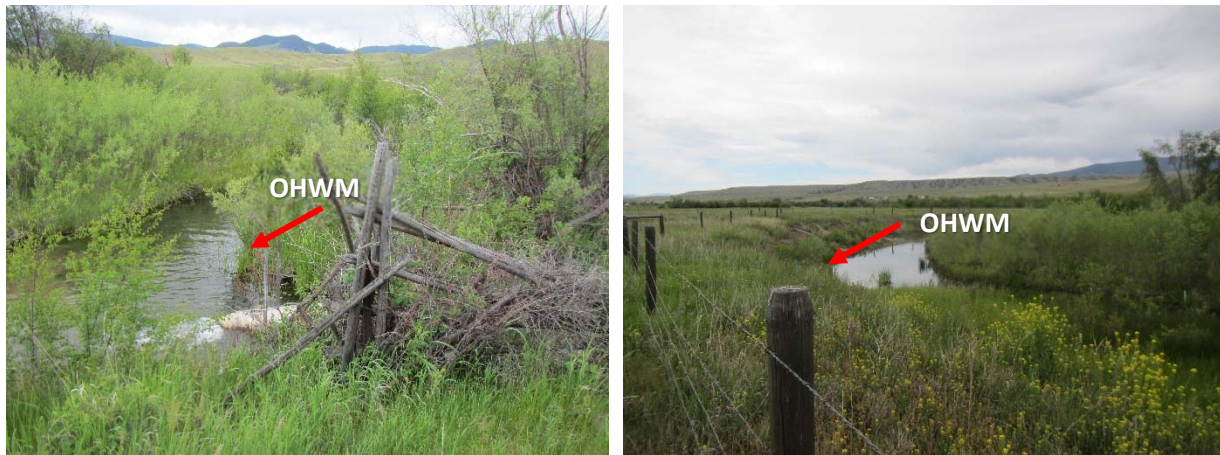
Figure 13. Outlet channel culvert entrance into Clark Fork River side channel (left photo) and view looking north from the outlet channel at the Clark Fork River Side Channel (right photo).

A side channel of the Clark Fork River is located in the northeast corner east of the project area. Water flows from the pond outlet channel into a culvert that runs under a berm and through a small section of palustrine scrub shrub before routing flows into the side channel. The side channel also intersects the project area near the fenceline on the north side of the pond. A ditch outflow from a sediment retention basin used during excavation in 2016 enters the Clark Fork River side channel at this location. The OHWM, indicated by a line of perennial vegetation along the side channel, is the boundary of this riverine wetland (Figure 13).

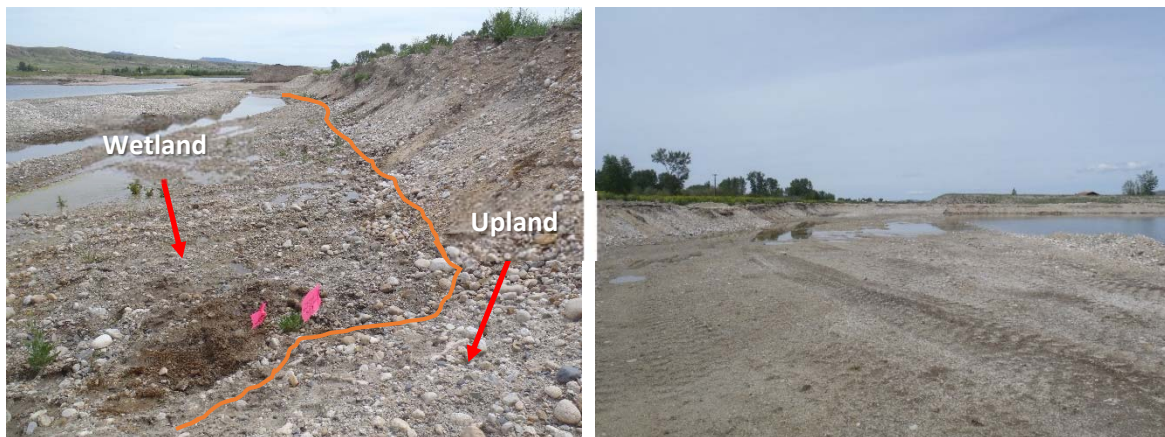
Figure 14. Wetland boundary between sample points RT09 (wetland) and RT10 (upland) looking east (left photo). Other recently excavated areas in the northern portion of Racetrack Pond that meet wetland criteria (right photo).

Palustrine unconsolidated bottom wetlands occur around the edges of the northern portion of Racetrack Pond (Figure 14) and in a drainage channel that routed water out of a sediment retention basin and into a side channel of the Clark Fork River in the northeast corner of the project area. This area was formerly an upland field that was excavated in 2016 to provide borrow material for the Clark Fork River, Phase 5 and 6 Remedial Action Project. The area was considered to have 'atypical, man-induced' wetlands due to the 2016 excavation that lowered the ground surface close to groundwater elevations. These lowered surfaces are similar to other adjacent locations that currently support palustrine emergent wetlands (i.e. sample point RT09). Soils at sample point RT09 included a layer with coated sand grains that met criteria for the Sandy Redox (S5) hydric soil indicator. The water table was observed at 8 inches below the ground surface and soils were saturated at 5 inches below the ground surface, meeting criteria for wetland hydrology indicators of High Water Table (A2) and Saturation (A3).
