# Natural Resource Damage Program

Symposium on Riparian Restoration in a  
Contaminated Environment

## The Evolution of Channel and Floodplain Restoration Design Approaches Based on Lessons Learned Over the Past Few Decades

John Muhlfeld  
Principal Hydrologist  
River Design Group, Inc.

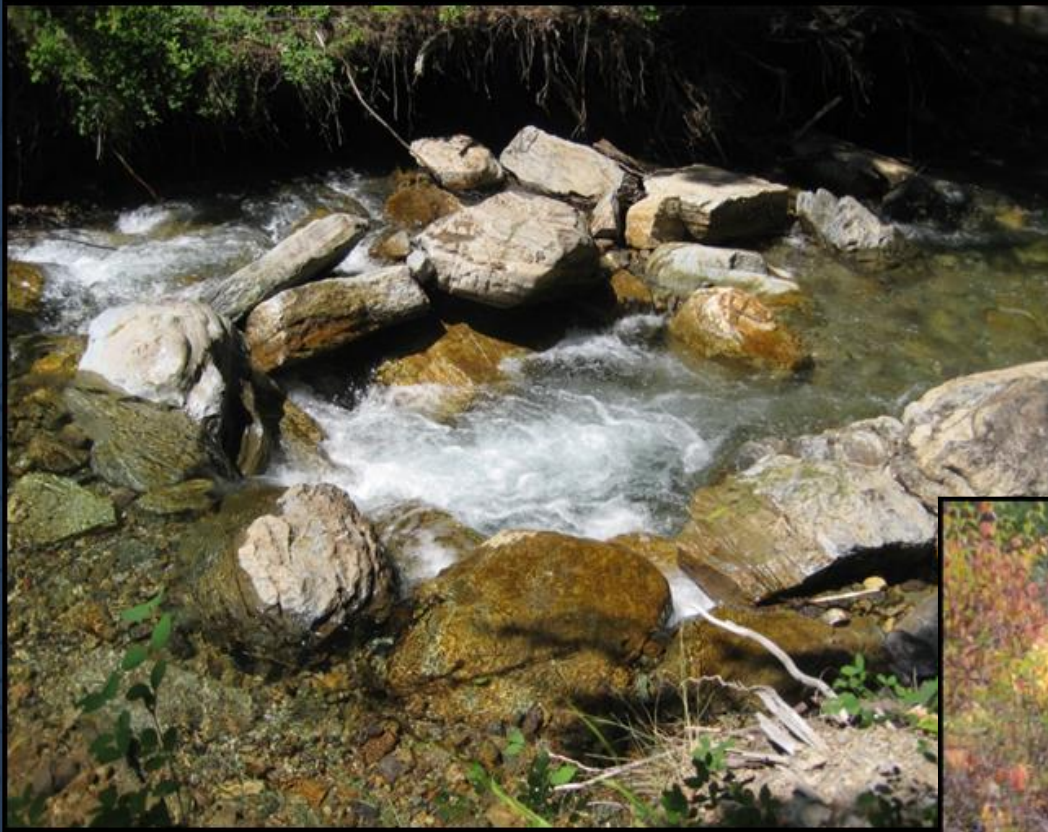
# Failure Modes and Geomorphic Response

← Rock Displacement  
and Flanking

Channel Incision and  
Floodplain  
Disconnection →

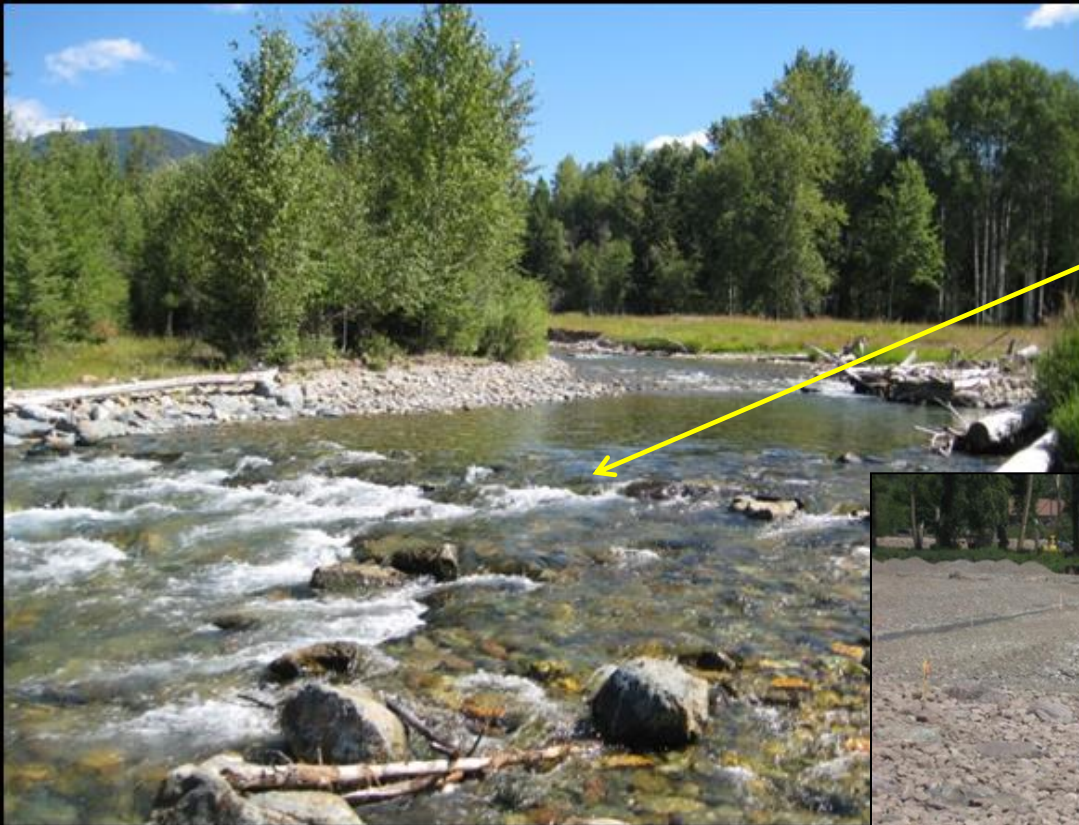
# Deformable Grade Control Structures

“Graded” Tailout

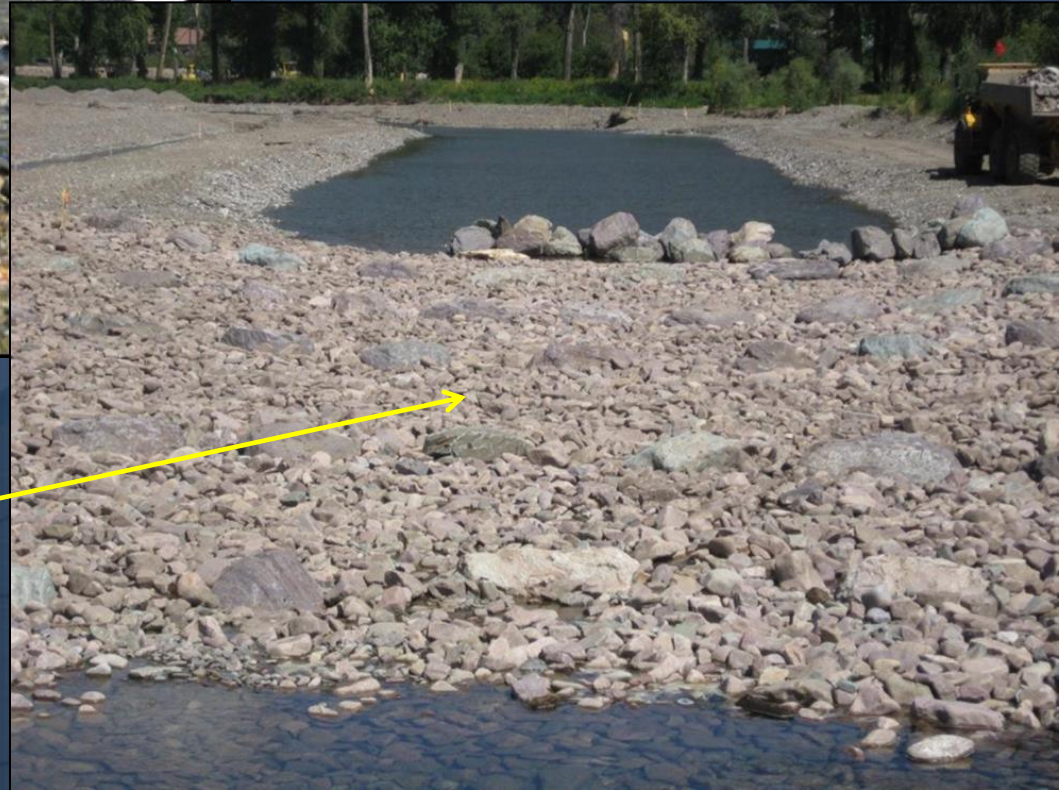
Boulder Energy  
Dissipater  
Structures

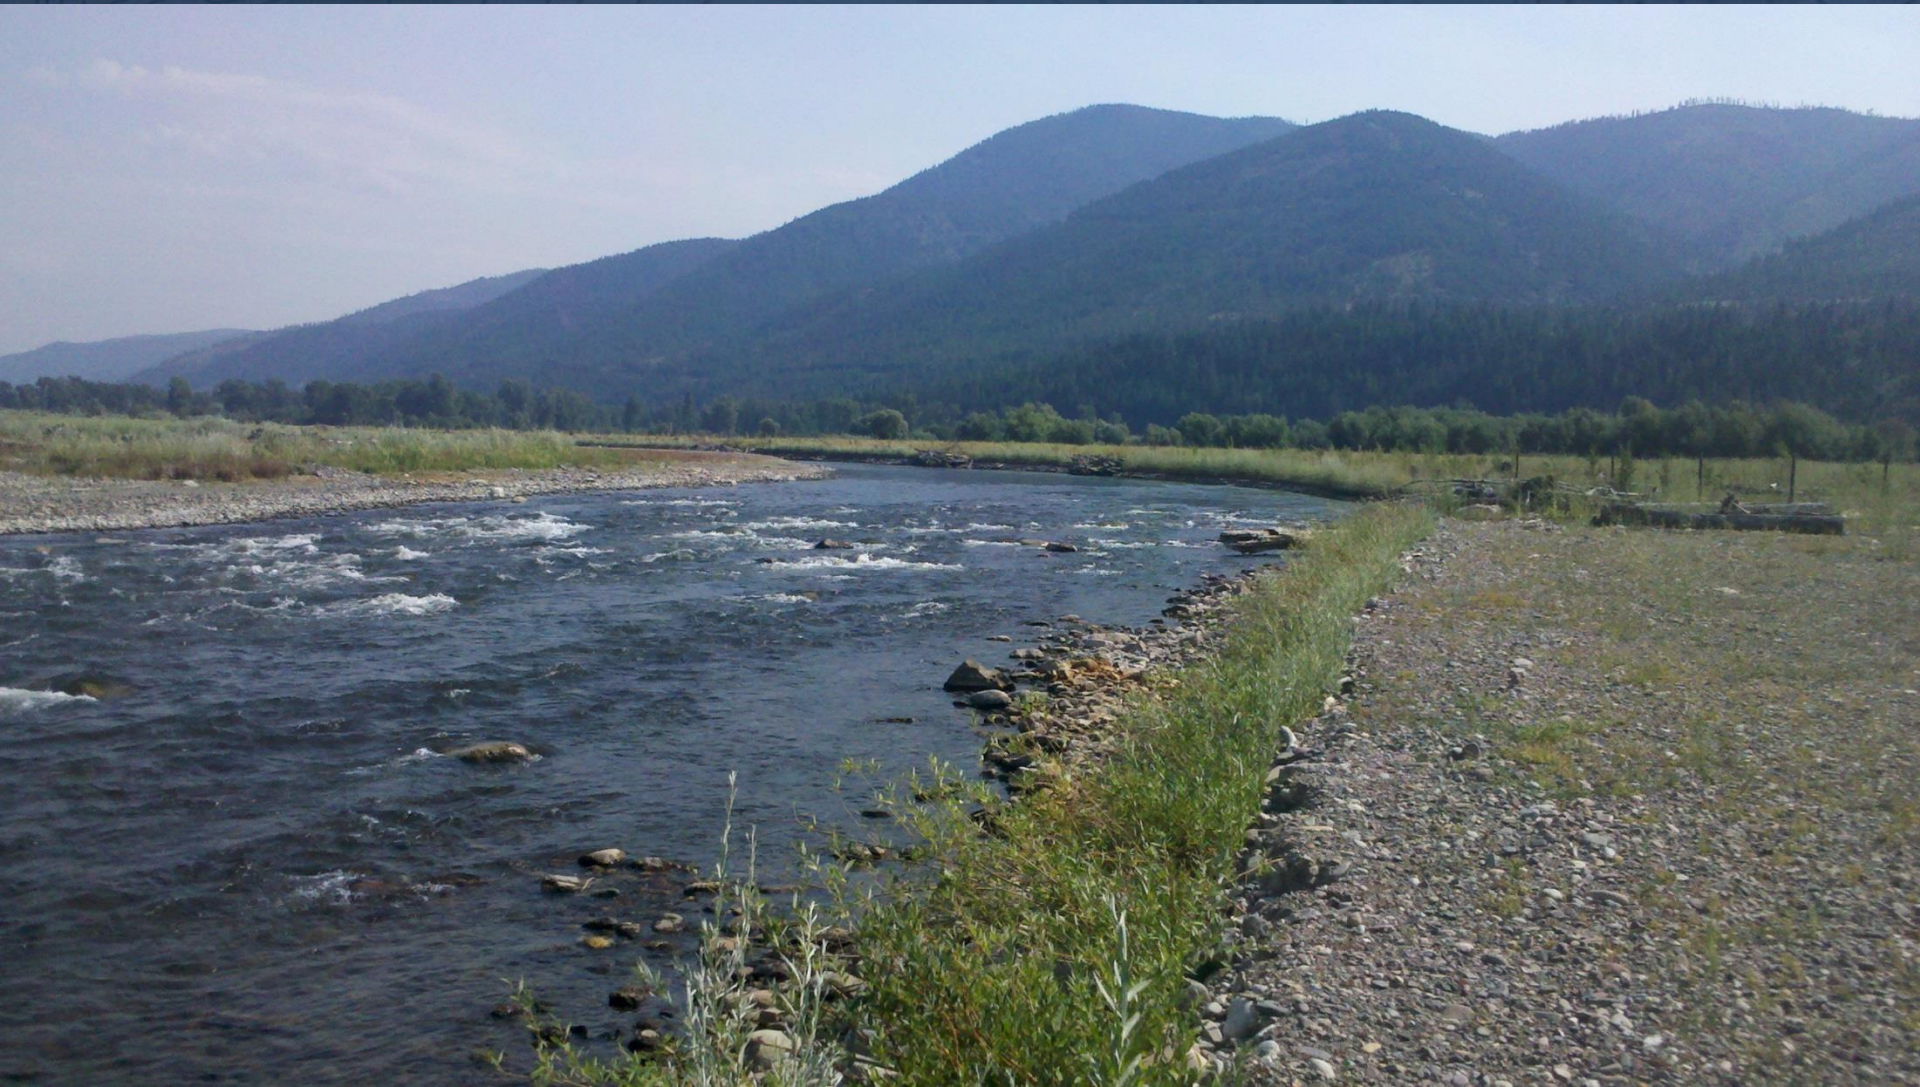
# Matrix Supported Constructed River Bed

Clark Fork River at the Former Milltown Dam Site – Reach CFR 2

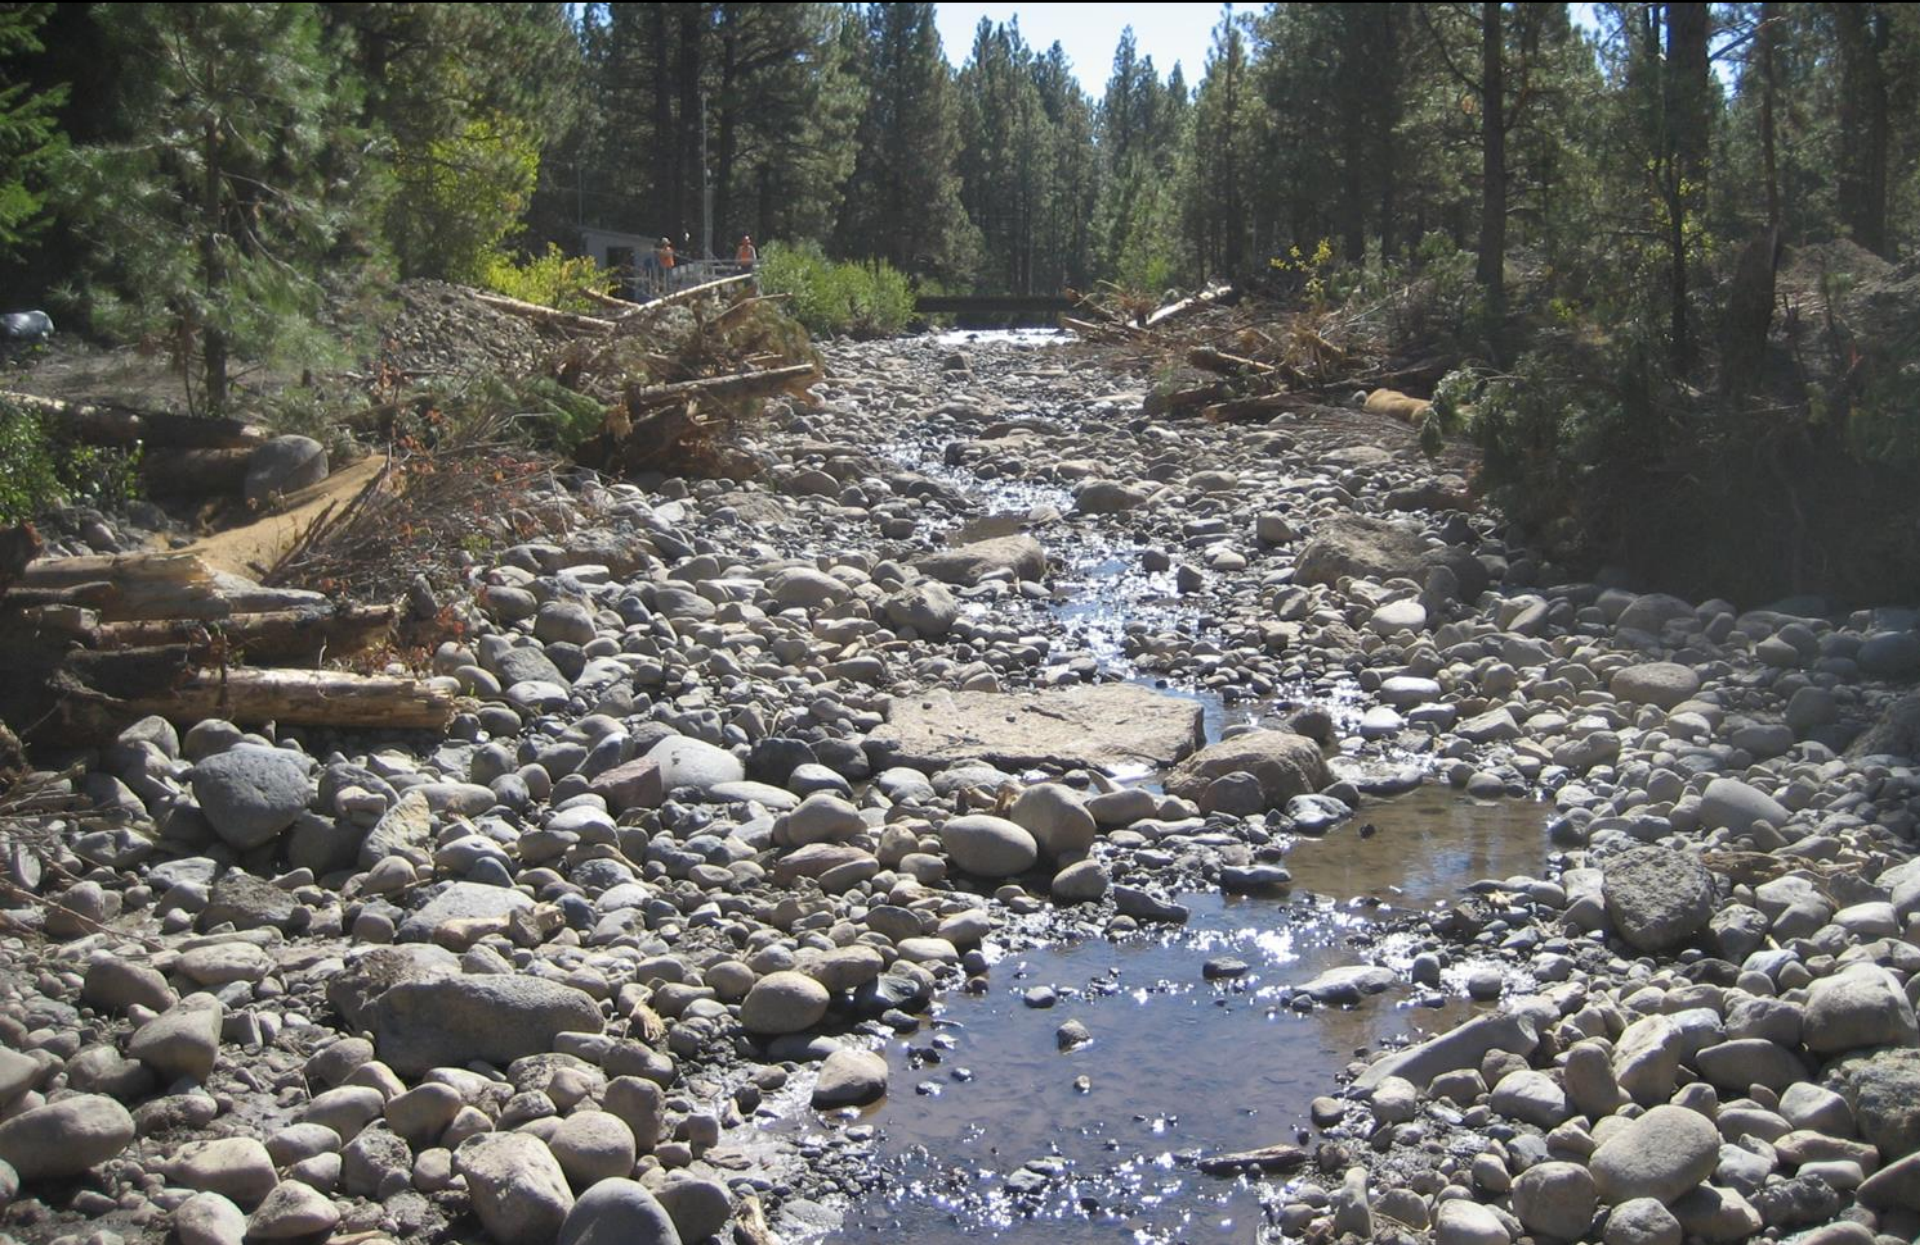
# Matrix Supported Constructed River Bed

Pre Flow Activation - Whychus Creek, Oregon

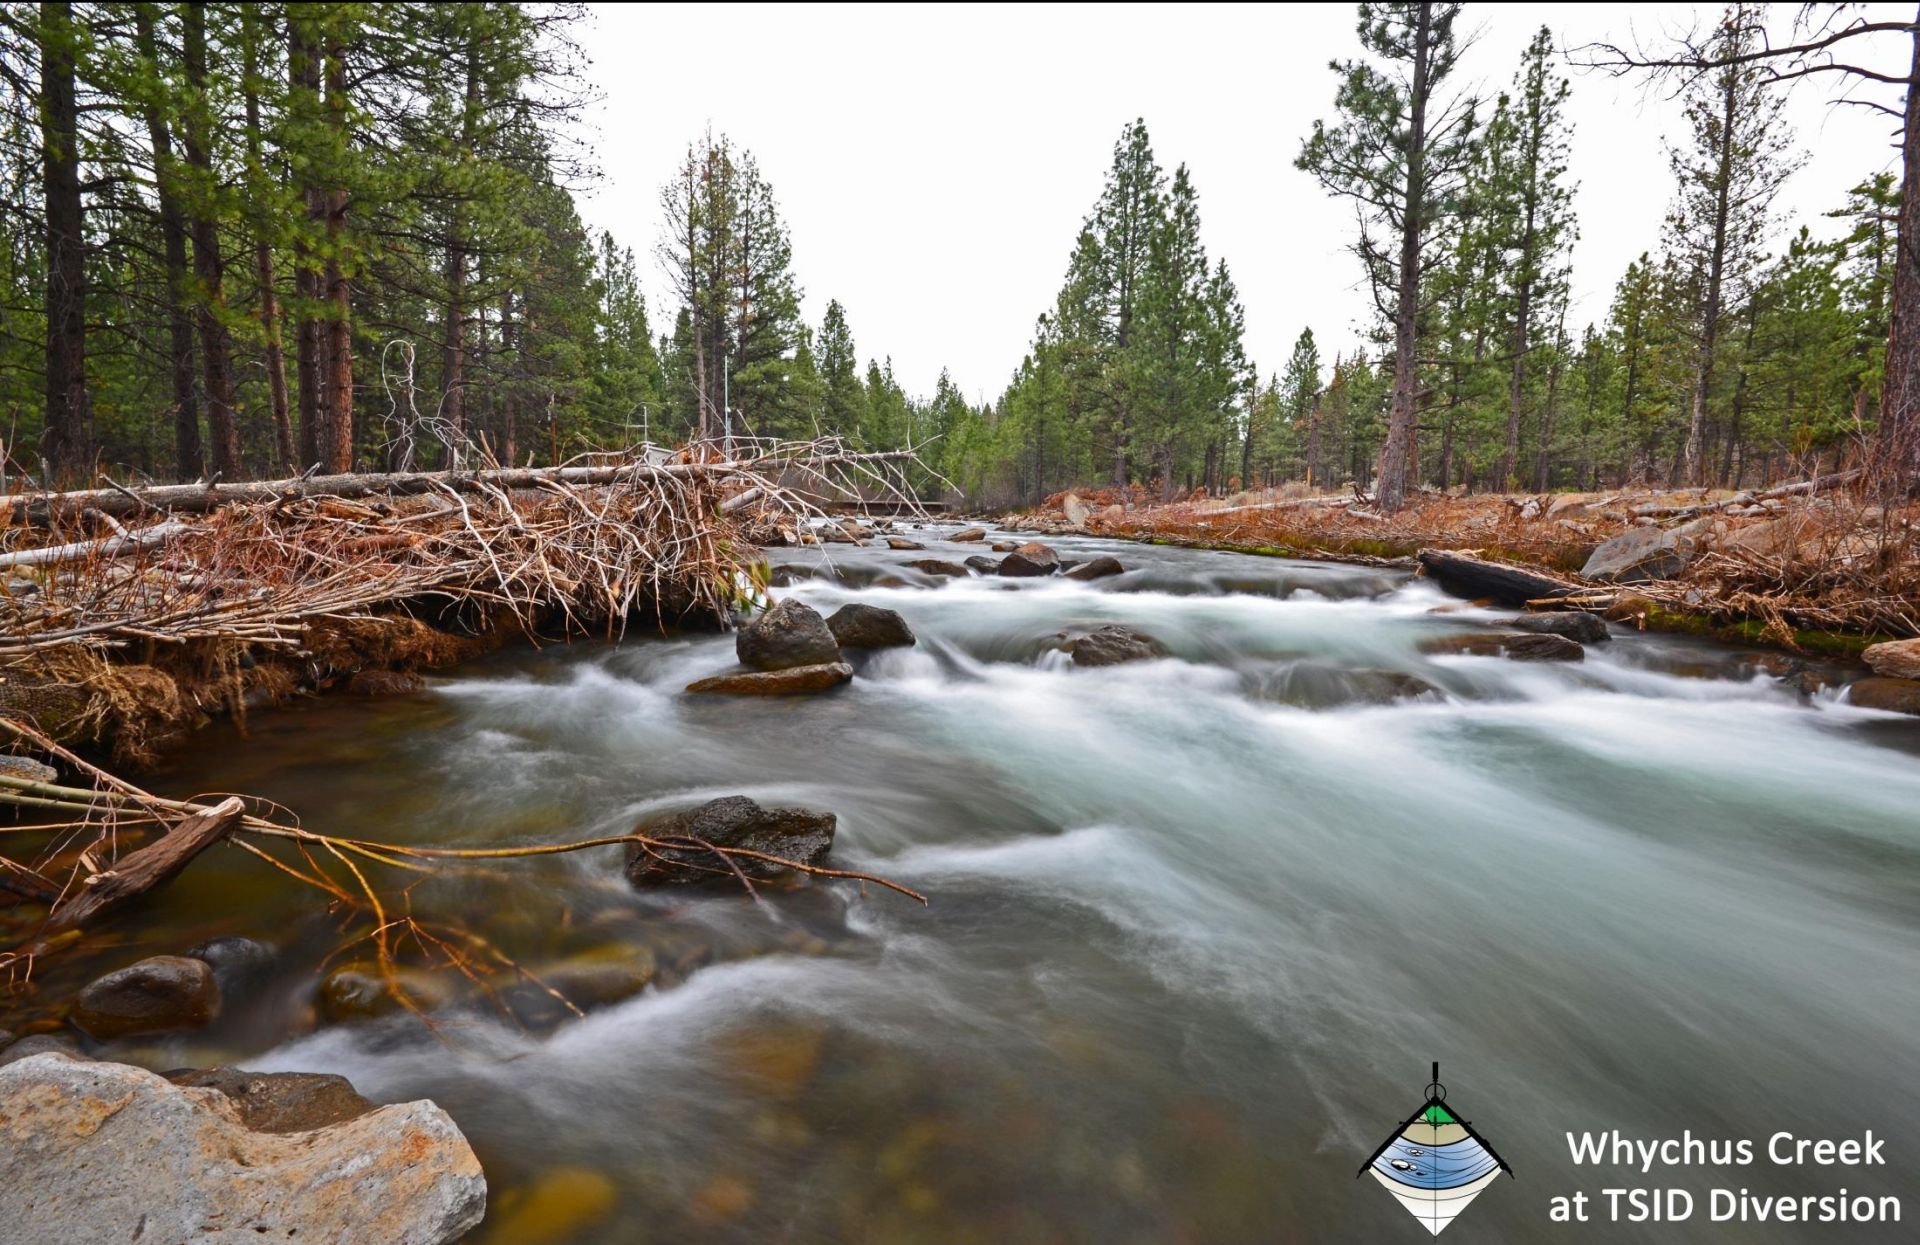
# Matrix Supported Constructed River Bed

Post Flow Activation - Whychus Creek, Oregon

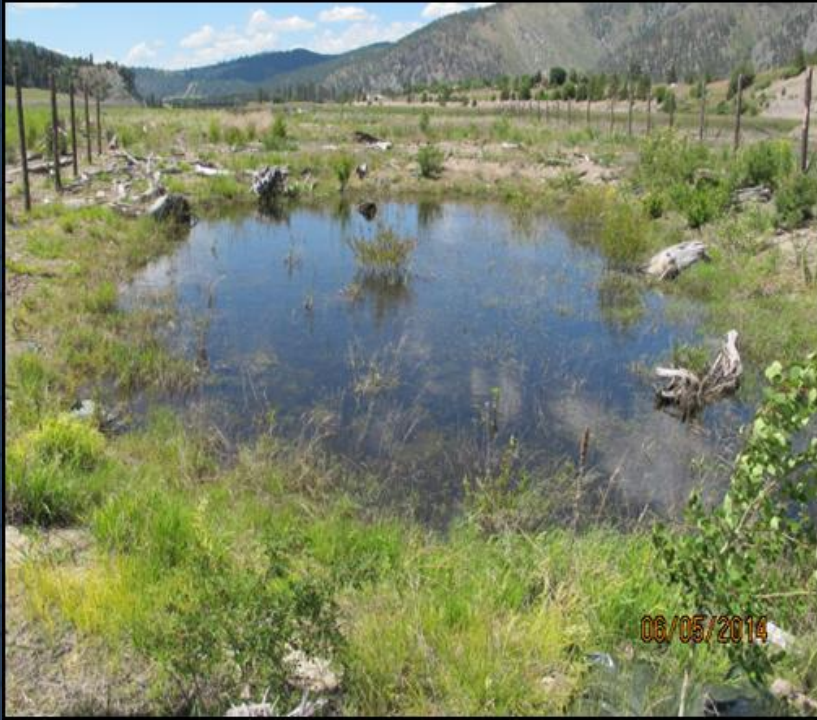
# Complex Floodplain Grading

Swales

- Add roughness to raw floodplain surfaces
- Create micro-topography to promote natural recruitment
- Place coarse woody debris to augment organic content

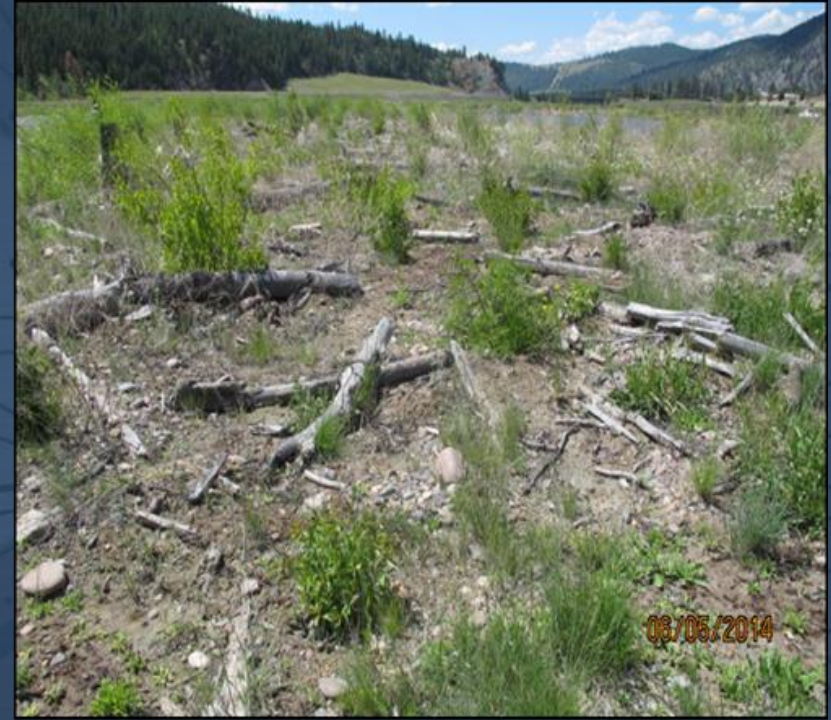
Micro-topography

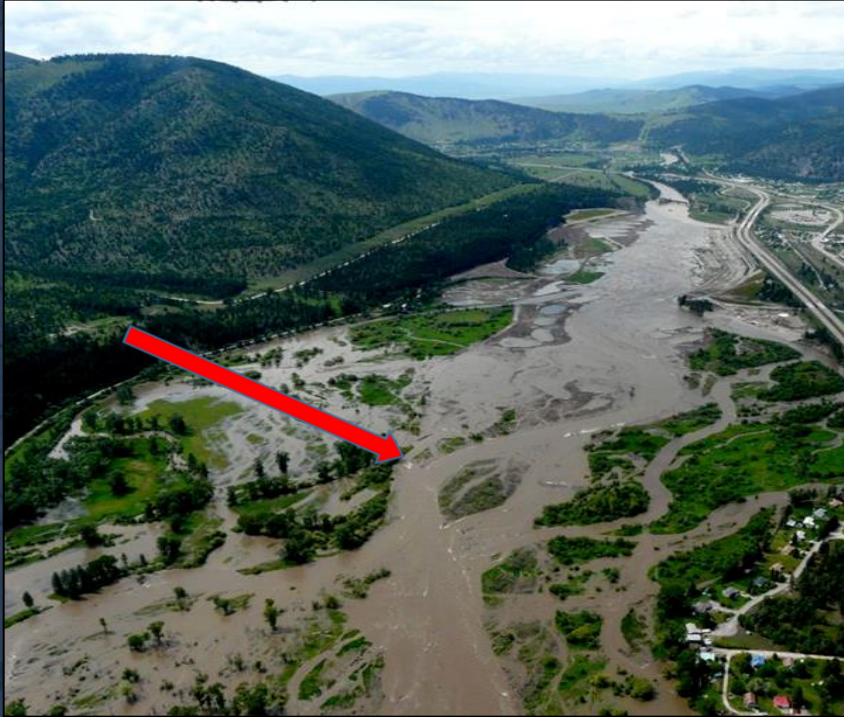
Clark Fork River 2011 38-Year R.I. Flood

Flood Stage

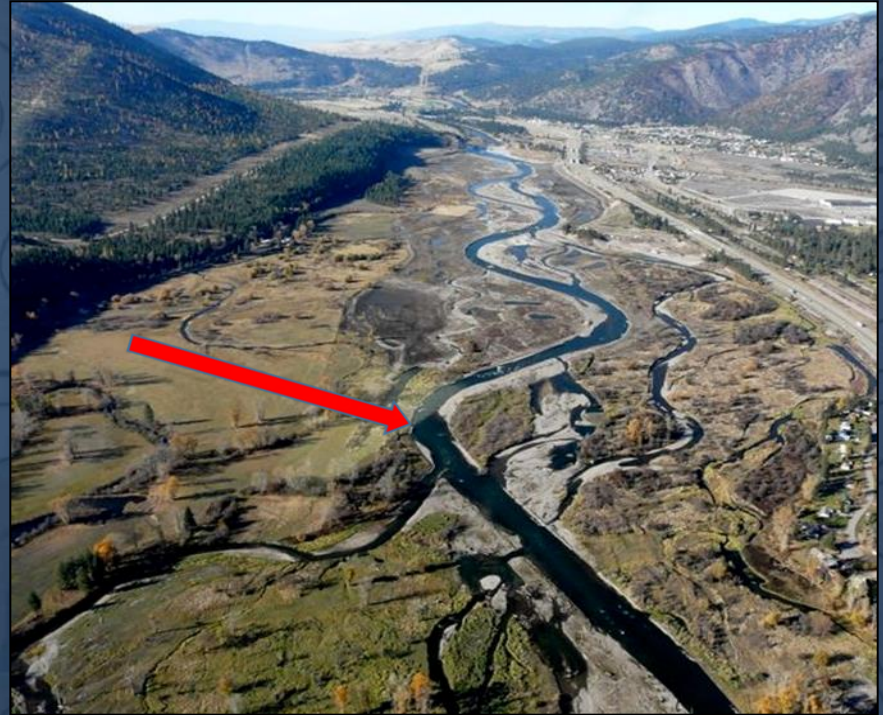
Post Flood

- Distribute flow, sediment and nutrients across floodplain surfaces
- Provide flood and ice jam relief
- Off-channel aquatic habitat during floods

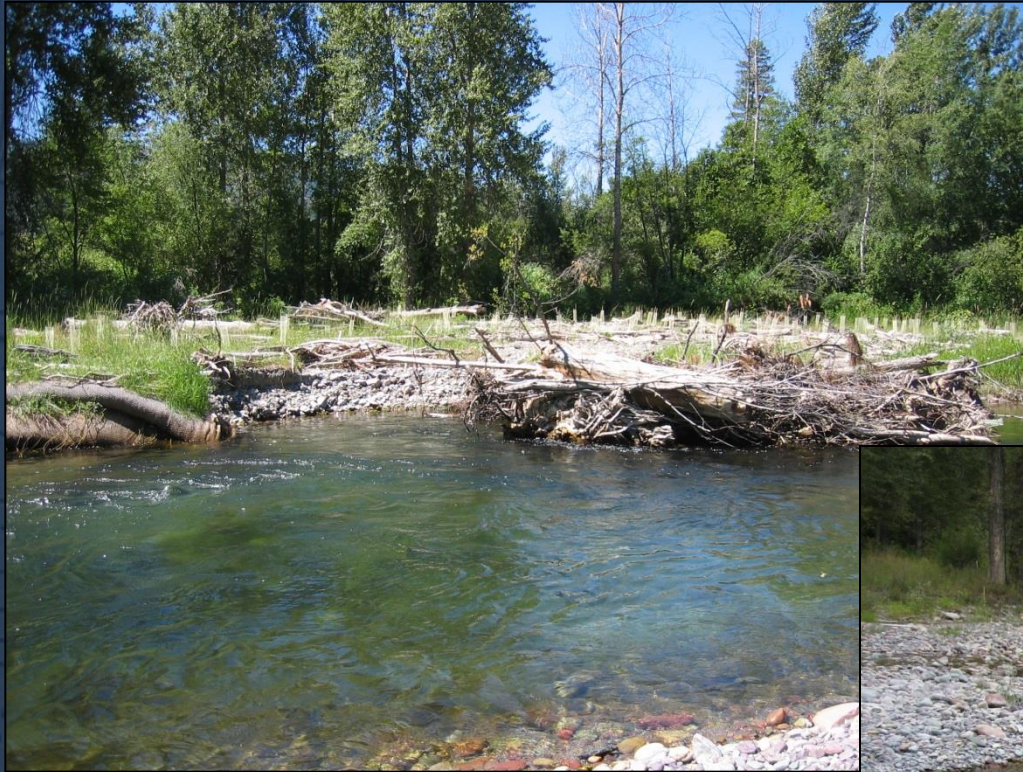
← Large Wood  
Structure Flanking  
and Eddy Erosion

- **Planform** - Lower radius meanders experienced deposition in the thalweg and scour across point bars
- **Profile** - Abrupt transitions between features caused features to adjust.
- **Cross section** - Average channel depth increased (slight incision)
- **Structures** - Channel vertical stability compromised as discrete grade control structures deformed (e.g. dislodged rock)

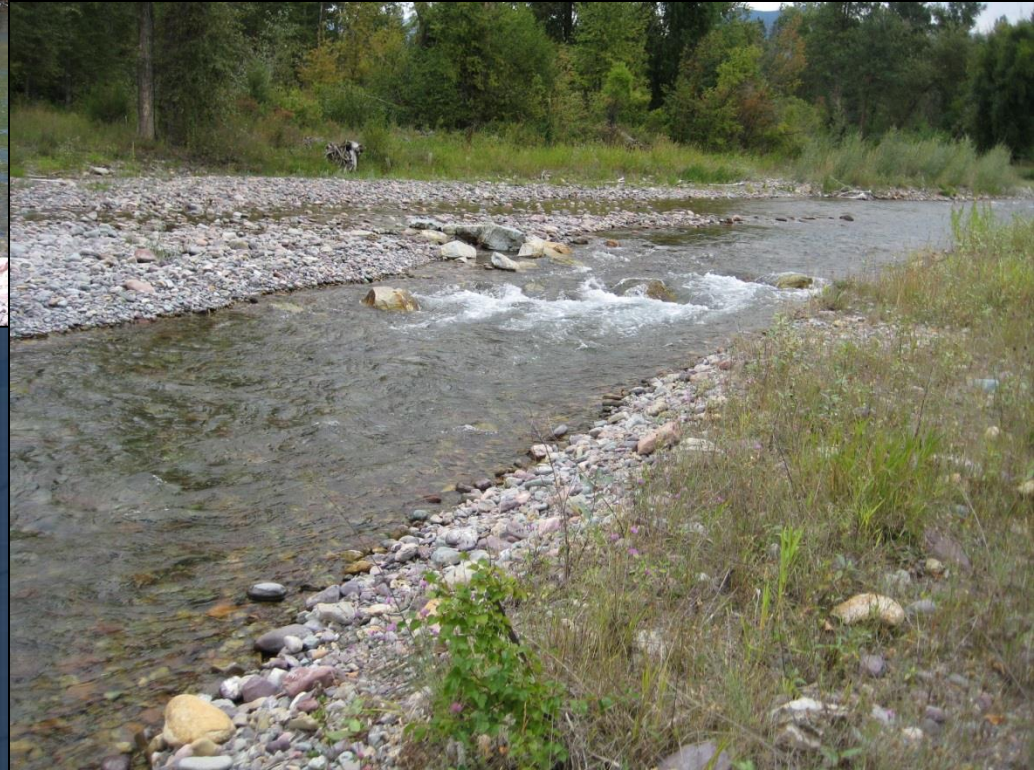
Grade Control  
Structure  
Compromised  
and Channel  
Response

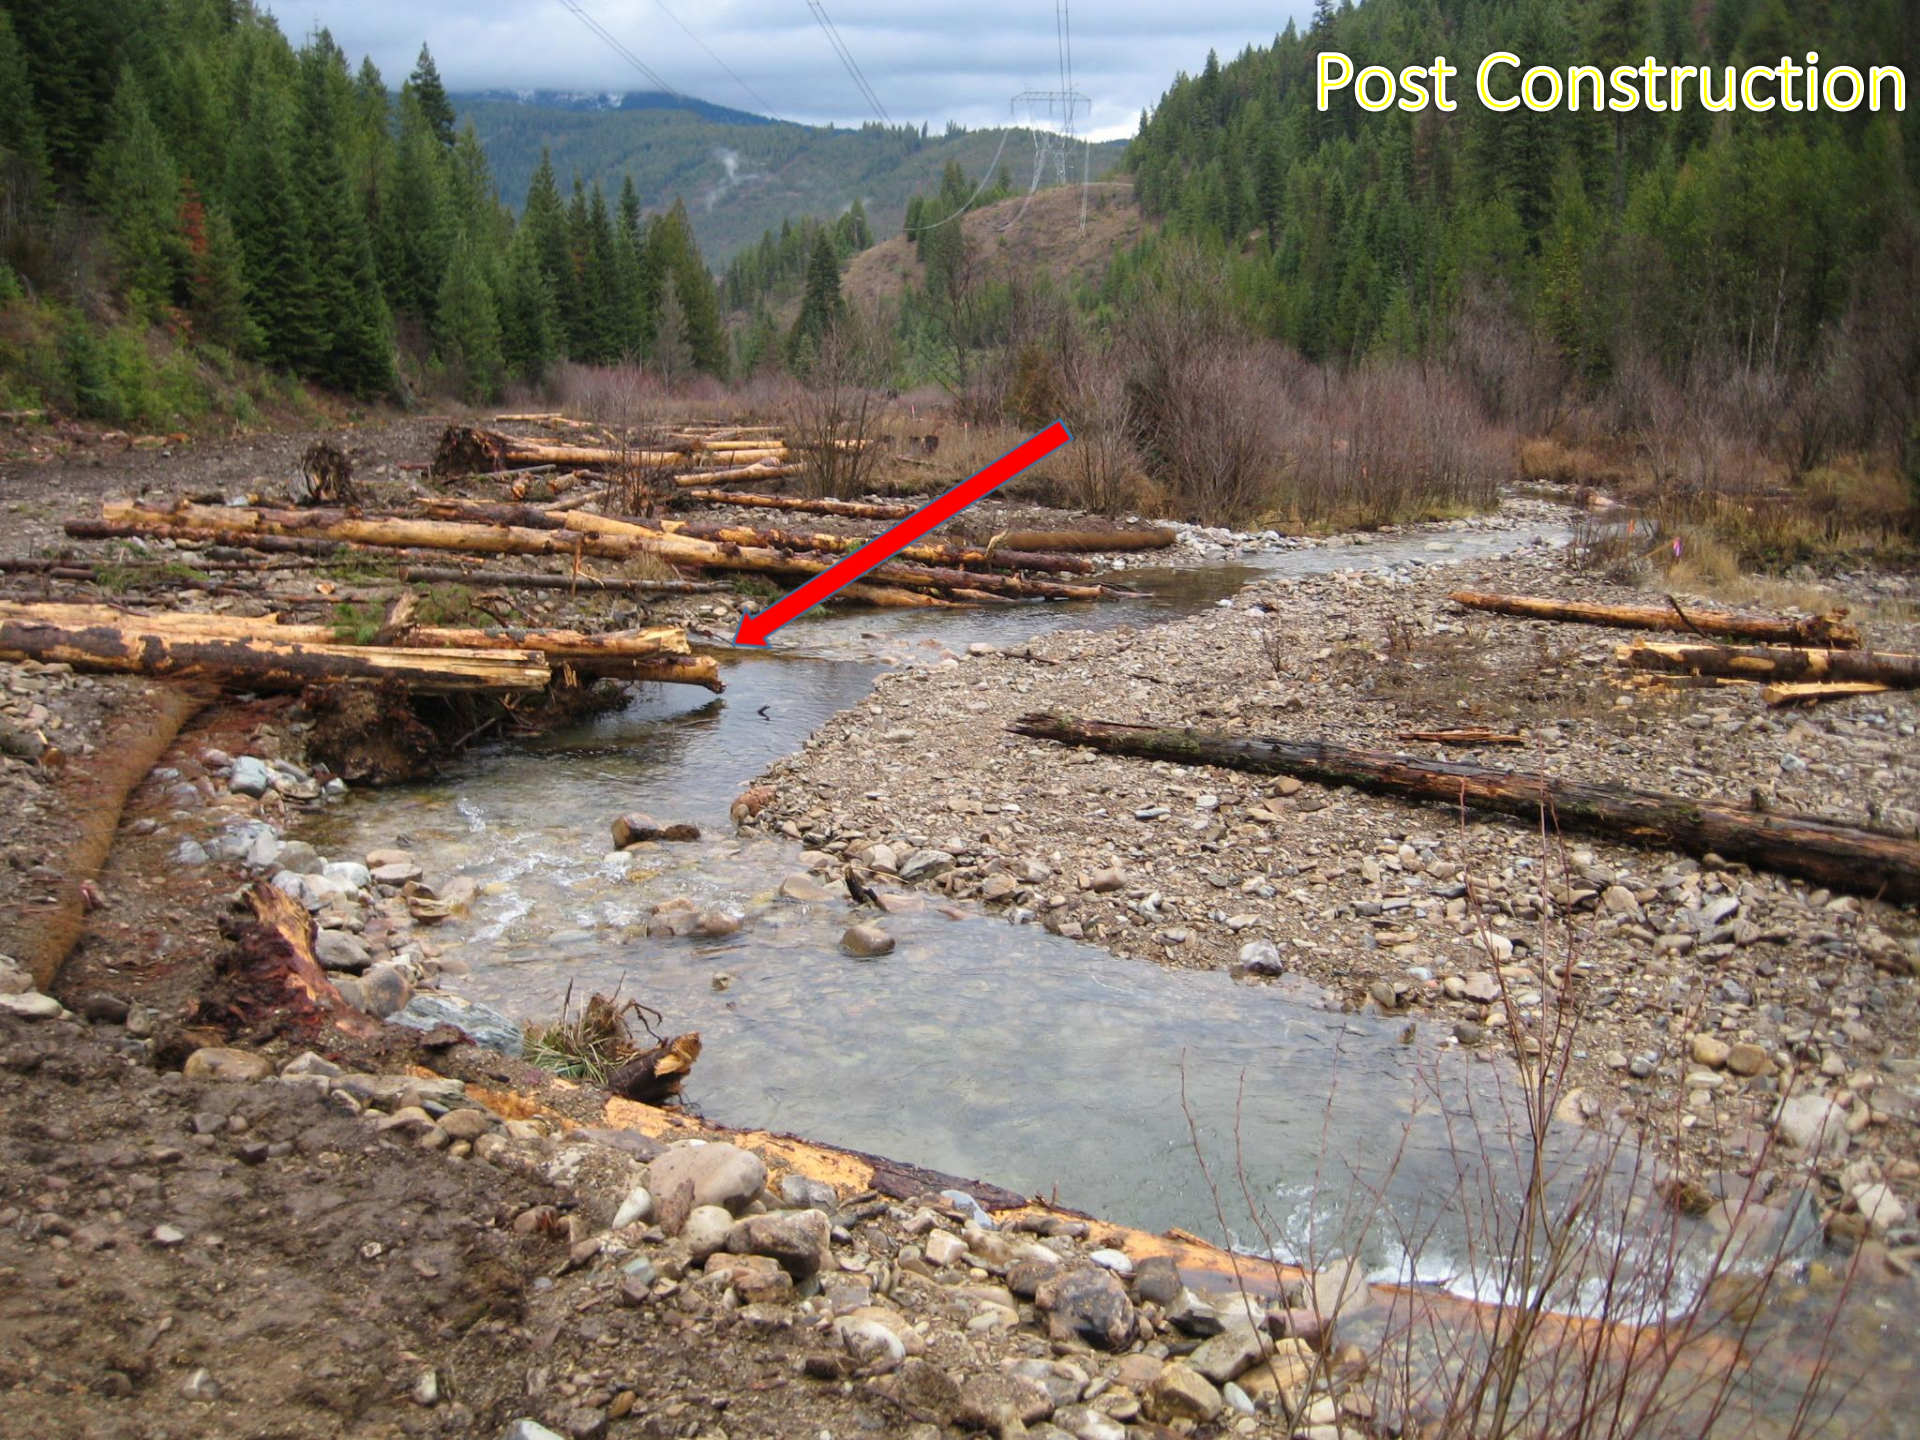
# Vegetated Wood and Brush Fascine Bank Restoration Structure Passive Margins

Post Construction

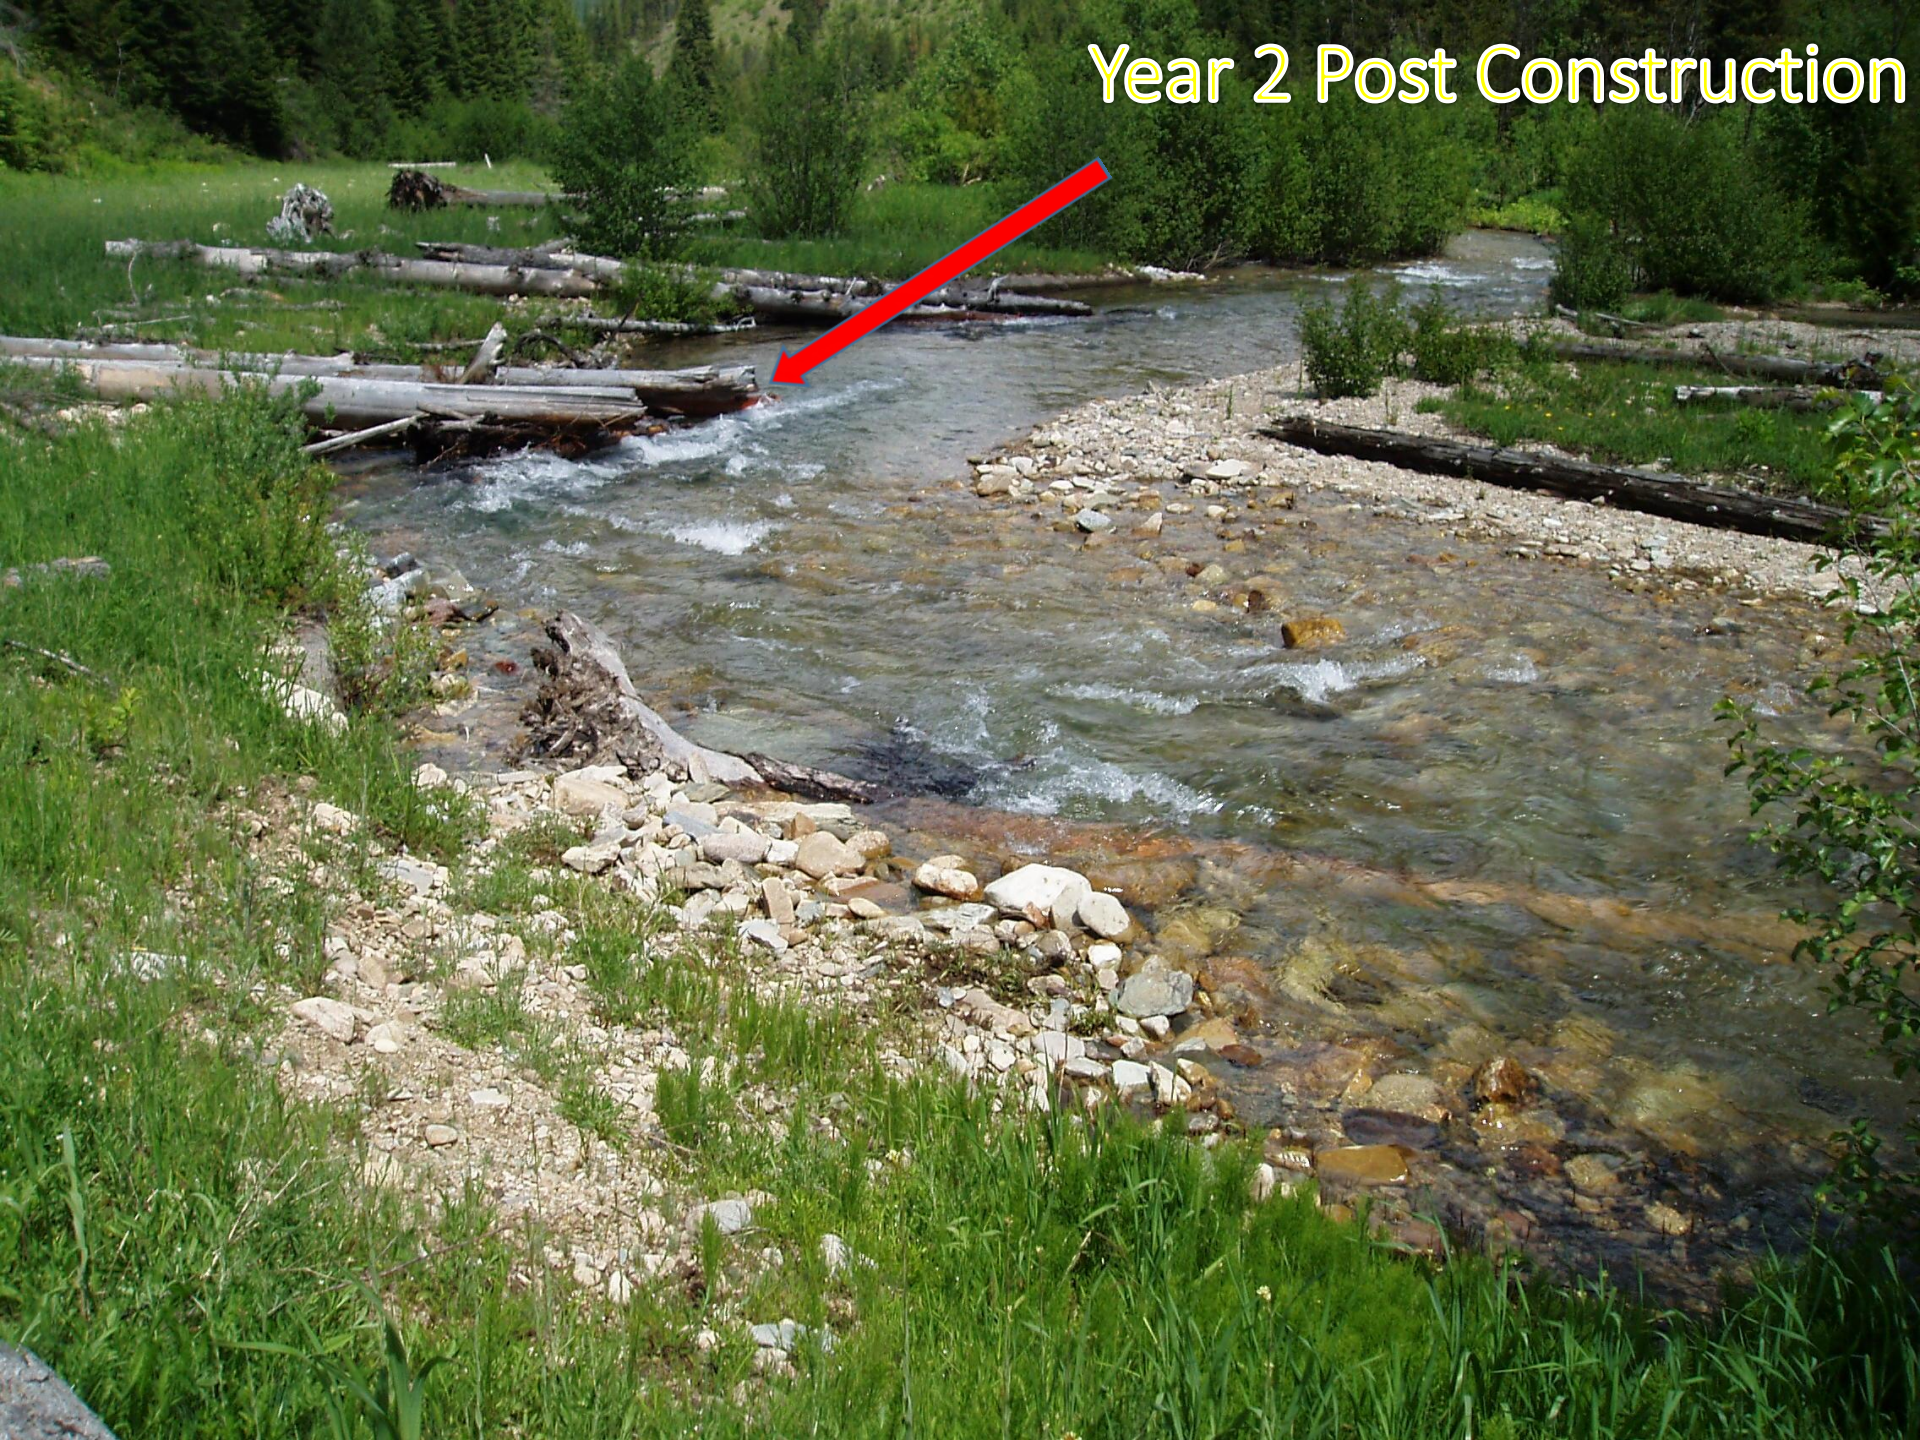
Year 2 Post Construction

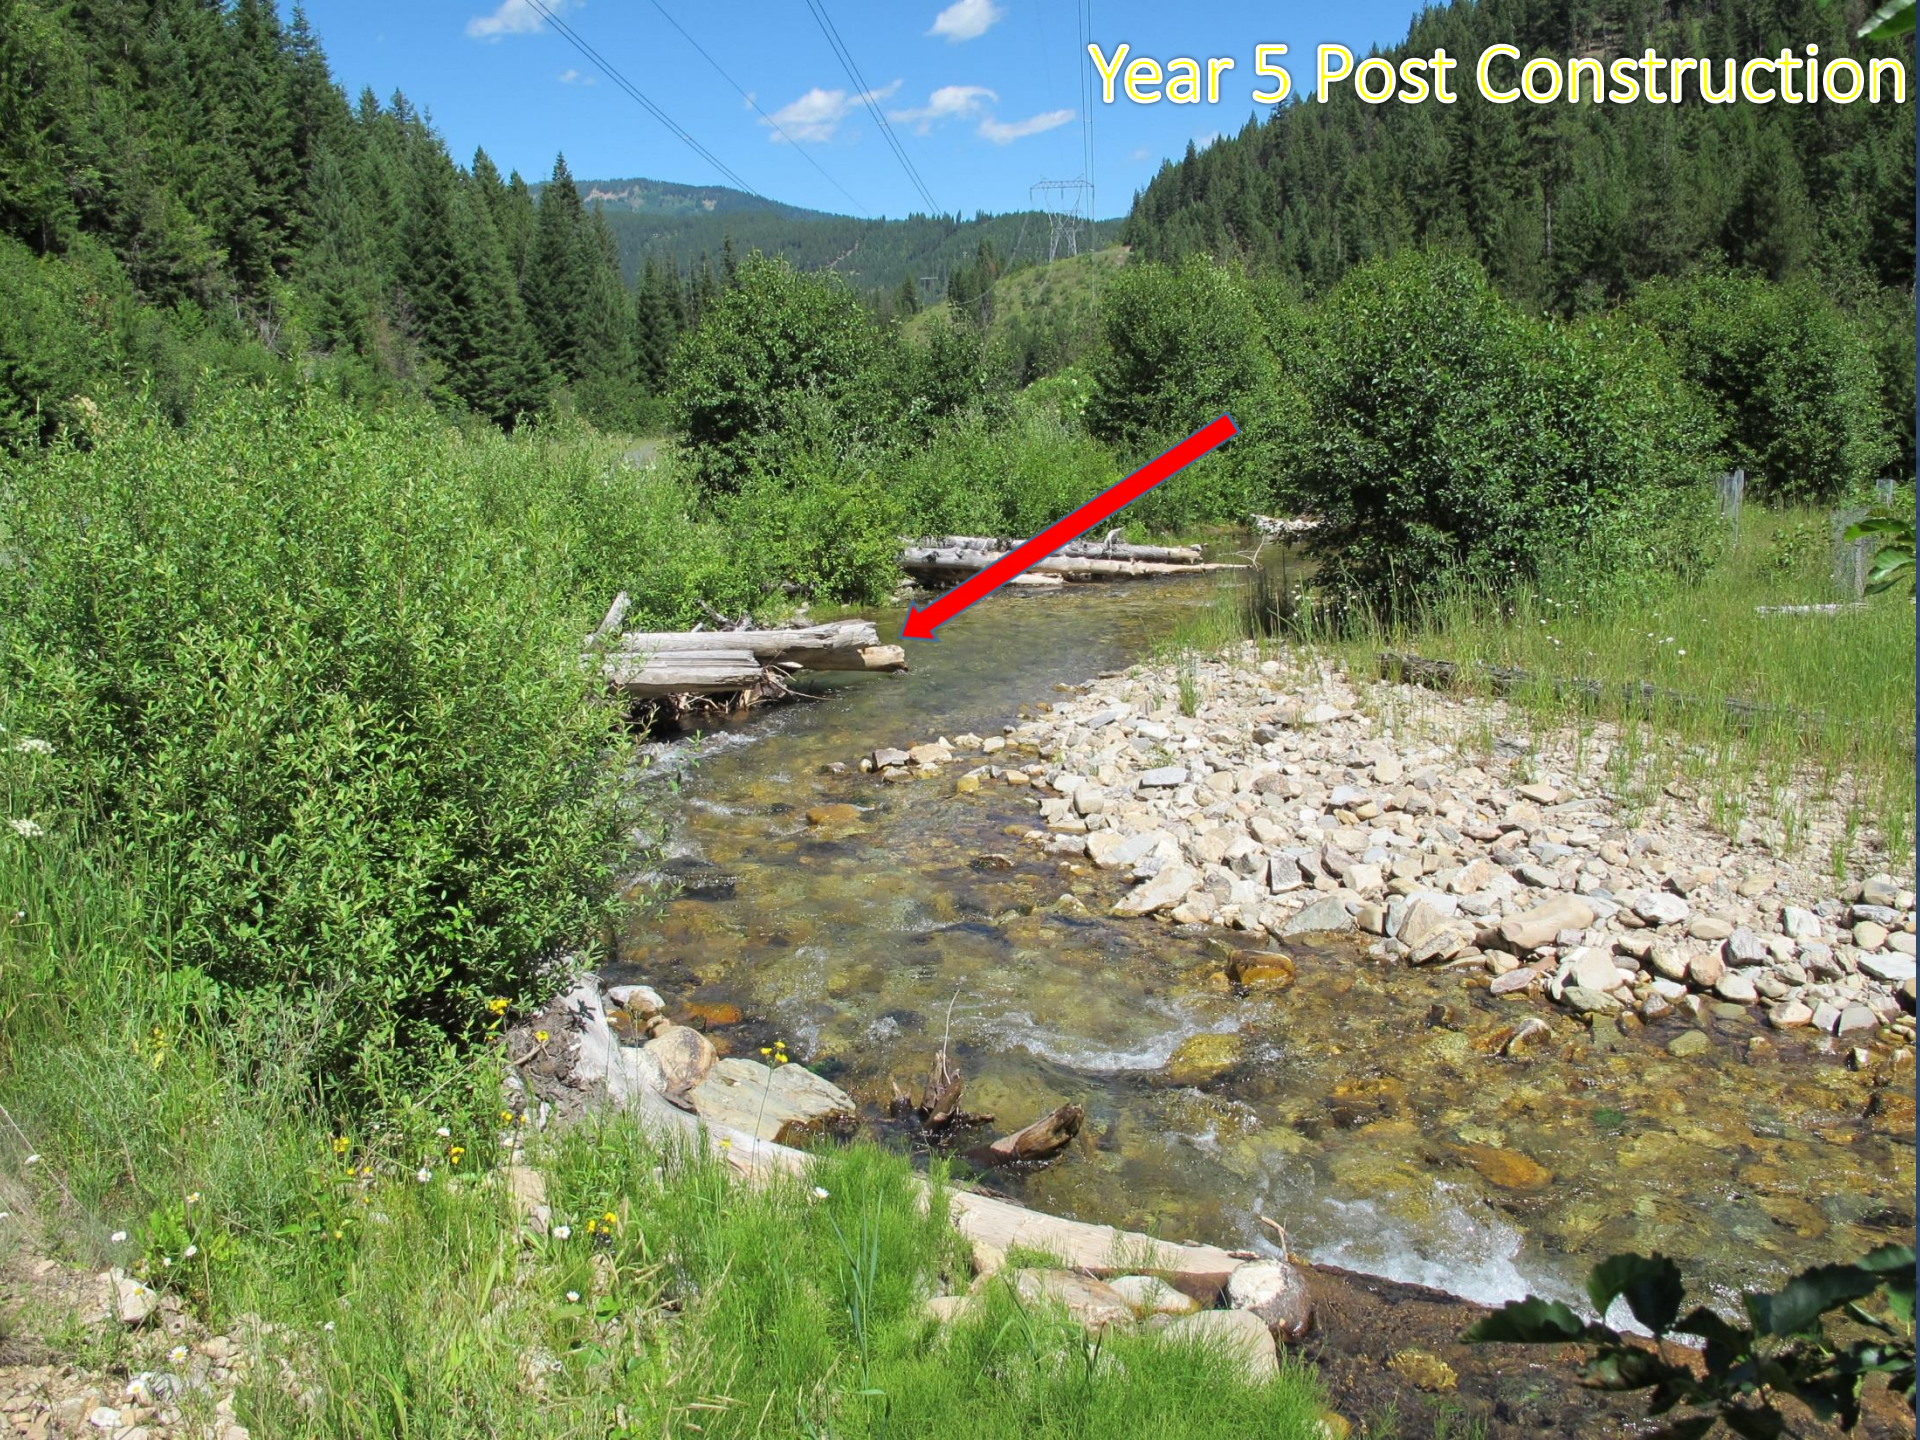
Year 5 Post Construction
