# Floodplain Connectivity in Restoration Design

2015 Symposium on Restoration in a Contaminated Environment:  
Lessons Learned and Challenges in Moving Forward Part II

Karin Boyd

Applied Geomorphology, Inc.

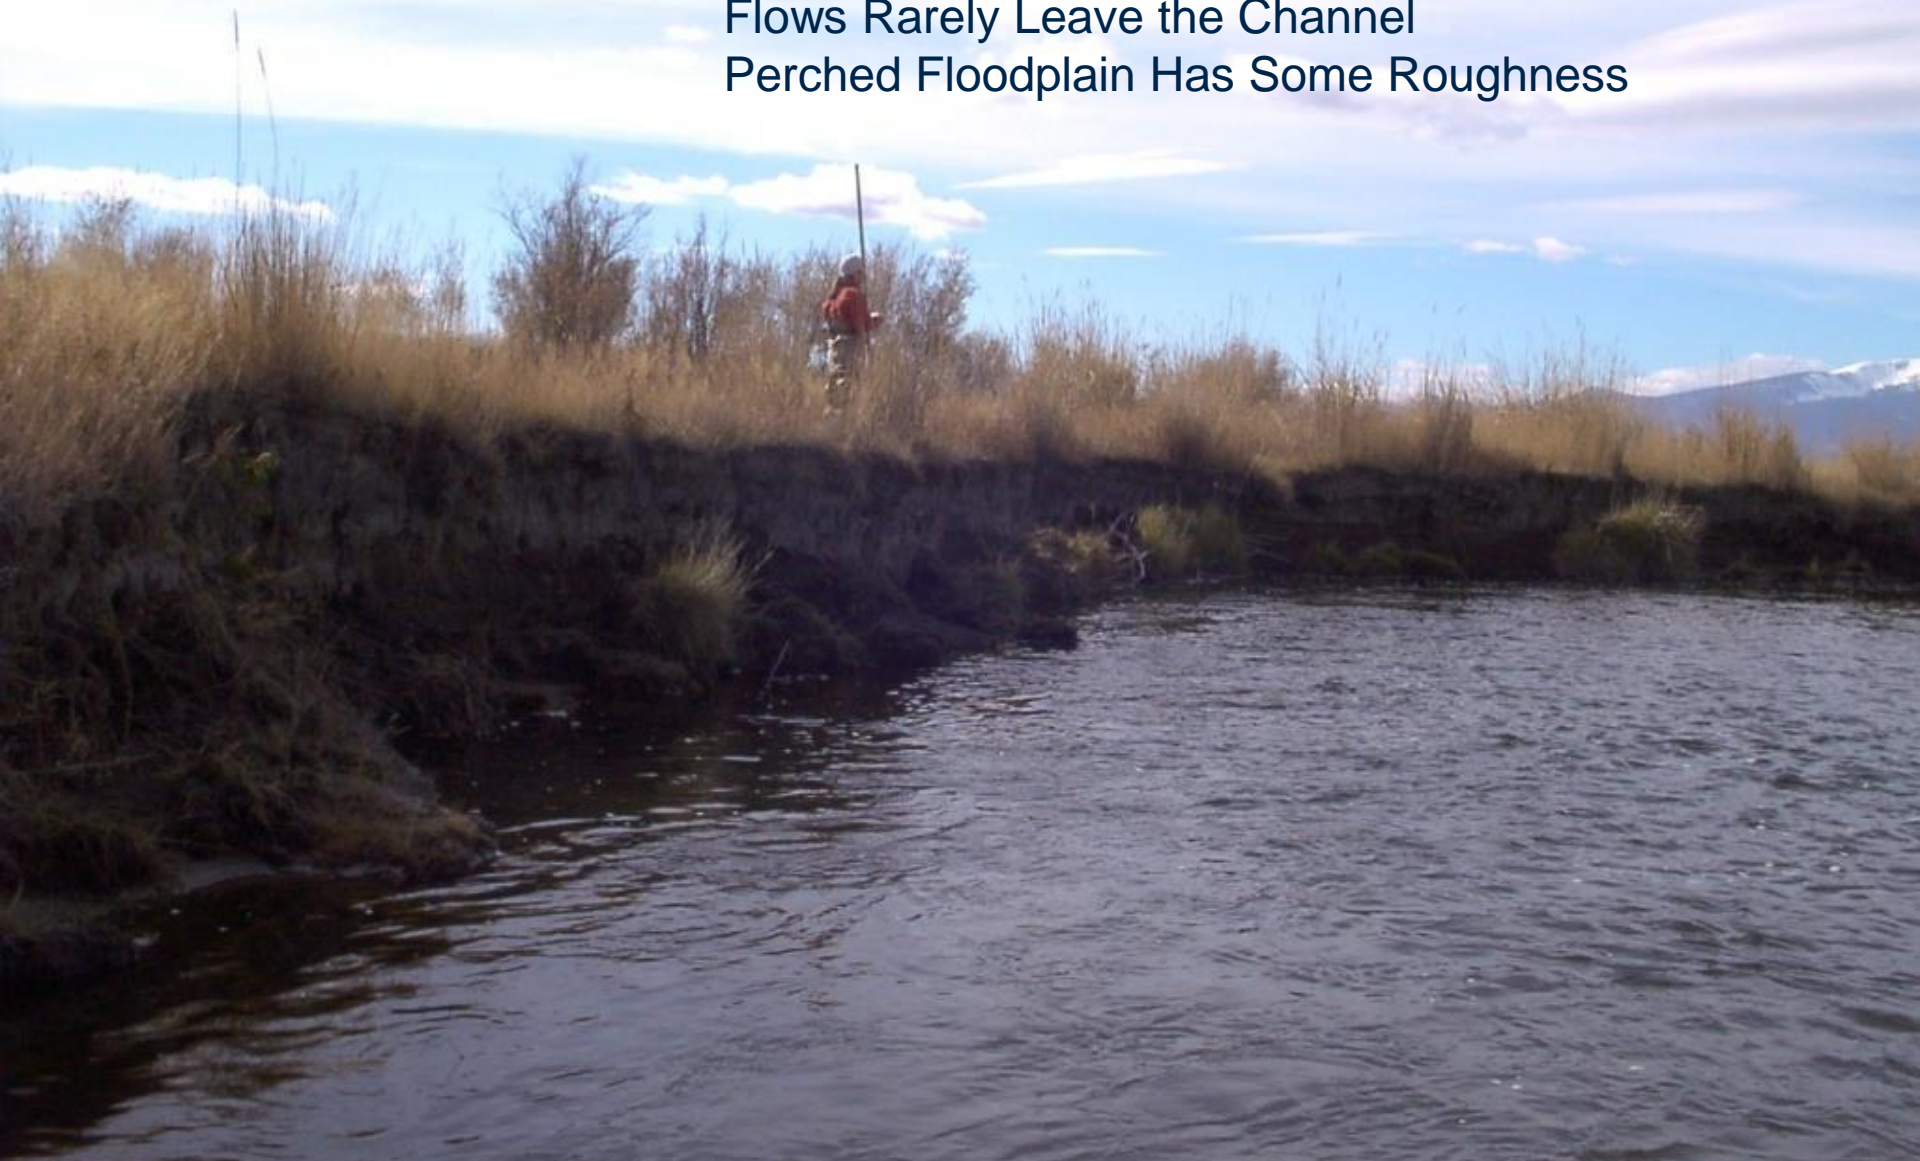
# Before

Flows Rarely Leave the Channel  
Perched Floodplain Has Some Roughness

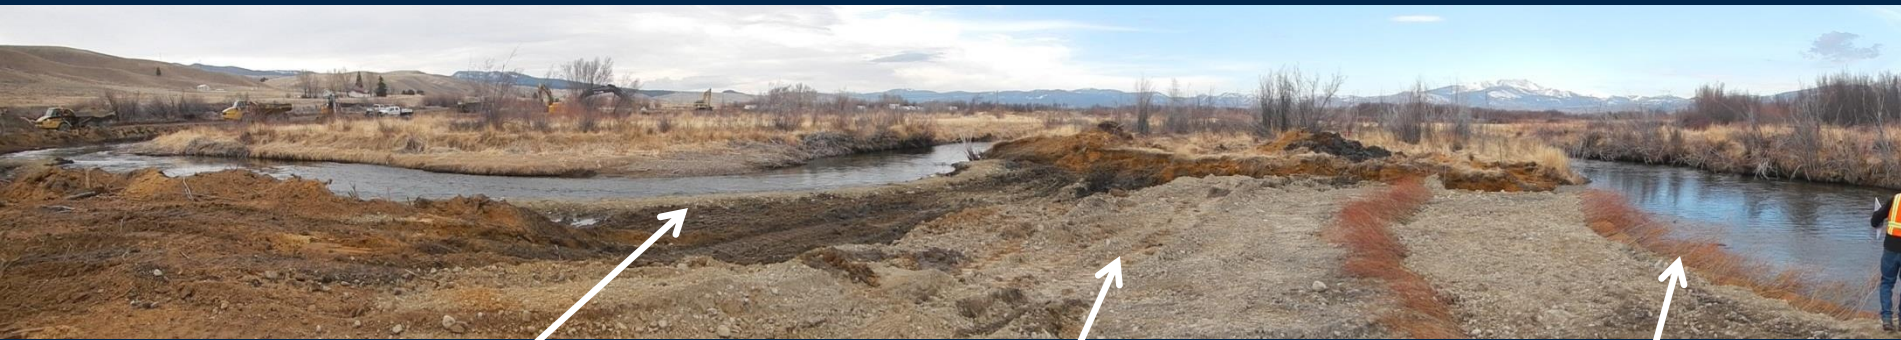
Super-Elevated Bank  
Dense Woody Plantings

Elevated Core  
Woody Debris

Double Lift

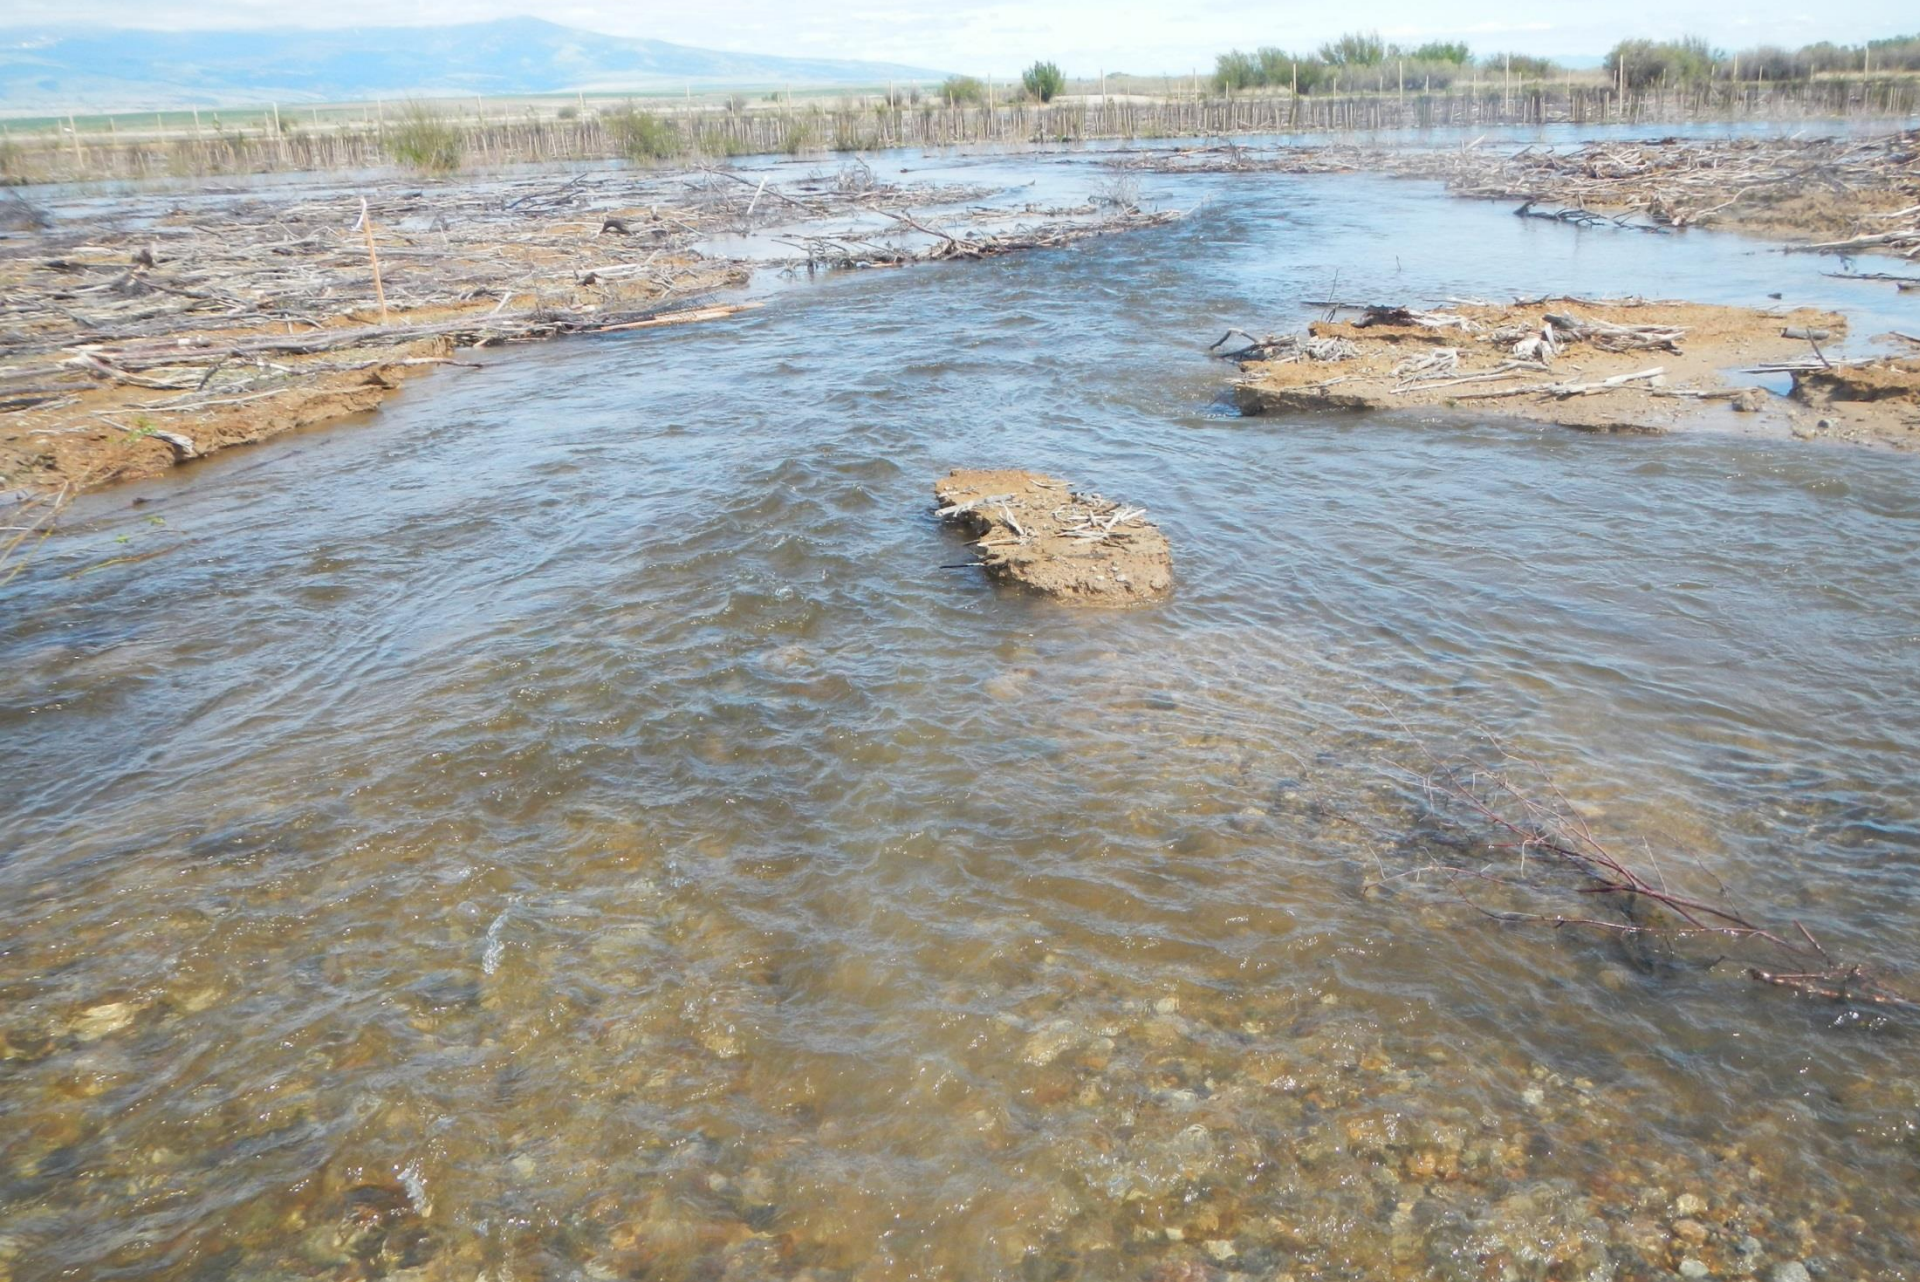
## Channelized Flow Across Core Creating Avulsion Risk

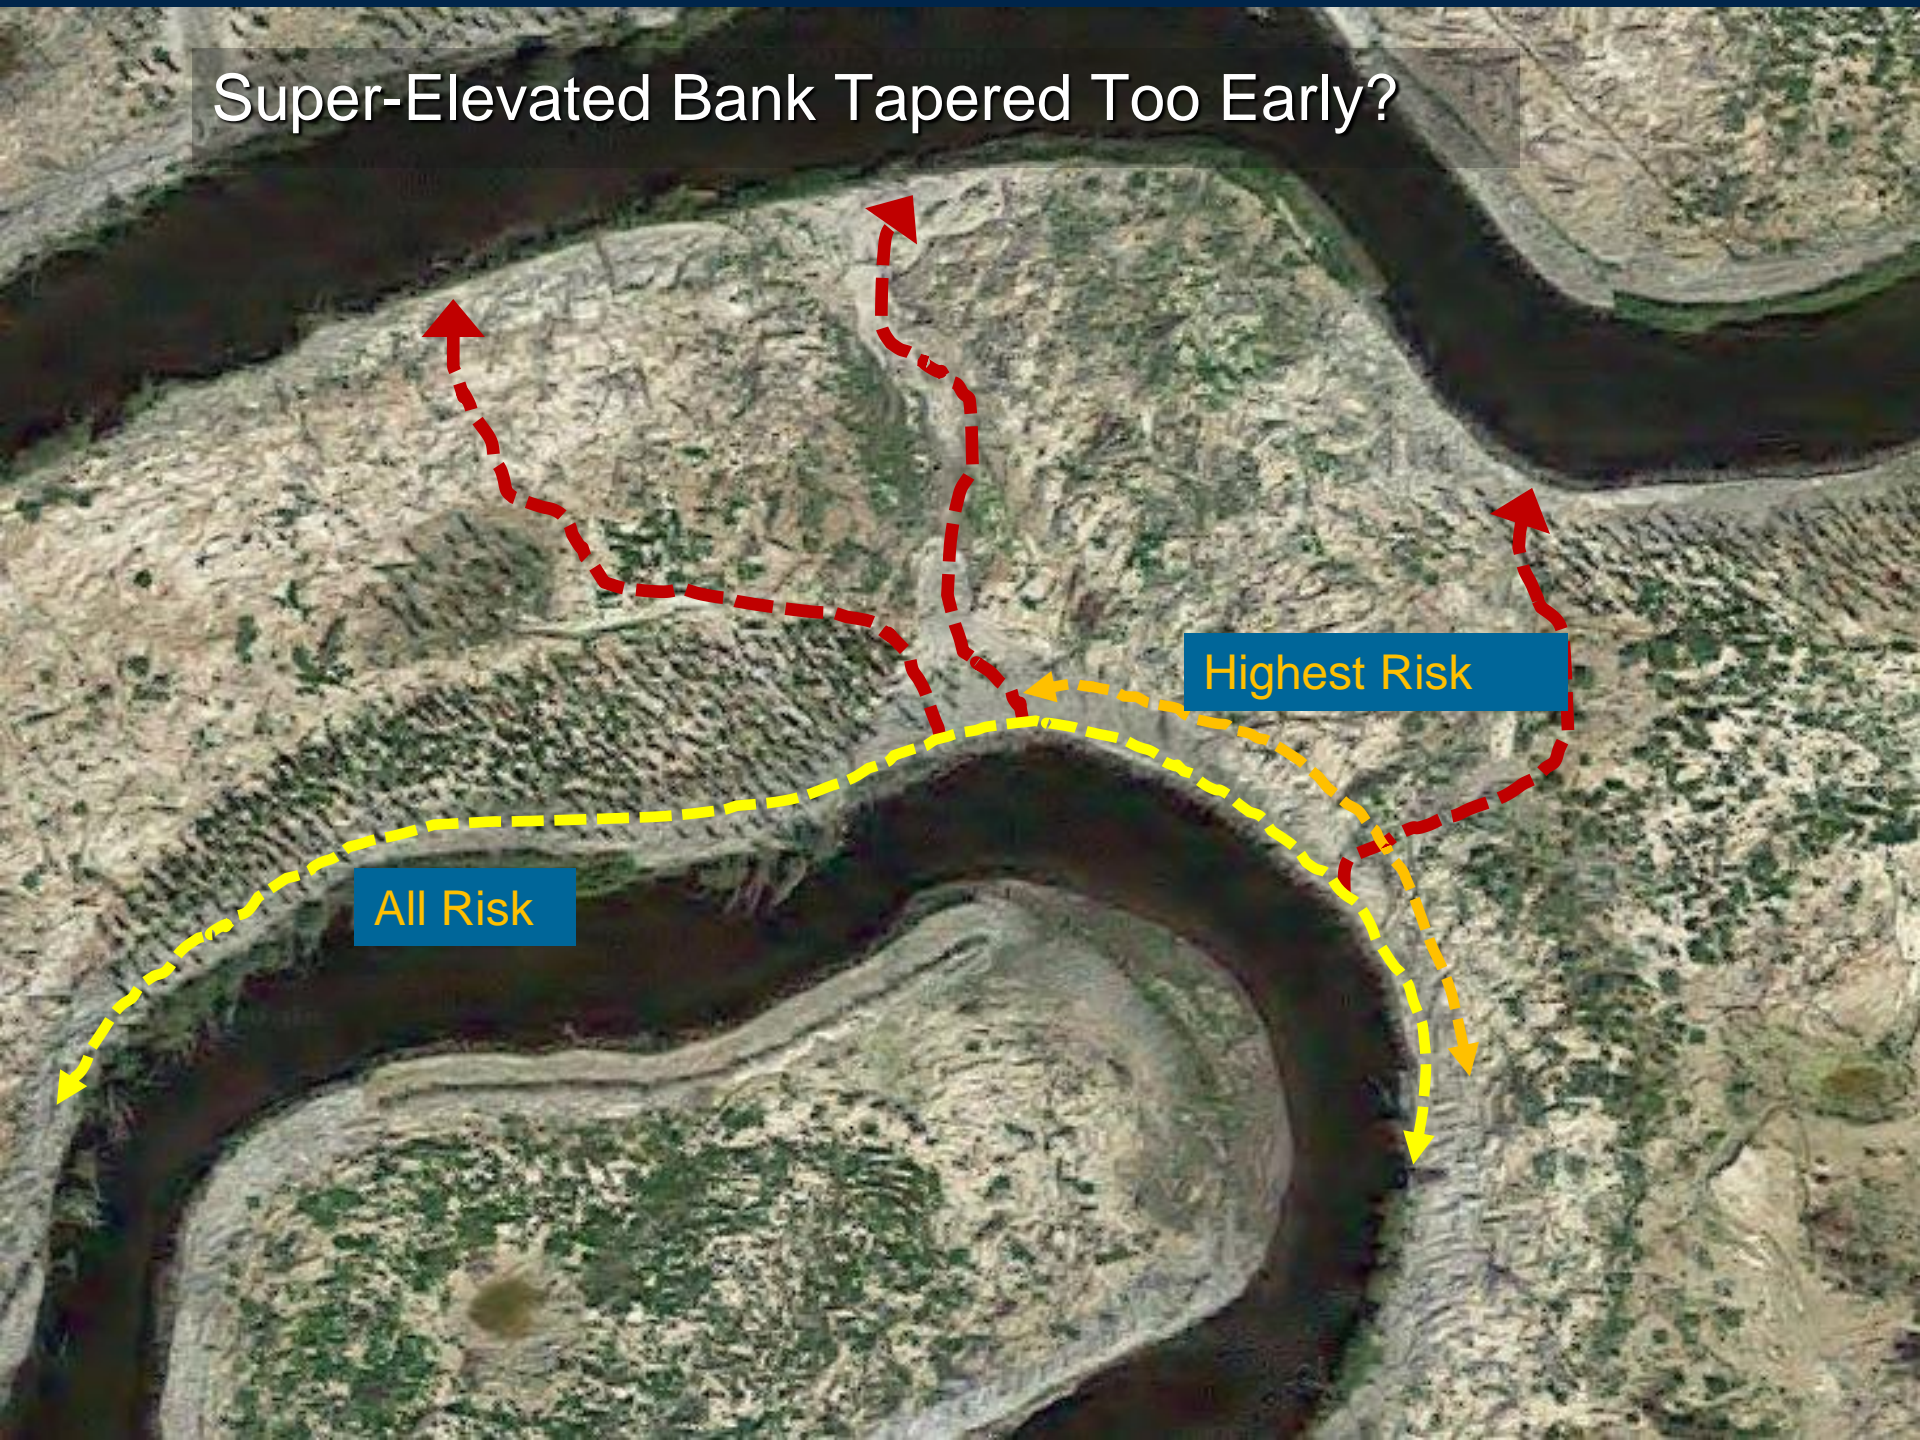
# Super-Elevated Bank Tapered Too Early?

Highest Risk

All Risk

Outer Bank Shrubs Hadn't Been Planted Yet

- Carry the super-elevated bank (0.5 feet high) through the entire downstream bend length before returning to the 2-year water-surface elevation.
- Construct elevated meander cores with floodplain alluvium or floodplain alluvium mixed with some vegetative backfill
- Construct wider flatter point bars on bends that feed high risk avulsion paths.
- Install higher density woody debris in areas of higher avulsion risk (i.e., 2 x the density of coarse wood).
- Consider incorporating willow plantings in all return flow areas to trap debris and decrease return flow velocities.

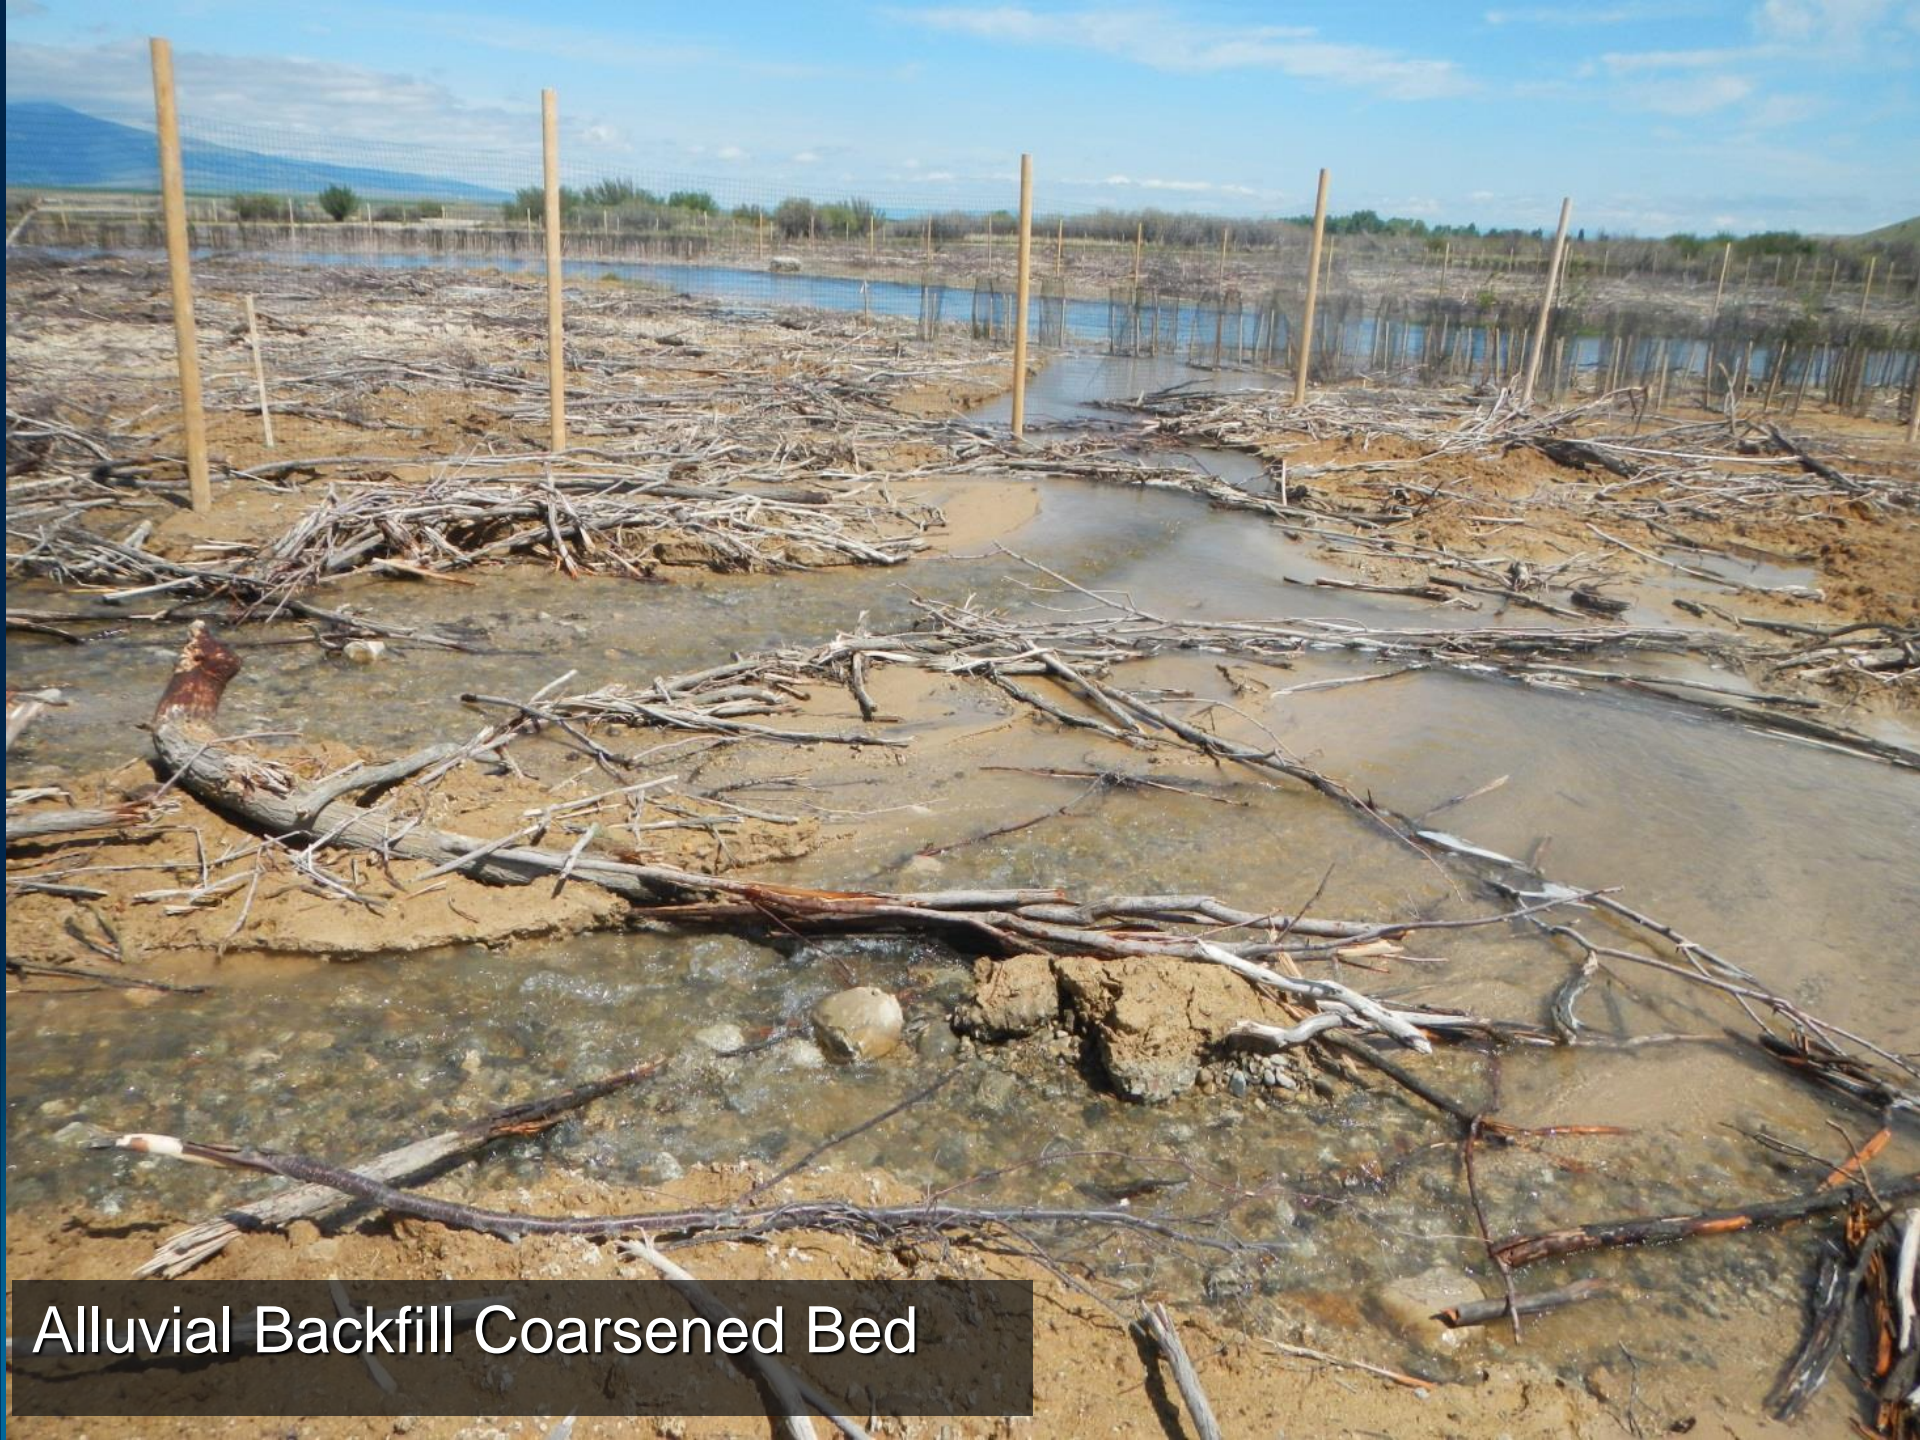
Use Vegetative Backfill for Elevated Core

- Material Eroded or Slurried Out

Alluvial Backfill Coarsened Bed

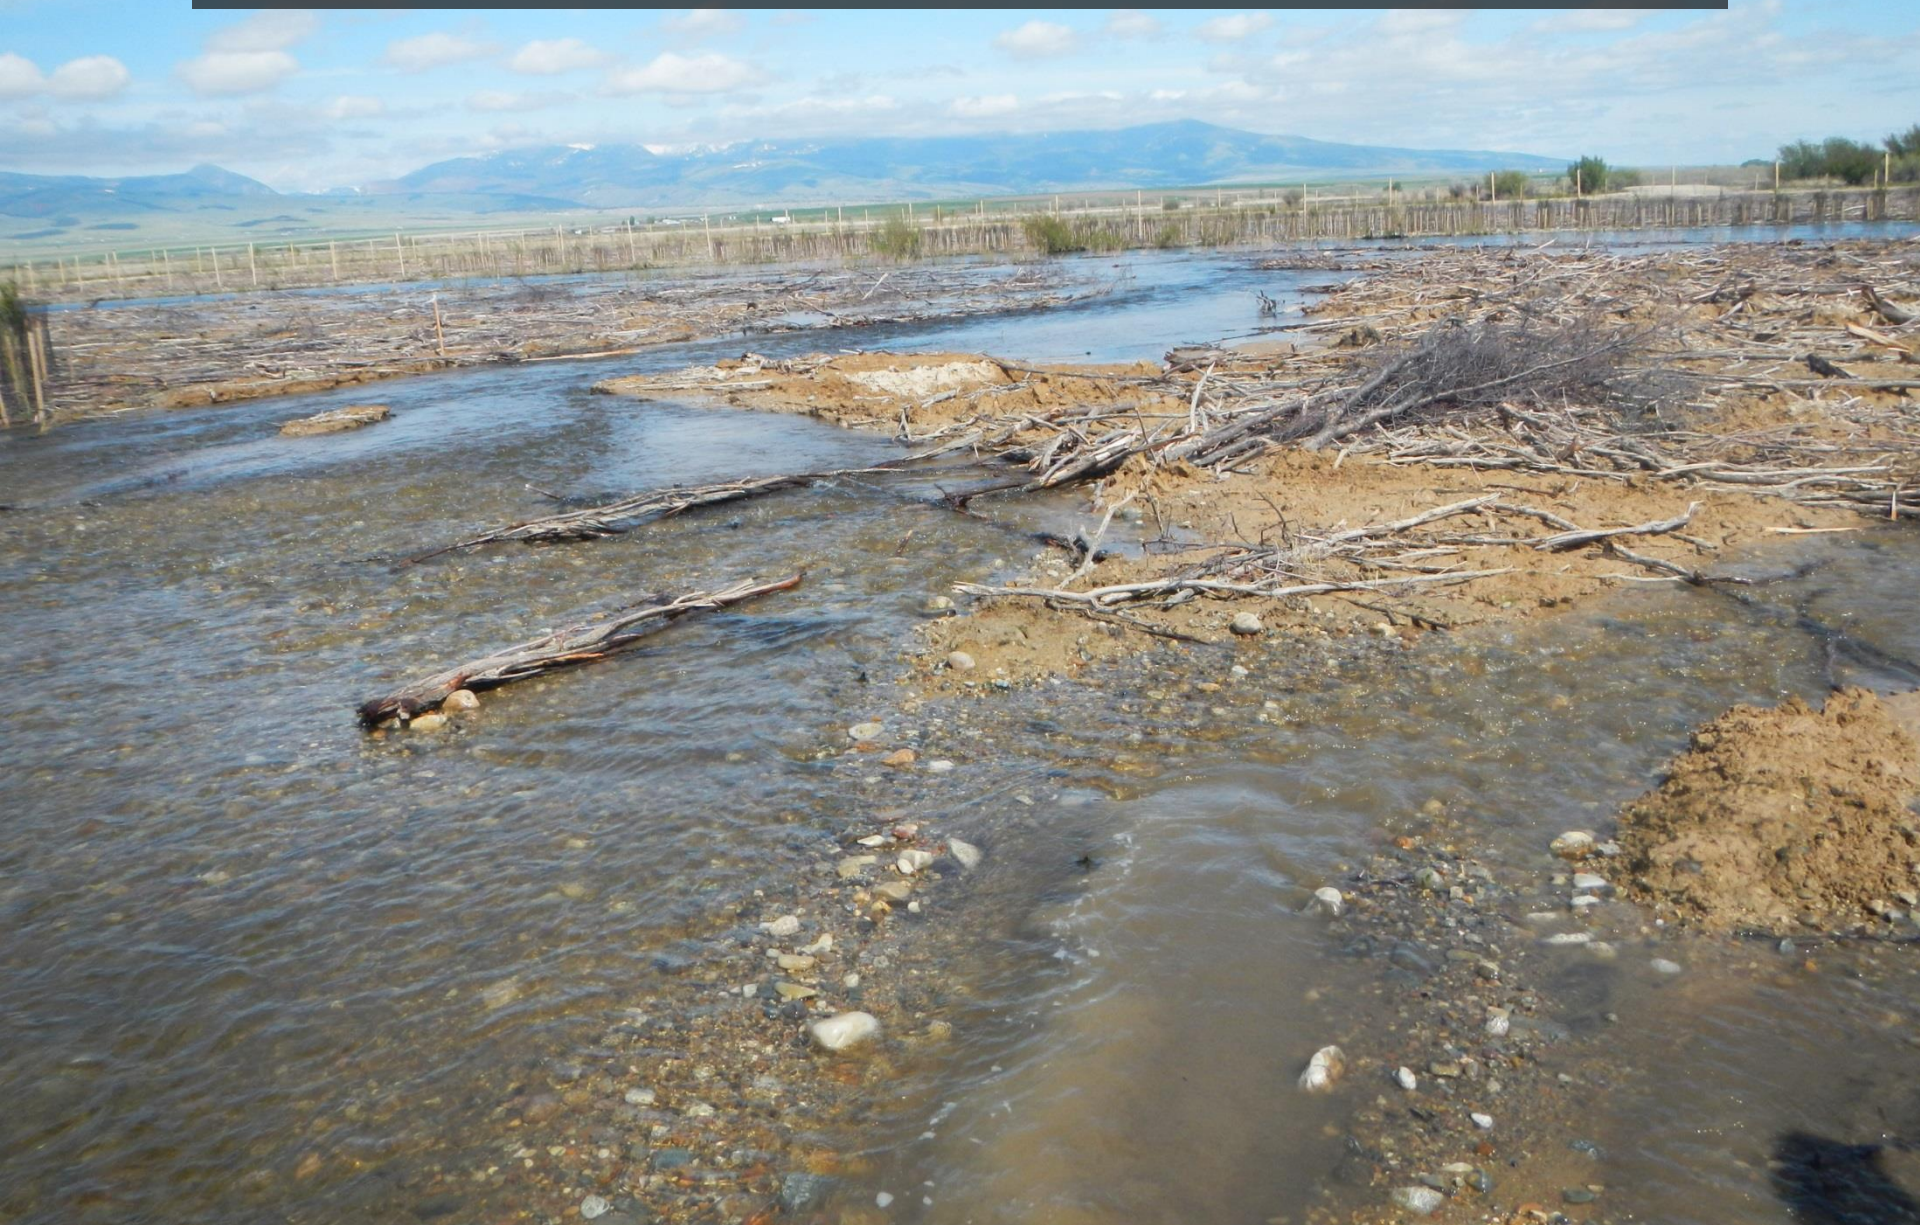
# Floodplain Woody Debris?

- Debris washed out and spread flows downstream

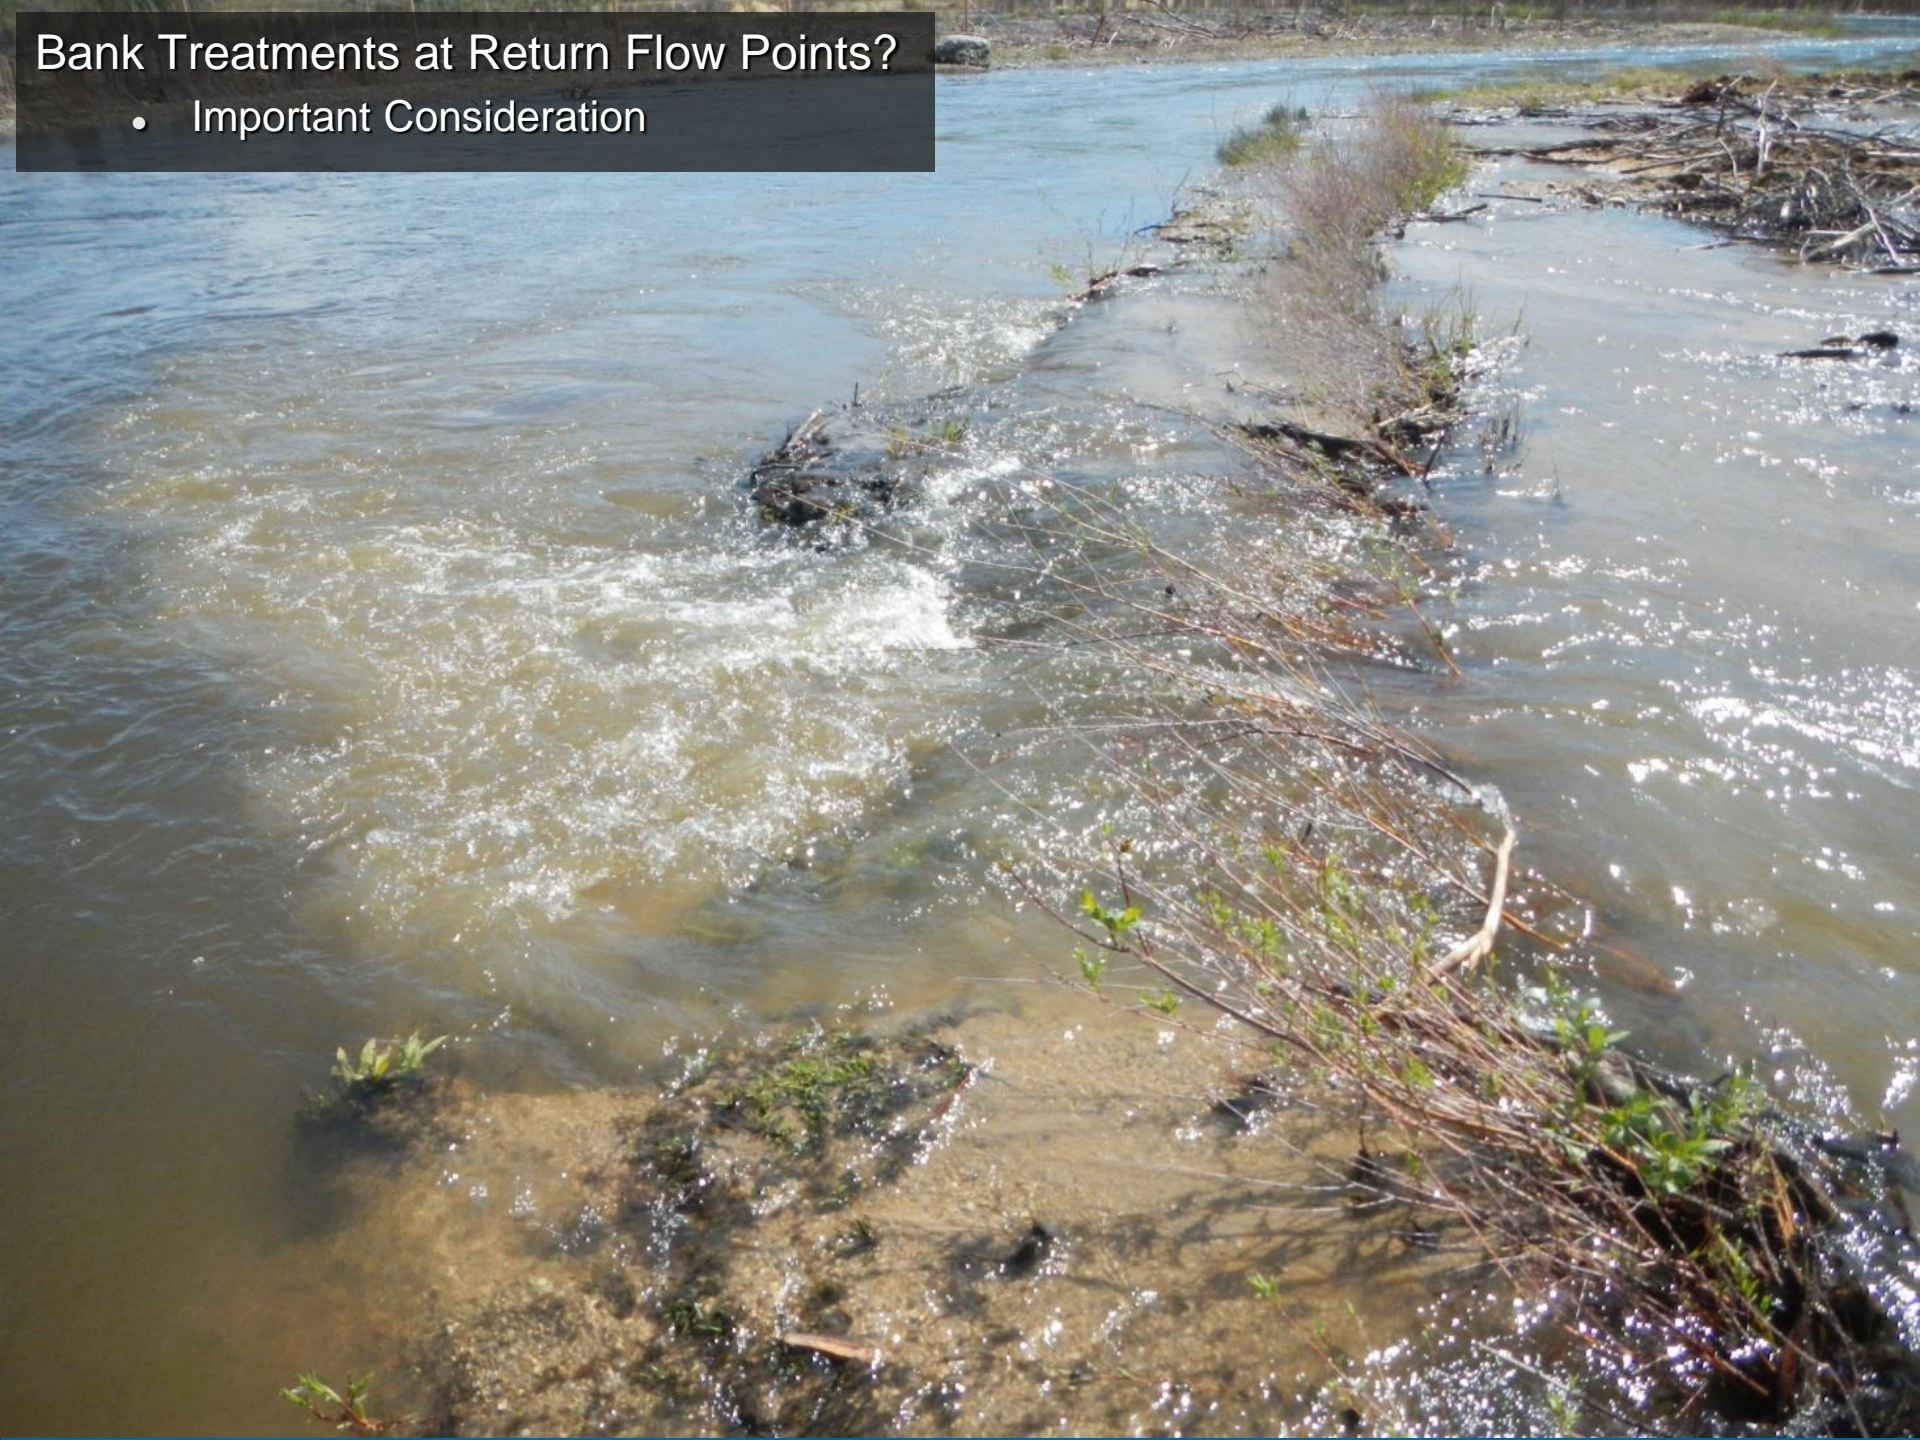
## Bank Treatments at Return Flow Points?

- No Headcutting
- PV Banks Held Up Well
- Brush Trenches Spread Flows
- Woody Debris Spread Flows
