# MILLTOWN RESTORATION

## Lessons Learned

Symposium on Riparian Restoration  
in a Contaminated Environment  
April 2012

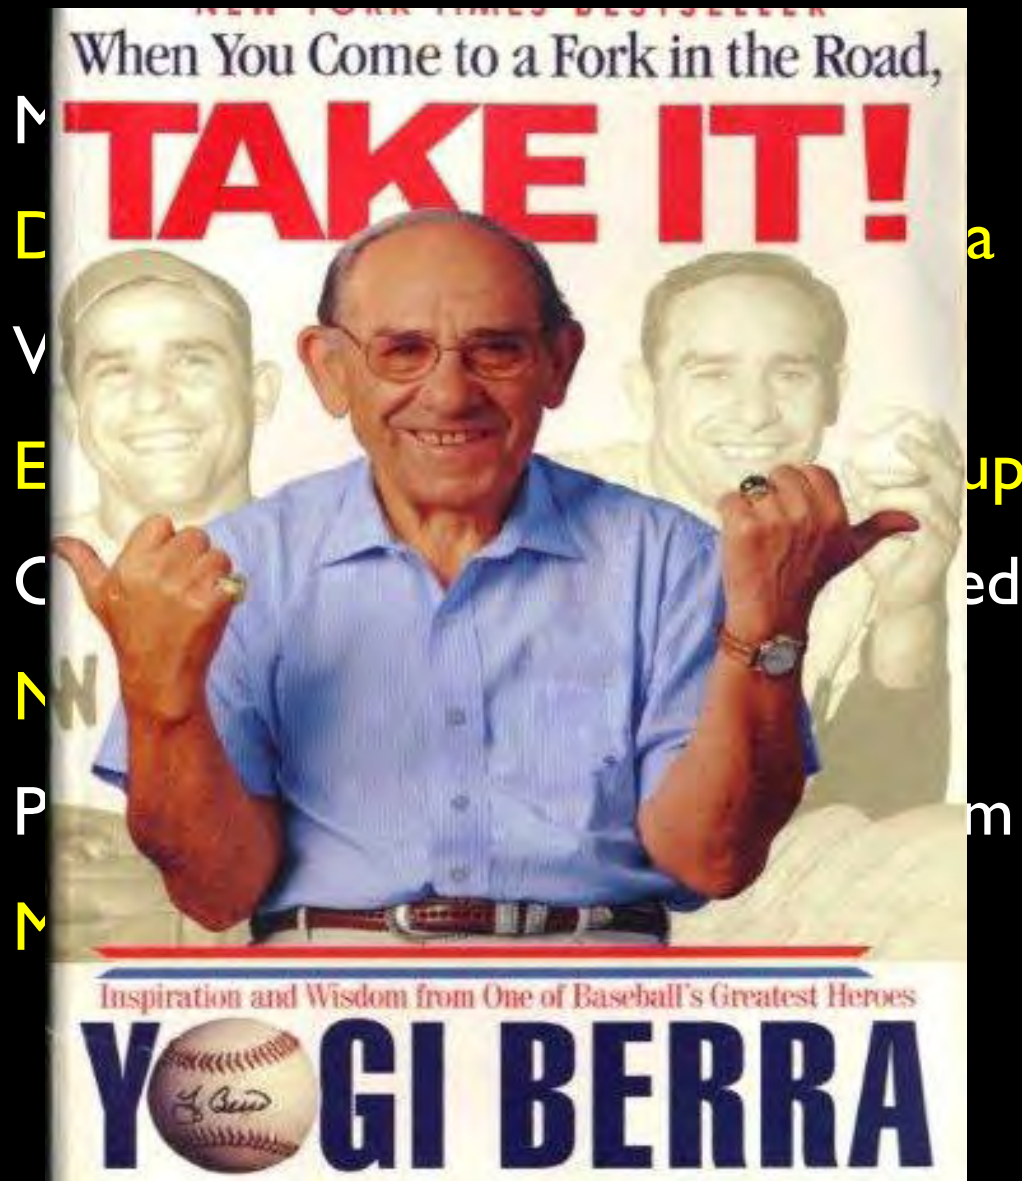
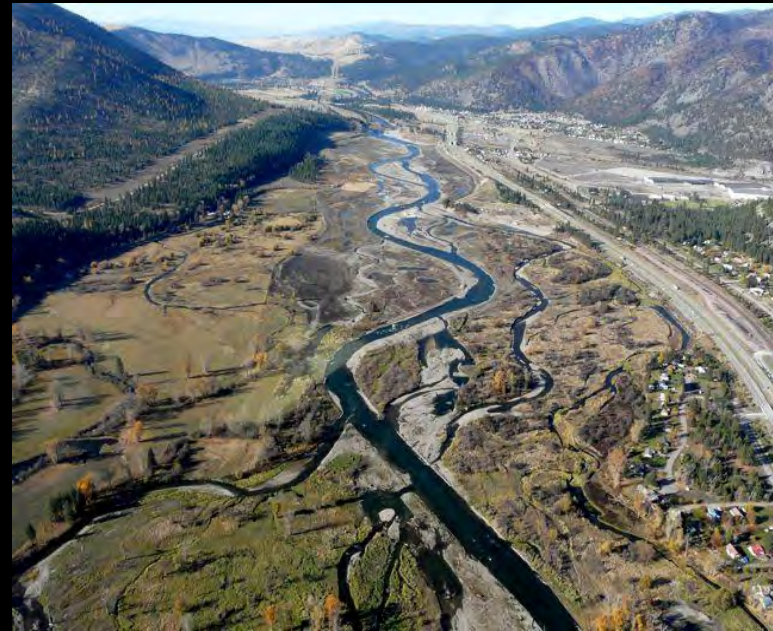
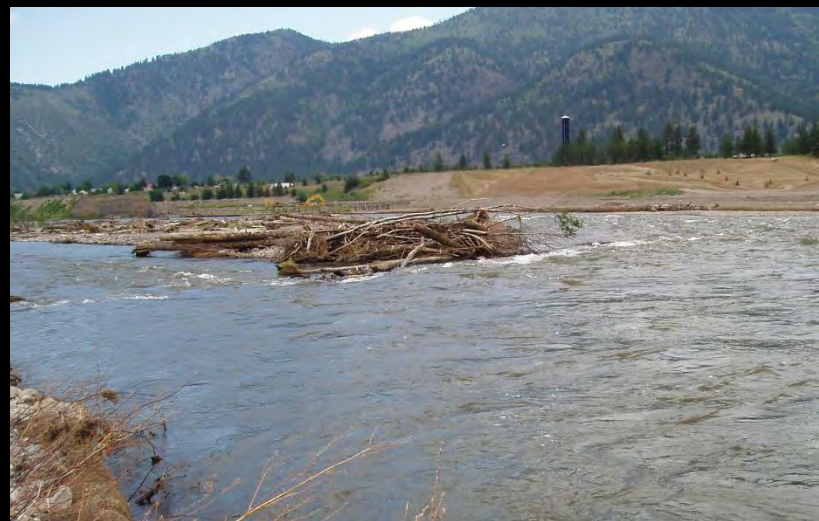
# Side Channel Performance

Entrance damage and debris buildup

Conveyed more flow than expected

New side channels formed

Modified design criteria for  
maintenance
