Qualitative Rapid Assessment

2023 Status Report

Milltown Reservoir / Clark Fork River NPL Site Clark Fork River Operable Unit, Reach A, Phase 1, Phase 2, and Phases 5 and 6

Geum Environmental Consulting, Inc.

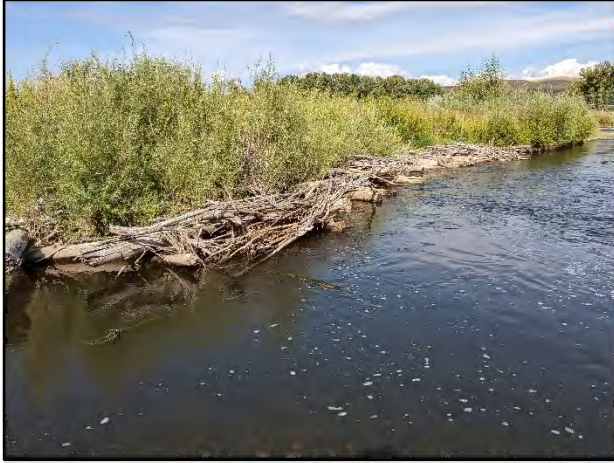
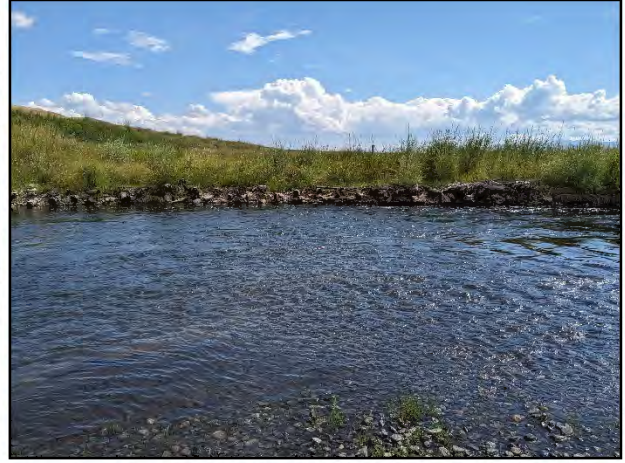
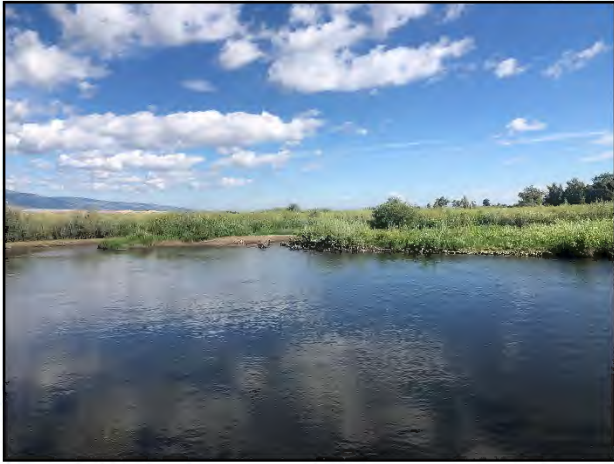
- Treatments remained intact in 2023 and are maintaining deep pools (Figure 11).
- Woody vegetation is expanding in all locations.
- Coarse wood is beginning to accumulate at structure locations (Figure 11, left photo).

Figure 11. Top left - Phase 2 Bifurcation treatment. Top right - Phase 2 Large Wood streambank treatment. Bottom – Phase 5 Bifurcation treatment at head of island.

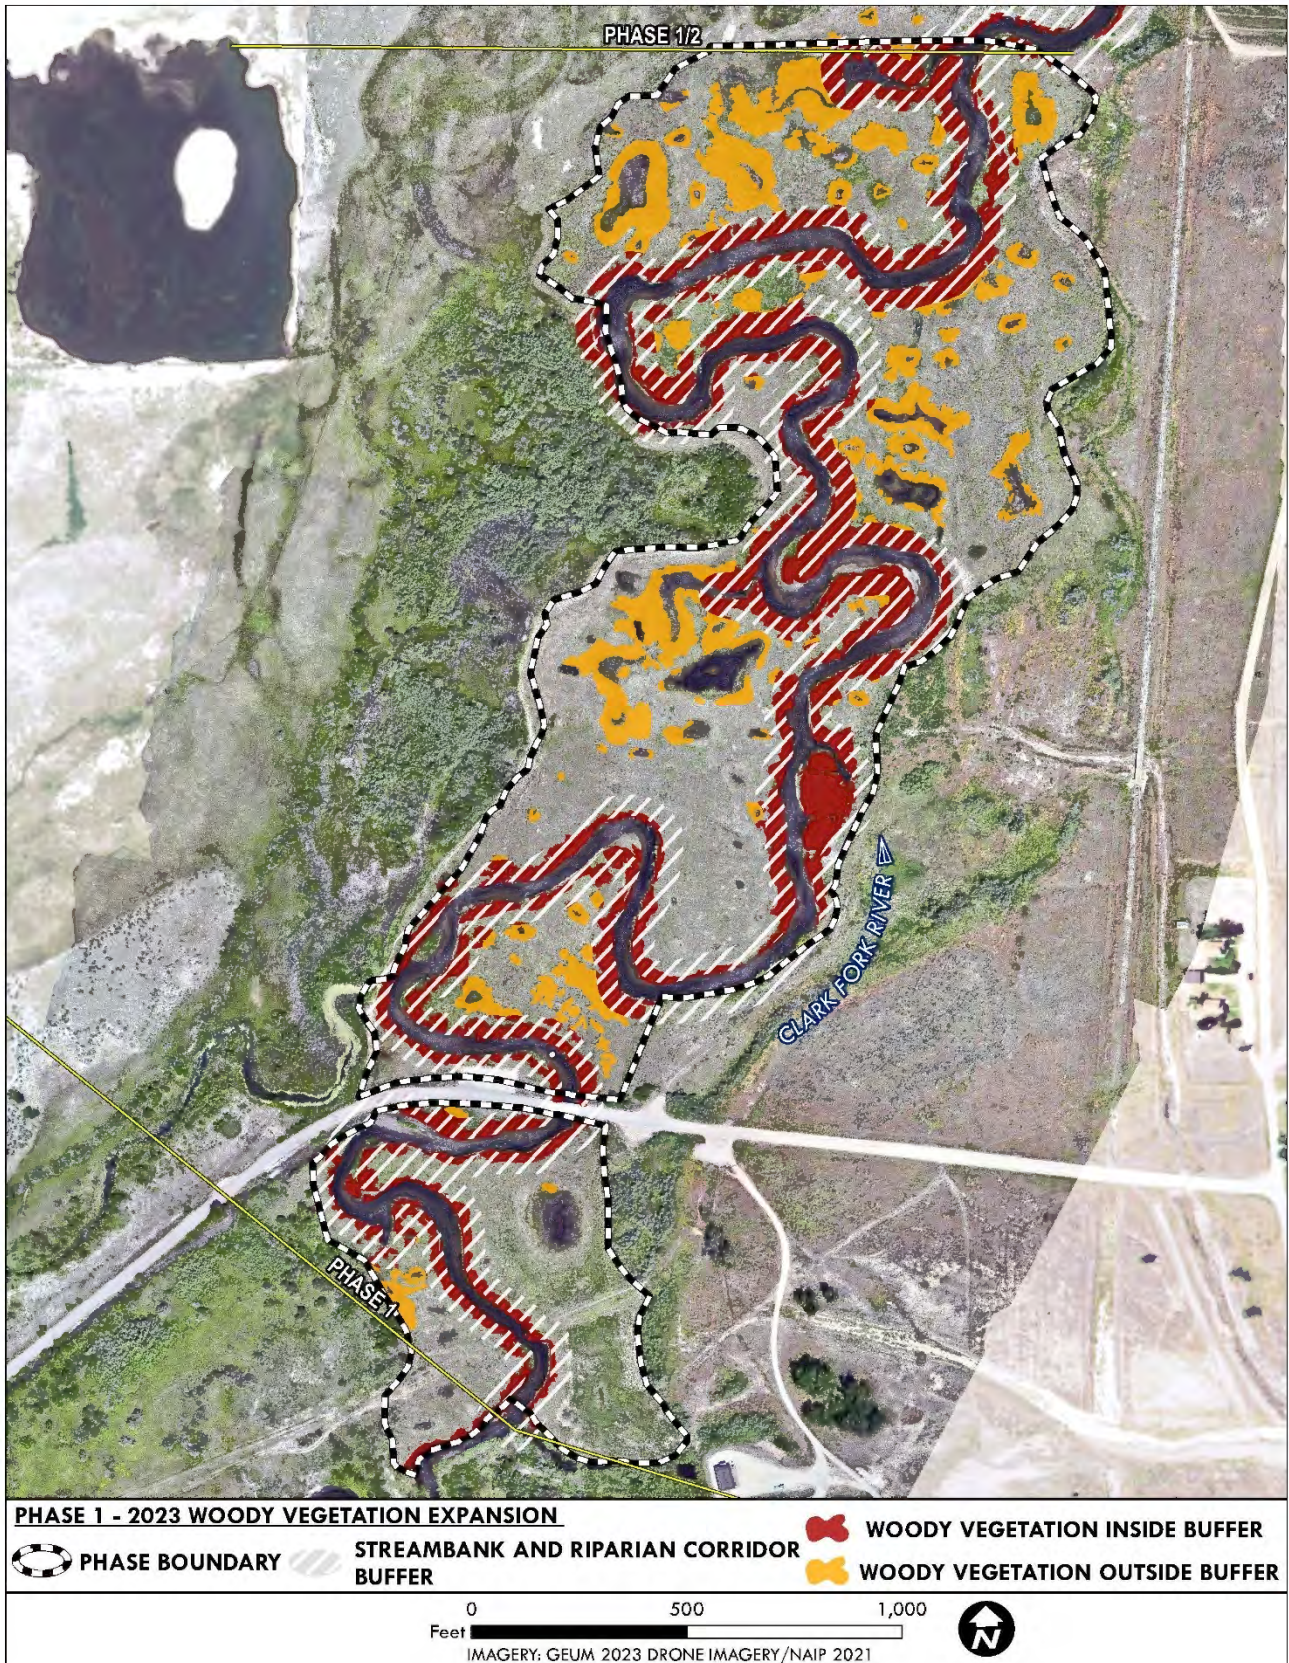
Figure 15. Estimated woody vegetation cover within the 50-foot Streambank and Riparian Corridor Buffer Zone and outside this Zone but within construction limits for Phase 1.

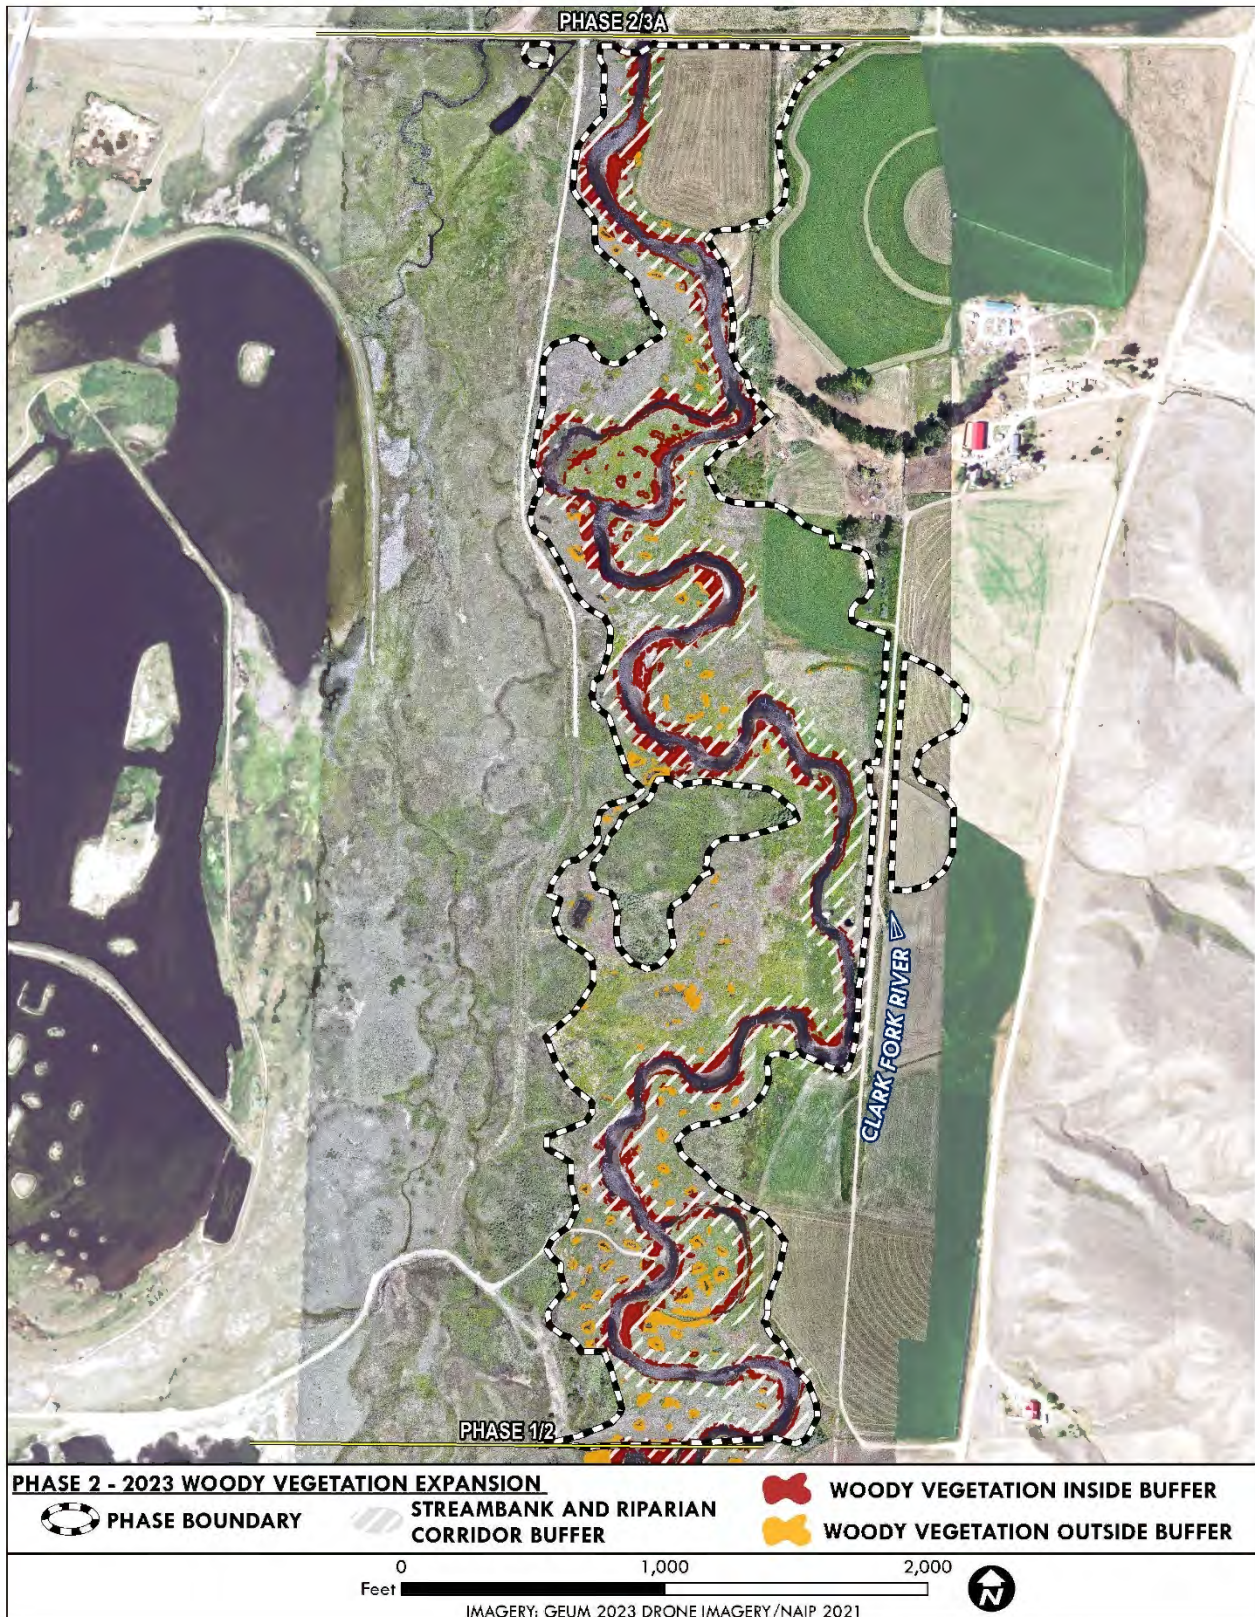
Figure 16. Estimated woody vegetation cover within the 50-foot Streambank and Riparian Corridor Buffer and outside this zone but within construction limits for Phase 2.

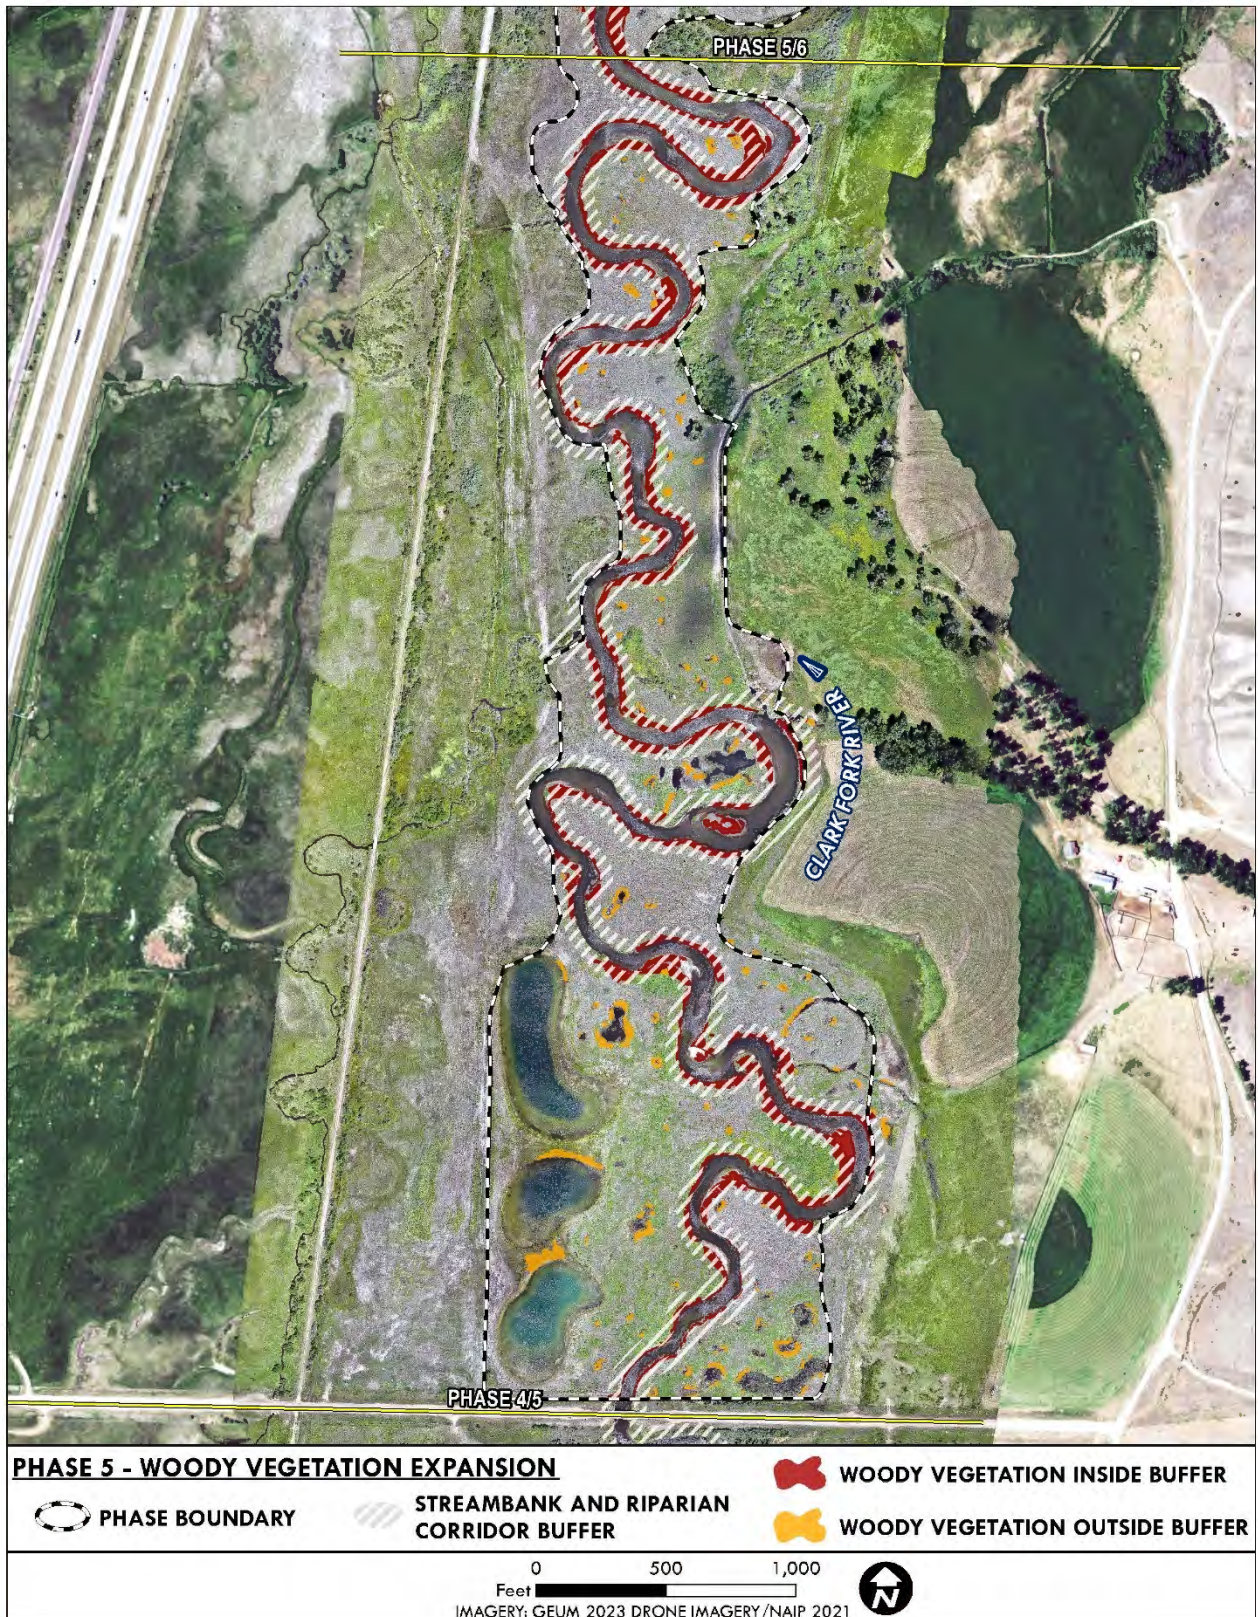
Figure 17. Estimated woody vegetation cover within the 50-foot Streambank and Riparian Corridor Buffer Zone and outside this zone but within construction limits for Phase 5.

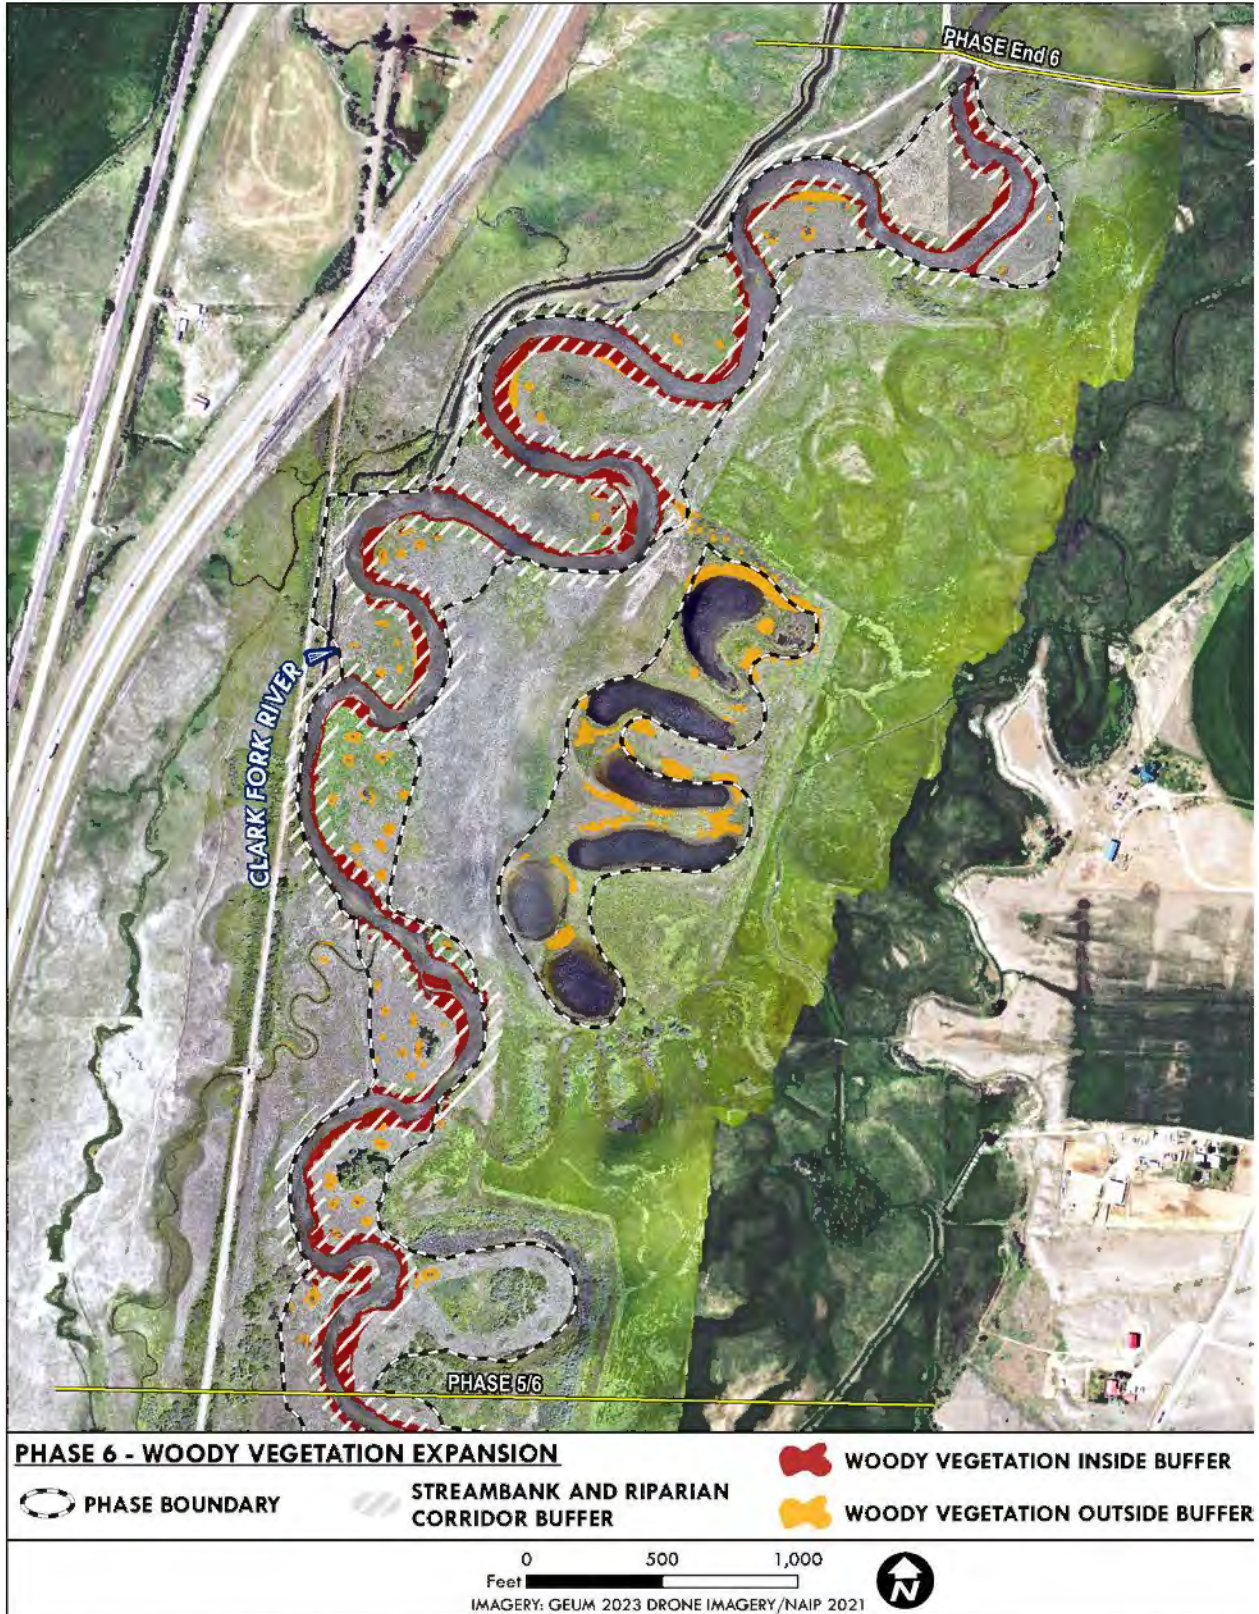
Figure 18. Estimated woody vegetation cover within the 50-foot Streambank and Riparian Corridor Buffer Zone and outside this zone but within construction limits for Phase 6.

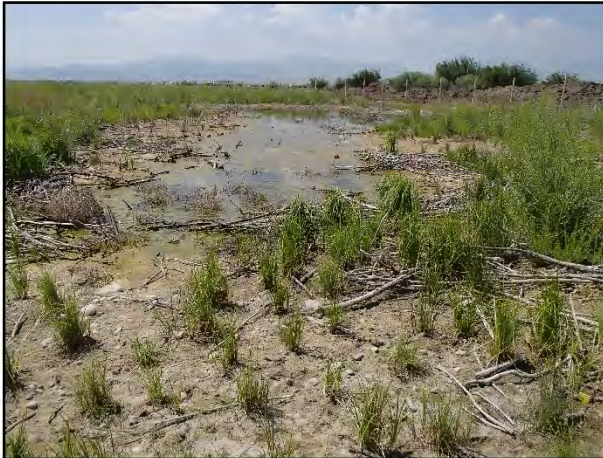
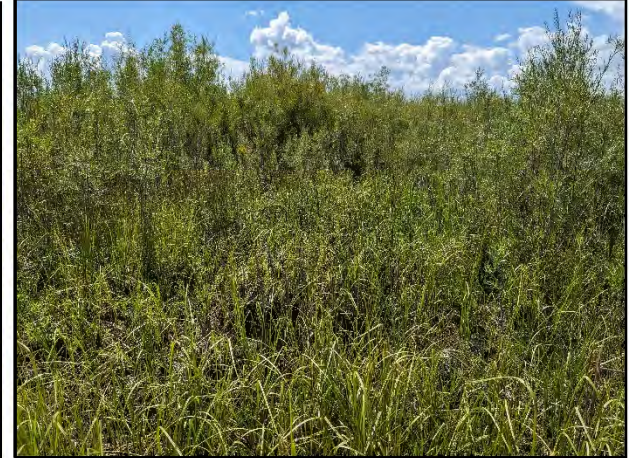
Figure 27. Phase 1 side channel wetland in 2015 and in 2023.

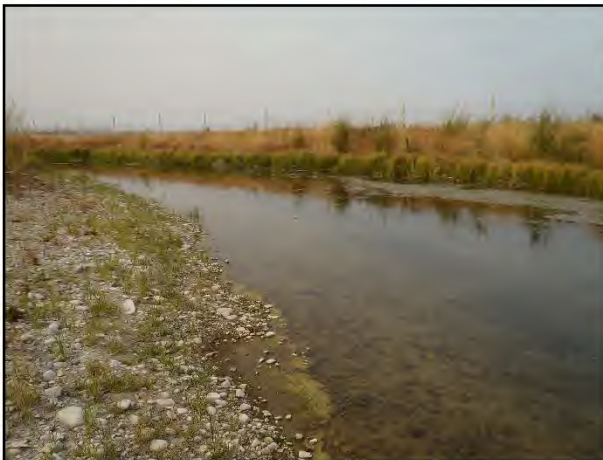
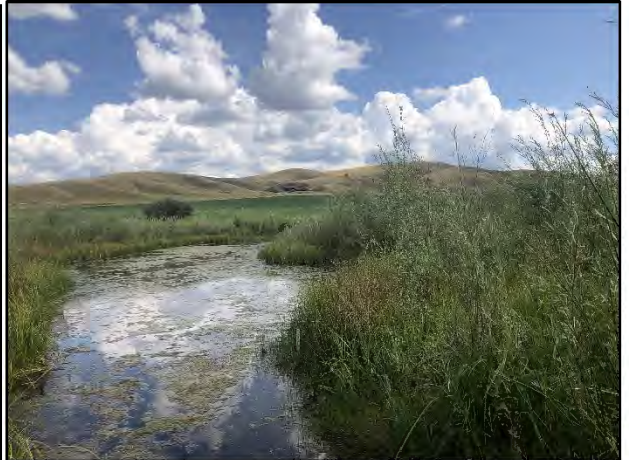
Figure 28. Phase 2 oxbow wetland in 2017 and 2023.

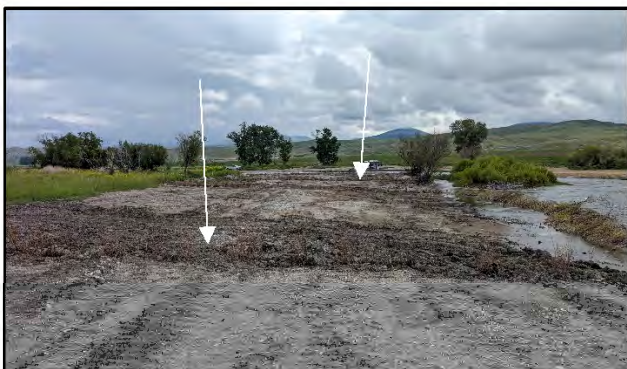
Figure 33. Willow trenches installed in Phase 4A perpendicular to streambanks.

2. **Incorporate willow trenches into the floodplain.** Willow trenches are trenches dug approximately 4 feet deep or to a depth that intercepts the low flow groundwater elevation with willow cuttings placed in the trench intercepting the groundwater depth. In Phase 4A (the most recently constructed phase), willow trenches should be constructed perpendicular to streambanks (except along point bars) and oriented perpendicular to the primary down valley high flow paths across inside meander bends (Figure 33).
