MILLTOWN GREENLINE PHOTOS: 2010 - 2024

September 2024

Natural Resource Damage Program

Geum Environmental Consulting, Inc.

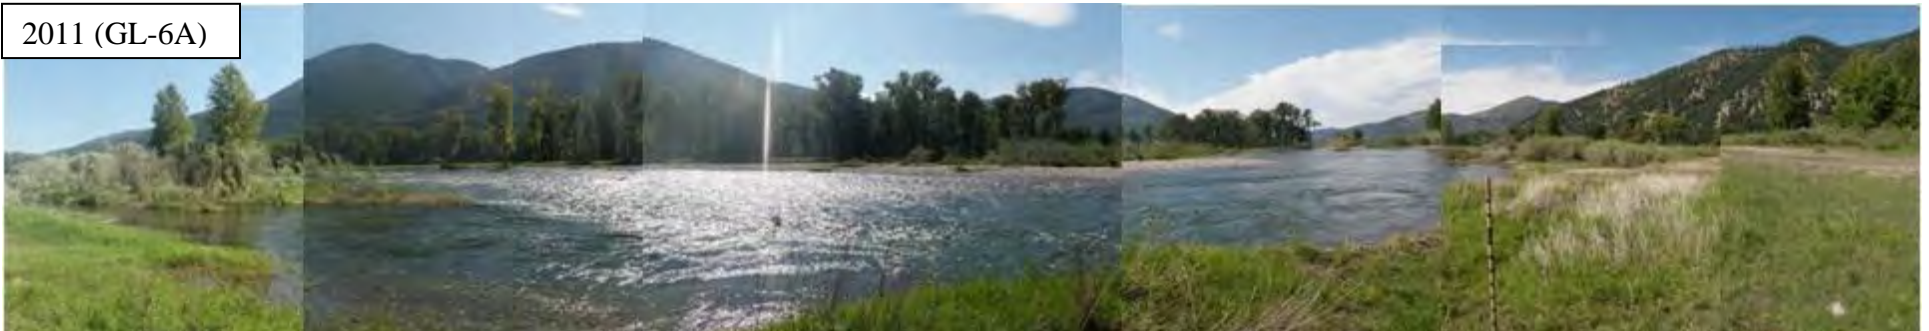
2011 (GL-6A)

Note: Point GL-6 was inaccessible in 2011 and 2012 due to changes in channel alignment following the 2011 spring flood. GL-6a was established on the opposite bank in 2011 to document the post-flood channel alignment. In 2013, the original GL-6 photo point location was accessible again, and greenline photos resumed at the original location.

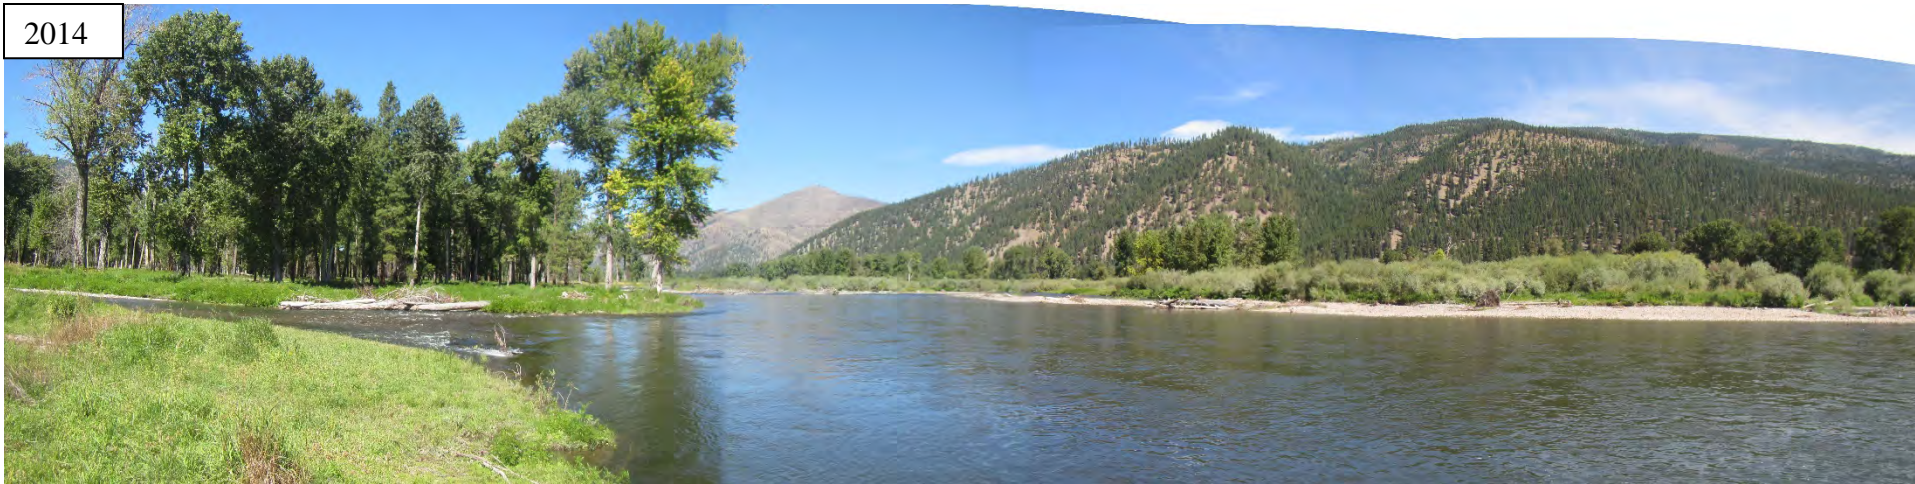
2014

Note: In 2014, the GL-6 photo point location was moved upstream approximately 150’ to capture the entrance to the left bank side channel.

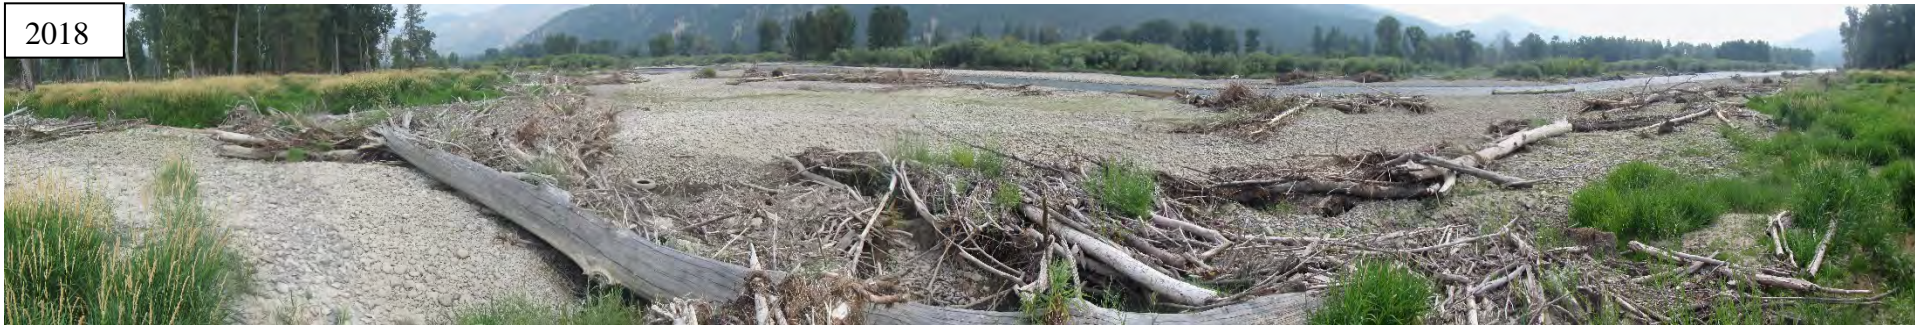
2018

Note: Taken from same location as 2017. In 2018, the main channel has migrated approximately 100' east.

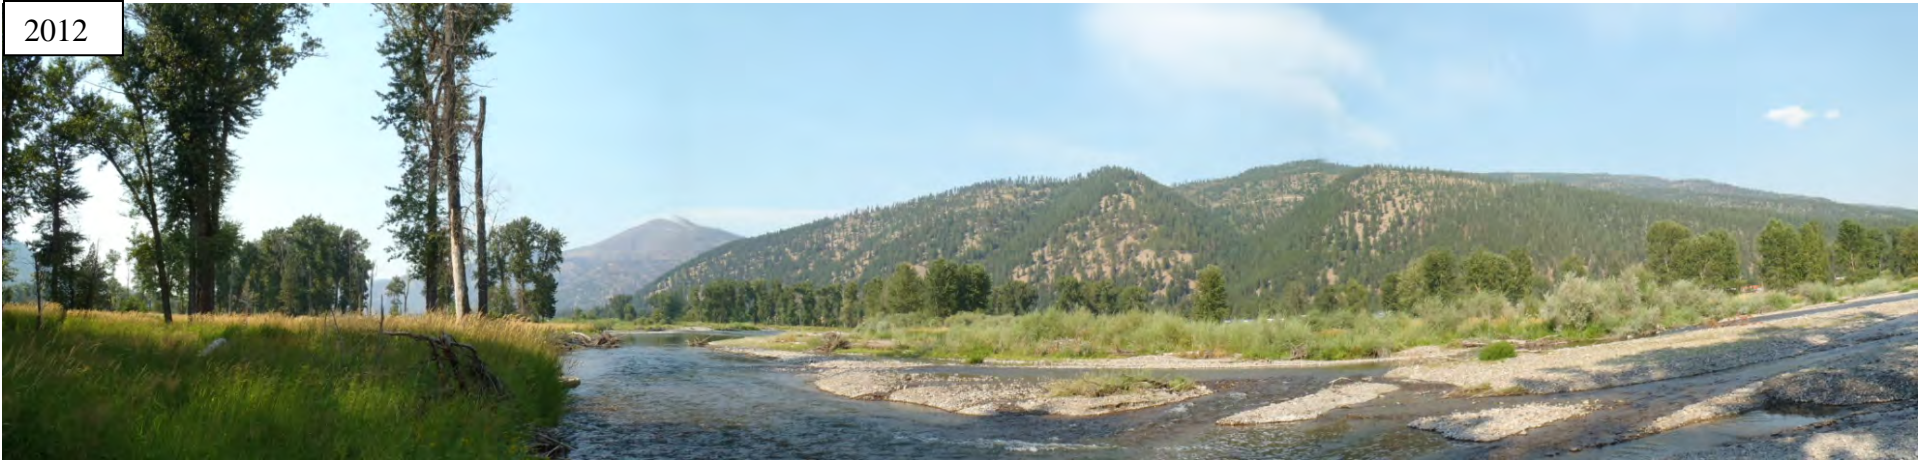
Note: Photo point GL-7 was moved approximately 500' upstream in 2012 following changes to the channel and left bank resulting from 2011 flooding.

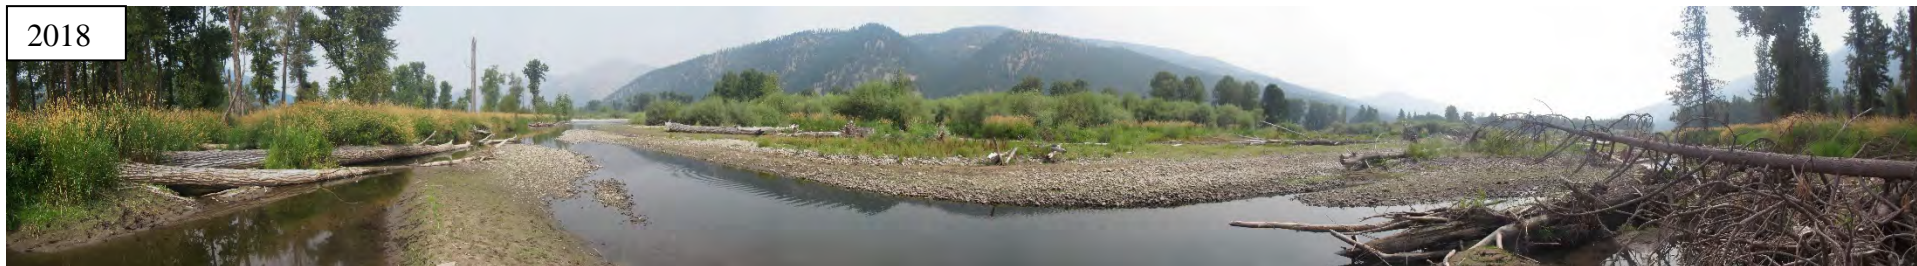
Note: Channel migration in 2018 has resulted in a backwater feature at GL-7. See alternate photos from main channel below.

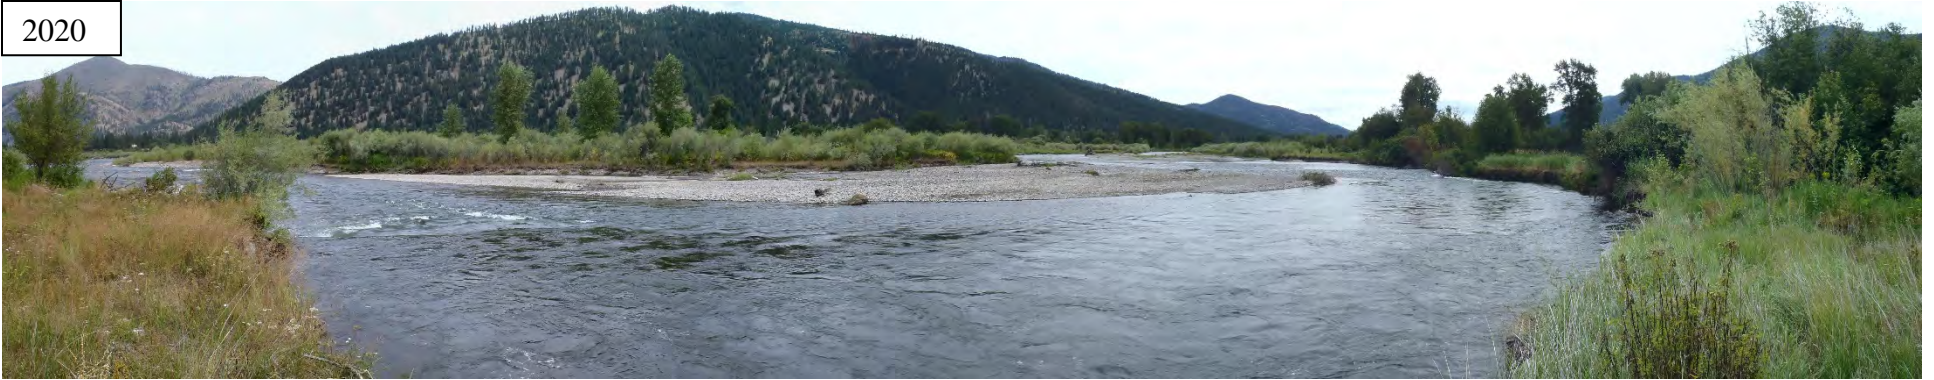
2020

Note: Photopoint location moved inland (west) ~100 ft due to bank erosion.

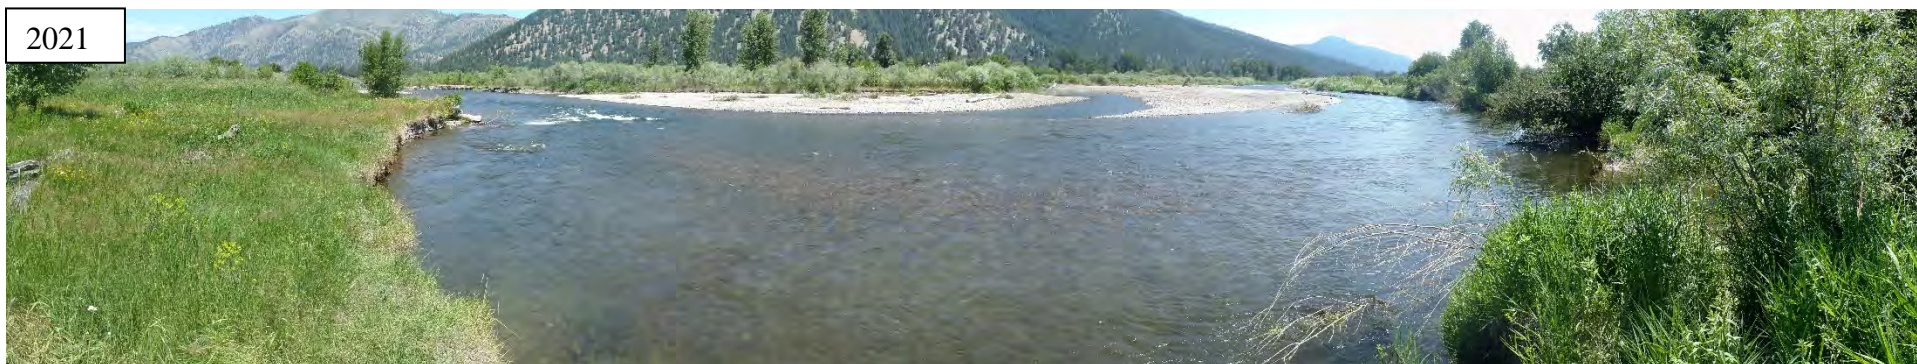
Note: Photopoint location moved to capture extents of bank erosion. Bank upstream of photopoint (including GL-10 photopoint location) is eroded to mature tree/shrubs.
