2013

Blacktail Creek Assessment

Capri Gillam, Tom Waring, Seth Reedy

Department of Environmental Engineering

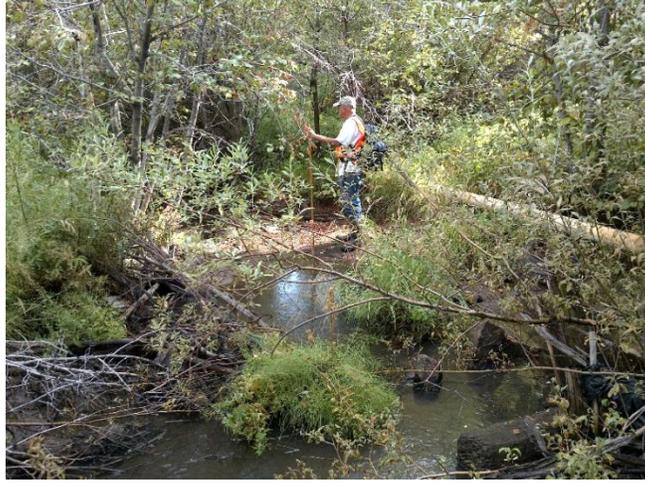
Photo 1

Overview: This uppermost reach of stream starts at the junction with Hwy 2 and precedes downstream for about one mile (**Photo 1**) showing downstream view. Historically, this reach has been heavily impacted by highway construction and agricultural use which has resulted in the stream being moved and straightened to accommodate the highway and hay meadows. The stream was moved many years ago and, now, channel vegetation is well established. The channel shows signs of trying to increase its sinuosity by eroding some of its outside banks.

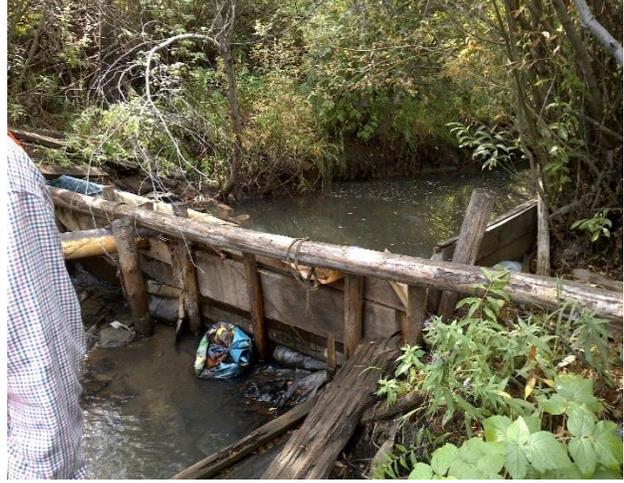
Photo 2

In the upper part of the reach, there is an irrigation ditch which is fed from the stream by an iron pipe and water diversion structure (**Photo 2**). This structure and pipe are impacted by flood flows and there is evidence that they have been rebuilt in the past.

Possible Projects: A permanent diversion structure and water pipe into the irrigation ditch, just downstream of the nine mile junction, could be constructed. This construction would prevent long term erosion around the diversion and could be built to provide low flow fish passage which the current structure does not allow.

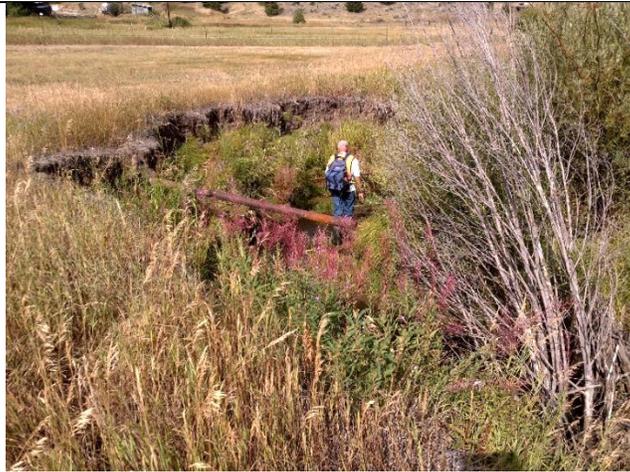
Photo 3

Channel and Erosional Characteristics: The channel is incised from 5-7 feet in this reach and has no access to its floodplain (**Photo 3**). The channel material is predominantly sand and fine gravel (**Photo 4**). A three-quarter inch diameter walking stick can easily be pushed 2 feet deep into this substrate. The source of this excess sand and gravel must be from upstream and out of the assessment area because the reach itself shows only slight erosion. A few outer banks have eroded and fallen helping the stream to form a new lower floodplain but most of the channel has steep banks and no lower floodplain shelf. One landowner has planted willow cuttings on some turns and these cuttings have grown into young willows that are starting to provide erosion protection (**Photo 5**).

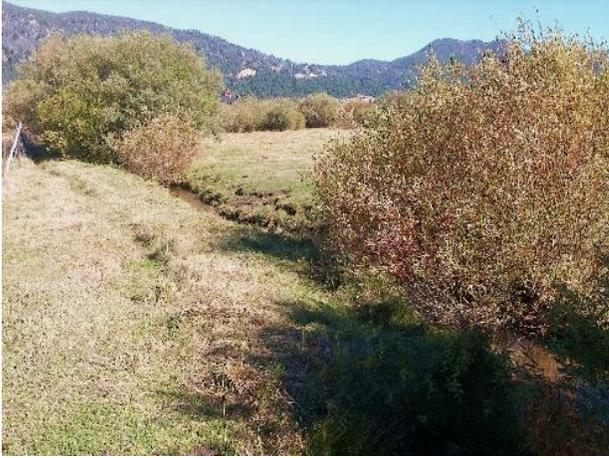
Photo 15

Riparian Vegetation: The vegetation is characterized by two species of willows and abundant sedges and some bulrush. Near the breach, willows are scattered and only about 30 percent of the cover (**Photo 15**) but, near the end of the sub-reach, willows provide nearly continuous cover (**Photo 16**).

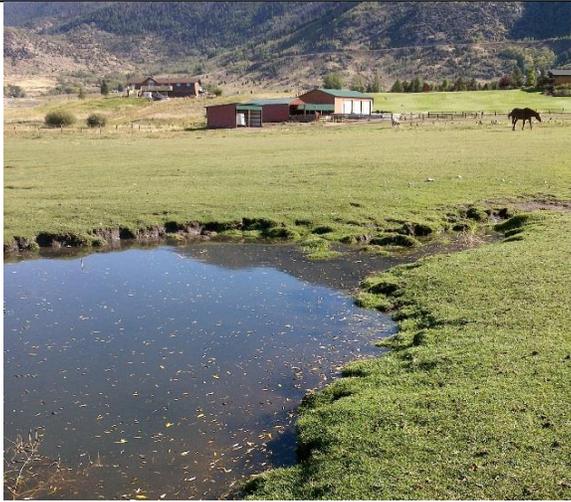
Photo 19

Riparian Vegetation: Just South of Blacktail Loop Road, the willows are thinned or not present due to grazing practices. Grazed areas have little willow cover, some eroding and fallen banks, and livestock trampling (**Photos 19 & 20**). Comparatively, ungrazed properties have more willow cover and stable banks (**Photos 21 & 22**). Some fallen banks are revegetating with riparian vegetation (**photo 23**). The lowest section of the reach has the most riparian vegetation with abundant willows and sedges present in the adjacent wetland.

Possible Projects: Assistance in developing BMP’S for grazing and for protecting the stream corridors and riparian zone should be provided to interested landowners. This could include fencing, protection of banks through bioengineering or plantings, etc.

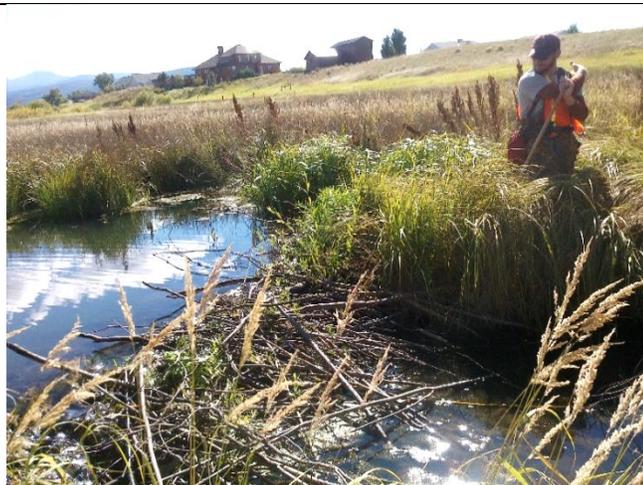
Photo 24

Fish: This reach again has few riffles and an embedded sand and fine gravel substrate. There are some undercut banks and abundant willow cover in ungrazed parcels. Some deep scour pools occur below beaver dams (**photo 24**) while a couple of riffles have some larger gravel. Large woody debris is scarce.

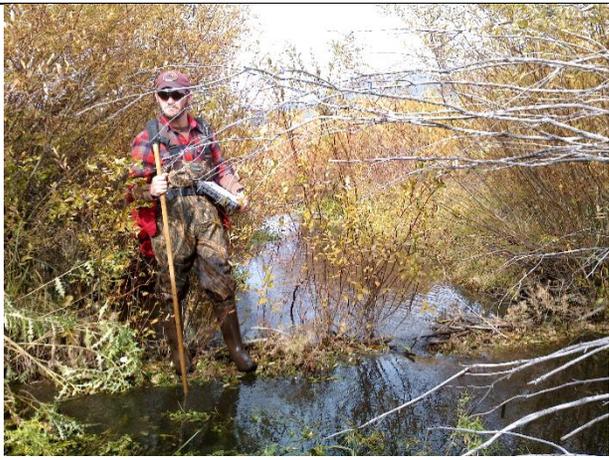
Photo 25

Channel and Erosional Characteristics: The original channel in the wetland portion has been and continues to be heavily impacted by beaver dams (**Photo 25**). In some places, erosion has occurred where water has flowed around dams and formed a new channel. There are multiple channels in this area some or most of which are ephemeral or carry water only during high water flow (**photos 26-28**).

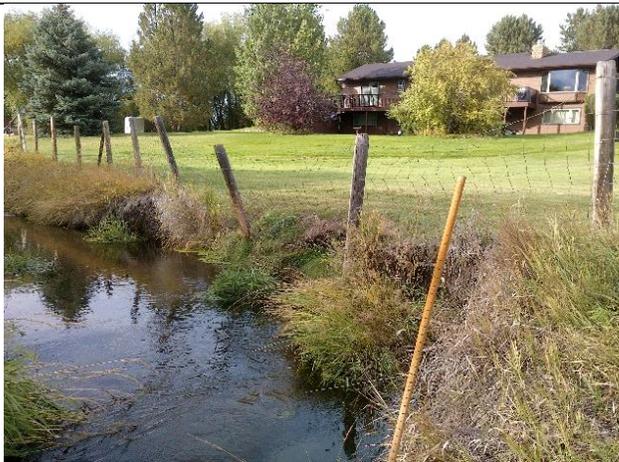
Photo 29

The stream is encroaching into one yard (**photo 29**) and the water control structure is causing some lateral bank erosion (**photo 30**).

Possible Projects: Remove the concrete water control structure and restore the eroded banks below the structure. Work with landowners to use BMP's for stream protection.

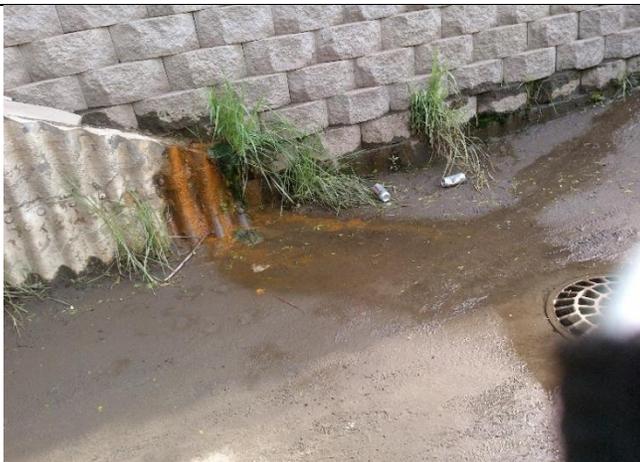
Photo 41

Iron oxidizing bacteria could be impacting water quality where seeps enter the creek (**Photos 41 & 42**).

Possible Projects: Where the channel enters and above Father Sheehan Park there is erosion occurring. This will require channel and bank stabilization efforts. BMP's for weed management and bank protection should be part of restoration efforts along the entire reach. Vigorous algal and vascular aquatic plant growth, along the reach below Harrison Avenue, suggests that nutrient enrichment is occurring and the origin(s) of the nutrients could be investigated further.

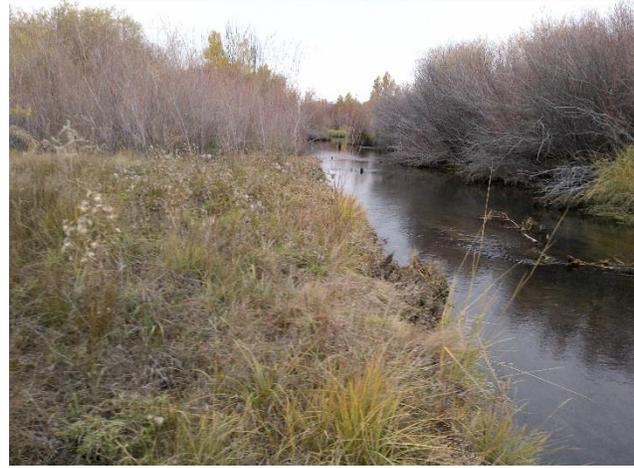
Photo 43

Overview: As the channel leaves the double culvert under Kaw Avenue it enters a gentle meander with a walking trail on the north side and I-90 on the south side of the channel bank. There is a large pool created by an older beaver dam below the double culvert. The channel then flows past the Butte Chamber of Commerce parking lot and a USGS monitoring station before it flows under the bridge at George Street. Below George Street large rock has been placed on both banks to help control erosion from past disturbances. Large patches of Canadian thistle were observed on the upper section of the reach (**Photo 43**).

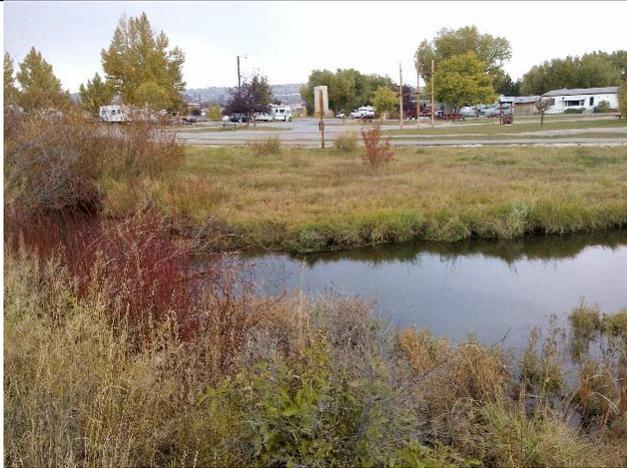
Photo 44

Riparian Vegetation: The upper section of the reach is dominated by willow, with four species and varying age classes present (**Photo 44 & 45**). Sedges are abundant here also, along with a few cottonwood trees and a variety of riparian grasses. Below George Street, where rocks cover the reconstructed banks, there are currently two species of sapling willows present and there is a noticeable lack of sedges in this lowest section (**Photos 46 & 47**). Here, there is an abundance of short non-native grasses which do not provide much erosion protection during high water events. Heavy patches of Canadian Thistle are present on the upper section of the reach.
