Riparian Habitat Assessment for Flint Creek and Boulder Creek Granite County, Montana

Environmental Services Contract #SPB-12-2177V

Task Order 1.28

January, 2015

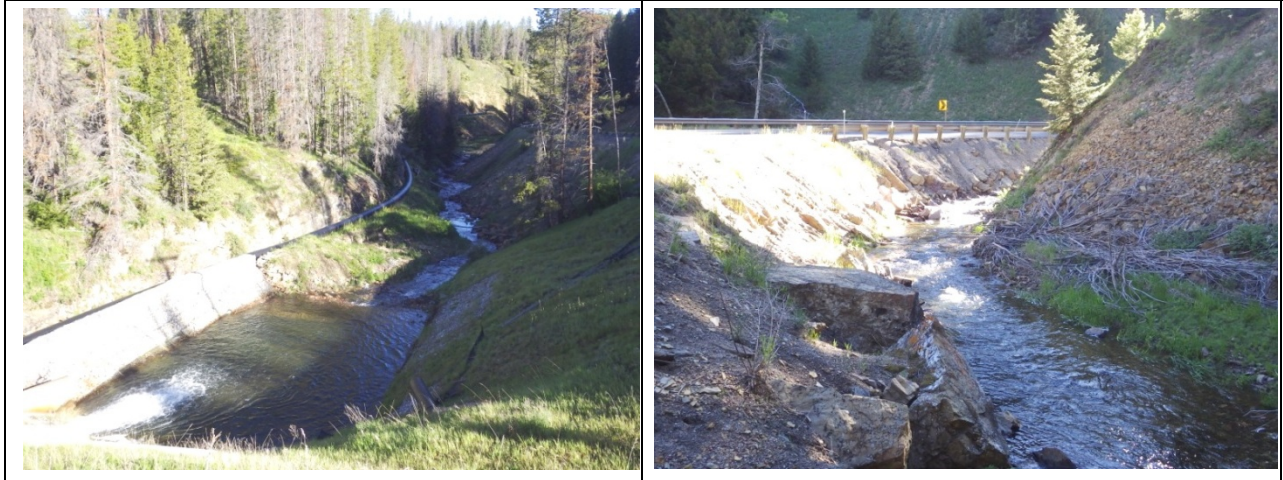
The condition of this subreach may be in slow decline due to the likely chronic sediment inputs from the highway and severe dewatering, but habitat value would be limited here, regardless of these influences. The dam upstream of this reach and the very long and steep cascade downstream of subreach F01 constitute fish barriers and limit the potential of this subreach for fish habitat, in addition to the constraints posed by dewatering.

View of F01ra from Georgetown Lake Road, at the dam

Confined channel at the downstream end of subreach F01ra

- Recruit woody debris or install other sediment-trapping features in-stream or along the road prism
- Revise sanding practices and road run-off management.

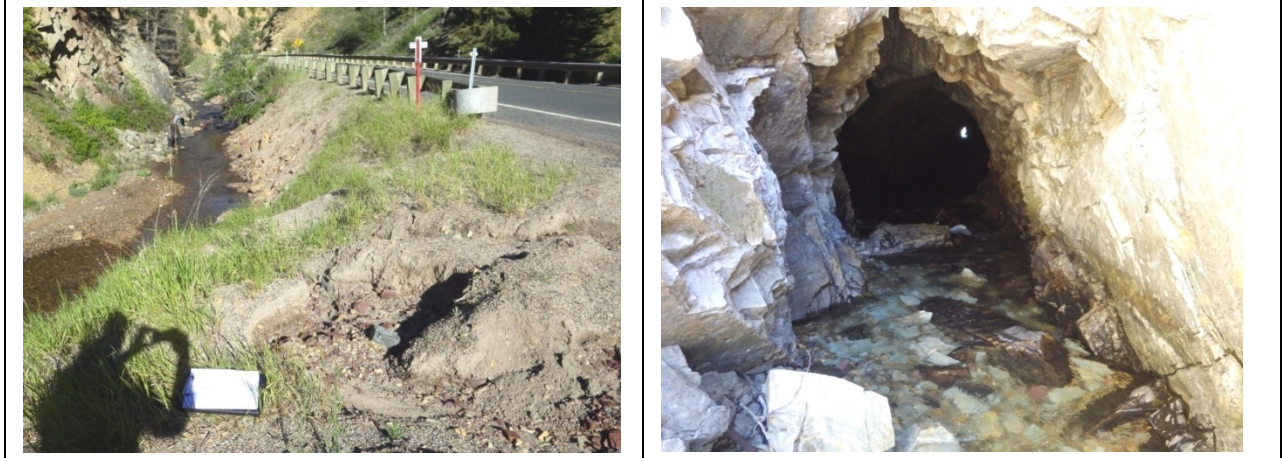
Confined channel and erosion of road fill from Hwy 1 in F01

Tunnel forming the boundary between F01 and F02ra

- Install sediment-trapping features in-stream or along the road prism, such as sediment traps and filter windrows where feasible along the road fill
- Recruit woody debris or other pool-forming features
- Revise sanding practices and road run-off management

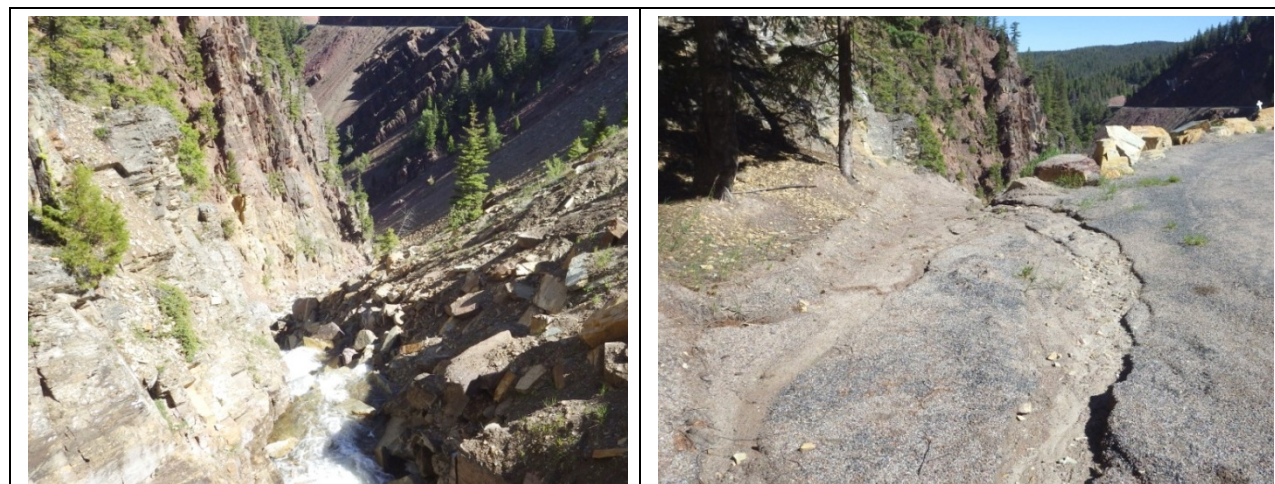
Upstream end of reach, directly below tunnel in F02ra

Runoff and sediment delivery from Hwy. 1 in F02ra

- Address road runoff and associated sediment delivery from Highway 1.
- Determine if the channel can be re-watered by revising the water management by the dam and power plant

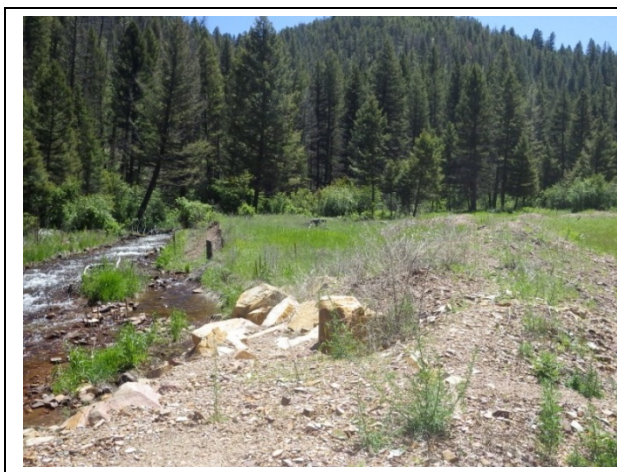
Noxious weeds on berm material in upper portion of subreach F02.

- Noxious weed control

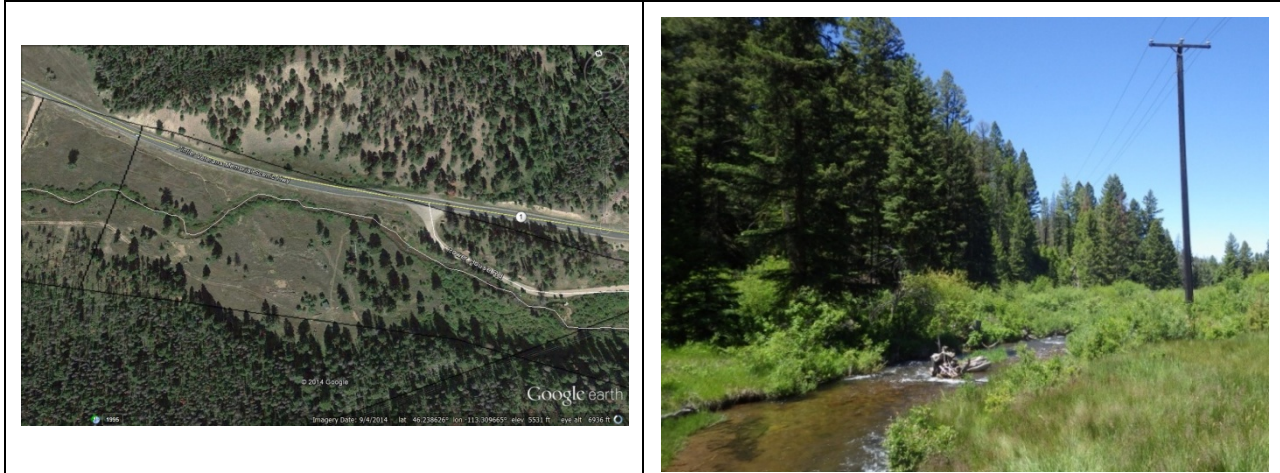
Aerial view of F03ra-1

Conditions at upstream end of F03ra-1

- Low intensity: stabilize banks with bioengineering techniques and riparian planting, and currently are likely a chronic source of sediment to Flint Creek.
- High intensity: channel reconstruction and bioengineering to restore sinuosity and channel length
- Medium intensity: Re-activation of overflow channels

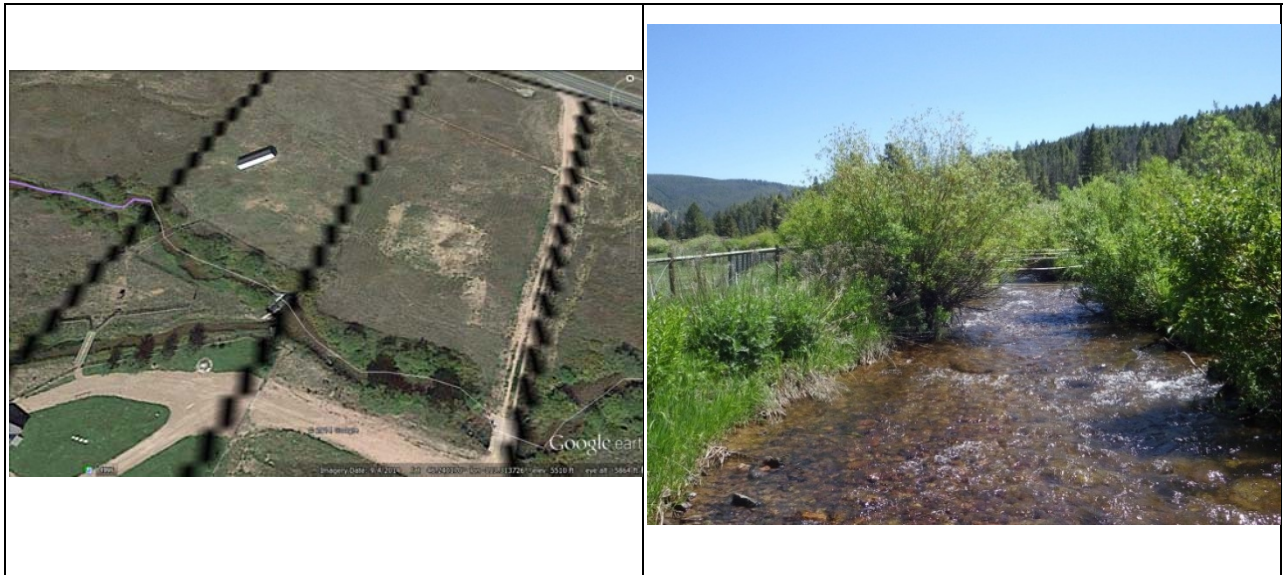
Aerial view of F03ra-2

Fenced riparian area at downstream end of F03ra-2. Common tansy on right bank

- Upgrade diversion to improve fish passage and prevent entrainment to the ditch;
- Noxious weed control
- Install in-stream aquatic habitat structures with large wood to encourage lateral cutting where riparian vegetation is intact
- Planting of shrubs in areas currently dominated by common tansy
- Install of brush fascine or other similar bioengineering technique, followed by riparian planting, to stabilize and speed recovery of the eroding portion of the south streambank.

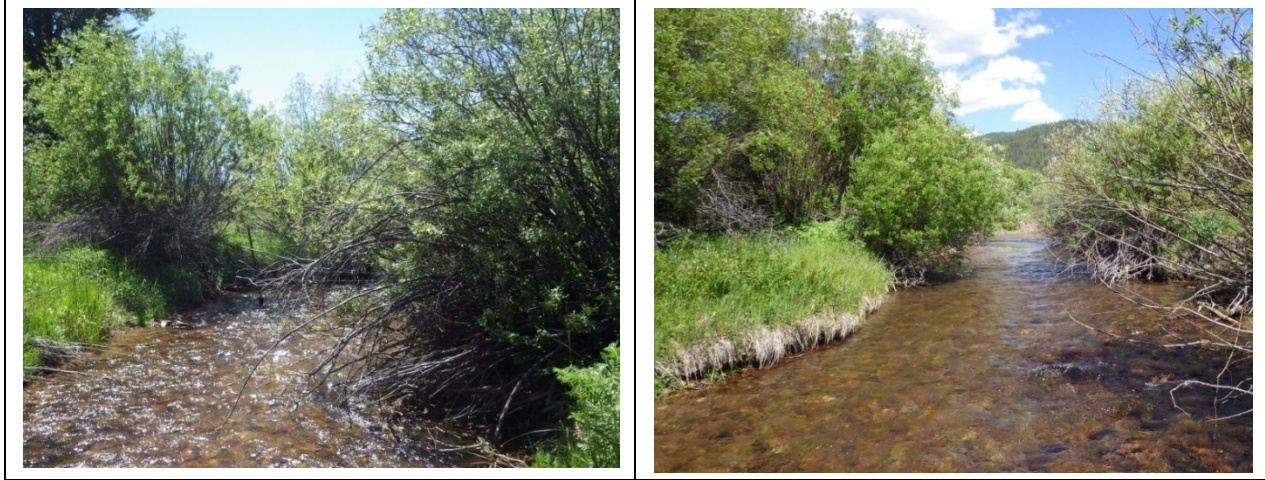
Conditions at upstream boundary of F04ra

Conditions at downstream boundary of F04ra

- Riparian planting and bioengineering to stabilize eroding banks, primarily at the downstream end of the site

- In-channel bioengineered structures such as post and willow lines or barbs to narrow the channel and raise the water table to help re-activate side channels.
- Temporary riparian fencing with a grazing management shift or long-term fencing to protect riparian shrubs.

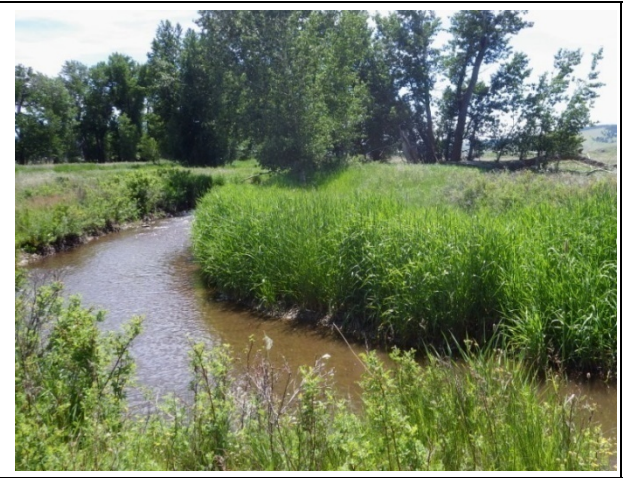
Conditions at downstream end F07

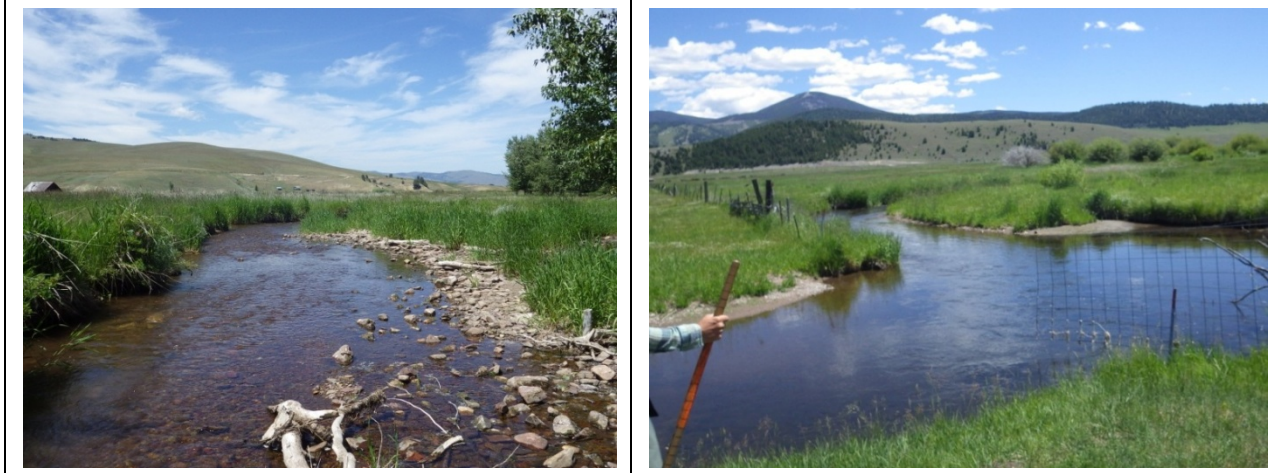
Conditions at upstream boundary of F08ra, looking downstream into subreach.

Conditions at downstream boundary, looking upstream into subreach F08ra

- Plant riparian shrubs and trees
- Bioengineering to stabilize eroding banks, narrow stream and improve aquatic habitat

- Temporary riparian fencing with revised grazing management or long-term fencing to protect riparian shrubs
- Reactivate side channels in selected areas where doing so will not impact current operations negatively

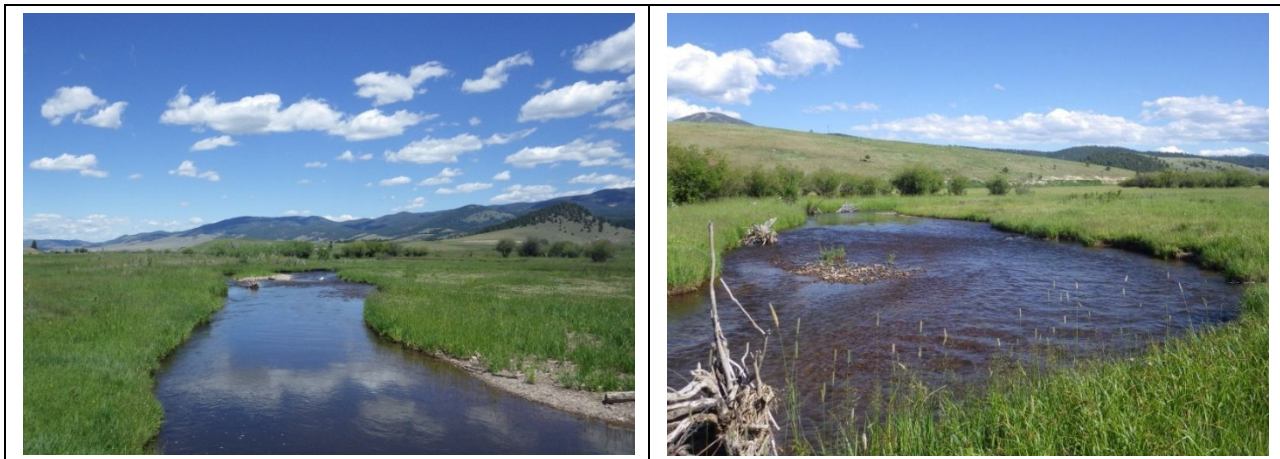
Conditions at upstream end of F08

Conditions at downstream end of F08

- Remove car bodies and stabilize higher eroding banks using bioengineering techniques
- Bioengineering techniques and riparian planting to narrow the stream channel and improve aquatic habitat
- Re-activate old meander bends (mid-reach) and side channels to improve floodplain function, habitat diversity, and stream sinuosity
- Work with landowner and lessee to revise riparian grazing management.
- Weed control

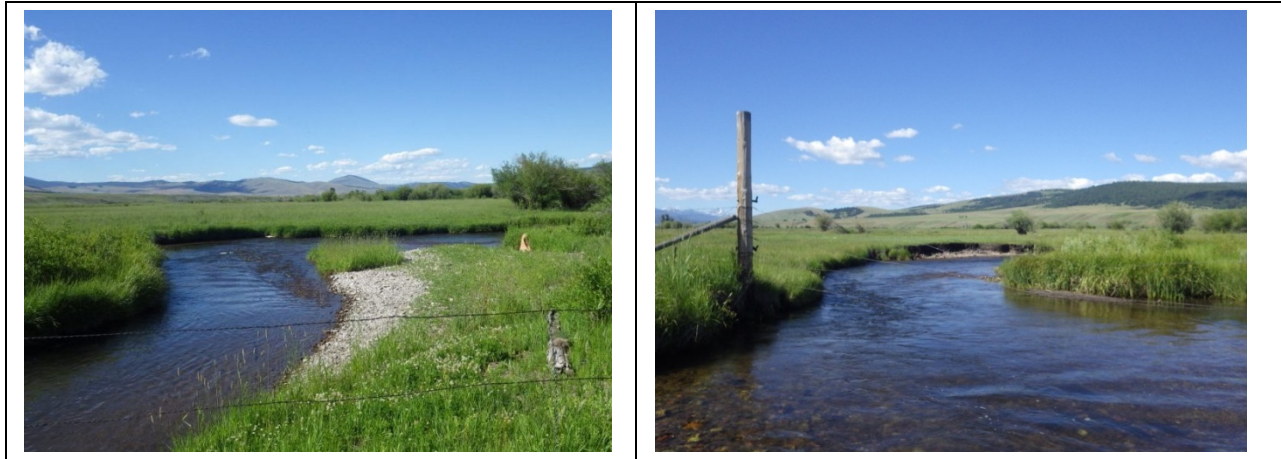
Conditions at upstream boundary of subreach F09ra

Conditions at downstream boundary of subreach F09ra

- Riparian planting and bioengineering to stabilize eroding banks, allow channel narrowing, and reduce loss of pasture
- Temporary riparian fencing with revised grazing management or long-term fencing to protect riparian shrubs
- Landowner outreach to determine interest in upgrading any diversions or headgates to improve function. Any project involving irrigation infrastructure would need to include contingency for maintenance if there are any issues with the new structure

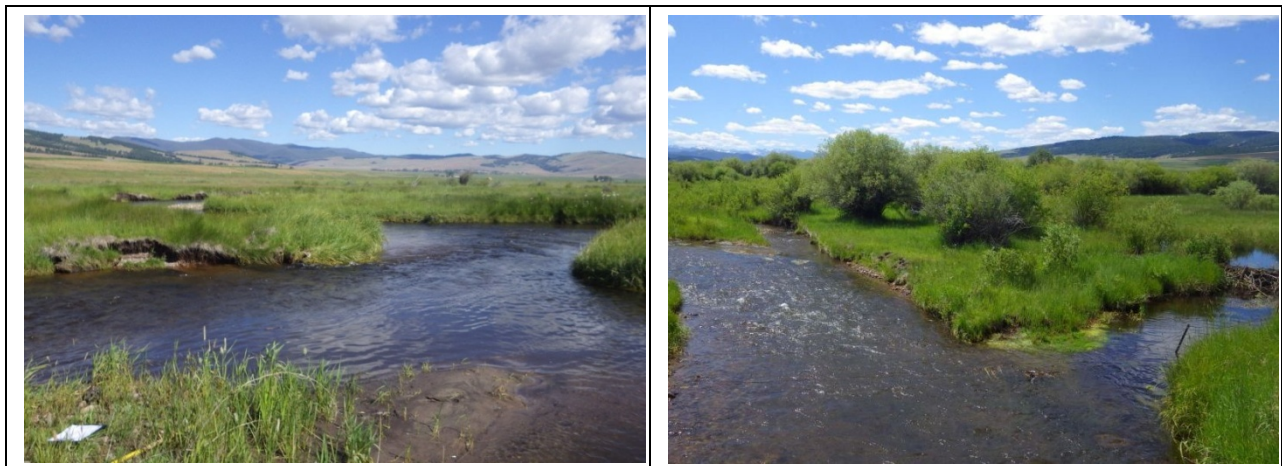
Conditions in upstream portion of subreach F09

Conditions at downstream end of subreach F09

- Bank stabilization with bioengineering to increase sediment trapping and narrow the channel
- Riparian planting in selected areas, and temporary browse protection for riparian shrubs regenerating on site

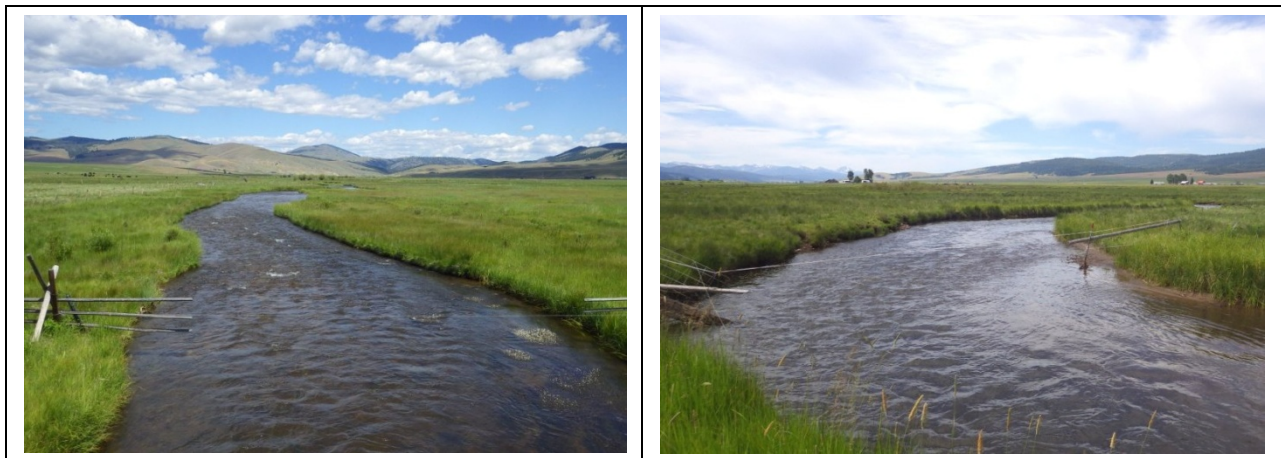
Conditions at upstream boundary of subreach F10ra

Conditions at downstream boundary of subreach F10ra

- Restore natural sinuosity to the upper third of this subreach to reduce streambank erosion and channel widening downstream
- Conduct further analysis to determine if a natural sinuosity could be achieved by reconnecting historic meanders still visible in aerial photos
- Plant native riparian shrubs to protect streambanks with temporary riparian fencing with a grazing management shift or long-term fencing
- Bioengineering to stabilize the most severely eroding banks and reduce the channel width is also recommended. Restoration would be supported by

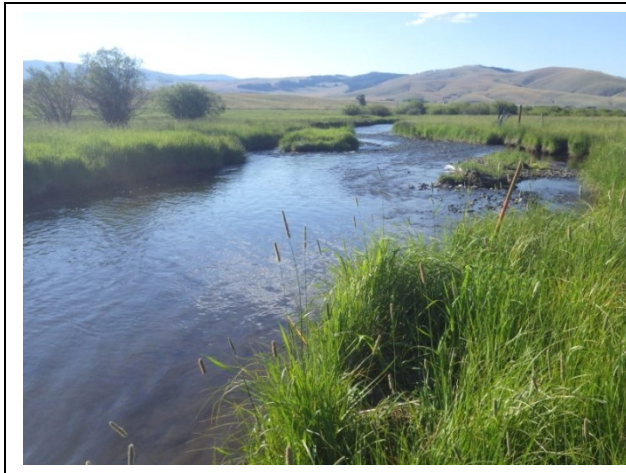
Conditions at upstream end of subreach F12

- Restoring native riparian shrubs to streambanks, which will benefit the hay fields as well as the stream by reducing bank erosion.
- Temporary fencing of the stream belt width to increase existing shrub density where browse is limiting factor
- Active planting of riparian shrubs where grass competition is heavy, beginning with weed fabric or ground cloth to suppress graminoids
- Improve stream meander and floodplain connectivity by removing railroad grade

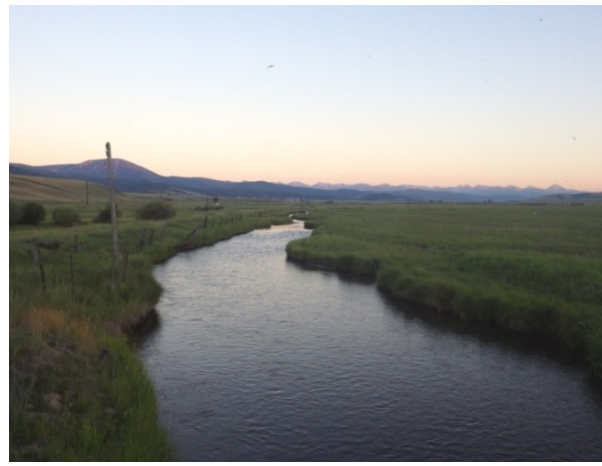
Conditions at downstream end of subreach F12

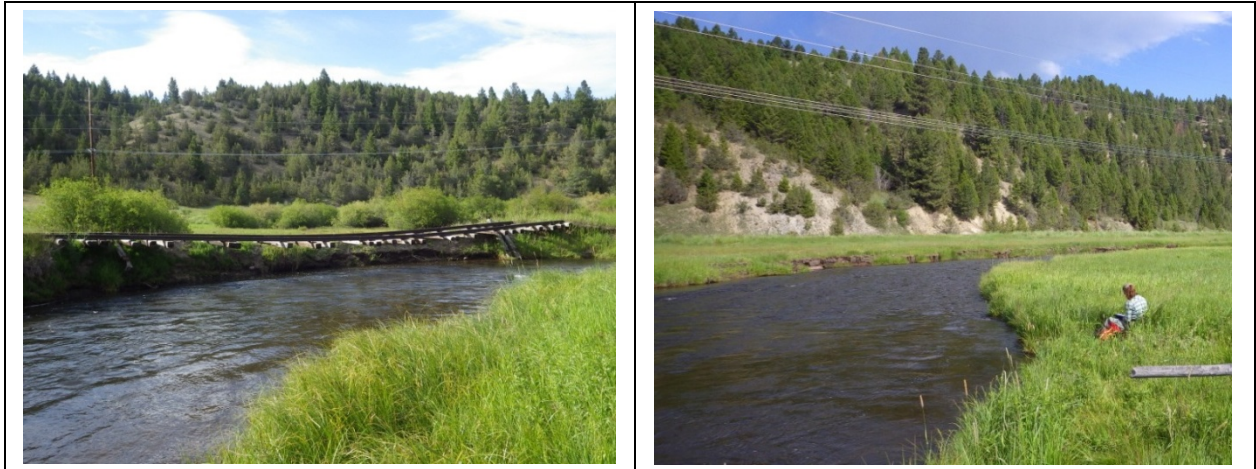
Subreach F15 is a high priority for restoration, depending on landowner participation. At one area of the railroad grade within this subreach the stream has cut almost all of the way through fill placed for the rail road bed and is about seven feet from reconnecting to a historic meander.

Stream has washed out railroad grade and nearly reconnected to historic meander in F15

Erosion on low grass-dominated banks in F15

- Restore hydrologic function and increase channel length by removal of railroad grade
- Riparian shrub planting and browse protection, with weed matting
- Bank fascines and toe-slope willow stakes to stabilize severely eroding banks.

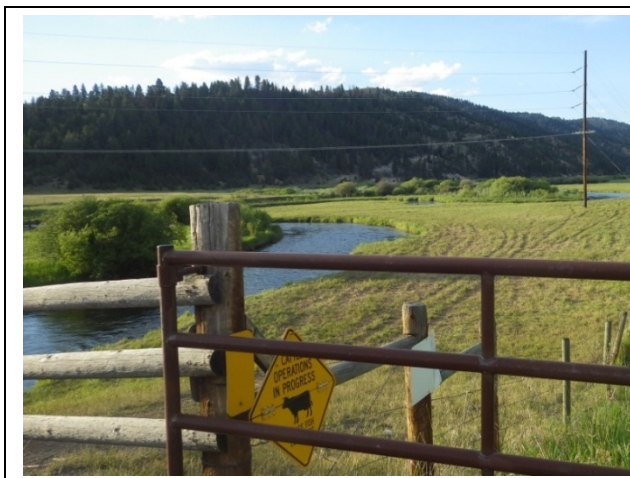
Recently-grazed pasture at upstream end of F16

- Reconnect meanders and restore floodplain connectivity lost by historic railroad grade
- Riparian shrub planting and browse protection, with weed matting
- Bank fascines and toe-slope willow stakes to stabilize severely eroding banks
- Outreach landowner to gauge interest in opportunities to improve water storage and surface flows in Sawmill Creek and other tributaries on the same ownership
- Restoration of wetlands in headwater tributaries with passive restoration techniques to benefit water supply to the creek and agricultural uses.

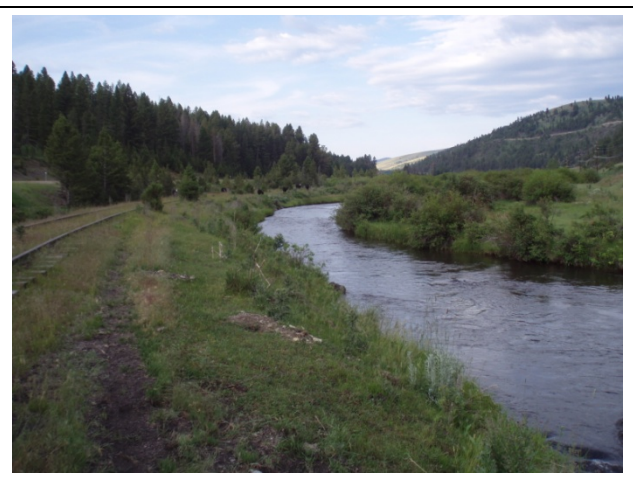
Conditions at downstream end of F16

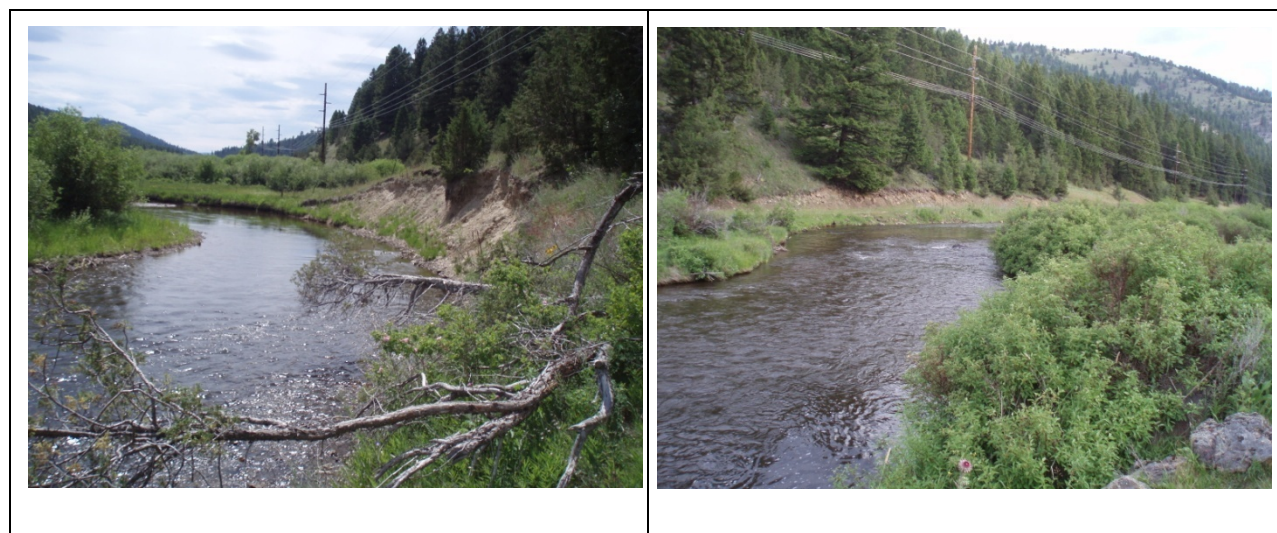
View of downstream character of F17ra

View downstream from top of F17ra

- Riparian shrub planting and browse protection, with weed matting
- Bank fascines and toe-slope willow stakes to stabilize severely eroding banks

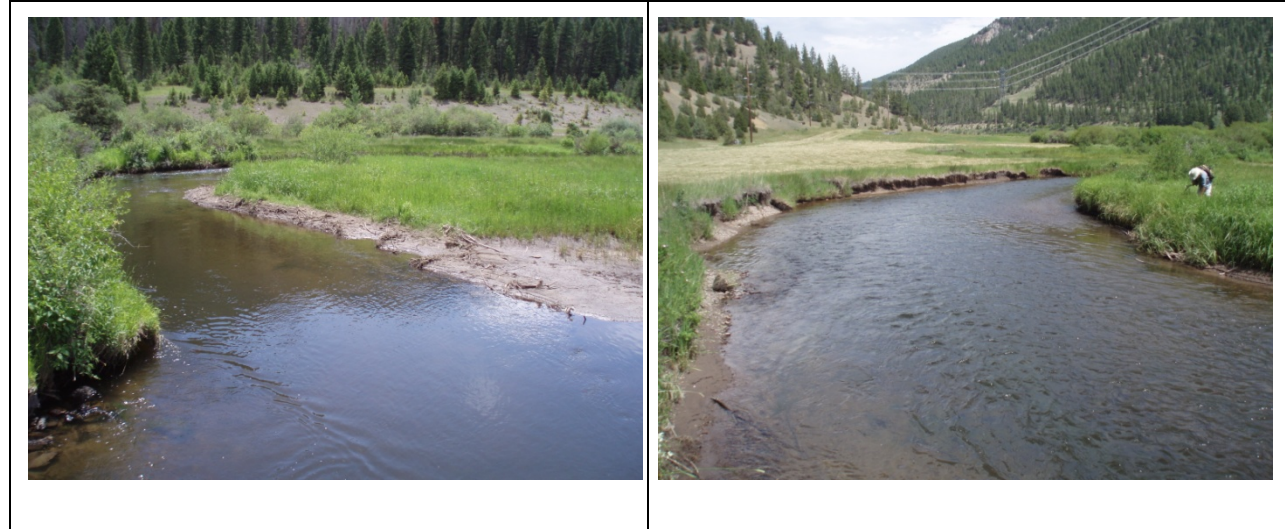
View downstream showing vegetation character on both banks at F17

View downstream of haying activities to streamside and collapsing banks at F17

- Expand woody riparian buffer in grass and hay-dominated areas, likely with fencing and weed matting as needed

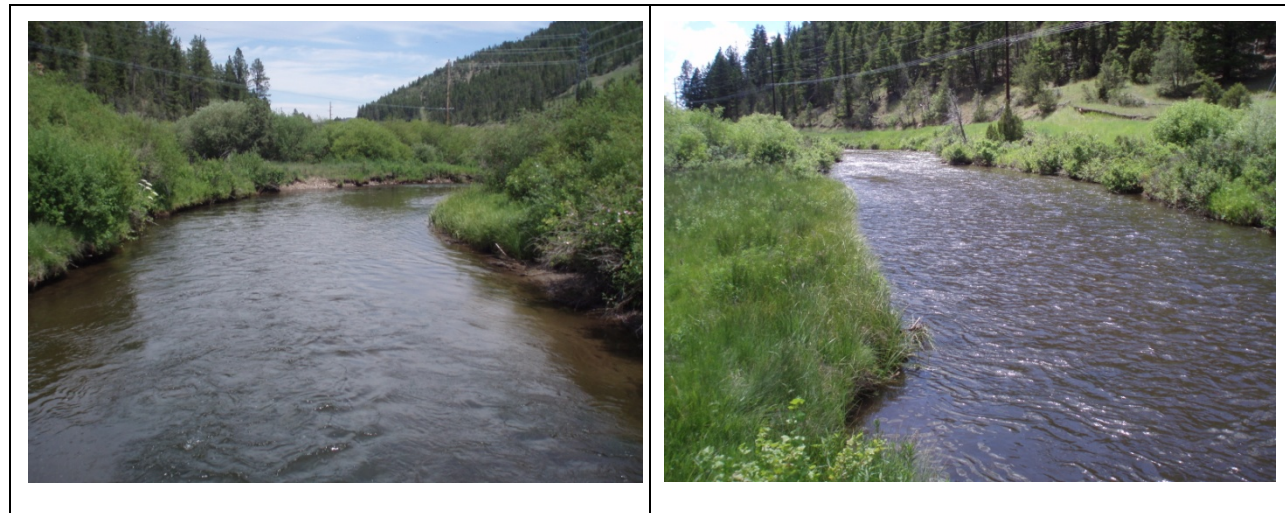
View downstream from top of subreach F18ra

View upstream from bottom of subreach F18ra

- Expand woody riparian buffer in grass and hay-dominated areas, likely with fencing and weed matting as needed
- Reconnect meanders and restore floodplain connectivity lost by historic railroad grade

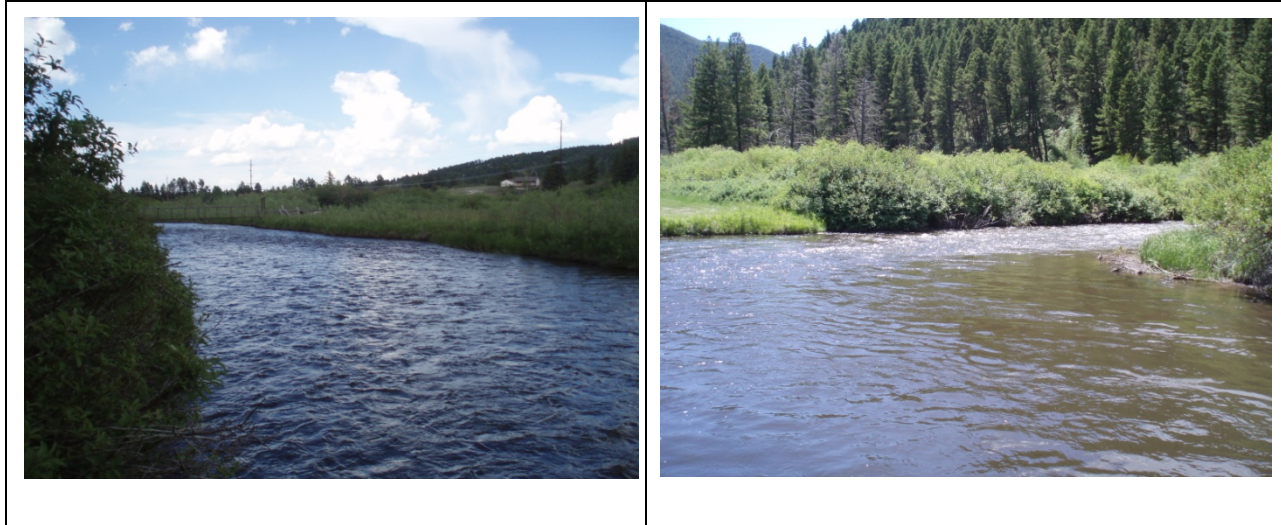
View downstream from top of subreach F19ra

View upstream from downstream end of subreach F19ra

- Connect hydrology on either side of railroad grade where feasible
- Widen riparian buffer in upstream section with plantings and fencing

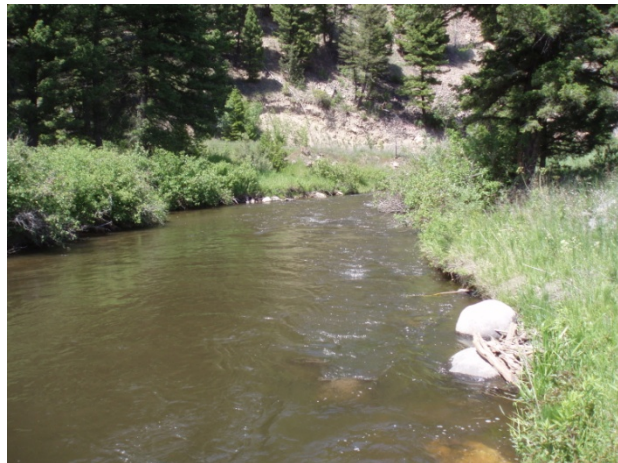
View downstream from top of subreach F19- old
Londonderry mine site in distance

- Conservation
- Mine site remediation (outside scope of this report)

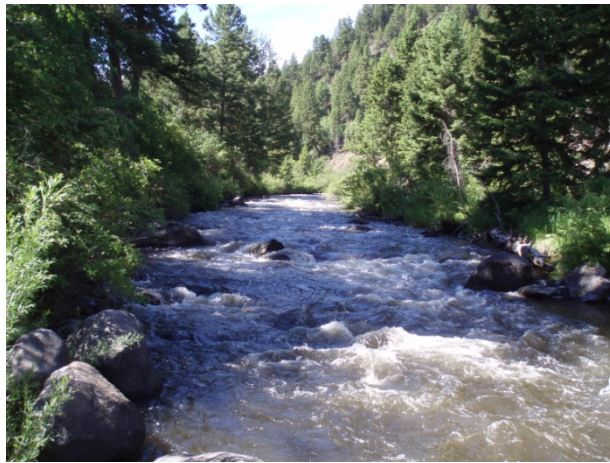
View upstream near confluence with Boulder Creek in
F19

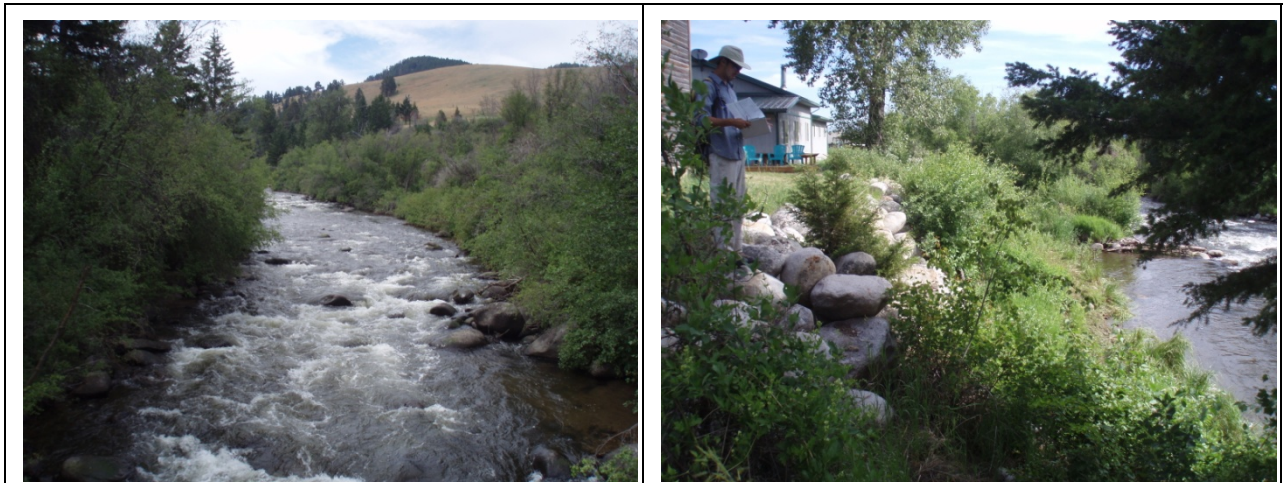
“Prime” trout habitat upstream of diversion in F20

View downstream of rip-rapped banks at vacation property on F20

- Conservation of streamside riparian habitat

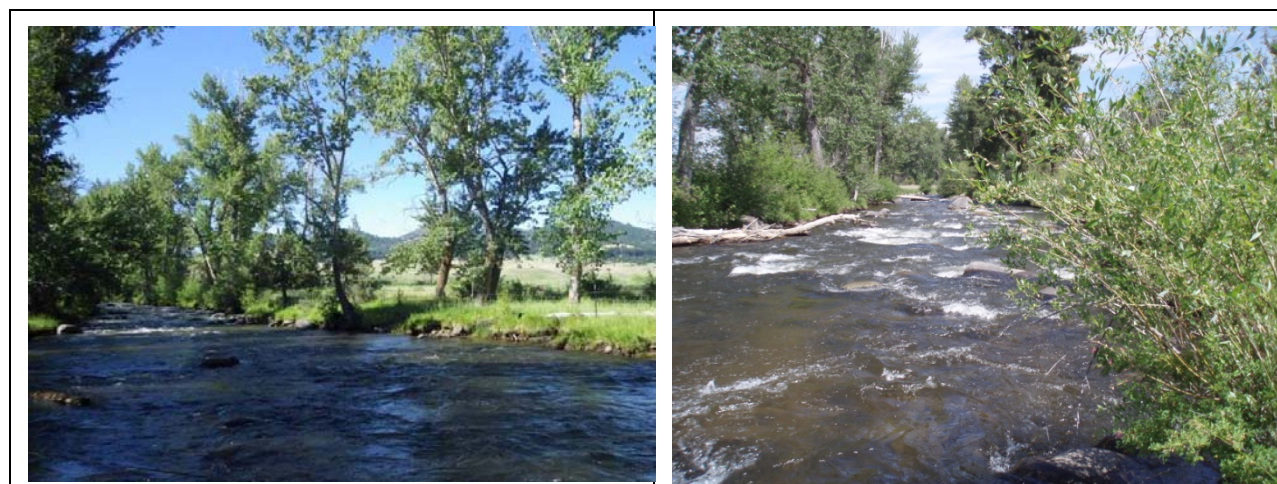
Downstream boundary of subreach F22ra

Typical riparian habitat and some woody debris at upstream end of subreach F22ra

- Conservation of streamside riparian habitat
- Irrigation ditch improvements

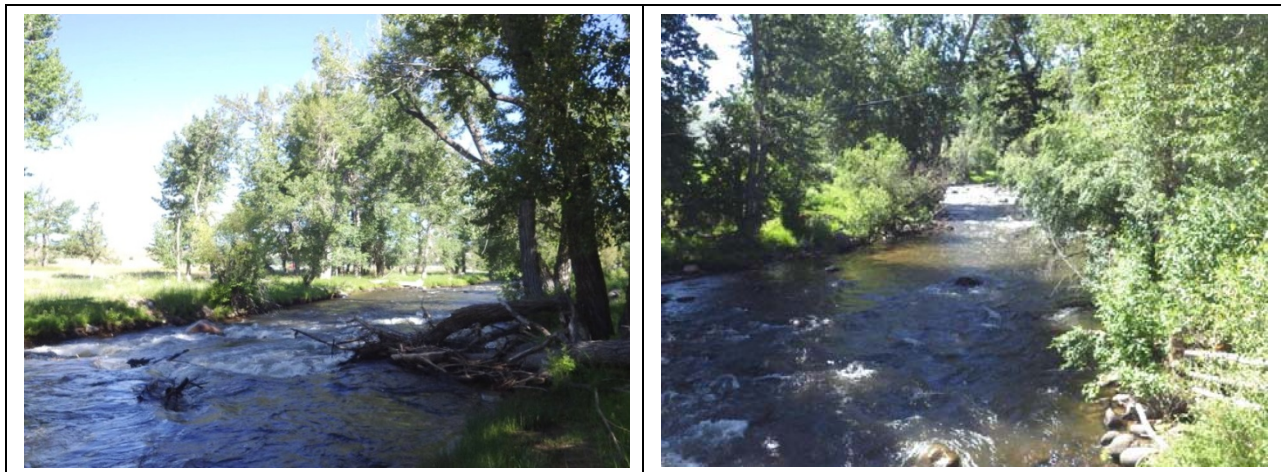
Subreach F22 is a low priority for restoration because habitat is in good condition.

Conditions at upstream end of subreach F22

Conditions at downstream end of F22

- Conservation of streamside riparian habitat

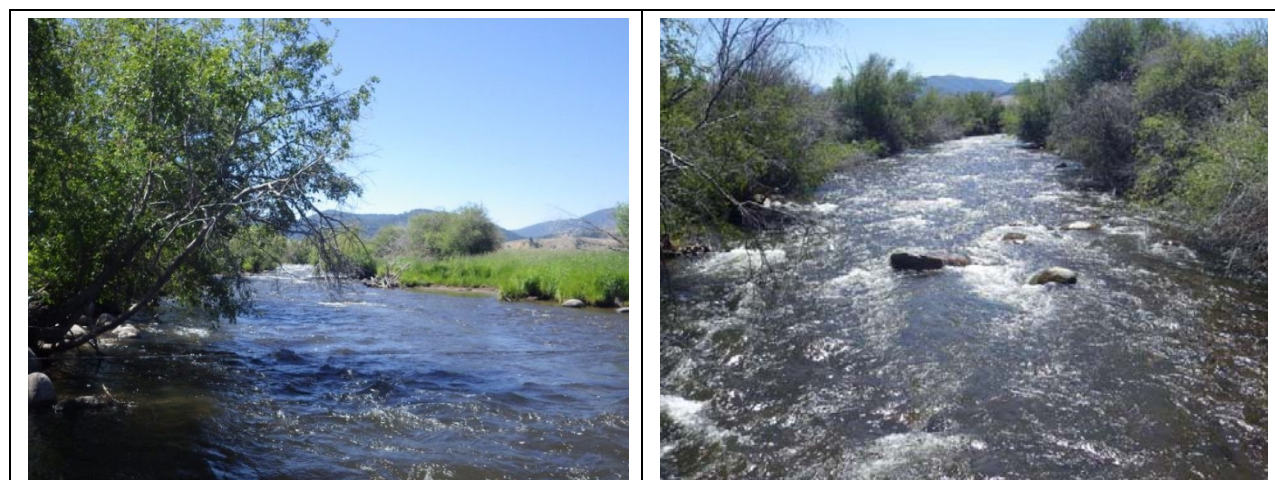
Two properties compose this subreach. The upstream property exhibits more impact from grazing use and a declining trend in riparian condition, with higher cover of grass in the understory compared to the downstream property. The smaller portion of the subreach within the downstream property appears to be in a recovery trend, based on greater diversity and regeneration of shrubs. Banks are sheared by livestock to some extent but are healing and the understory has a greater diversity of riparian forbs and less grass cover.

Subreach F23 is a moderate priority for restoration, and the highest priority subreach within reach 5. Restoration considerations for this subreach include:

Conditions above property boundary within subreach F23

Conditions at downstream end of F23

- Review of grazing management to encourage shrub regeneration
- Install hardened crossings in the downstream half of the reach
- Install browse protection and additional riparian shrubs, particularly in the downstream half of the site.
- Stabilization of high eroding banks only with techniques effective under high energy flows, and which will re-establish riparian shrubs.
- Upgrade irrigation diversion to improve function and habitat value.

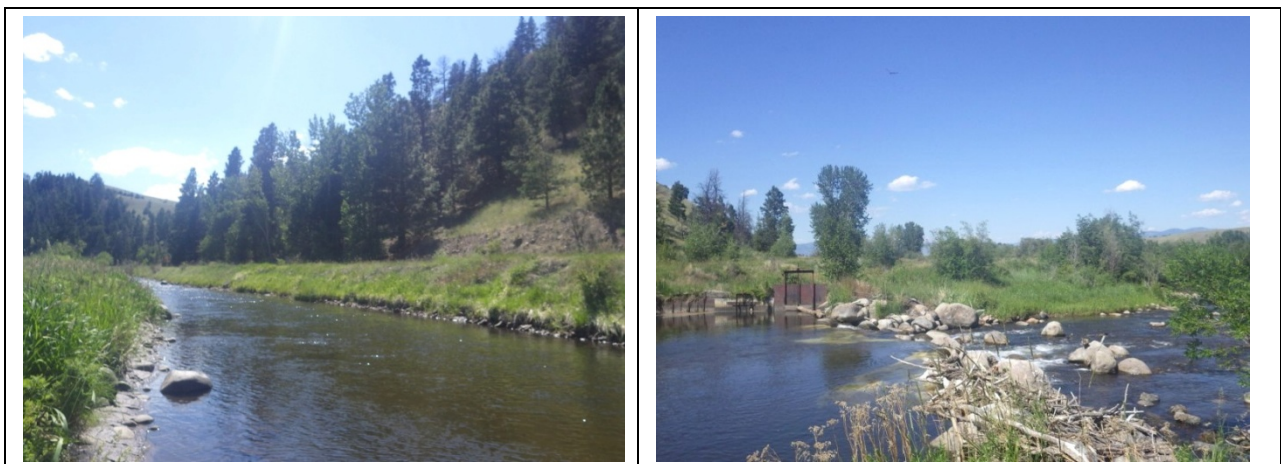
Subreach F-24 is a low priority for restoration, unless water users support upgrading the Allendale diversion to improve fish passage. The potential for restoring natural channel form and dynamics is limited by the irrigation infrastructure. Other restoration would include:

Straightened stretch between diversions in subreach F24

Diversion forming downstream boundary of subreach F24

- Restoring riparian shrubs at discrete sites with eroding banks
- Establish a riparian vegetation buffer where none currently exists along hay fields

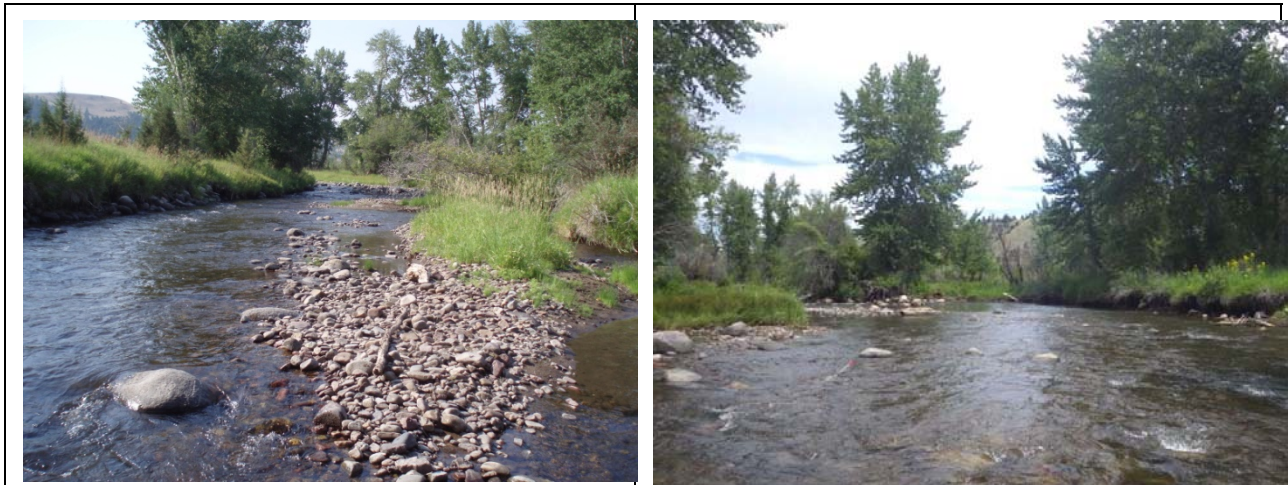
Subreach F26ra is 1,614 feet in length and is located approximately 1,100 feet downstream of the crossing of Highway 1 and Flint Creek upstream of Hall, Montana. This subreach is classified as a C3 Rosgen stream type, with an average slope of 0.8%, a sinuosity of 1.1%, and an estimated width to depth ratio of 17.5. Channel substrate appears to be dominated by cobble, based on examination of aerial photographs and conditions observed from upstream and downstream ends of the subreach. This subreach appears to be entrenched and removed from the original channel, based on presence of a meandering remnant channel still visible in aerial photos. The channel may have been relocated when the highway was built.

This subreach is a moderate priority for restoration. Restoration of this subreach would involve:

View upstream from downstream end of subreach F26ra

Conditions at upstream end of subreach F26ra

- Reconnect original channel as the primary channel to restore sinuosity to Flint Creek; the connection point may best be located upstream of this site, in subreach F-25
- Streambank stabilization using bioengineering techniques
- Riparian shrub planting and protection where streambanks lack them

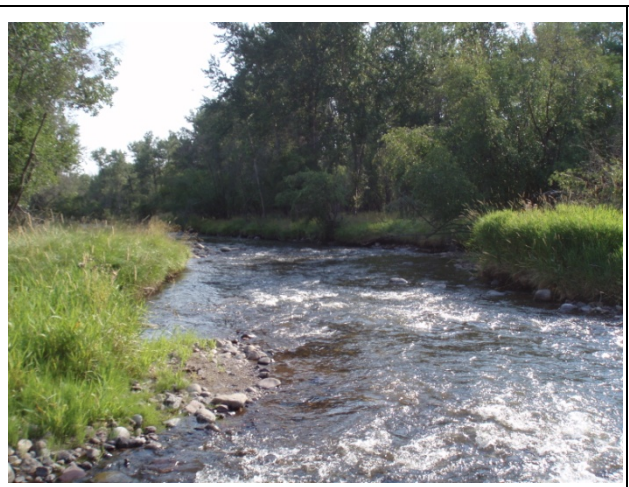
Due to the abundance of streamside grasses, bank erosion rates in this subreach are moderately high. Half of the length of eroding bank was seen in a side channel that, at the time of the survey was flowing, but was dry in late summer aerial images from 2013. Some areas near properties on river right had a smaller riparian buffer and in one location vegetation was entirely pasture grasses. Canopy cover, the narrowed and stable stream in its lower extent and downed woody debris provide good fish habitat conditions in this subreach.

View downstream of typical bank conditions in lower part of F26

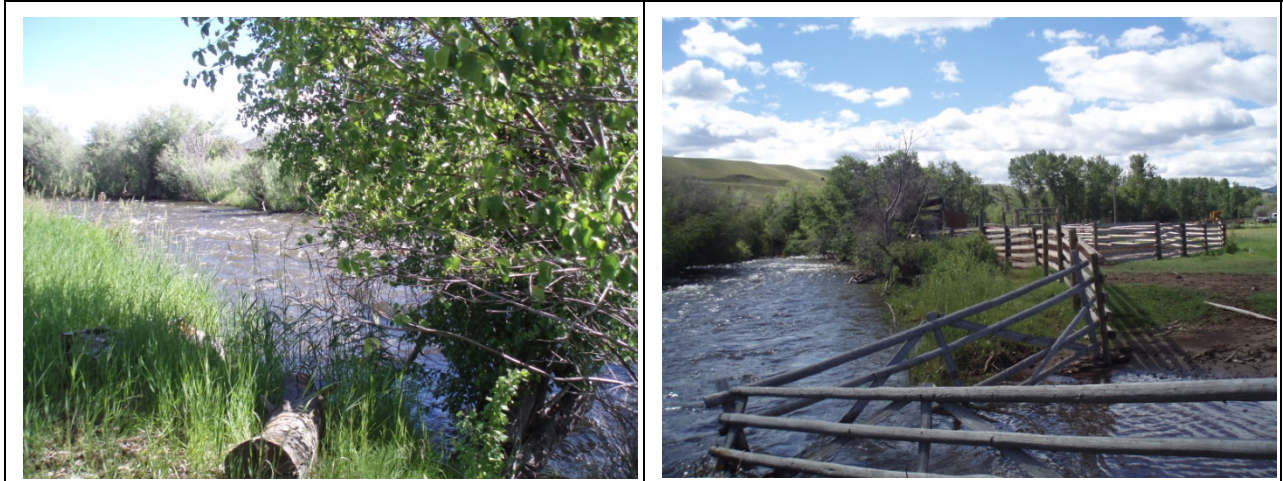
View downstream of typical bank conditions at subreach F27

View upstream near top of reach of corral and watering structure in F27

- Weed matting to suppress reed canary grass followed by riparian planting

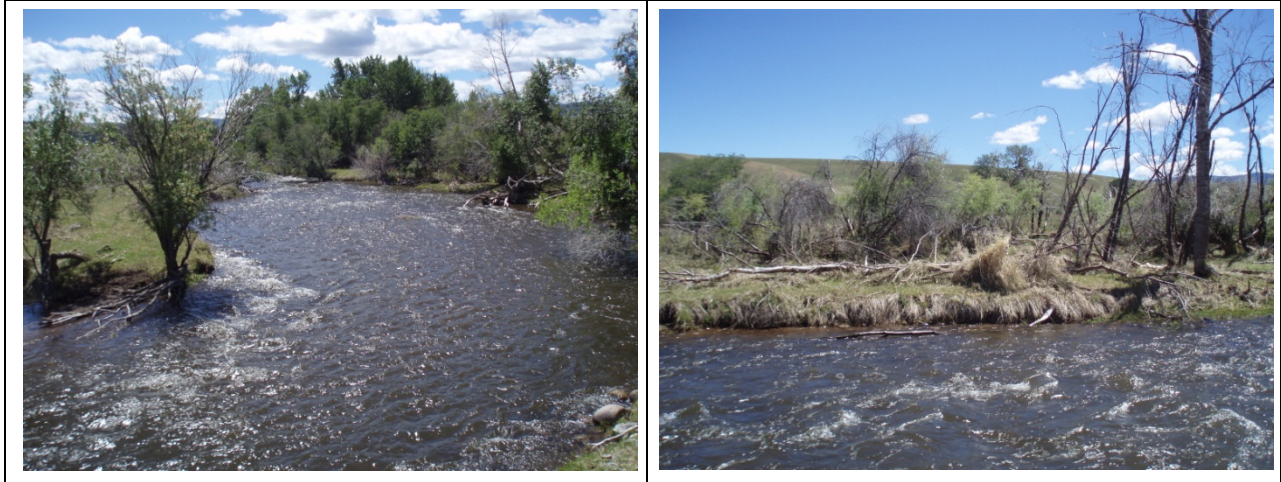
Woody riparian vegetation was found in patches throughout the subreach, primarily consisting of alder, willow and cottonwood. Pasture grasses, including reed canary grass, was found growing vigorously throughout, even under cottonwood stands and other woody species such as alder and willow, river birch and an occasional hawthorne. Riparian fencing installed on both sides of the channel does little to offer prevent browse within the riparian buffer, where stands of cottonwood are mature to decadent and regeneration is stifled by herbivory.

View upstream at typical conditions in subreach F28.

View across channel at decadent stand of cottonwood and grass-covered banks in F28

- Decrease grazing pressure on banks with fencing, grazing management
- Riparian planting and plant protection
- Bank stabilization with fascines

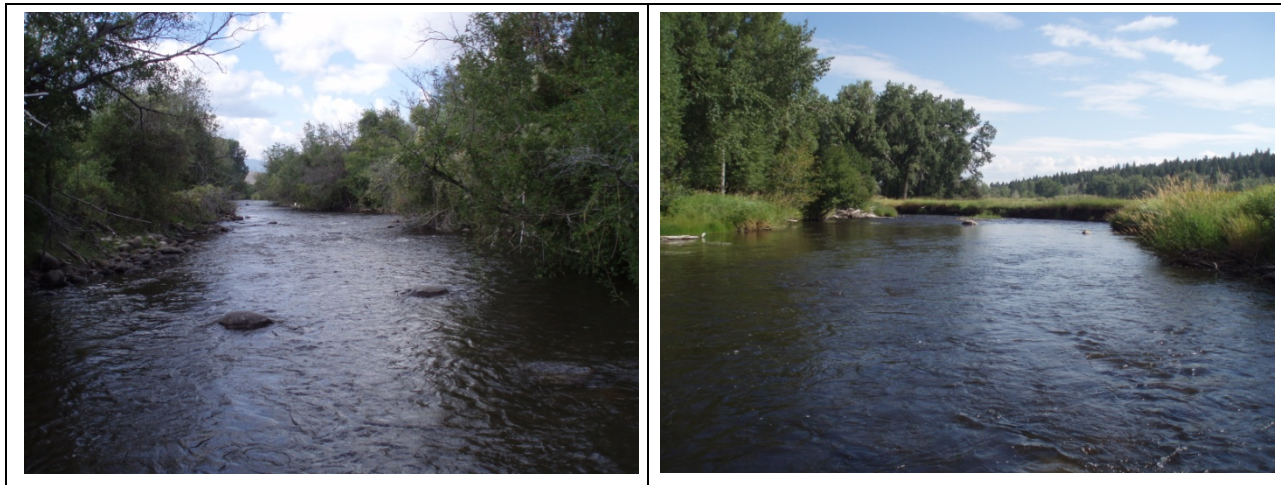
View upstream of typical bank vegetation in lower part of subreach F29

Upper section of subreach F29 where grasses are dominant, unstable vegetation.

- Weed mat and riparian planting with bank stabilization in upper section of reach where grasses are heavy
- Conservation of riparian buffer

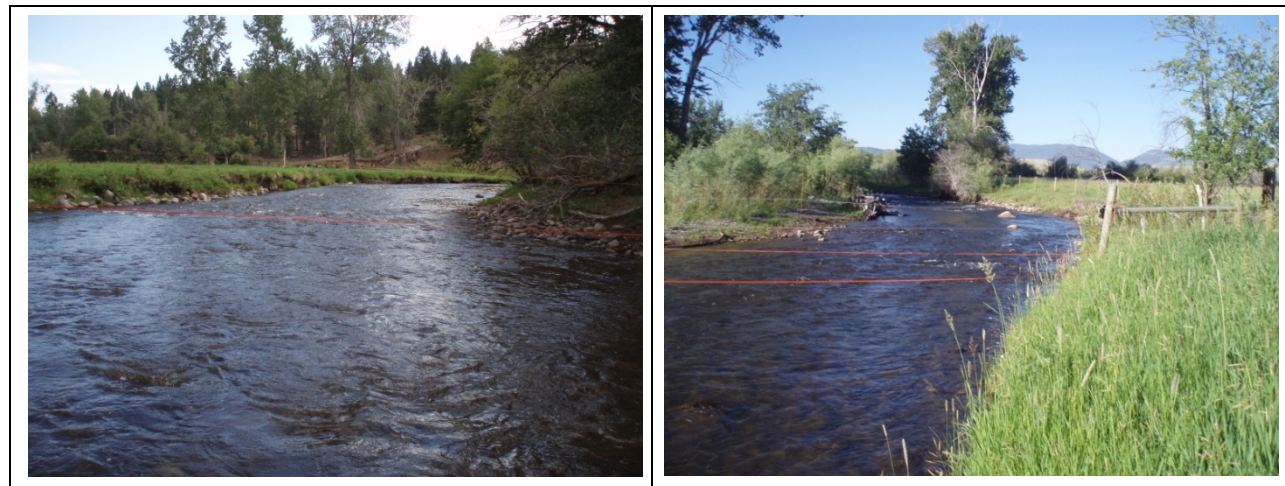
A stream diversion halfway through the reach is located on a side channel and was found to pose little concern for fish passage. The non-lockable headgate may be an entrainment issue.

View downstream into top of reach F30ra

View upstream into bottom of reach F30ra

- Riparian planting, weed matting (for reed canary grass) and plant protection
