Riparian Habitat Assessment for Flint Creek and Boulder Creek Granite County, Montana

Environmental Services Contract #SPB-12-2177V

Task Order 1.28

January, 2015

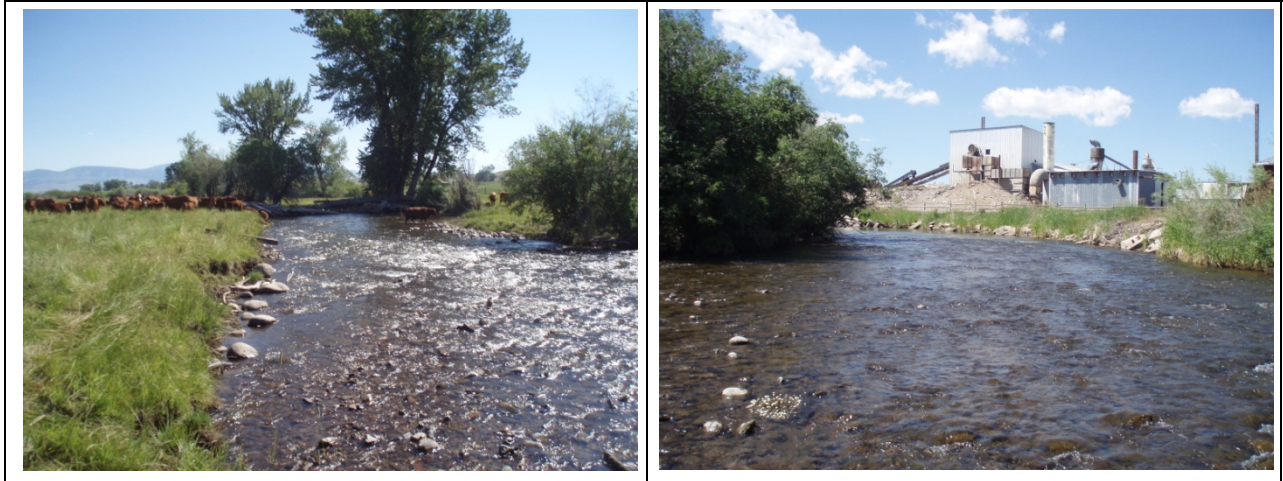
throughout the ownerships and have significant impacts on the riparian vegetative community. The stream has moderate to high levels of lateral bank erosion, particularly on outside meander bends. These conditions have led the stream to be over-widened in many areas, perpetuated by cattle-trampled banks and minimal woody riparian vegetation. Lacking robust vegetation, banks of outside bends were regularly found cleaving off and falling into the stream. Mid-channel bars indicate a stream out of balance with its sediment and in places excessive algae was noted growing in the channel.

Bank vegetation is dominated by escaped pasture grasses, with sporadic clumps of willows and river birch. Rose and hawthorne are also present throughout, an indication of the heavy browse pressure in this subreach. Cottonwood stands are small and far between, comprised primarily of mature individuals with heavy cattle use underneath them. Downstream of these cottonwood stands, piles of woody debris against banks are providing some stabilization as well as improving fish habitat conditions. Fish habitat is otherwise fair throughout this subreach, with a noticeable lack of overhanging vegetation and deep pool habitat.

Two irrigation diversions were found in this subreach. The uppermost diversion was closed and determined to be old, but still leaking water and likely posing an entrainment problem. The lower diversion, also showing its age was determined to be a high risk for entrainment.

Heavy cattle use area in F31

View upstream near lumber operation and rip-rapped banks in F31

- Riparian fencing or fencing of cottonwood and willow stands to promote regeneration
- Grazing management including off-site water, decreased intensity on riparian areas
- Fish screens or removal of diversions

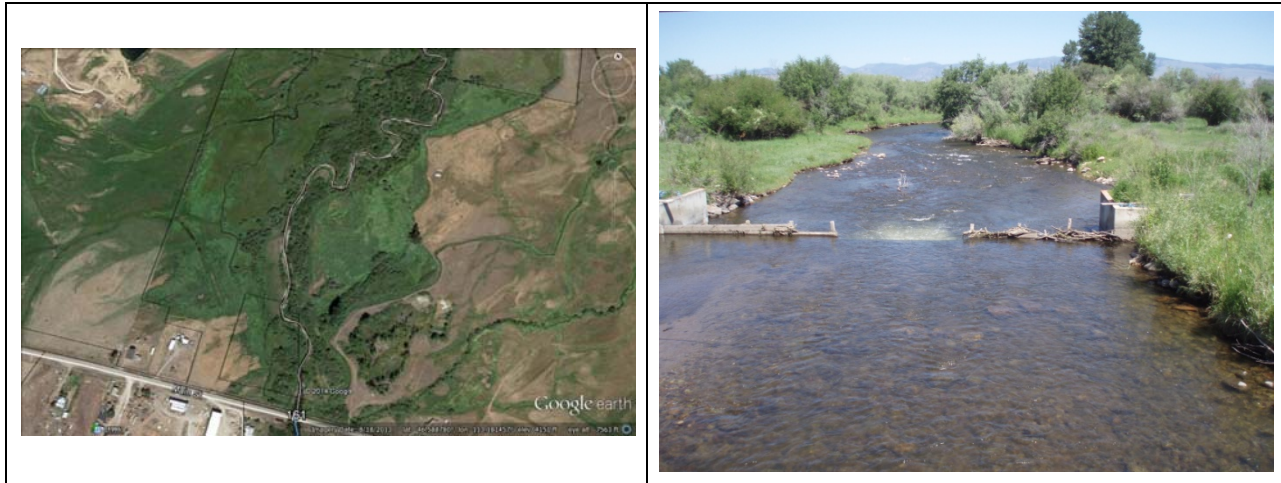
Aerial view of subreach F32ra-1

View downstream from top of reach showing dense riparian vegetation in F32ra-1

- Conservation/Preservation of existing riparian vegetation (easement?)
- Improve fish passage at diversion

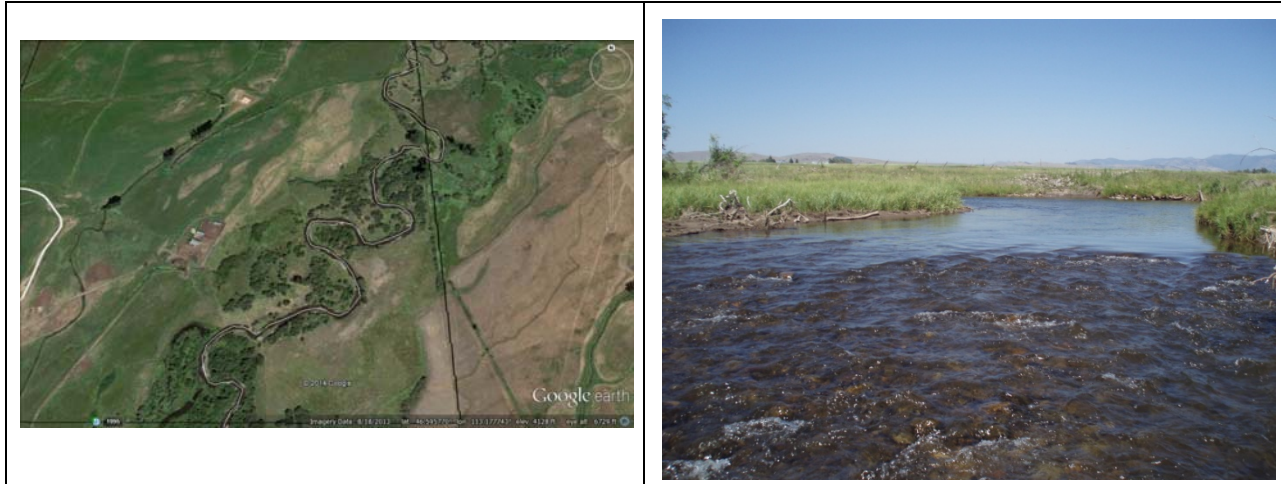
The stream here appears to be out of balance with its sediment supply, with large point bar formation visible and some mid-channel bars present. The subreach is likely over-widened in places and pool habitat conditions are assumed to be slightly to moderately impacted (i.e. shallow).

Aerial view of subreach F32ra-2

View upstream from downstream end of F32ra-2

- Offsite water by corrals
- Riparian fencing and planting (particularly river right)
- Grazing management

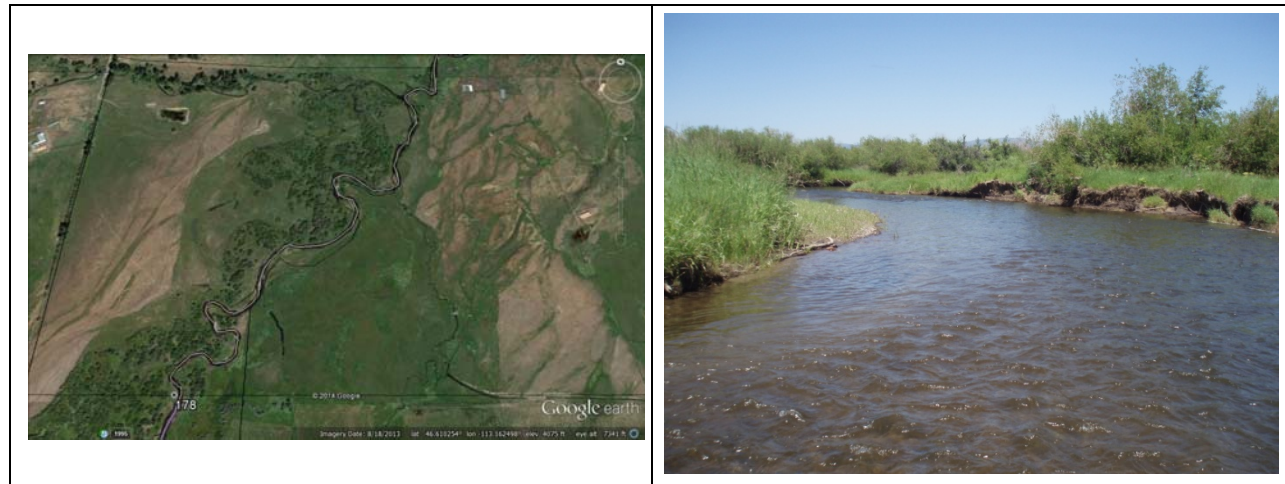
Aerial image of subreach F33ra-1

View downstream from top of subreach F33ra-1 showing typical riparian vegetation and bank condition

- Riparian planting and plant protection
- Bank stabilization on active bank erosion

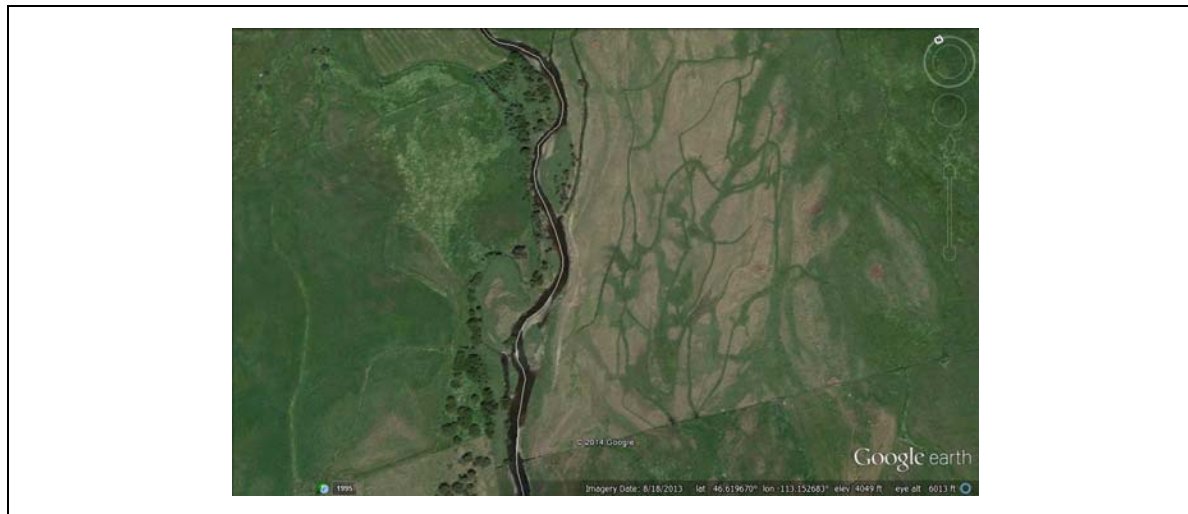
The reach appears to be in a moderately stable condition in regards to its sediment load, with regularly spaced meander intervals and noticeable point bar formation, although older overflow channels and oxbows have been cut off from the stream.

There are two irrigation diversions in the reach, neither of which pose a barrier to fish passage, although one was noted as a potential risk for entrainment. The fish passage and entrainment study also confirms observations made from aerial interpretation, that streambanks on river right have very little riparian vegetation with deep, binding root mass, with estimates that less than 65% of banks for the whole stream contain adequate riparian vegetation. Grazing activities and bank erosion are significant impairments to the stream.

Aerial image of subreach F33ra-2

- Riparian planting and buffer expansion
- Mitigate entrainment risk at diversions

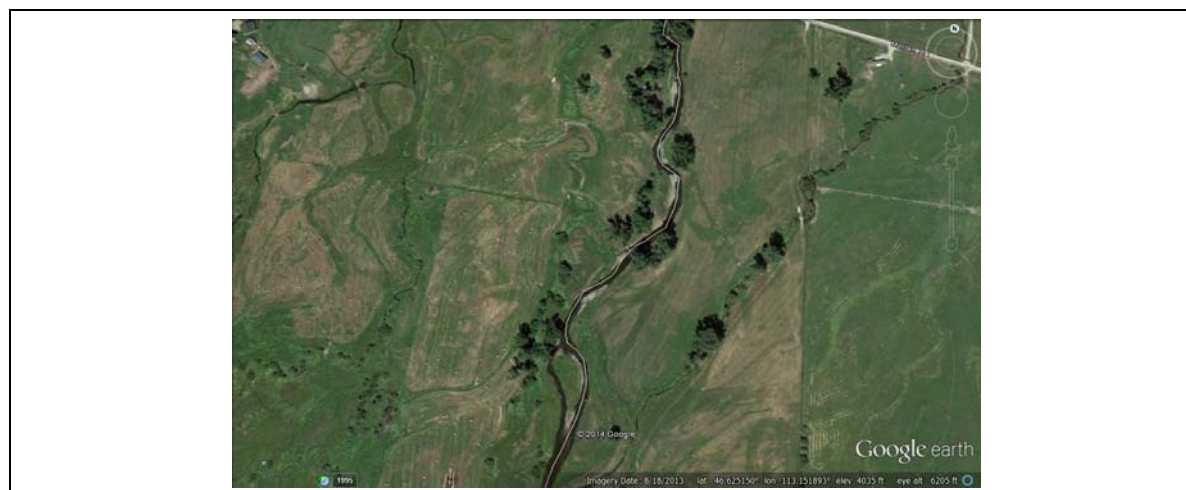
Aerial image of subreach F33ra-3

- Riparian planting and buffer expansion
- Mitigate entrainment risk at diversions

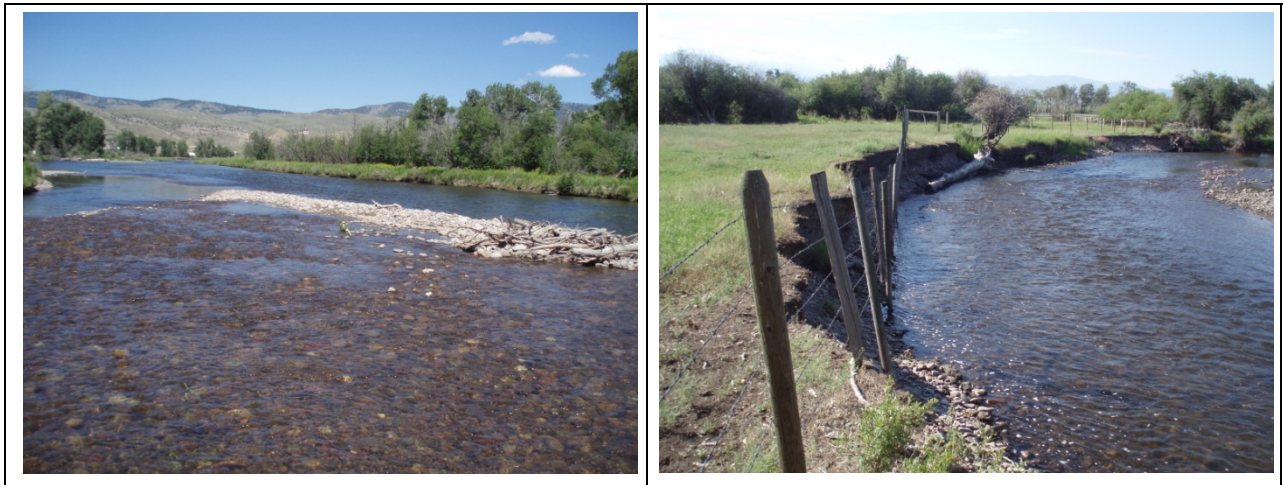
This reach flows entirely through agricultural lands, and much of the riparian area shows significant impacts from cattle grazing. Bank vegetation is dominated by pasture grasses with very low density of vegetation with deep binding root mass. Some of the highest abundance and diversity of weed species in the whole stream were found in this reach. Existing cottonwood stands tend to be outside of the immediate riparian area, although one point bar was entirely covered by cottonwood seedlings. In several stretches of the stream an abundance of aquatic vascular plants and algae indicate likely water quality impairments.

In several locations along the lower and mid sections of the subreach, earthen and rock berms were installed by the landowner, straightening the stream in places and limiting the stream's access to its large floodplain. According to the landowner's son, ice scour is a concern and cause of bank erosion in this subreach.

View downstream at confluence of F33 and Clark Fork River

View downstream of typical eroding outside bend and grass-dominated riparian vegetation in F33

- Grazing management off stream
- Riparian fencing and revegetation
- Bioengineering structures on outside meander bends
- Assessment and mitigation of streamside berms for floodplain connectivity

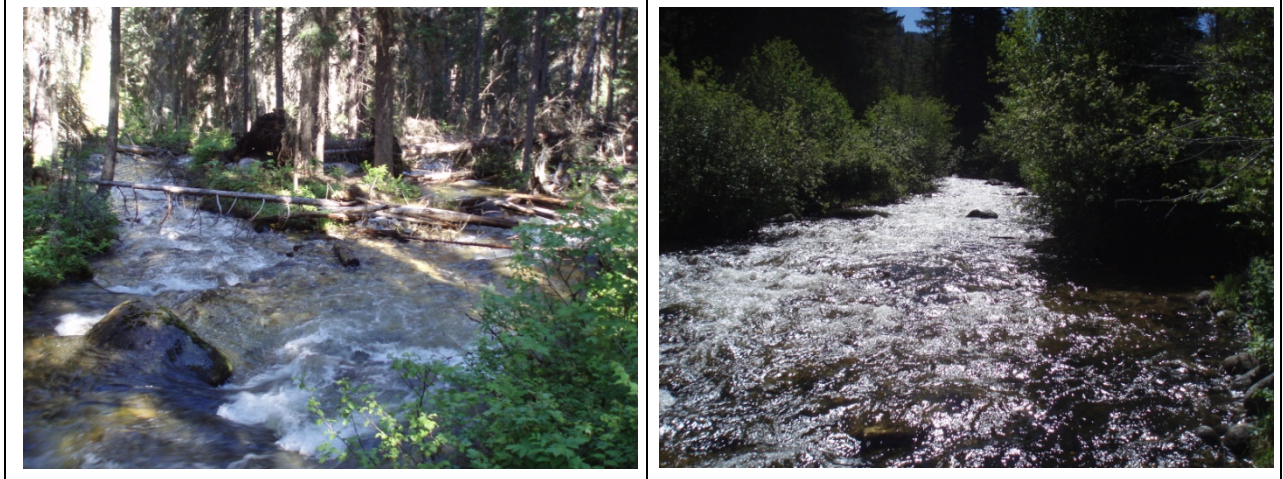
View downstream at confluence with Copper Creek
in B02

Bank vegetation in lower extent of B02

- Mitigate sediment delivery from Royal Gold culvert and bridge crossing at ATV trail

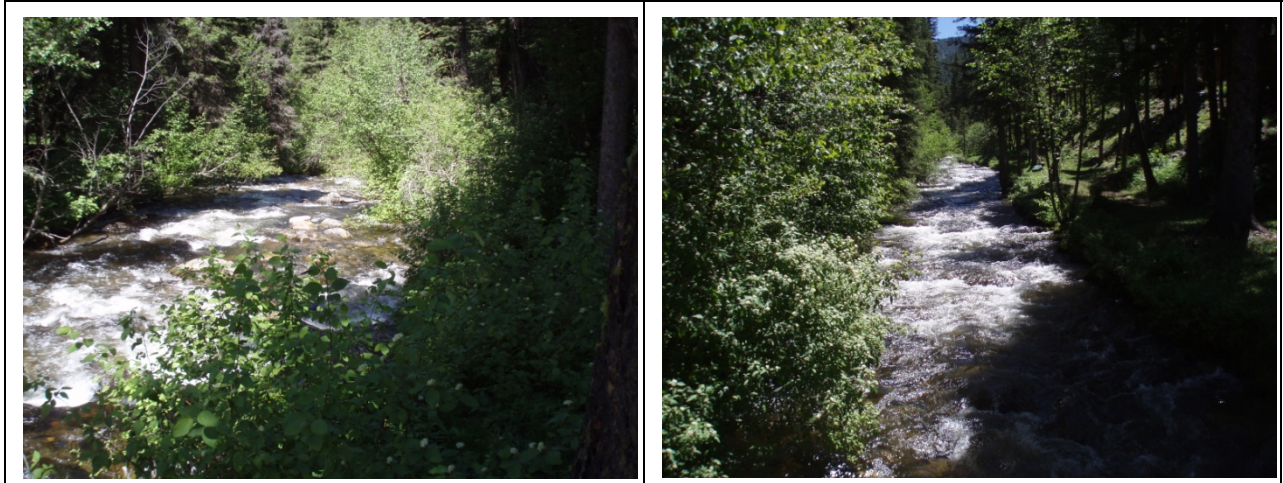
This subreach was given a low restoration potential. Actions on this short stretch could only include:

Dense riparian vegetation in B03

Boulder Creek on private property with some vegetation removal on river left in B03

- Planting riparian shrubs and trees where they were removed

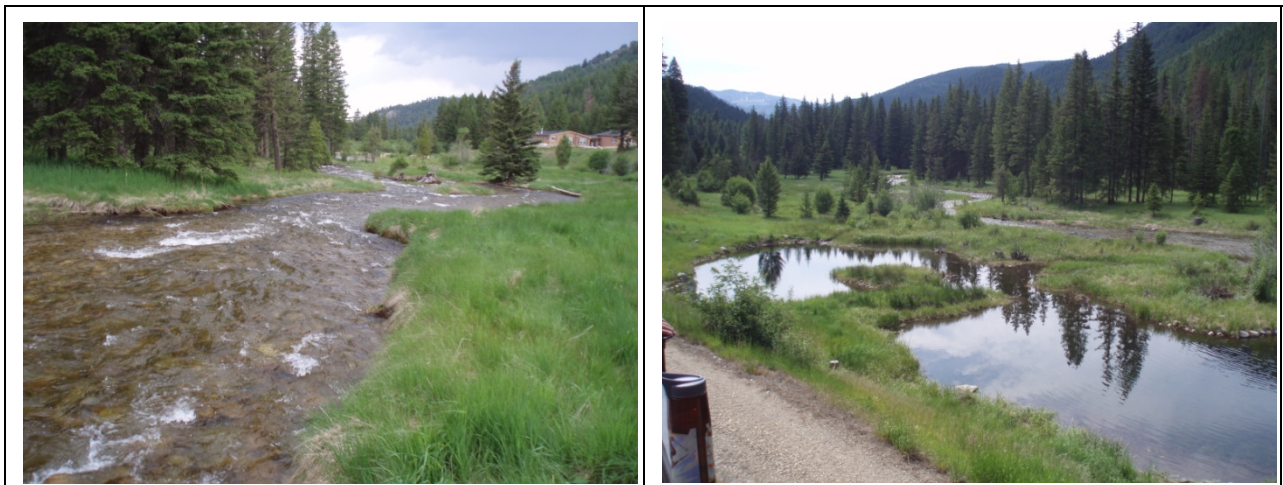
This subreach is given a very high priority for restoration. A project here could not only address the new hydrologic challenges posed by 2011 flooding, but could enhance the water-holding and sediment retaining functions of the wetland complex downstream of the pond structure. A project could be designed that would:

Boulder Creek in its new channel near top of subreach B04

View from landowner property of new stream channel and pond in B04

- Stabilize new channel banks by planting and protecting riparian vegetation (this would likely include weed matting and appropriate bioengineering techniques on banks)
- Engineer pond hydrology to allow overflow into side channels and wetlands downstream
- Assess bridge crossing and mitigate channel constriction where necessary

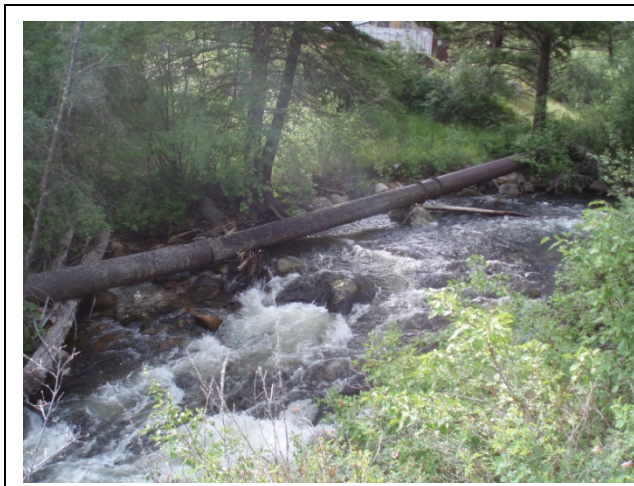
Old pipe suspended over stream runs along banks throughout reach in B09

- Widening of riparian buffer by planting shrubs/trees on river right on private ownerships where vegetation was removed.

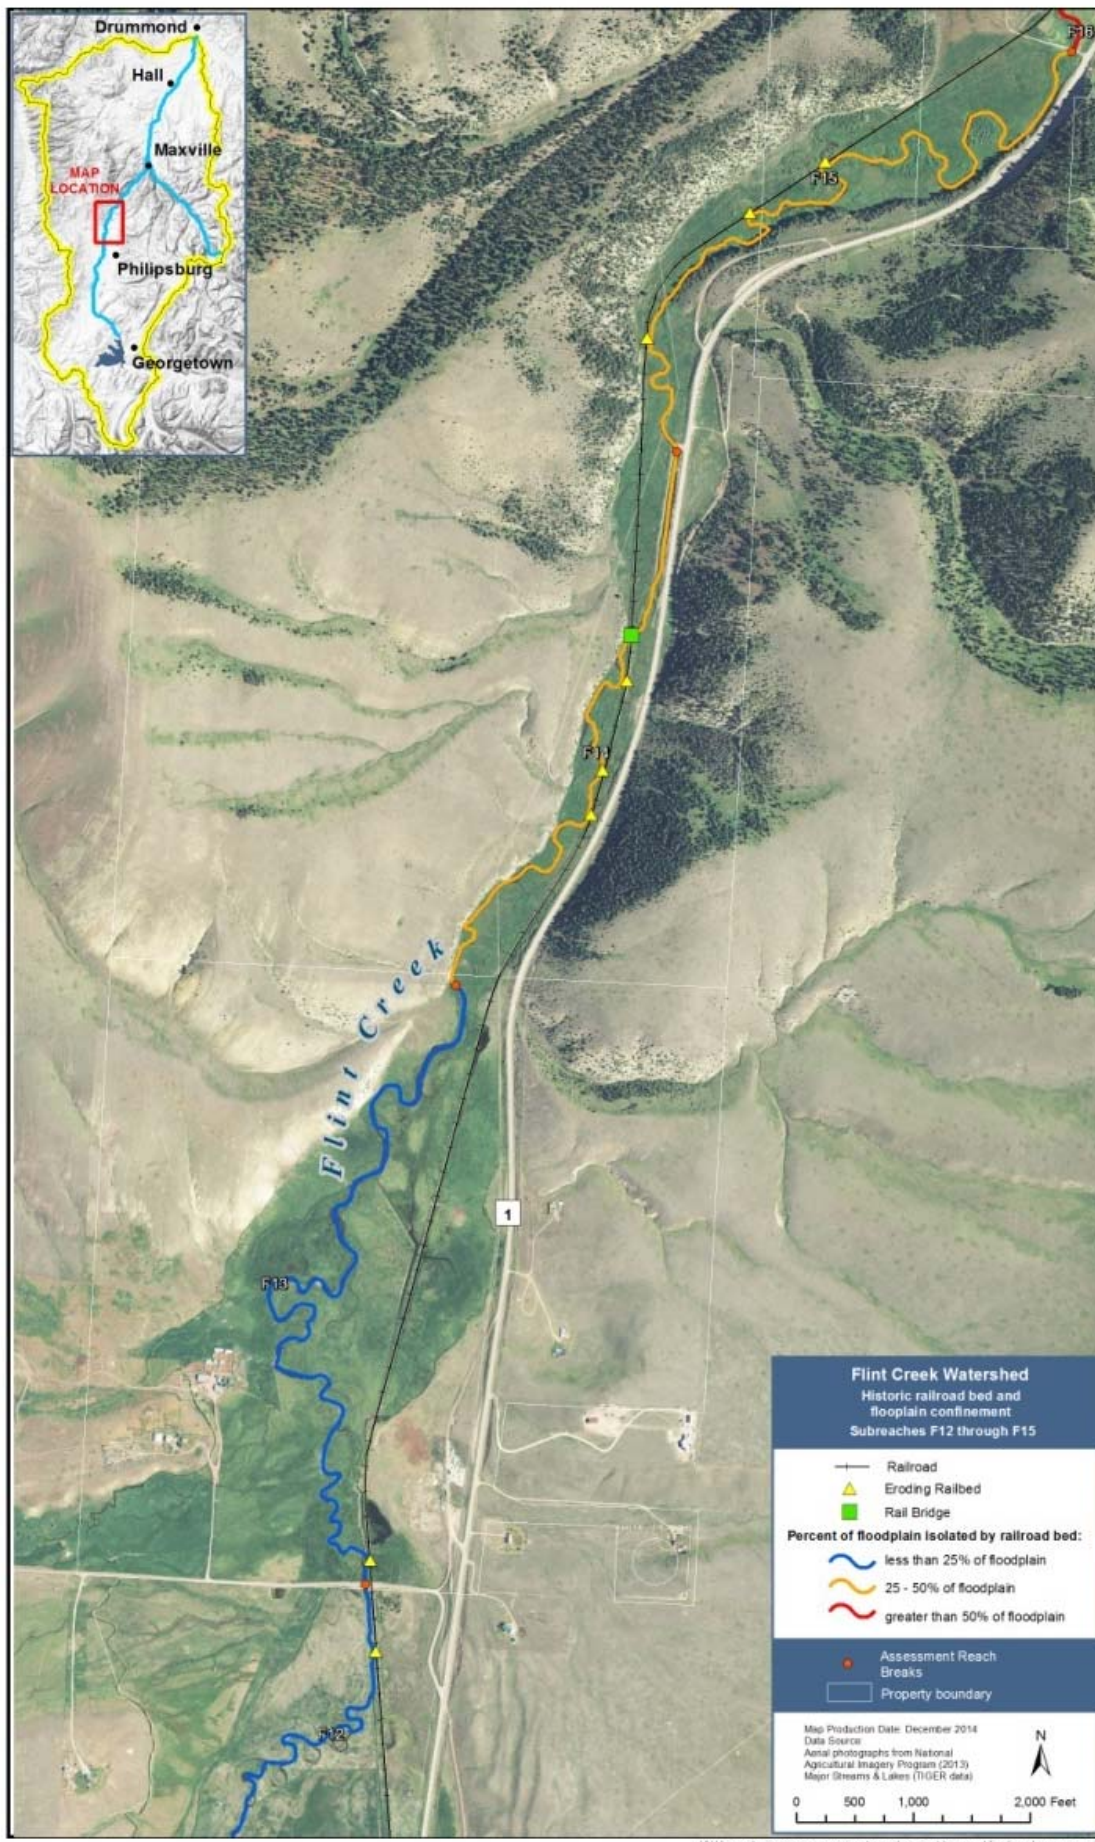
Figure 17. Railroad constriction of stream between F12 – F15

Addressing floodplain constriction by the historic railroad grade is one of the most important restoration actions to improve habitat and natural process functioning on Flint Creek. Addressing the influence of the railroad grade also will be one of the most complex restoration efforts, as it will require a high level of outreach, coordination, and planning. It is unrealistic to assume that removal of the railroad bed can be initiated as one of the first- tier restoration actions, but starting the initial outreach and scoping to define alternatives is recommended as high priority.

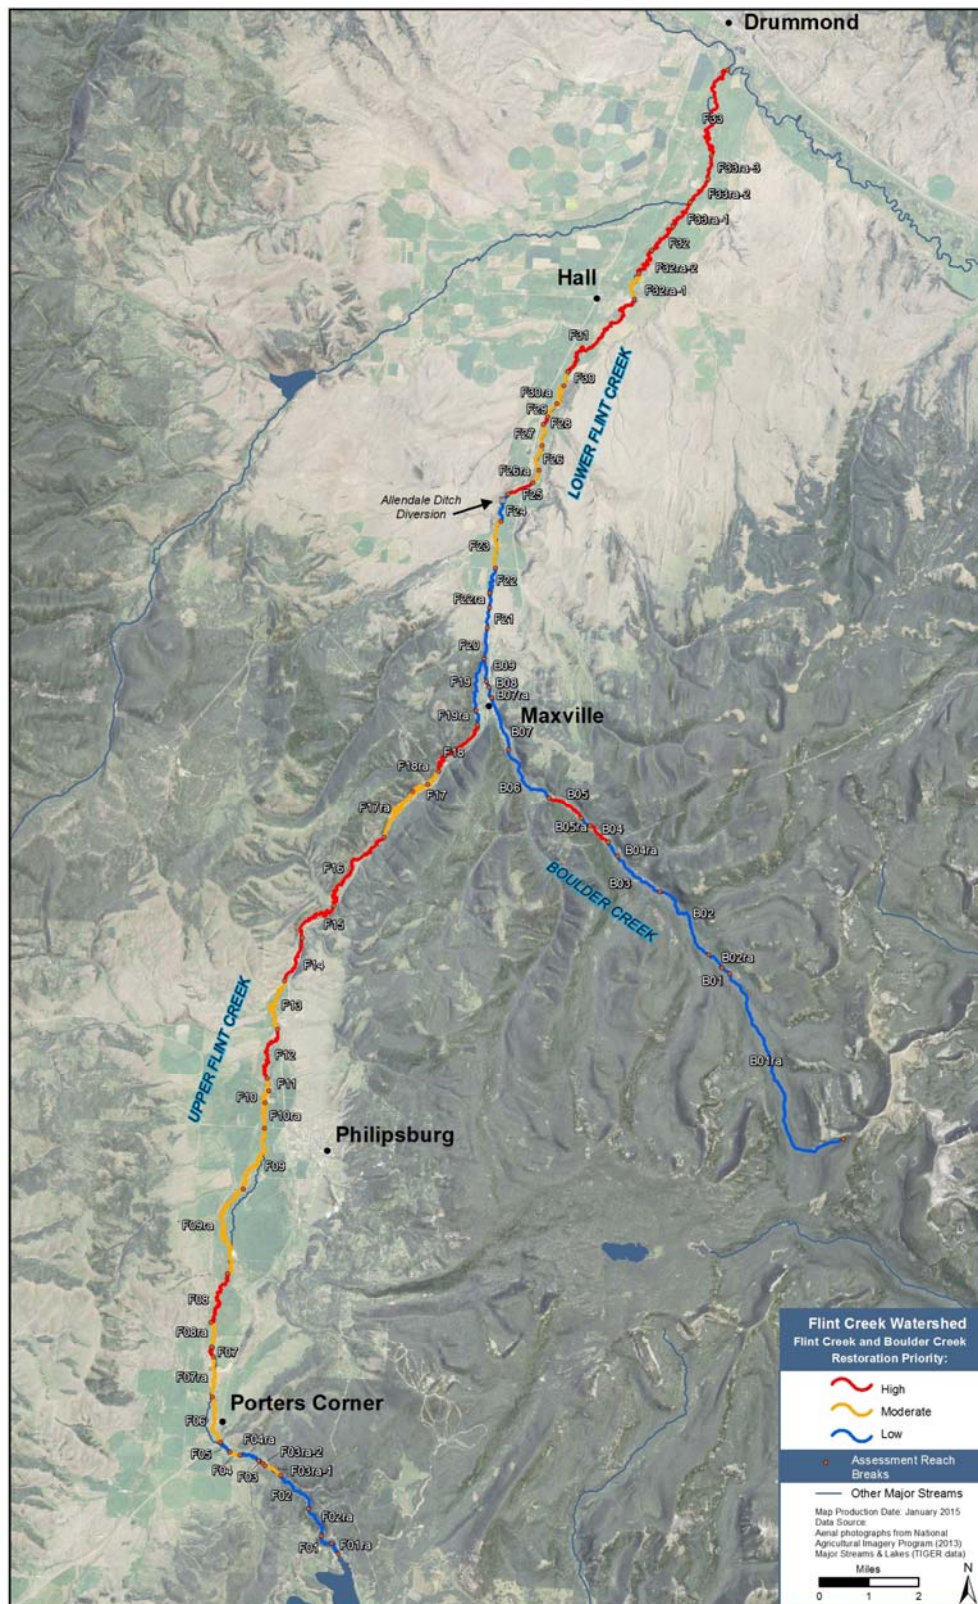
Figure 20. Project Priority Rankings for Flint and Boulder Creeks

Figures 20 and 21 below show priority rankings for all of Flint Creek and Boulder Creek respectively.
