Conceptual Restoration Plan for the Upper Blackfoot Mining Complex

Restoration of the Stream and Floodplain Ecosystem

February 2011

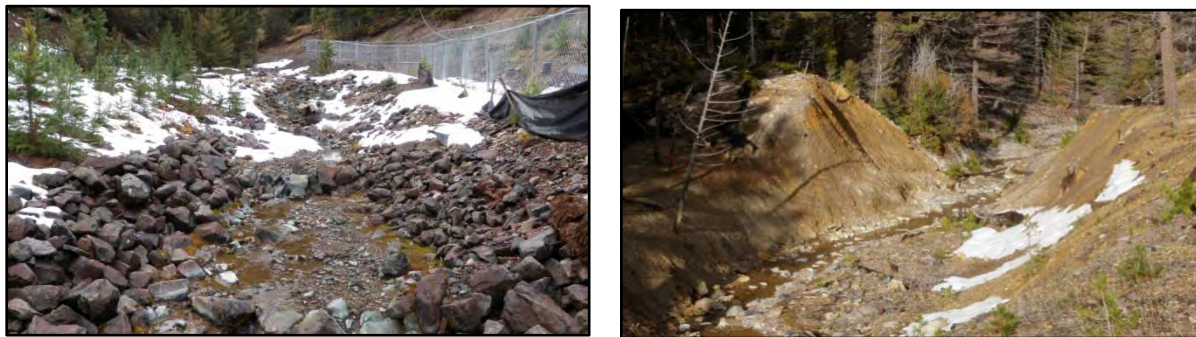
Figure 2-1. Existing valley and channel conditions in Reach 1 Mike Horse Creek. The upper reach (left photo) has been extensively armored and stabilized with rock. Downstream of Mike Horse Road, the channel is highly unstable and characterized by mass wasting features that contribute large volumes of sediment to the channel network (right photo).

Upstream of the main crossing of Mike Horse Road in Reach 1, the channel has been highly manipulated by past channel stabilization efforts that included lining the channel with angular cobble-size material and installing rock check dams. Bank erosion, fine sediment deposition, and pool filling are common characteristics due to the increased supply of sediment and altered channel morphology. Throughout Reach 1, past mining activities have resulted in loss of riparian and streambank vegetation and hillslope surface erosion. Downstream of the Mike Horse Road crossing to the confluence with Reach 2 Upper Beartrap Creek, Mike Horse Creek is deeply incised with frequent hillslope failures, unstable channel obstructions, and high bank erodibility conditions. Figure 2-1 depicts the existing conditions of the channel and valley in Reach 1.

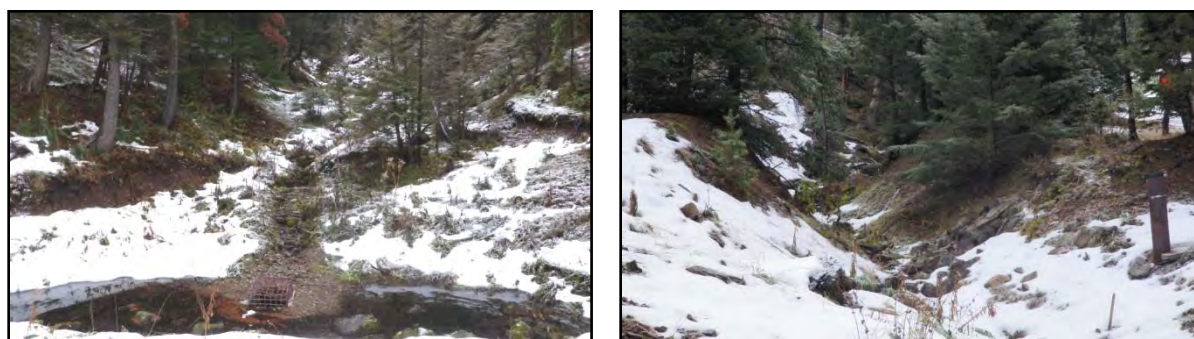
Figure 2-2. Desired valley and channel conditions in Reach 1 Upper Mike Horse Creek. Well-vegetated, narrow riparian areas are dominated by conifers with some shrubs in the understory.

A narrow riparian area and floodplain would occupy the full valley bottom width and transition to an upland conifer forest with little exposed soil. The riparian plant community would be dominated by conifers, including subalpine fir, Douglas-fir and lodgepole pine. A narrow band of riparian shrubs would be present along the streambanks. Figure 2-2 illustrates this desired condition.

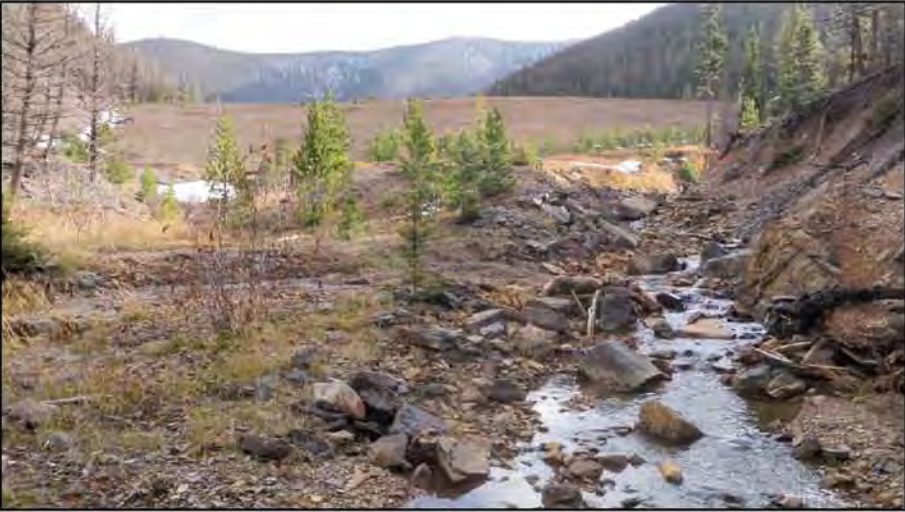
Figure 2-3. Example restoration treatments that may be applicable to Reach 1.

The Reach 1 existing condition (A), and desired future condition (B).

Three revegetation zones would be included within Reach 1 (Figure 2-3): 1) a riparian shrub zone, 2) a riparian conifer zone, and 3) an upland conifer zone. The riparian shrub zone would occupy approximately a narrow band along the length of each bank at elevations between bankfull and approximately one foot above bankfull. While over the long-term this area would ultimately be colonized by conifers, a disturbed site with high available light and nutrients would typically be initially colonized by shrubs. A riparian conifer zone would occupy the next band further from the stream, between approximately one to four feet above bankfull. An upland conifer zone would occupy higher elevation areas where the floodplain ties into existing upland vegetation. The upland conifer zone may include areas where infrastructure such as roads and portions of the inactive water treatment facility are removed. These revegetation zones are described in more detail in Section 3.

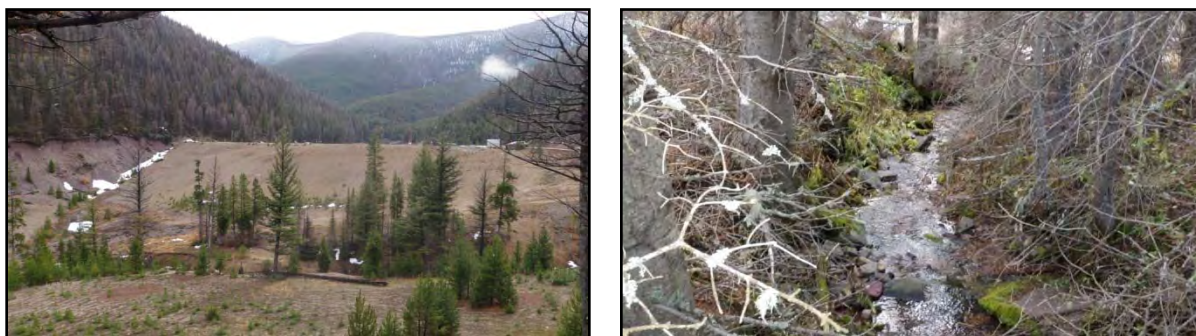
Figure 2-4. The Mike Horse Tailings Impoundment and associated mining activities have altered the natural landscape and valley morphology of Upper Beartrap Creek (left photo). Upstream of the impoundment, Beartrap Creek has a stable, riffle-pool channel with stable streambanks and a well-vegetated floodplain and riparian corridor.

Reach 2, Upper Beartrap Creek, has been directly impacted by the Mike Horse Tailings Impoundment. Presently, surface water is routed into a lined diversion canal at the transition from the natural Beartrap Creek channel to the impoundment reservoir. Flow is routed through a collection facility and discharged to Beartrap Creek through a 36-inch pipe at the toe of the embankment. Upstream of the impoundment and reservoir influence, Beartrap Creek is characterized as a gravel and small cobble dominated B stream type with moderate entrenchment, riffle-pool bedforms, and a relatively narrow, forested riparian zone comprised of willow, alder, spruce and cottonwood. Similar to Reach 1, the stream is formed in a narrow, structurally controlled valley. Glacial terraces bracket the channel and limit floodplain development (Figure 2-4).

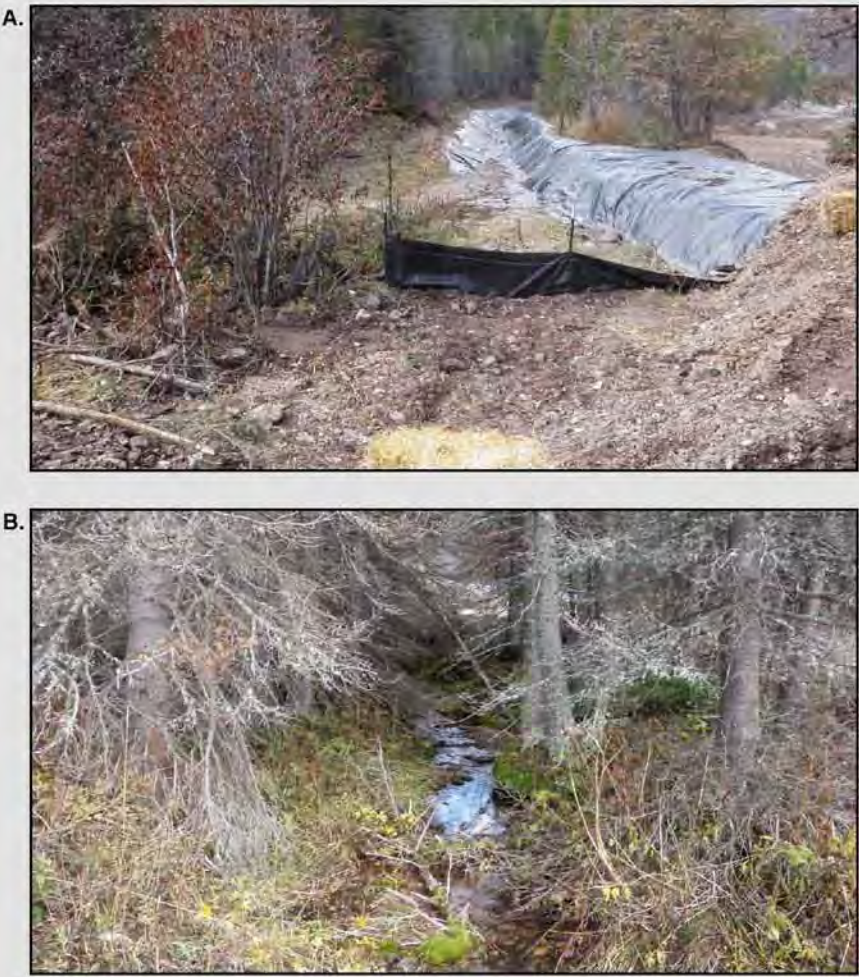
Figure 2-5. Example restoration treatments that may be applicable to Reach 2.

Reach 2 existing condition (A), and desired future condition (B).

In contrast to Reach 1 Upper Mike Horse Creek, restoring fluvial connectivity and habitat for native westslope cutthroat trout, bull trout and other aquatic organisms have been identified as important restoration objectives in Reach 2. Figure 2-5 shows desired conditions and examples of restoration treatments that may be applied within Reach 2.

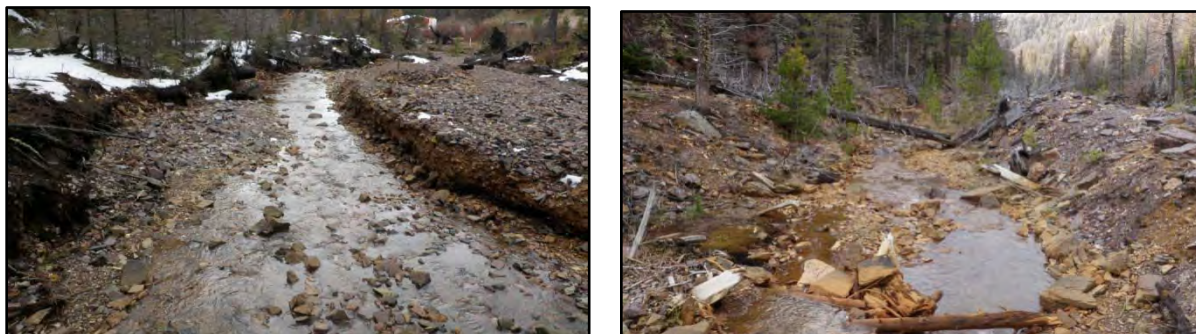
Figure 2-6. Existing valley and channel conditions in Reach 3, Lower Beartrap Creek. This reach is affected by large quantities of sediment transporting through the system, in addition to erosion from adjacent hillslopes.

The present morphology of the channel is typical of a braided, D stream type with in-channel sediment deposition forming transverse and mid-channel bars. Sediment deposition results in the disproportionate distribution of stress to the near-bank region of the channel, which further compounds streambank erosion and channel widening. Figure 2-6 depicts the existing conditions of the channel, floodplain and valley morphology in Reach 3.

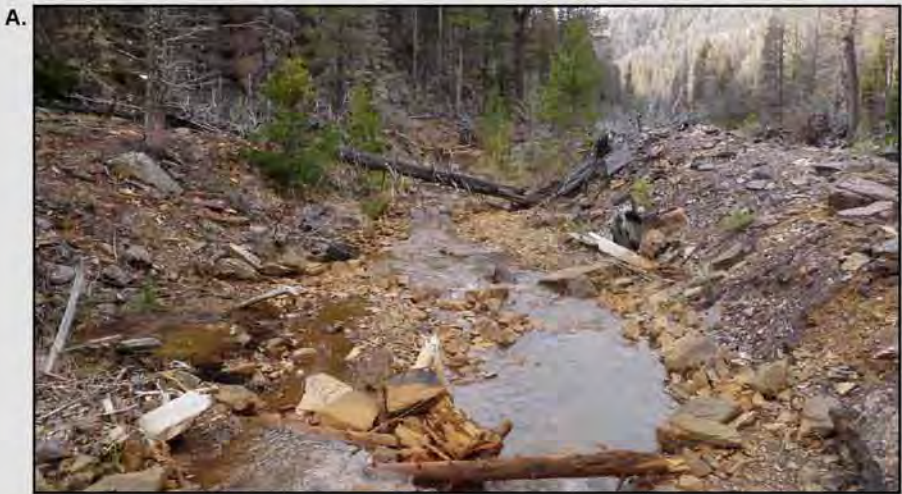
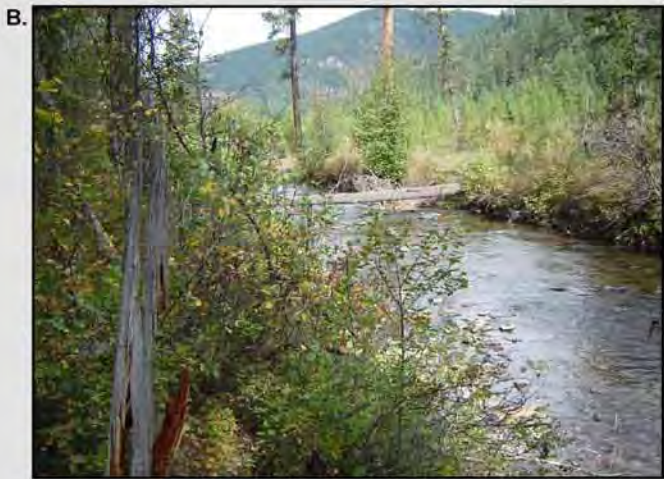
Figure 2-7. Example restoration treatments that may be applicable to Reach 3.

Reach 3 existing condition (A), and desired future condition (B).

The desired condition of Reach 3 would include complex aquatic habitat conditions that would support populations of westslope cutthroat trout and other aquatic organisms. Figure 2-7 illustrates the desired future condition for Reach 3 Lower Beartrap Creek.

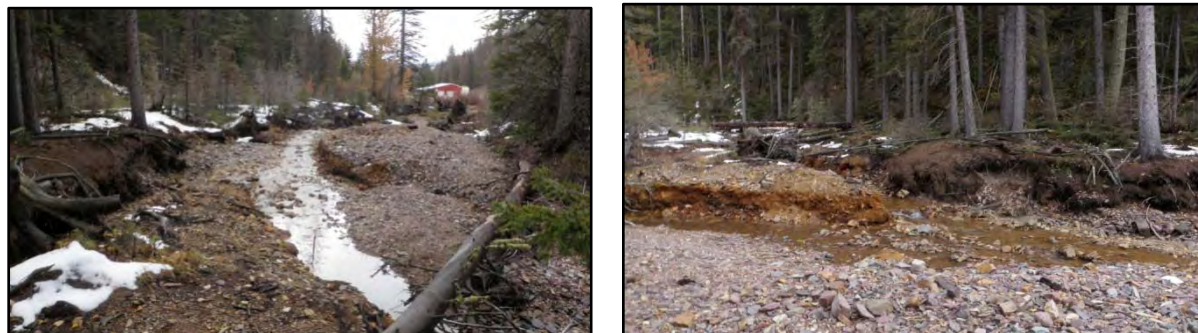
Figure 2-8. Existing valley and channel conditions in Reach 4 Transition Reach. This reach is influenced by large quantities of sediment moving through the system, in addition to erosion from adjacent hillslopes.

Figure 2-8 includes existing site conditions in Reach 4.

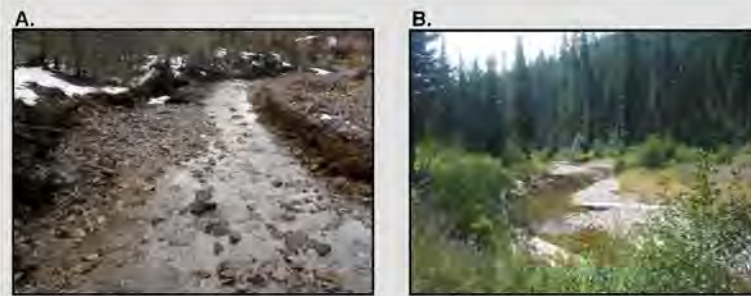
Figure 2-10. Example restoration treatments that may be applicable to Reach 4.

Reach 4 existing condition (A), and desired future condition (B).

Typical Valley Cross-section

The desired future condition of Reach 4 is based on the existing water treatment facility and related infrastructure remaining in place following remedial and restoration activities. The most probable state of the Upper Blackfoot River would include a low to moderate sinuosity, moderately entrenched, confined B4 stream type with coarse gravel and small cobble substrate. The channel bed morphology would be characterized by riffles and rapids with irregularly spaced scour pools. The floodplain width would be constrained by existing infrastructure and average 45 feet. A diverse mosaic of shrubs and trees of varying age classes would characterize the riparian zone.

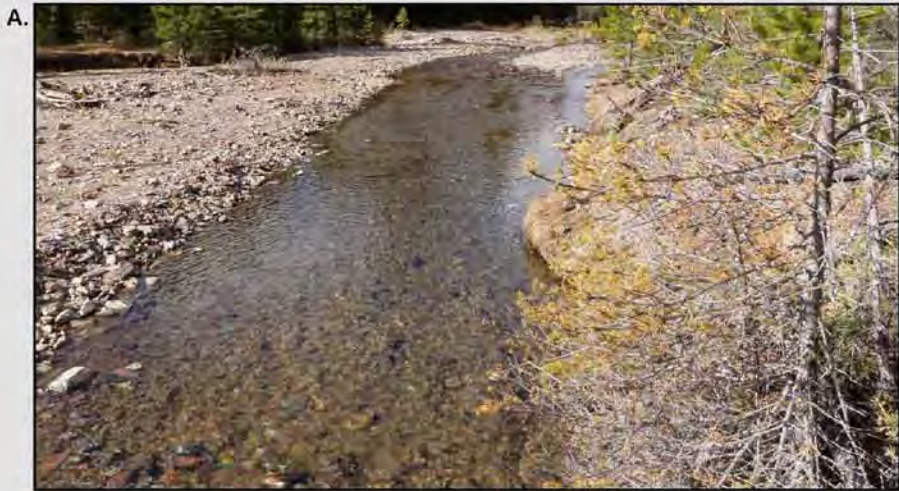
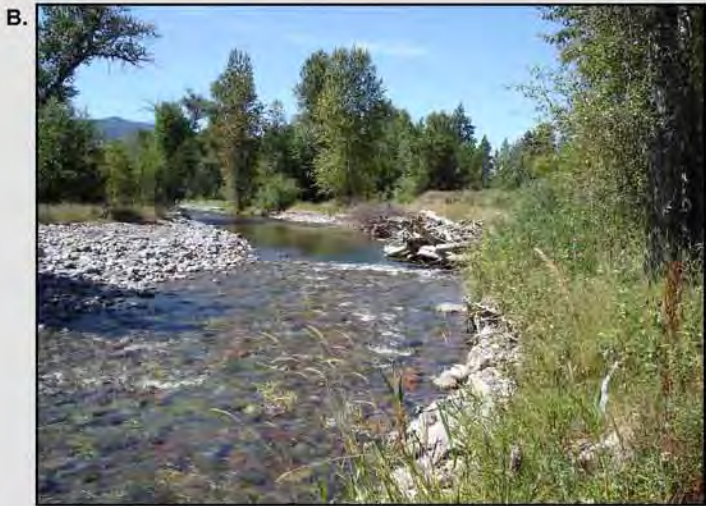
Reach 5 existing condition (A), and desired future condition (B).

Four revegetation zones would be included within the riparian area: a natural recruitment zone, a cottonwood/aspen shrub zone, a riparian conifer zone, and an upland conifer zone. These revegetation zones are described in more detail in Section 3 below. A natural recruitment zone would be left as exposed alluvial material (sand, gravel and cobble) on floodplain surfaces on the inside of meander bends. The cottonwood/aspen shrub zone would occupy areas within the bankfull floodplain outside of the natural recruitment zone, and would function as a transition zone between depositional surfaces and the riparian conifer zone. The riparian conifer zone would occupy higher positions in the floodplain such as low terrace features. The upland conifer zone would occur on higher ground such as where the berm is removed, or along road fill slopes. Figure 2-13 demonstrates the desired future condition of Reach 5 following restoration activities in the UMBC project area.

The desired future condition for Reach 5 is a moderately sinuous, slightly entrenched, B4 stream type with coarse gravel and small cobble substrate. The channel bed morphology would be characterized by riffles and rapids with irregularly spaced scour pools. The floodplain width would be constrained by existing infrastructure and average 125 feet. A diverse mosaic of shrubs and trees of varying age classes would characterize the riparian zone.

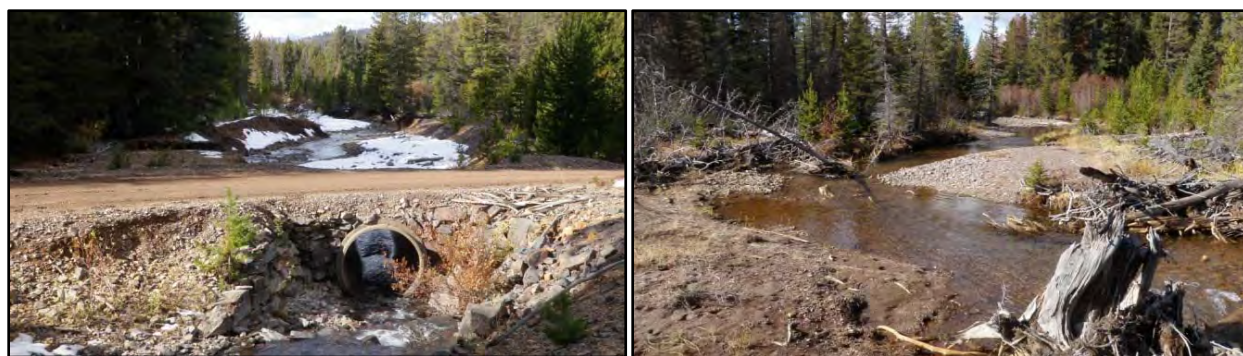
Figure 2-14. Existing valley and channel conditions in Reach 6 Upper Blackfoot River Wetlands.

Reach 6 Upper Blackfoot River Wetlands, includes the area in the vicinity of Shave Gulch, and the Upper Blackfoot River downstream from the current access road to Mike Horse Dam. As described for Reach 5, the Upper Blackfoot River valley gradually transitions from a semi-confined system to a lower gradient, more sinuous and unconfined morphology typical of B4c and C4 stream types. The existing stream morphology varies longitudinally based on the degree of floodplain disturbance and valley aggradation that occurred following the failure of the Mike Horse Dam embankment. Downstream of the Mike Horse Road crossing, the reach is highly incised and entrenched relative to the adjacent terrace surface and characterized by severe bank erosion (F4 stream type). Channel incision has initiated floodplain headcuts that contribute contaminated floodplain sediments to the channel.

Downstream of the confluence of Shave Gulch and the Upper Blackfoot River, channel morphology transitions to a more sinuous channel developed with a forested floodplain corridor. Alternating pool and riffle bedforms typical of a C4 stream type occur and the channel is controlled laterally by large wood complexes and mature trees that confine the channel to a relatively broad, terraced floodplain. The most prominent effects of upstream mining and land use activities in Reach 6 include the significant supply of coarse sediment that has deposited in the channel due to reduced sediment transport capacity and competency. Coarse sediment deposition and channel aggradation impairs aquatic habitat conditions by creating extremely high width-to-depth ratio channel conditions and diffuse flow patterns. Sediment deposition reduces the hydraulic capacity of the channel and likely encourages floodplain activation during flows less than bankfull or effective discharge.

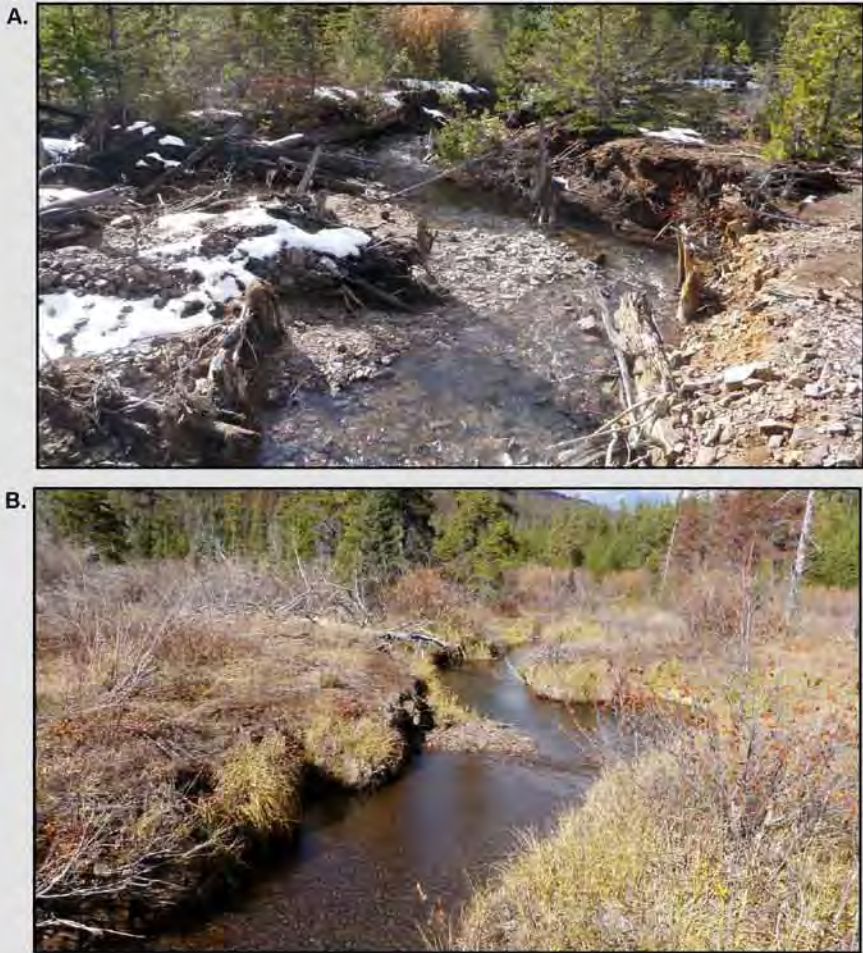
Reach 6 existing condition (A), and desired future condition (B).

The desired future condition for Reach 6 is a moderately entrenched, riffle-pool channel (B4c stream type) with inclusions of slightly entrenched, meandering, gravel-dominated channels characterized by riffle-pool bedforms and well developed floodplains (C4 stream type). The potential stream type and valley morphology would encourage development of a complex floodplain ecosystem with connected side channels and wetlands. Side channel habitats would be hydrologically connected to the channel during moderate to high flow events and provide aquatic habitat refugia and nutrient inputs to the channel. The desired condition for much of Reach 6 would be a riparian conifer forest (dominated by spruce) with inclusions of cottonwoods, aspen, riparian shrubs and wetlands.

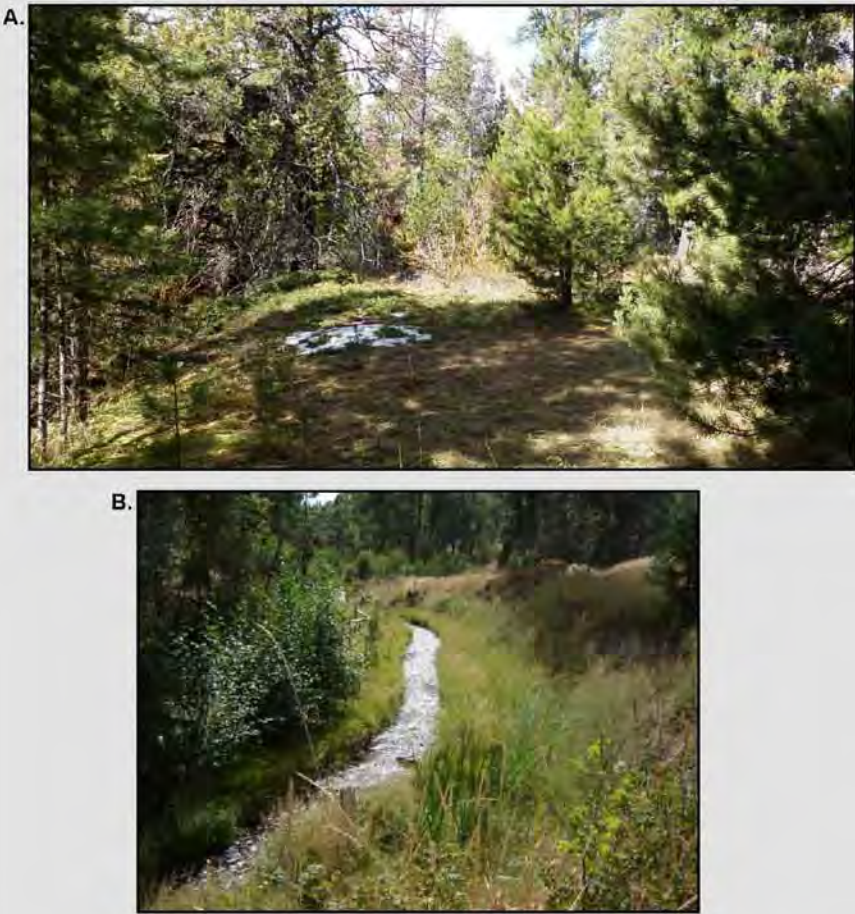
Shave Gulch existing floodplain (A), and desired future condition (B).

The channel and floodplain in the lower reaches of Shave Gulch, would be restored from the confluence with the Upper Blackfoot River to approximately 0.25 miles upstream of the Mike Horse Road. The primary goals of restoration would be to restore channel-floodplain connectivity, improve aquatic habitat complexity for westslope cutthroat trout and other aquatic organisms, and create a stable confluence with the Upper Blackfoot River in Reach 6 of the UBMC project area. The desired future condition of the channel and floodplain includes a moderately entrenched, riffle-pool channel with a narrow, well-vegetated floodplain corridor that would support a diverse mosaic of shrubs and trees of varying age classes. Exposed depositional surfaces would be more common in the vicinity of the confluence with the Upper Blackfoot River as the floodplain width increases in a down-valley direction.

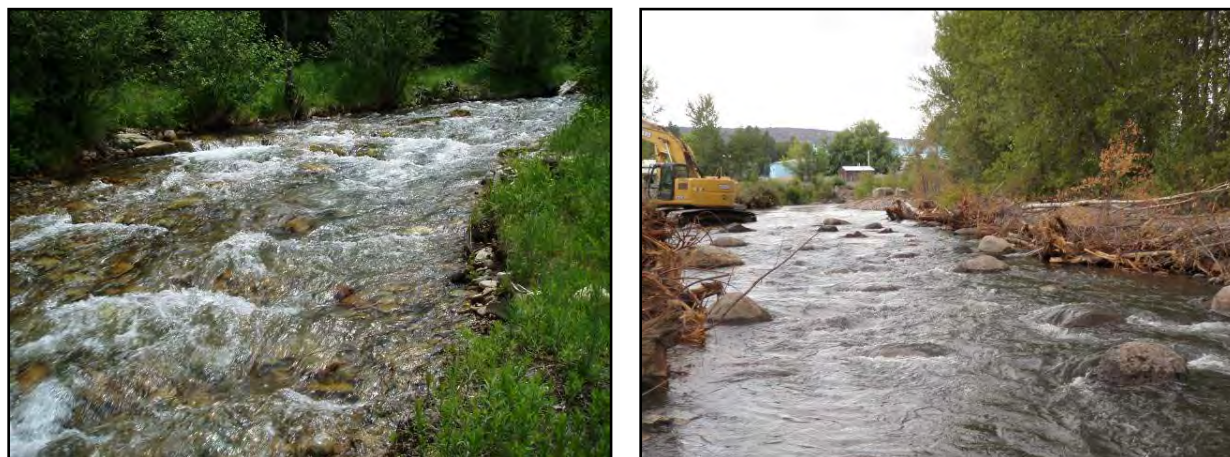
Figure 3-1. Example constructed channels incorporating graded alluvium and boulder placement for grade control and aquatic habitat diversity.

Constructed channels and riffles typically involve importing suitable graded alluvium placed within a framework of larger material (e.g. boulders) to counteract scour of the finer gradation matrix. Hydraulic effects of the alluvium placement include spawning material retention and deposition along the glide face or pool tailout. For higher gradient stream reaches, boulders will be incorporated in the bed material to dissipate

stream energy, create velocity gradients, and consolidate base flows for fish passage. Collectively, constructed channels and riffles will replicate natural stream conditions. Figure 3-1 includes examples of constructed channels that include a variety of bedform features including riffles, runs, pools and glides.

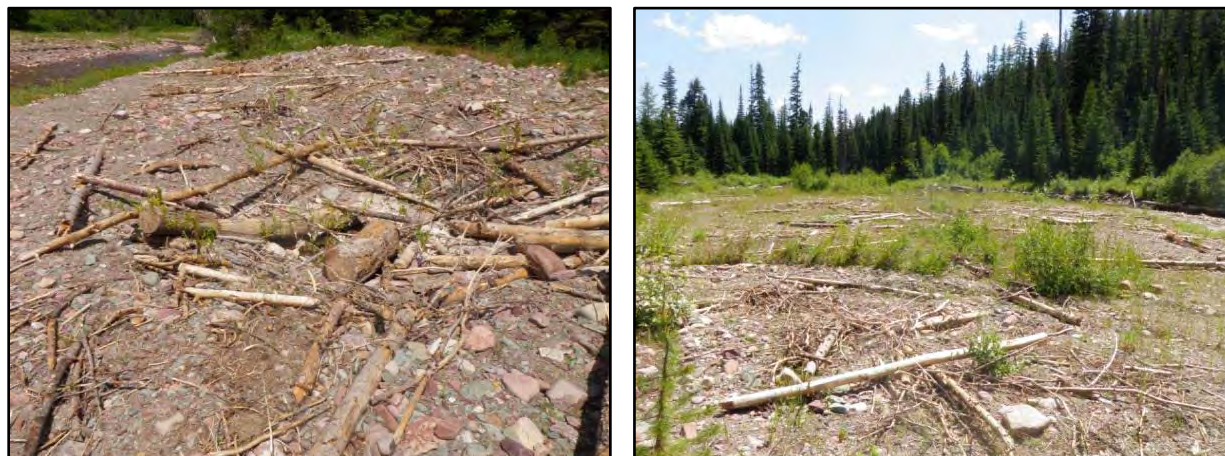
Figure 3-2. Floodplain woody debris and microtopography treatments are shown in the left photo. The right photo shows willows growing from buried cuttings combined with coir logs to sustain rooting zone moisture.

Floodplains would be constructed of native alluvial material with an overlying horizon of soil of varied textures depending on the revegetation zone (described below). Woody debris and micro-topography in the form of swales would be incorporated within floodplain surfaces. Woody debris and micro-topography function as sediment traps and microsites; they can increase sediment storage, flood storage, and debris retention; create stable points for vegetation development; promote topographic diversity on floodplain surfaces; and add habitat complexity. Figure 3-2 shows examples of restoration techniques that result in a complex floodplain surface.

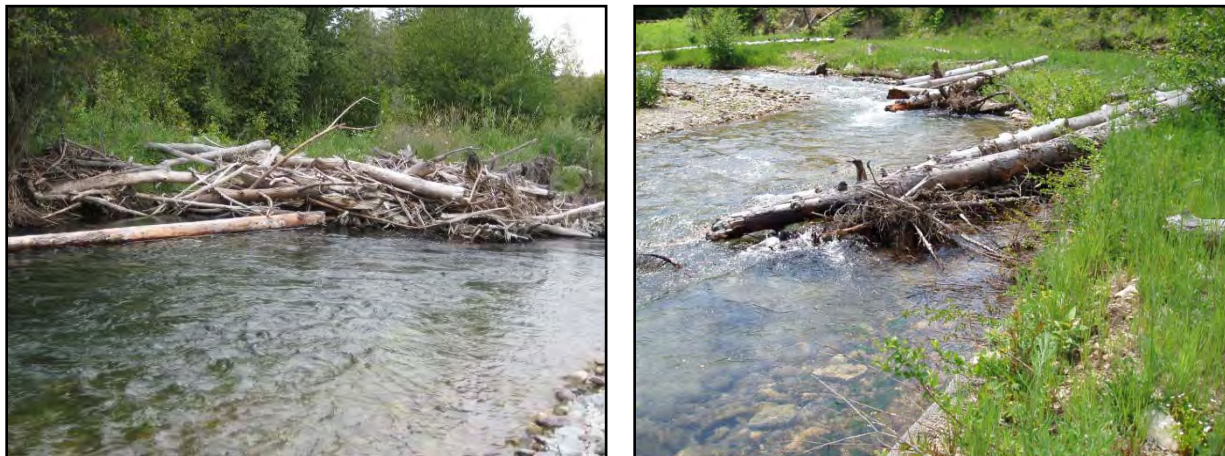
Figure 3-3. Photographs demonstrating the use of engineered log jams used in conjunction with streambank bioengineering structures and submerged wood to form a stable, vegetated land-water interface and create complex aquatic habitat along the channel margins.

Engineered log jams are engineered wood structures that intercept flow and reduce near-bank velocities, protect new floodplain surfaces, promote pool scour and maintenance, and provide habitat along the land-water interface. These structures span from the anticipated depth of the channel to over the bankfull channel elevation, and tie into existing stable bank vegetation where available. Engineered log jams are constructed of logs, whole trees with attached root wads, and either large anchor rocks or tree members for ballast and structural support. Engineered log jams are used in combination with streambank bioengineering structures. They create stable tie-in points for the streambank structures and provide aquatic habitat by encouraging scour along outside streambanks and meander bends. Figure 3-3 includes examples of engineered log jams used in conjunction with streambank bioengineering structures.

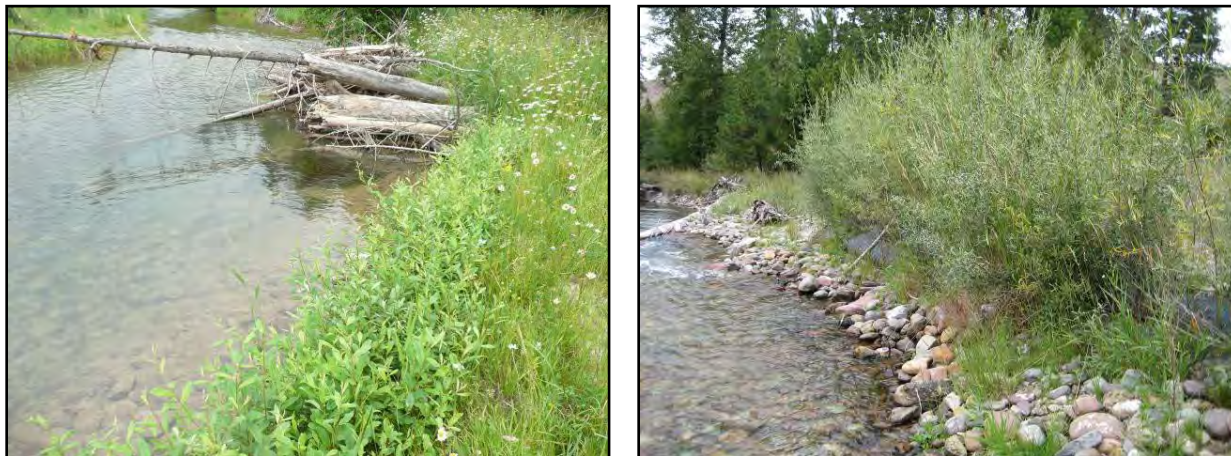
Figure 3-4. Vegetated soil lifts used in conjunction with engineered log jams (left) and as a stand-alone treatment (right).

Vegetated soil lifts are a revegetation and bank construction technique that combines layers of dormant willow cuttings with fabric-wrapped soil to revegetate and stabilize stream banks. Soil is wrapped within two layers of biodegradable coir fabric to hold the soil in place while vegetation becomes established in the relatively high stress land-water interface. The purpose of this treatment is to provide site conditions directly along the channel that are suitable for growing riparian vegetation. While vegetated soils lifts provide some degree of bank stabilization, they are primarily a revegetation technique. These structures reduce bank erosion rates, but they must be located within a sequence of other bank stabilization and grade control structures that provide bank stability. Over a five to seven year period, the fabric will decompose and be replaced by dense, woody vegetation that will provide rooting strength sufficient to maintain low bank erosion rates. Figure 3-4 below shows vegetated soil lifts used as a stand-alone treatment and in combination with other streambank treatments including engineered log jams.
