# LESSONS LEARNED

From 28 Years of Remediation and Restoration in the Upper Clark Fork River Basin

**CDM  
Smith**

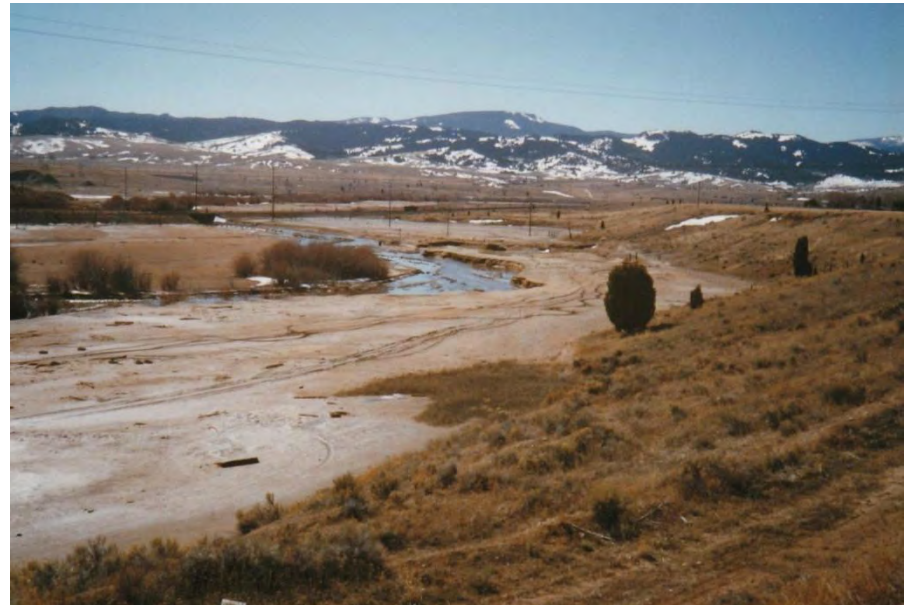
# Contaminant Removal – Base of Tailings

- Contaminants of Concern are arsenic, cadmium, copper, lead, zinc and mercury (SBC).
- Definition of 'Base of Tailings' can vary but preferably should be concentration based.
- Concentrations often abruptly decrease below base.

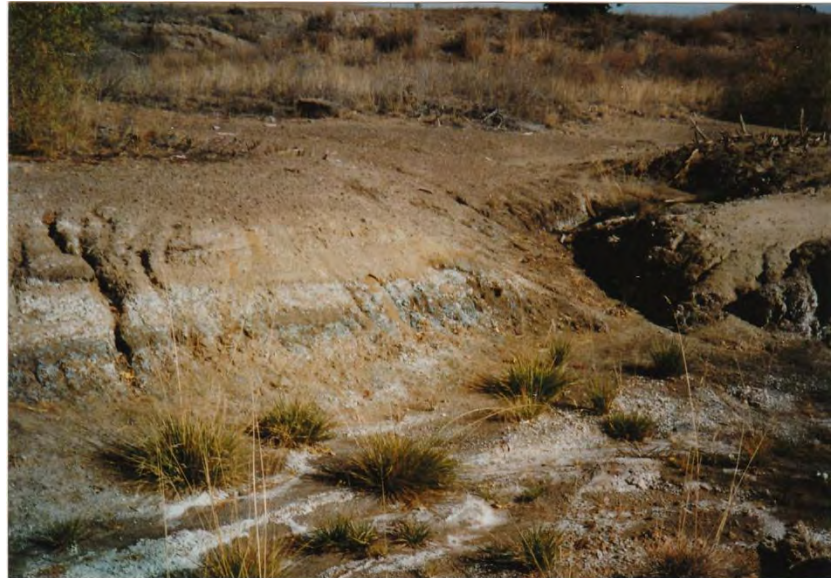
# Contaminant Removal – Base of Tailings

- In fluvial environments, pit sampling is usually feasible.
- Sample in increments and screen samples with XRF for submittal to a lab for accurate analysis.
- If material may be lime amended, retain materials above base for additional analysis (acid-base accounting).

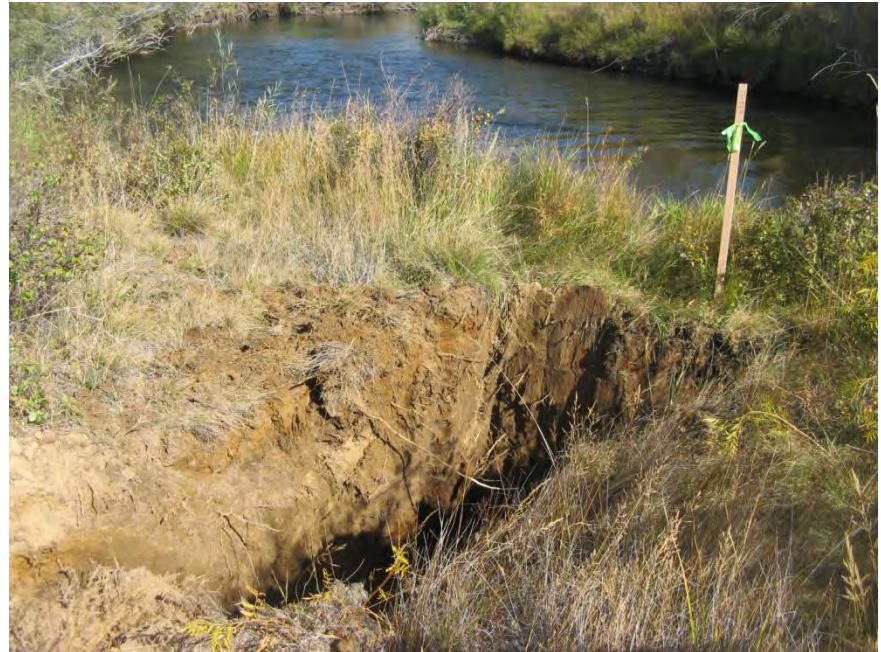
# Contaminant Removal – Base of Tailings

- Geostatistical analysis of elevations (Kriging) of tailings base allows modeling of removal surface.
- Kriging analyzes variance in base of tailings and allows prediction of the percent removal of tailings.
- For Reach A of Silver Bow Creek, we predicted that over-excavation of 6 inches of material below the base of tailings would remove 90% of the contaminants (as defined by the removal criteria).
- Because 6 inches of over-excavation proved to be correct (based on verification sampling) but did not allow provide sufficient margin of assurance, over-excavation was increased to 9 inches at downstream reaches.

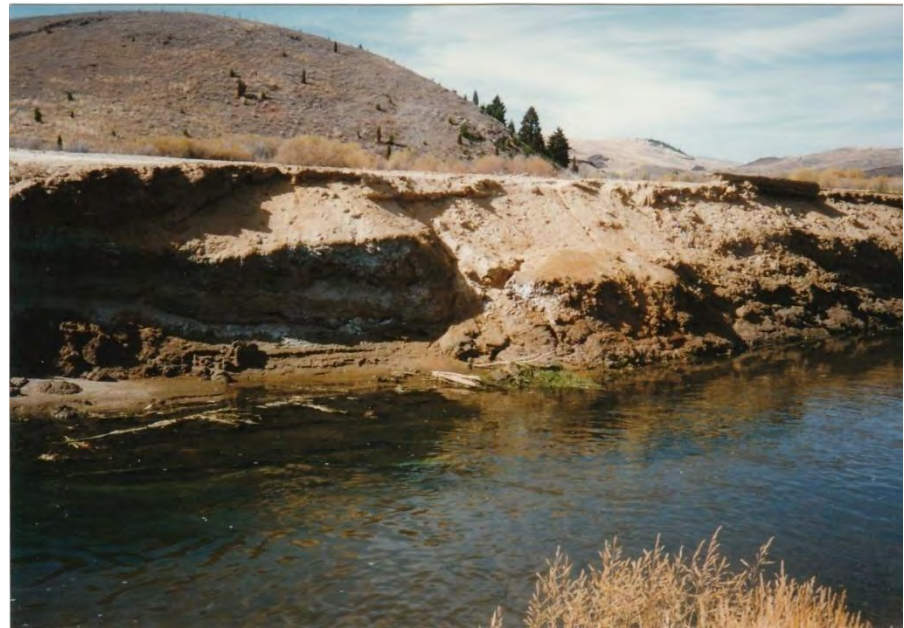
# Contaminant Removal – Waste Disposal

- Local Repository (Reach A)
  - Design required lime amendment of waste
  - Lime did not control arsenic
  - Arsenic control with zero-valent iron was impractical
  - Vegetative cap effectiveness could be questioned
- Advantages of a regional waste repository
  - Consolidate all waste in one area for long-term monitoring and maintenance
  - Offers better choices for repository siting
  - Use of rail transport was very economic

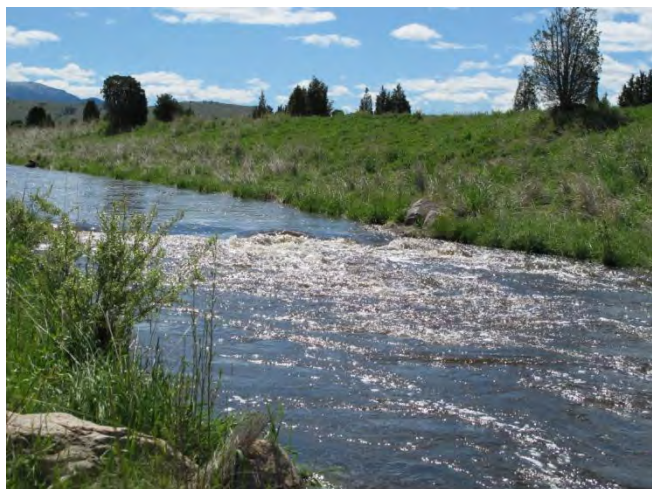
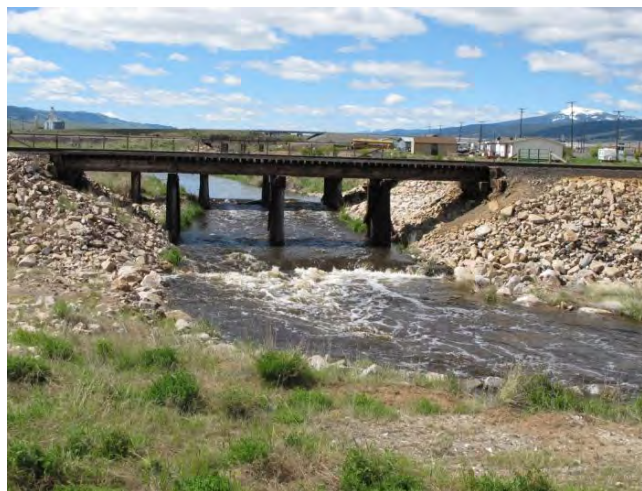
# Stream Design – Structures

- Structures were useful on Silver Bow Creek in confined reaches (Reaches D and E) where we need to lose elevation.
- Constructed drop structures some in conjunction with existing bedrock controls and bridges.
- At some sites, no structures are planned including Clark Fork River Phase 1.

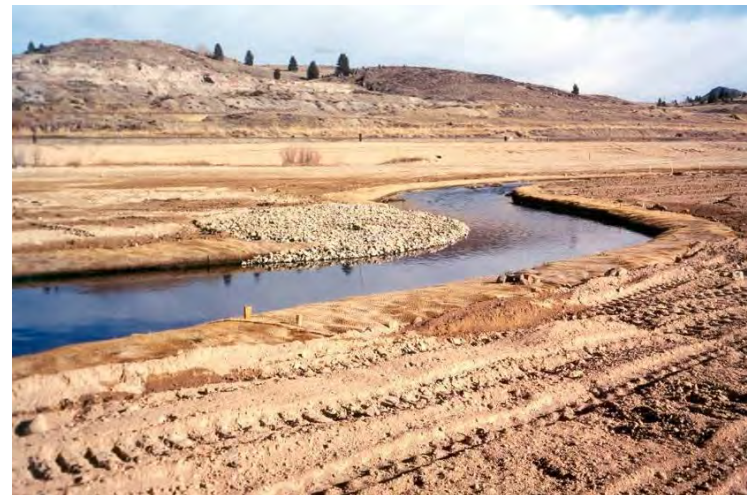
# Stream Design – Stream Gradient

- Generally matched grade at existing bridges to maintain current hydraulic conditions.
- Stream profile had a hump in it at Rocker.
- Most feasible remedy was to build a new railroad bridge that would be designed to work with lowered stream elevation.
- Redesigned stream transports sediment and prevents aggradation.

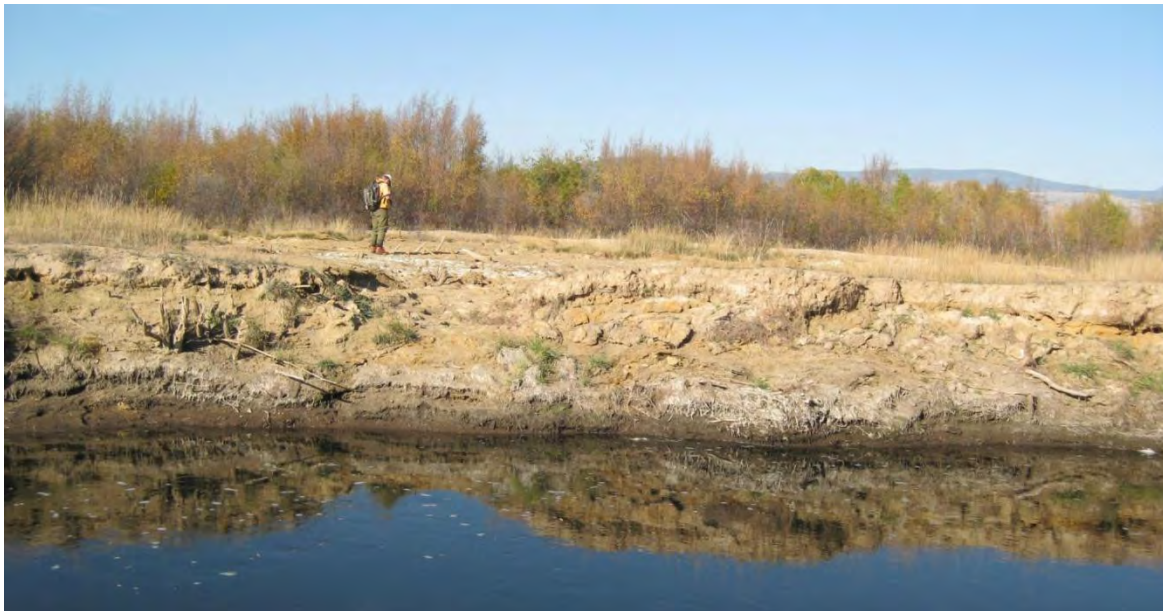
# Stream Design – Overflow Diversion on Silver Bow Creek

- Attempt to save money on expected high cost of fabric encapsulated soil (FES) lifts.
- Overflow diversion would route flows (starting at 50 cfs) through a rock lined channel in Reach A.
- Banks would consist of soil covered with coir fabric but no FES lifts.
- After bank vegetation was established, diversion structure and channel would be removed.
- Concept worked well (no bank failures) but there was probably no cost savings.

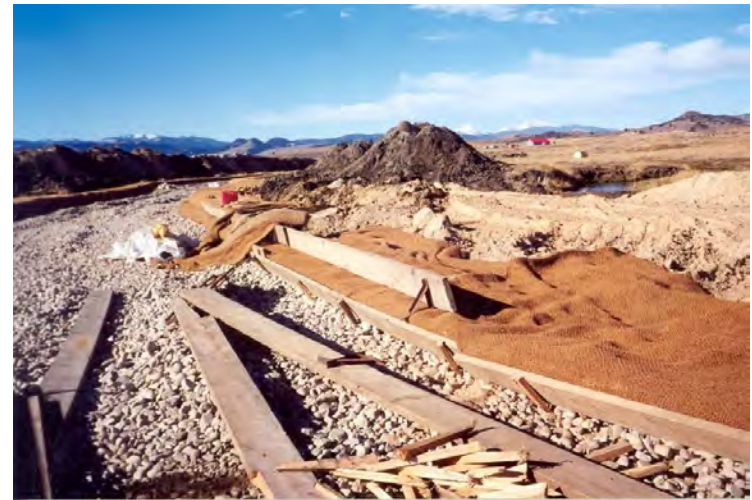
# Stream Design – Streambanks

- Clark Fork streambanks
  - Build Bank toe if needed!
