Final Report
January 8, 2016

Clark Fork River Channel Migration Zone Mapping Drummond to Milltown

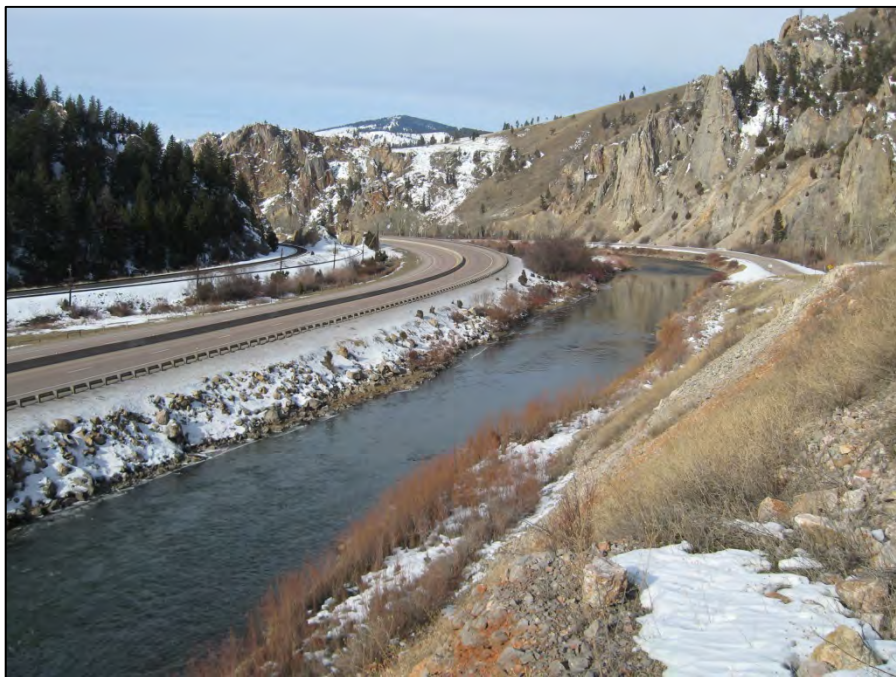
Figure 2-1. Main transportation corridor elements including (from left)—Milwaukee Line, BNSF Line, abandoned rail line, I-90, and Frontage Road on right.

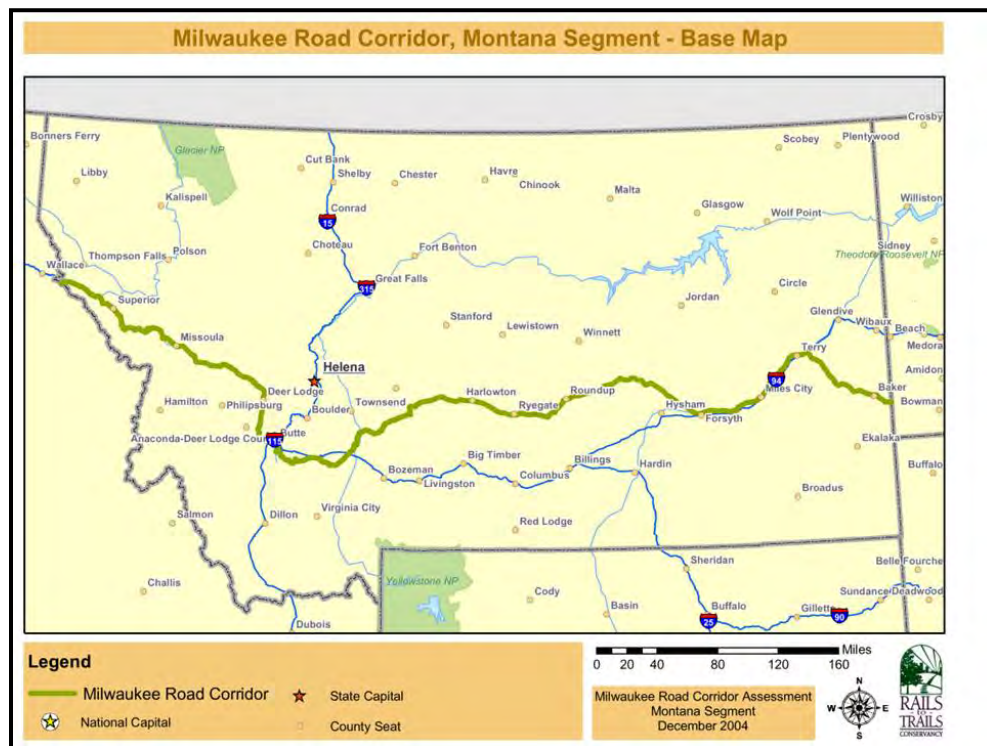
Figure 2-5. Route of the Chicago, Milwaukee & St Paul Railway through Montana (Rails to Trails Conservancy, 2004).

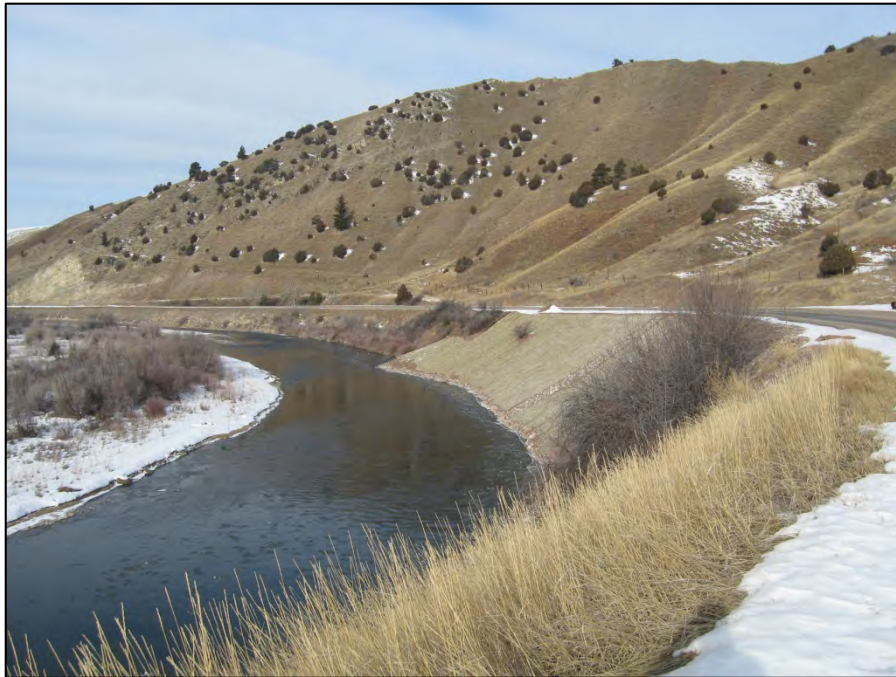
Figure 2-6. View downstream showing the Frontage Road following north valley wall of Clark Fork River corridor.

US Highway 10 is an east-west highway that extended from Detroit to Seattle. Much of this highway was obliterated when I-90 was constructed on top of its right of way. Within the project reach, however, imagery indicates that the highway has been maintained as the Frontage Road. This system was constructed in the mid-1920s tends to follow the north valley wall through the project reach.

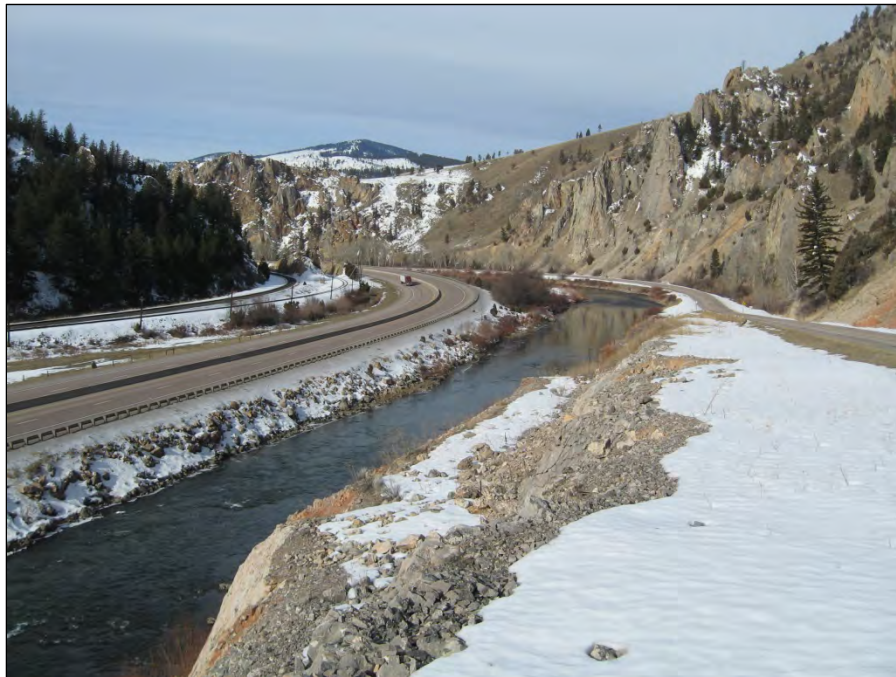
Figure 5-3. Main transportation corridor elements including (from left)—Milwaukee Line, BNSF Line, abandoned rail line, I-90, and Frontage Road on right.

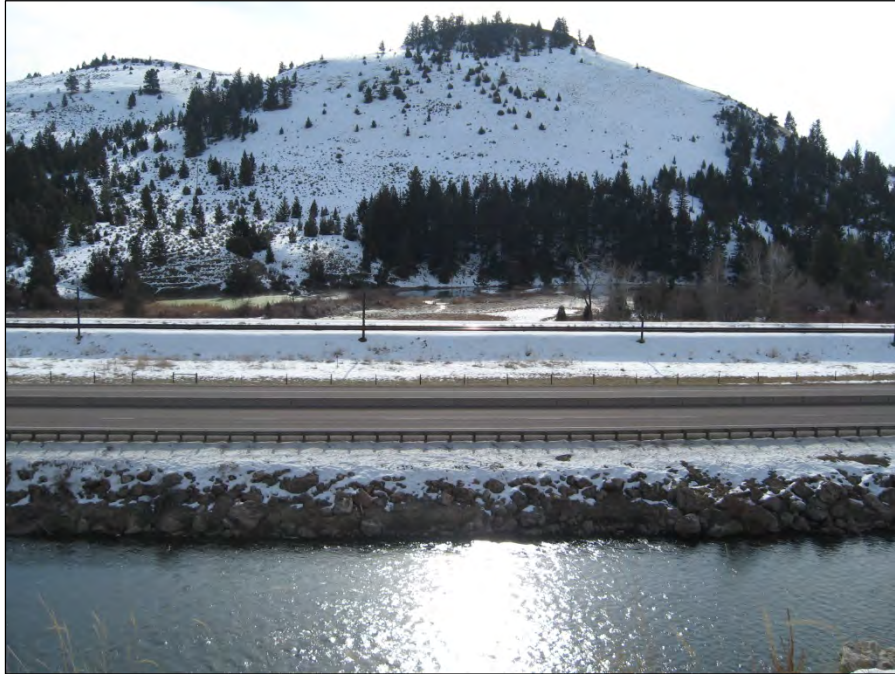
Figure 5-4. View across river (south) showing restrictions of CMZ by rock riprap, I-90, and rail line.

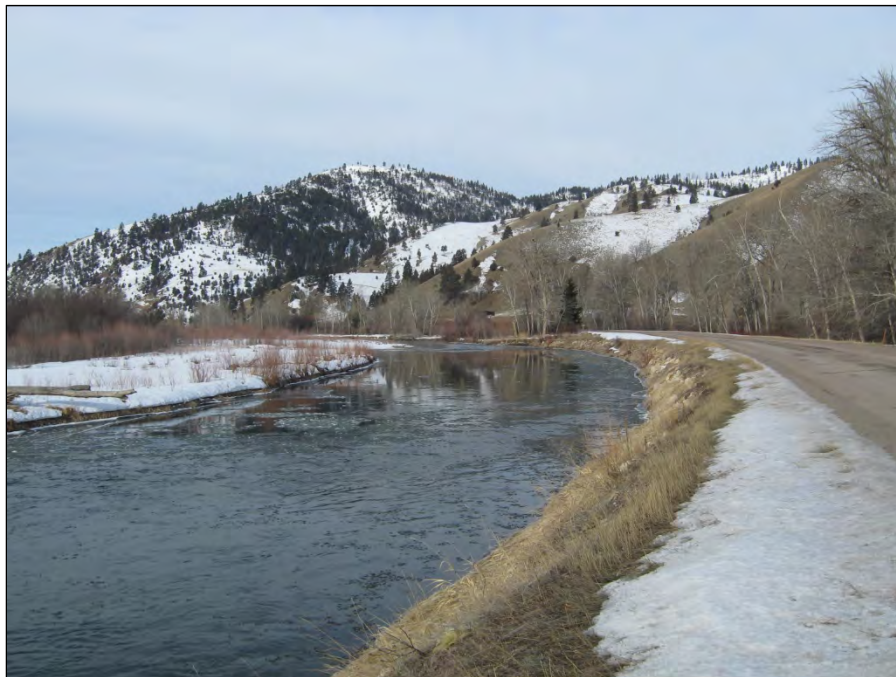
Figure 5-5. CMZ restriction by the Frontage Road.

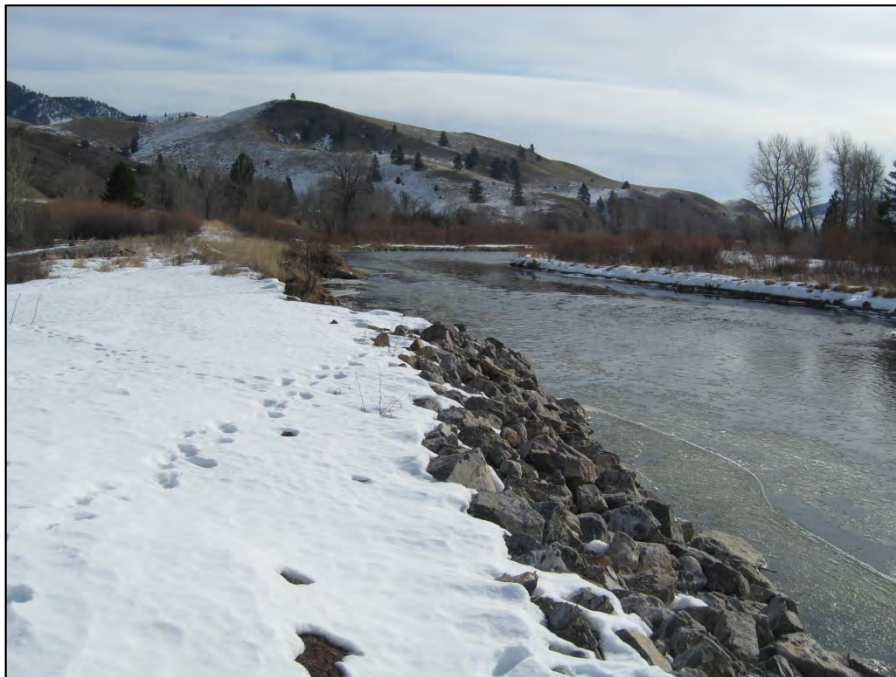
Figure 5-13. View upstream showing full bank rock riprap protection agricultural land.

Bank armor has been constructed throughout the project reach to protect a variety of land uses (Figure 5-13). A field inventory of armor type and extent was provided by Dan Brewer of the USFWS for Reach 2 through Reach 8, which extends from the upper end of the old Milltown Reservoir site to Drummond. The results show that there are a total of 21.4 miles of bank armor in those reaches, which covers about 21 percent of the entire bankline of the main channel (Table 4). The vast majority of bank armor is rock riprap (17.6 miles), with lesser extents of toe rock (3.8 miles). Armor densities are greatest in Reaches 2, 6, 7, and 8, where between 24 percent and 29 percent of the total bankline is armored (Figure 5-14).

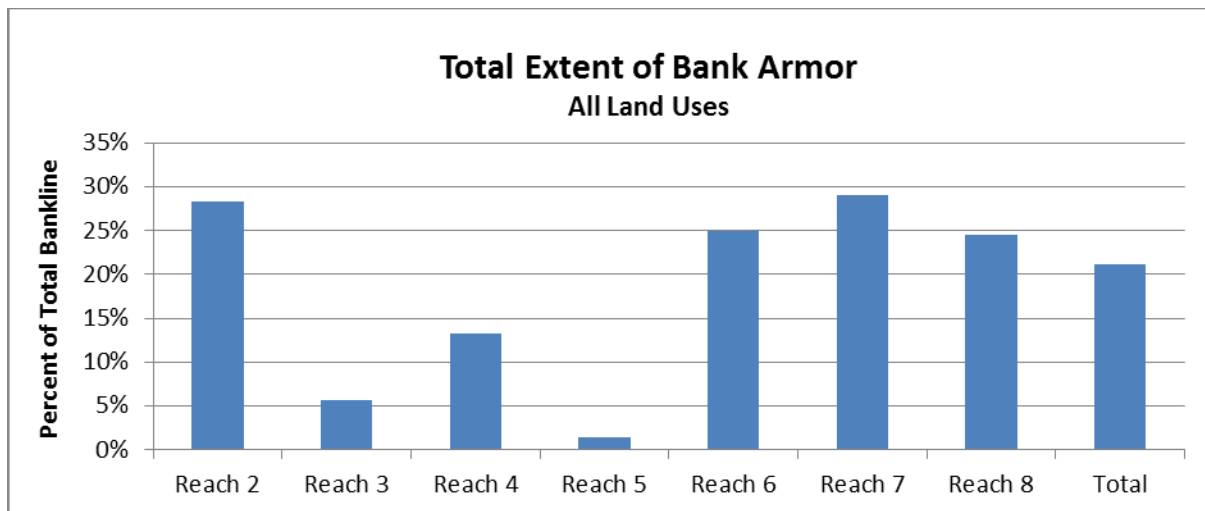
Figure 5-14. Percent of total bankline armored by either toe rock or full-bank rock riprap, Reaches 2-8.

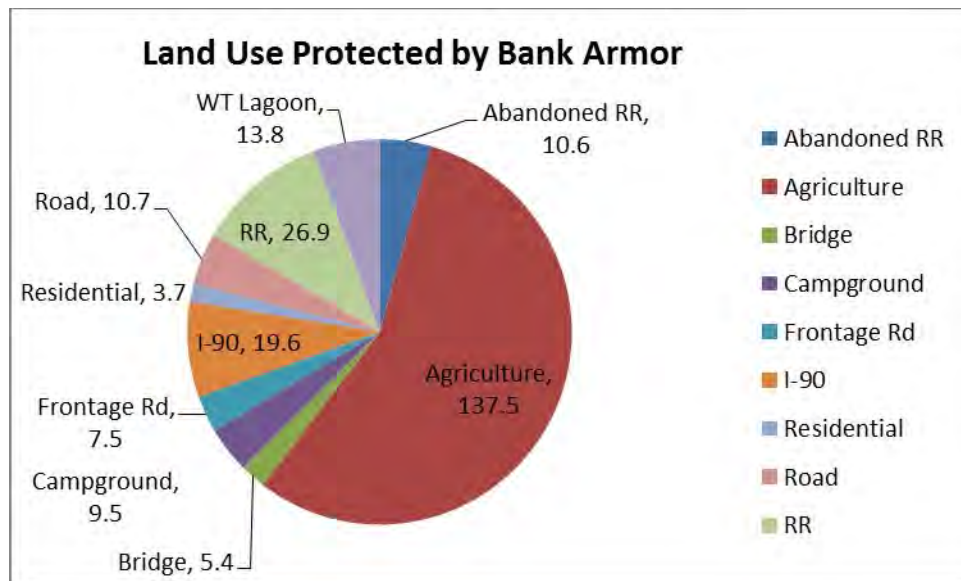
Figure 5-16. Total acreage of CMZ restricted by bank armor not on transportation embankment.

About 27 acres of CMZ have become isolated by armor that is adjacent to, but not on the railroad embankment. Similarly, there are another 20 acres of CMZ restricted by armor that is riverward of I-90. Most of these areas are relatively thin slivers of land that do not provide much CMZ restoration opportunity.

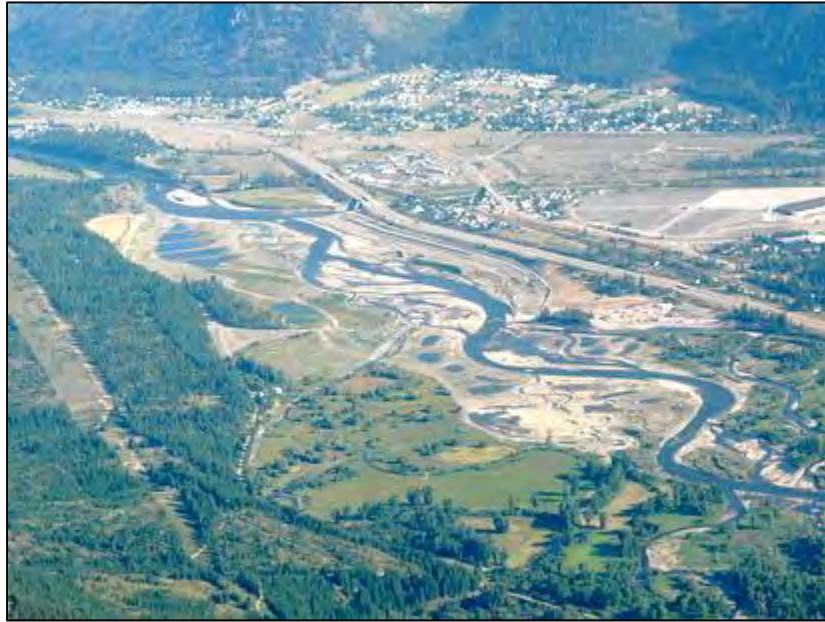
Figure 6-2. View downstream of Reach 1 showing Milltown Dam Removal and Restoration Site shortly after project completion (River Design Group).

The overall project goal of the project was to “Restore the confluence of the Blackfoot and Clark Fork Rivers to a naturally functioning, stable system” (Westwater Consultants and others, 2005).
