Butte Area One Restoration Planning Process and Draft Conceptual Restoration Plan State of Montana Natural Resource Damage Program

STATE OF MONTANA'S
CONCEPTUAL RESTORATION PLAN and PROPOSED PLANNING
PROCESS FOR BUTTE AREA ONE
GROUNDWATER AND SURFACE WATER RESOURCES

Prepared by
Montana Department of Justice

Natural Resource Damage Program

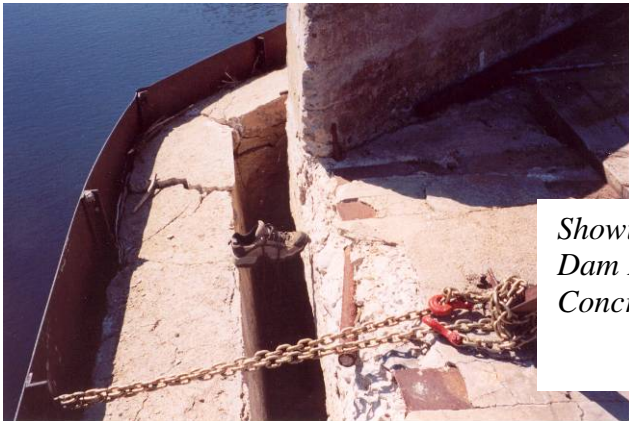
Showing Poor Condition of Dam Intake Structure Concrete

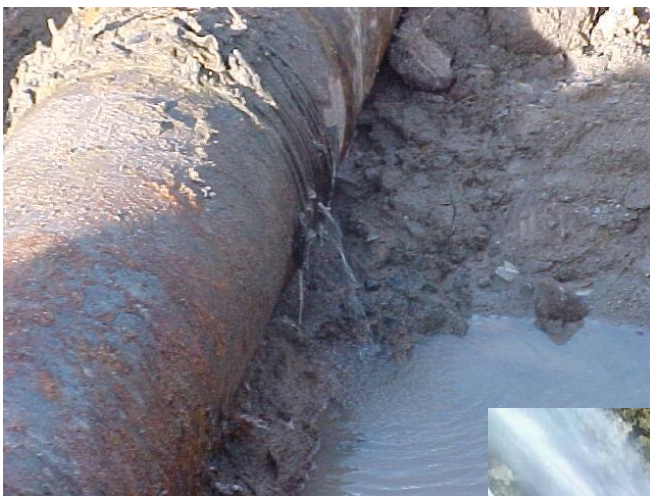
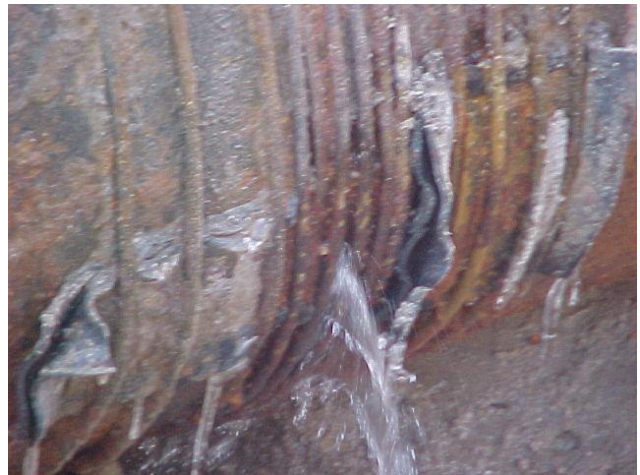
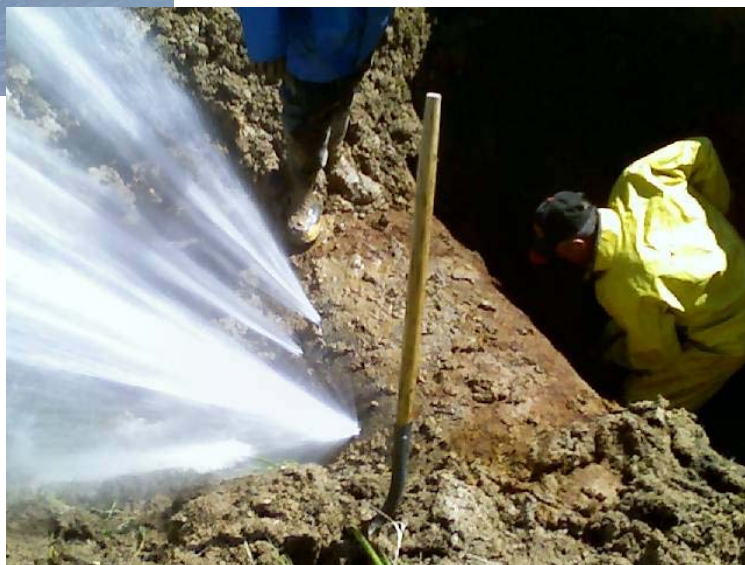
Photos of Leaks on Big Hole Pipeline

The pipeline was coated with very substandard material which consisted of hand painting coal tar on the inside pipe with brushes. The outside of the pipeline was coated only in areas where the pipe was below groundwater. There is no corrosion protection or cathodic protection system installed on the pipeline to protect it from corrosive soils. For these and the above reasons sections of this pipeline needs to be rehabilitated.

The 36-inch 19-mile long Big Hole steel transmission main was constructed in the late 1960's and 1970's with steel pipe. The Butte Water System Master Plan prepared in 1988 by James Montgomery Consulting Engineers indicated that the capacity of the transmission main is 17.7 million gallons per day. The Master Plan also stated that at that time the leakage rate of the main was nine percent. Current indications are that the condition of the line is continuing to deteriorate (based on repairs performed by BSB personnel). If this main were to fail, Butte would lose its main source of water until repairs could be made. The typical useful life for a large diameter steel pipeline is 40 years according to *Water Resources and Environmental Engineering* (Linsley/Franzini 3rd Edition). Most of the existing pipeline is now about 40 years old. Since 1994, BSB has repaired 250 leaks to the pipeline, this equates to about 20 repairs per year. The average cost of each repair is \$2,000. Photos illustrating the condition of the transmission main have been included below.

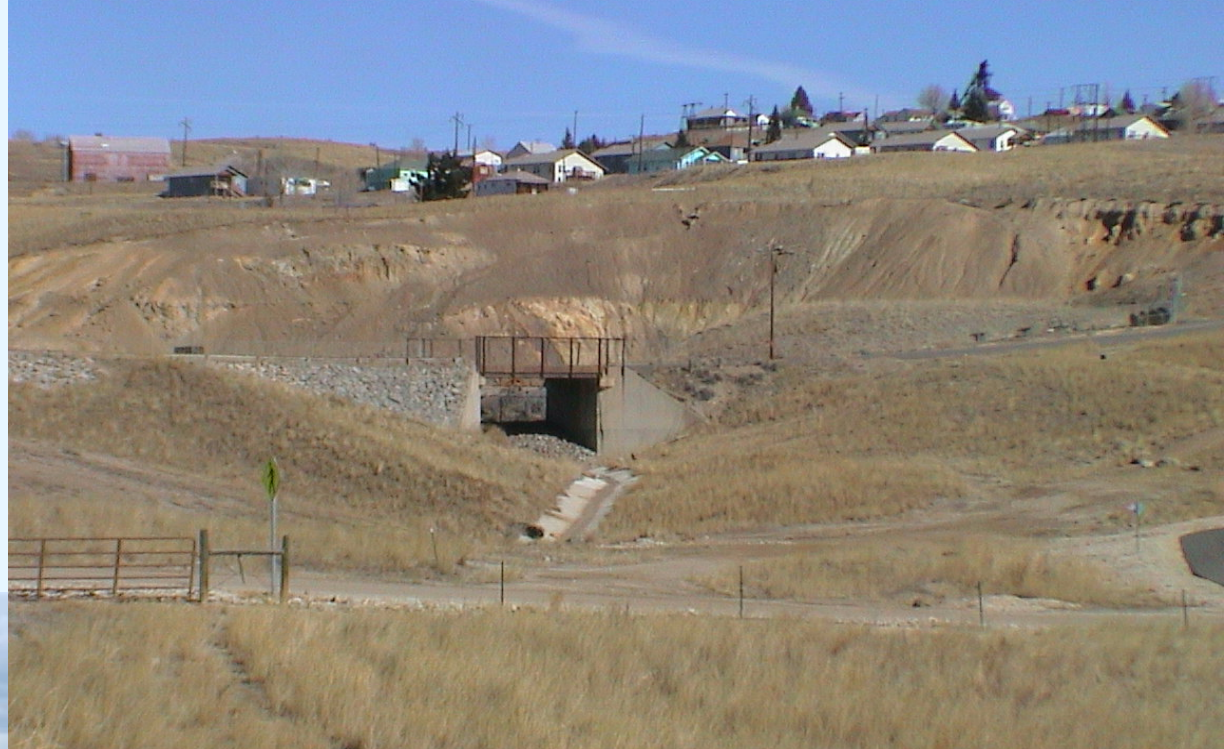
Bonanza Dump 1 (Site 120). Unreclaimed/failed reclamation prevalent throughout the site. View looking west. Runoff and sediments from site drain directly to West Side Drainage.

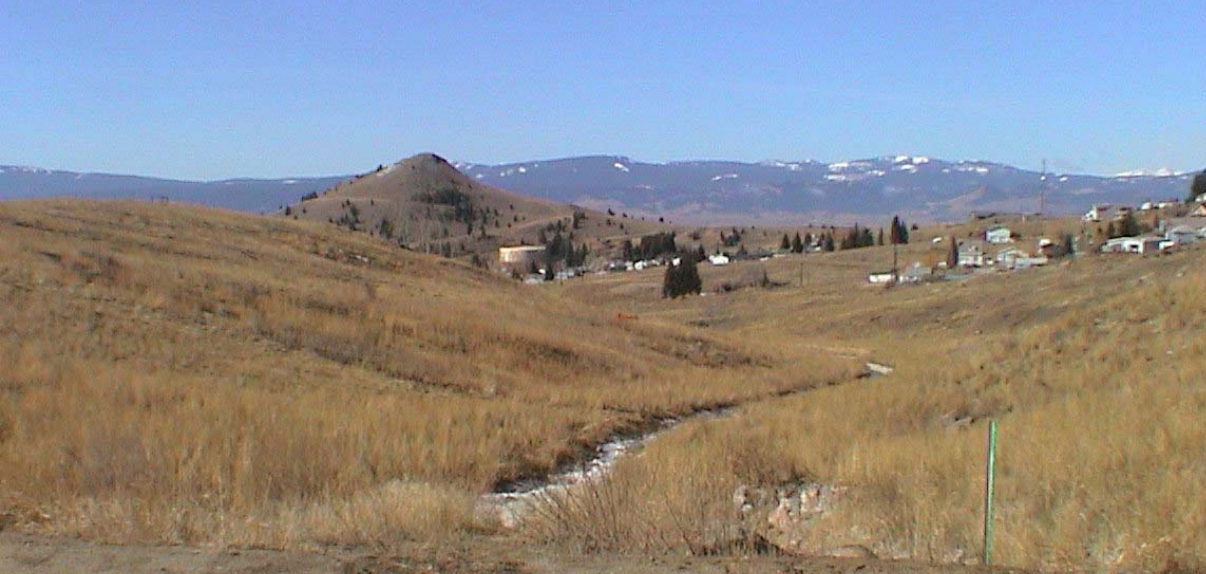
Syndicate Pit. View looking north at the Syndicate Pit unreclaimed area. Site will be specified for remedial action in the BPSOU ROD. Other sites in the photo are the Missoula Gulch concrete channel, the Anselmo Dump in the foreground and the Tullamore Dumps/Northeast Syndicate above the Syndicate Pit. All sites drain to the Missoula Gulch system.

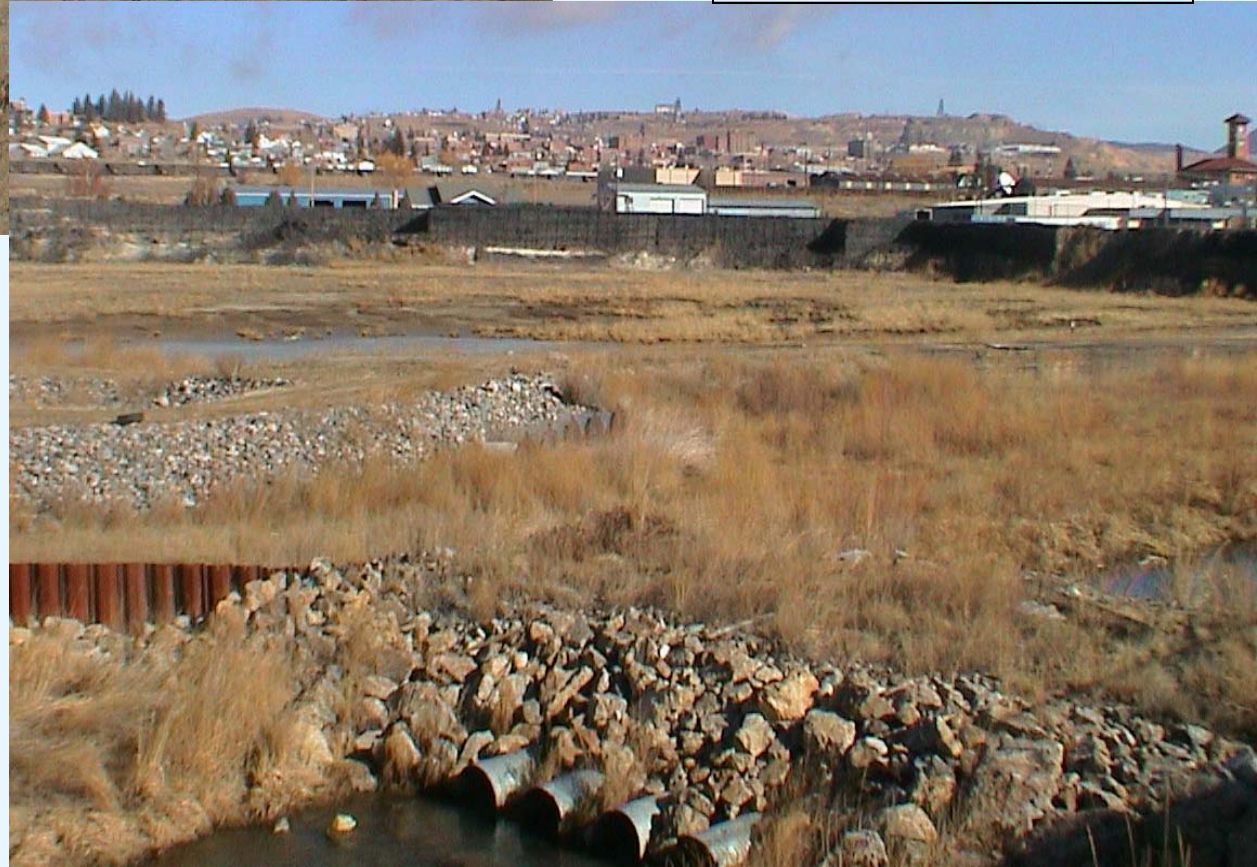
**Butte Reduction
Works/Lower Area One.**

View looking east of the unreclaimed area at the SBC/HCC diversion. Centennial Avenue lies directly on the other (north) side of the slag wall.

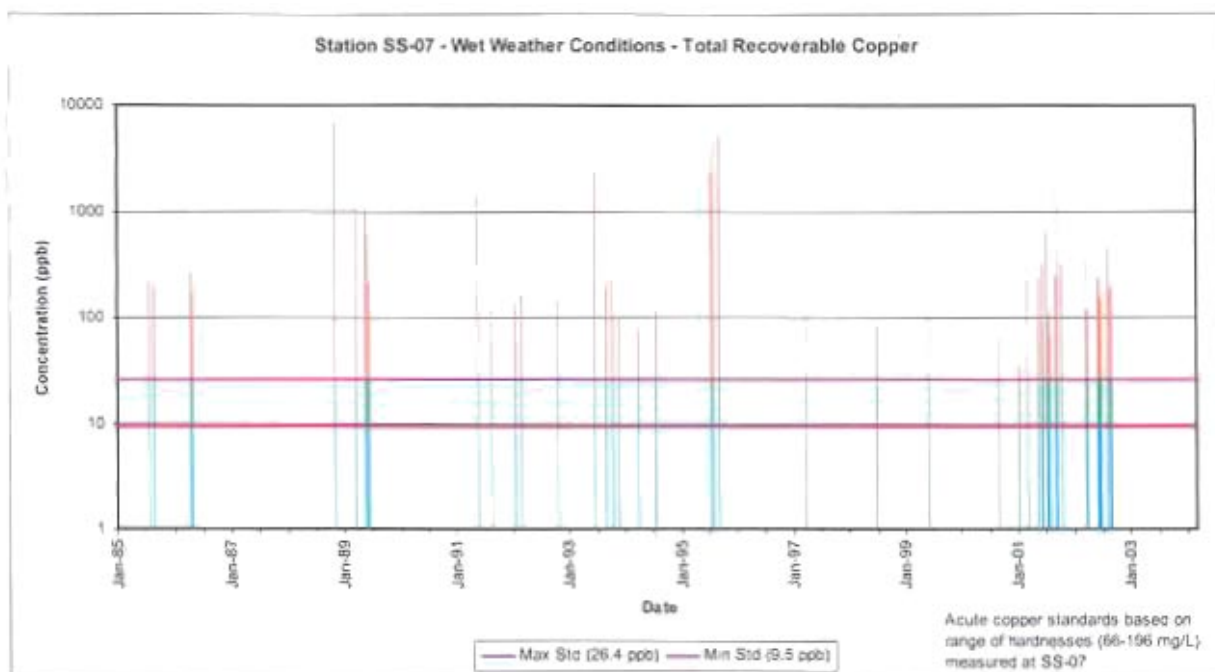
Figure 32 Wet Weather Total Recoverable Copper and Zinc Concentrations Over Time at SS-07

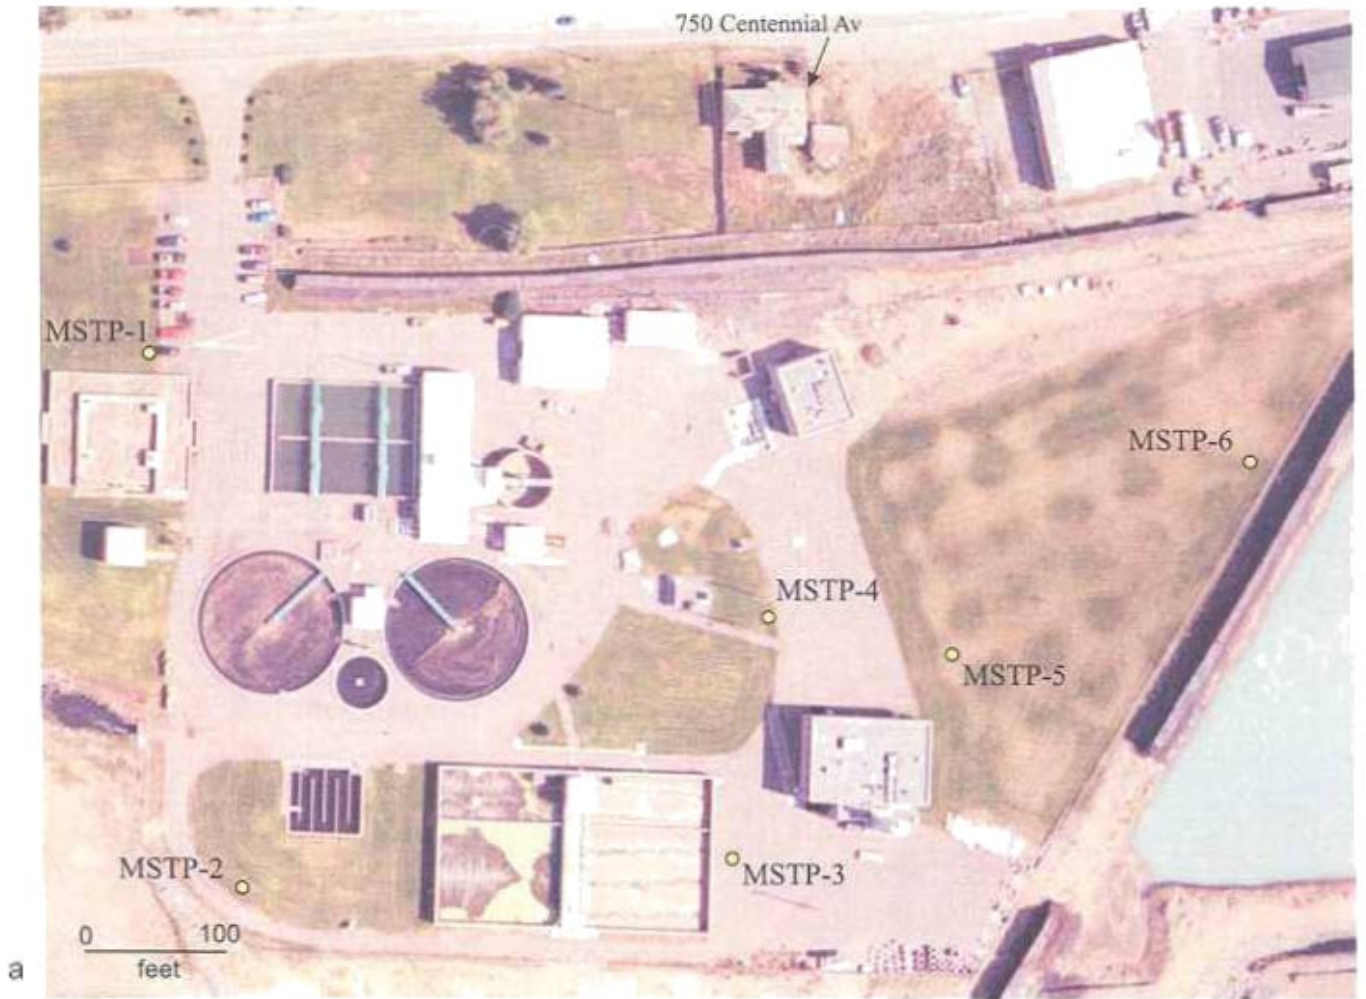
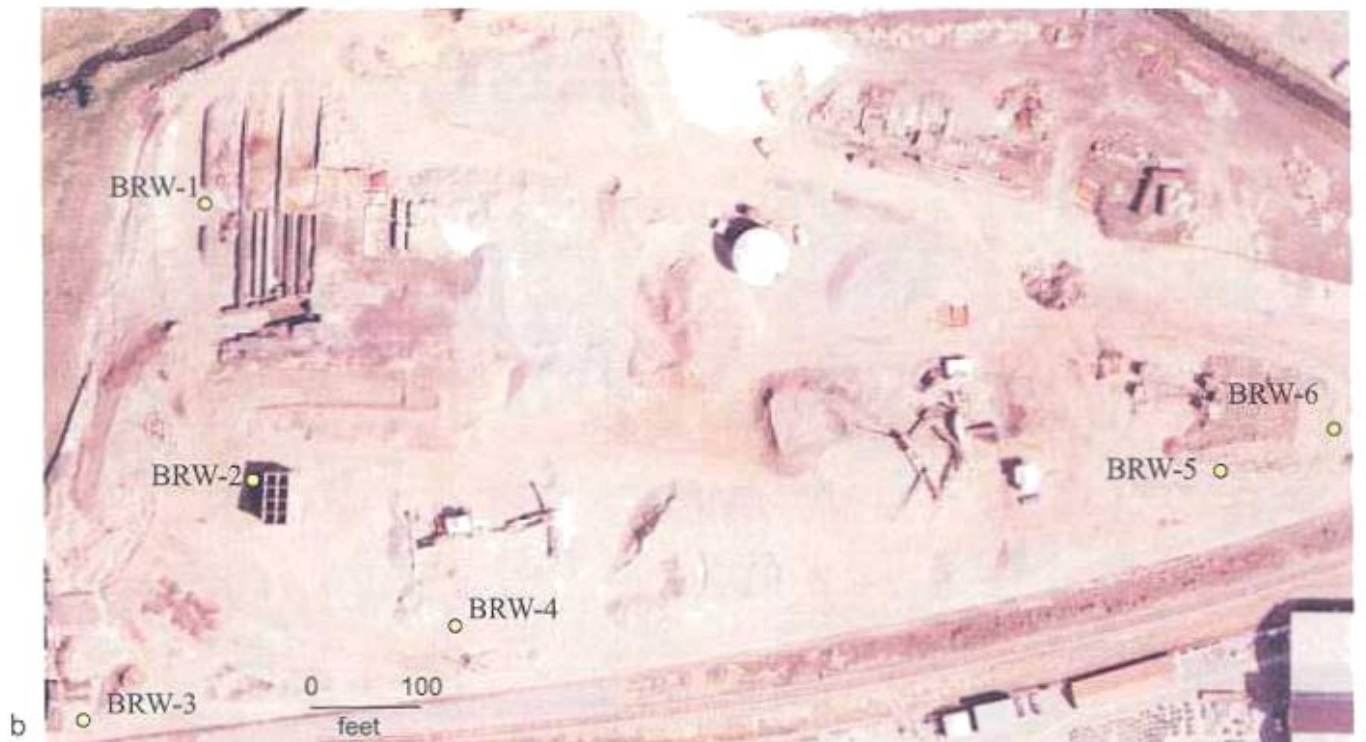
Figure 2--a) Six borings were drilled at the Butte Silver Bow Metro Sewage Treatment Plant, and b) six were drilled at the Butte Reduction Works. Compare (a) with figure 4; 750 Centennial Av. is shown in both.

Boreholes were drilled at six locations in the MSTP and at six locations in the BRW (figure 2); tailings were not encountered at either site. At MSTP, drilling at sites MSTP-2, MSTP-3, and MSTP-4 encountered massive slag that prevented the hollow stem augers and core barrel from advancing through the slag and into native material below. At these sites, slag was encountered less than 2 feet below the surface. The boring at MSTP-1 encountered fill to about 7.5 feet below land surface; the fill consisted of gravel-size pieces of slag in a sandy matrix; the material below

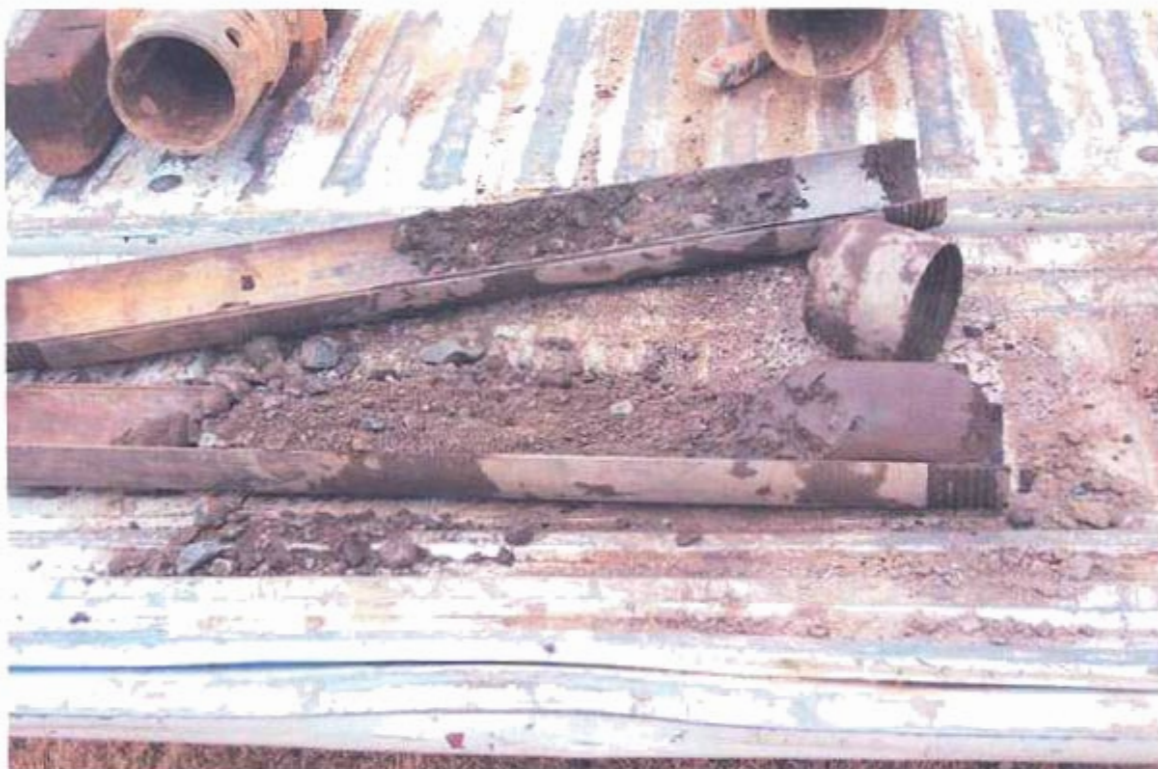
Figure 3--a) At site MSTP-5, slag and other fill were present to about 9 feet below land surface and overlie black silty clayey native material. b) A close-up photo showing slag in contact with native material.

the fill consisted of very coarse alluvium. At MSTP-5, slag was encountered at about 2 feet below land surface and persisted until about 9.5 feet below land surface at which point native black silty clayey material was encountered (figure 3). At site MSTP-6, the hollow stem auger and core barrel were advanced to about 6 feet below land surface before encountering hard material that prevented deeper penetration; this material appeared to be weathered bedrock.

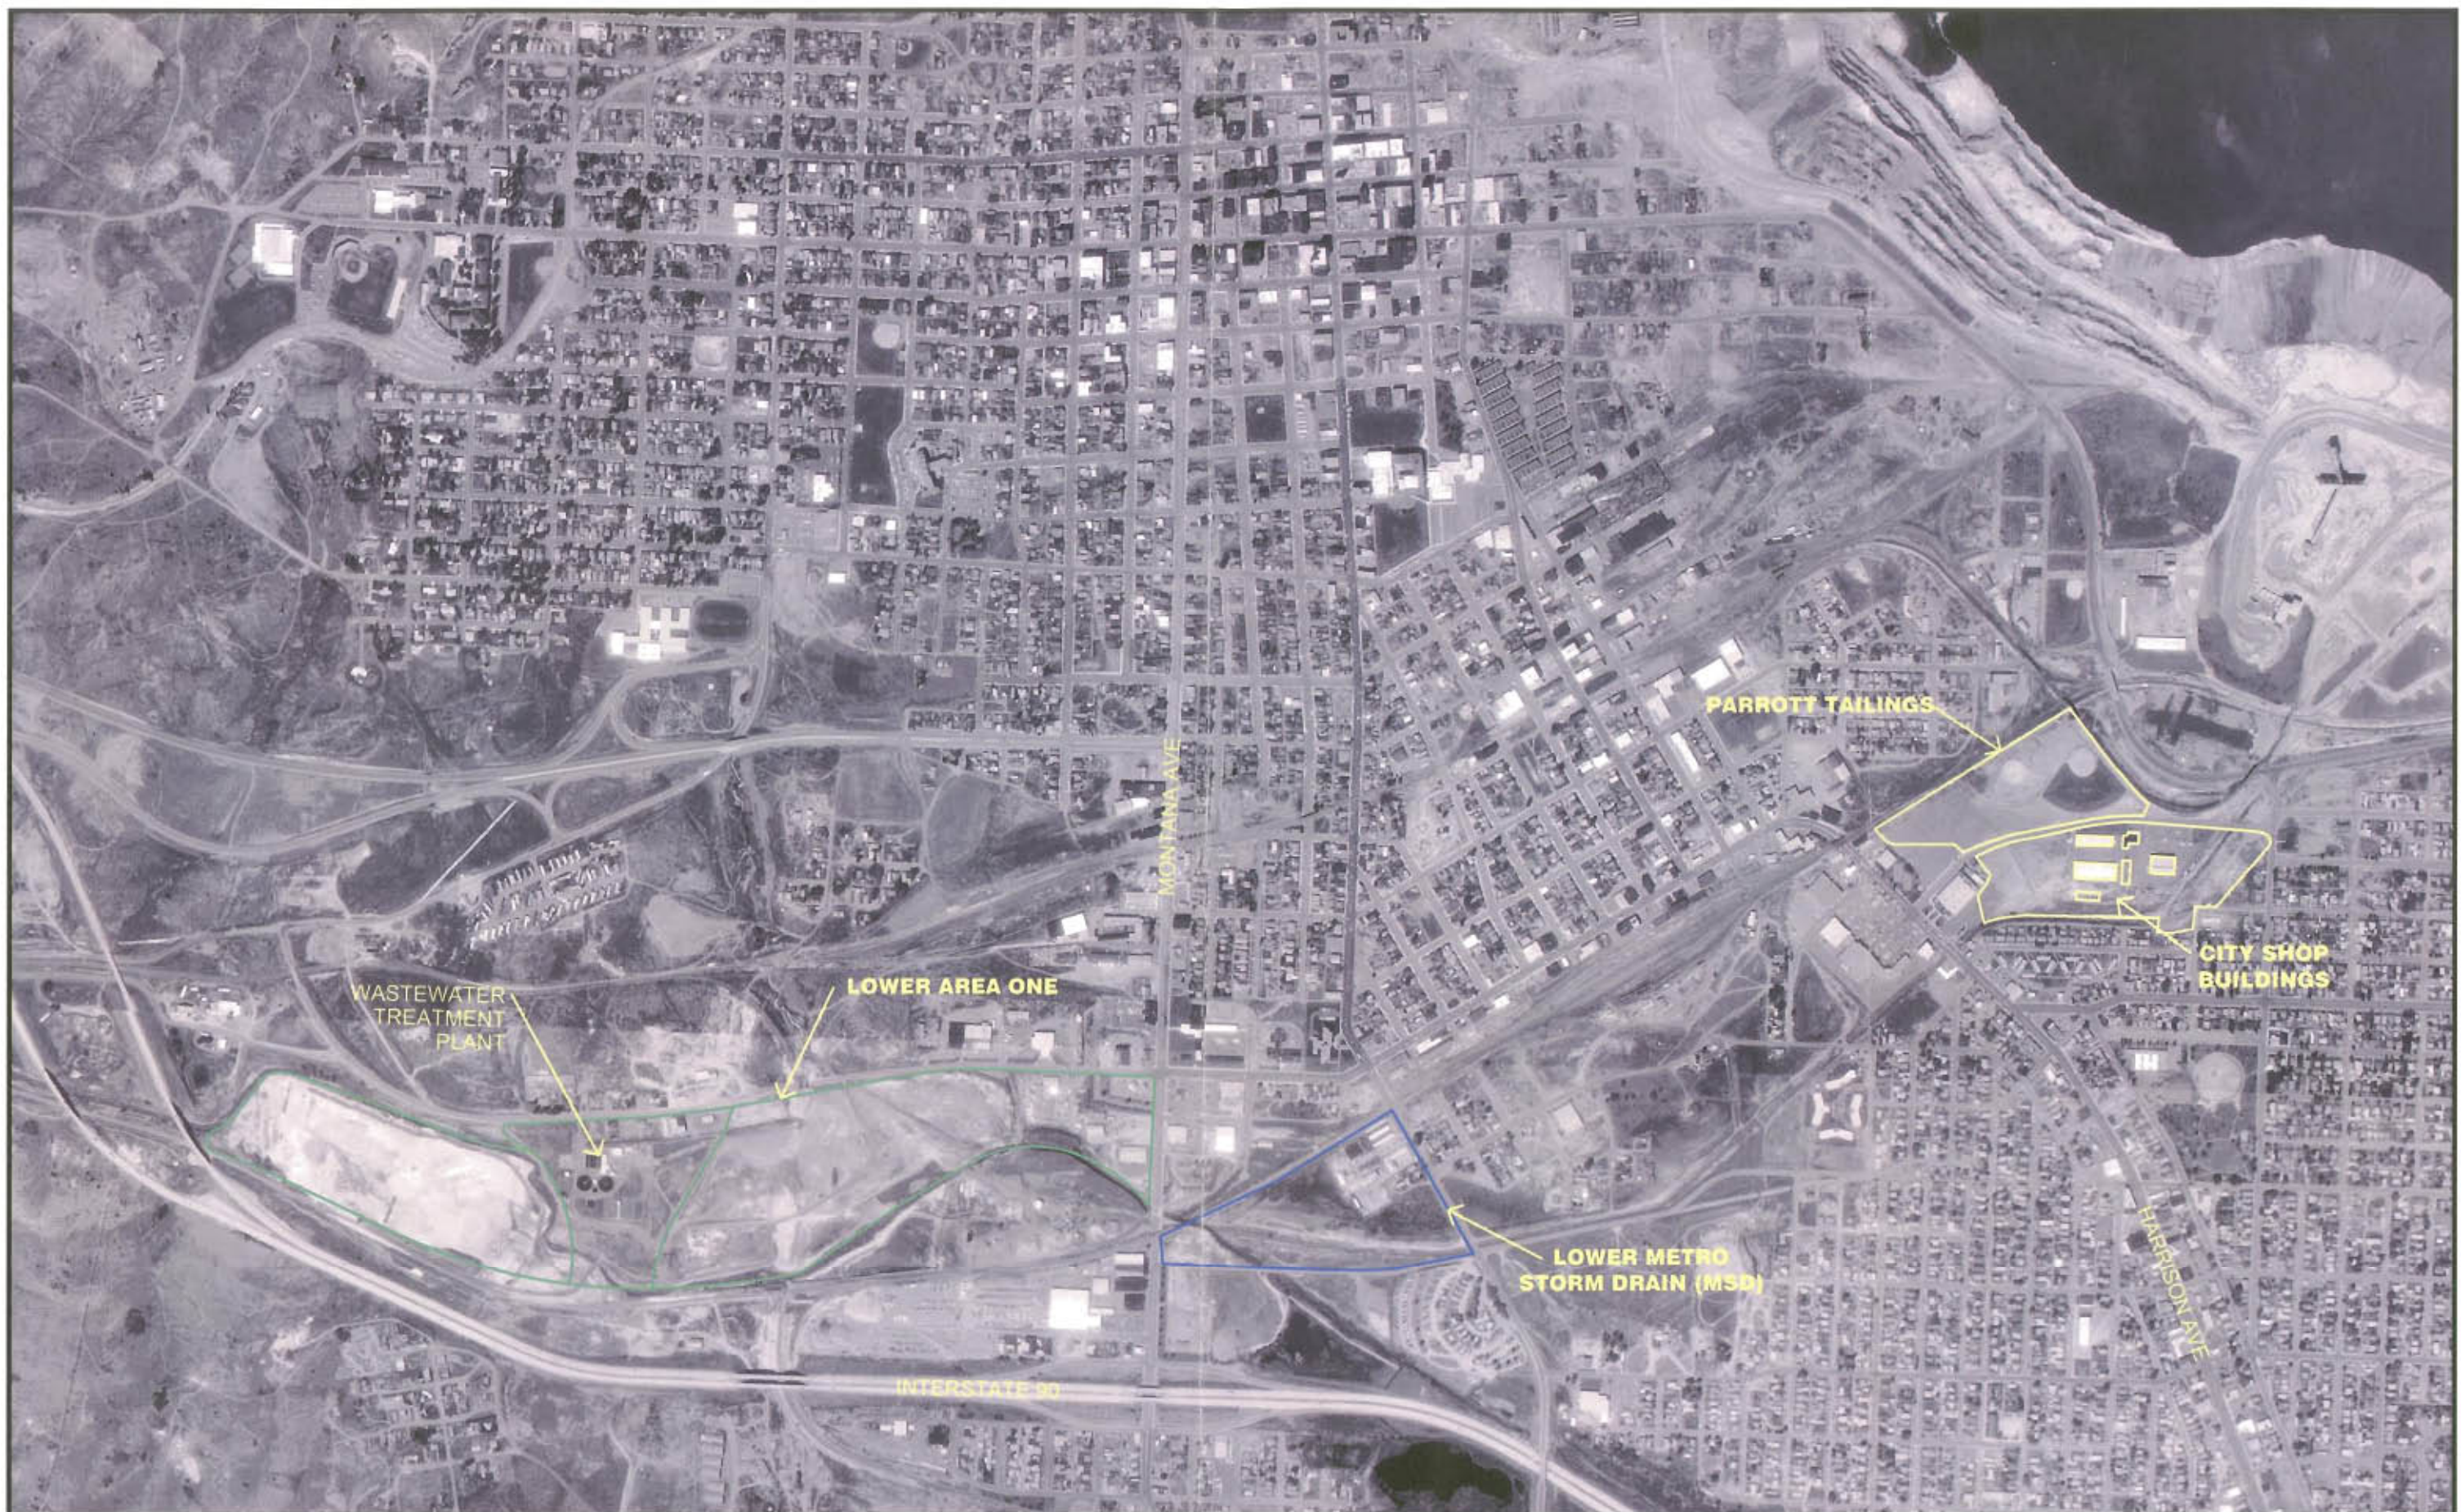
Figure 2

LOWER AREA ONE & LOWER METRO STORM DRAIN (MSD)

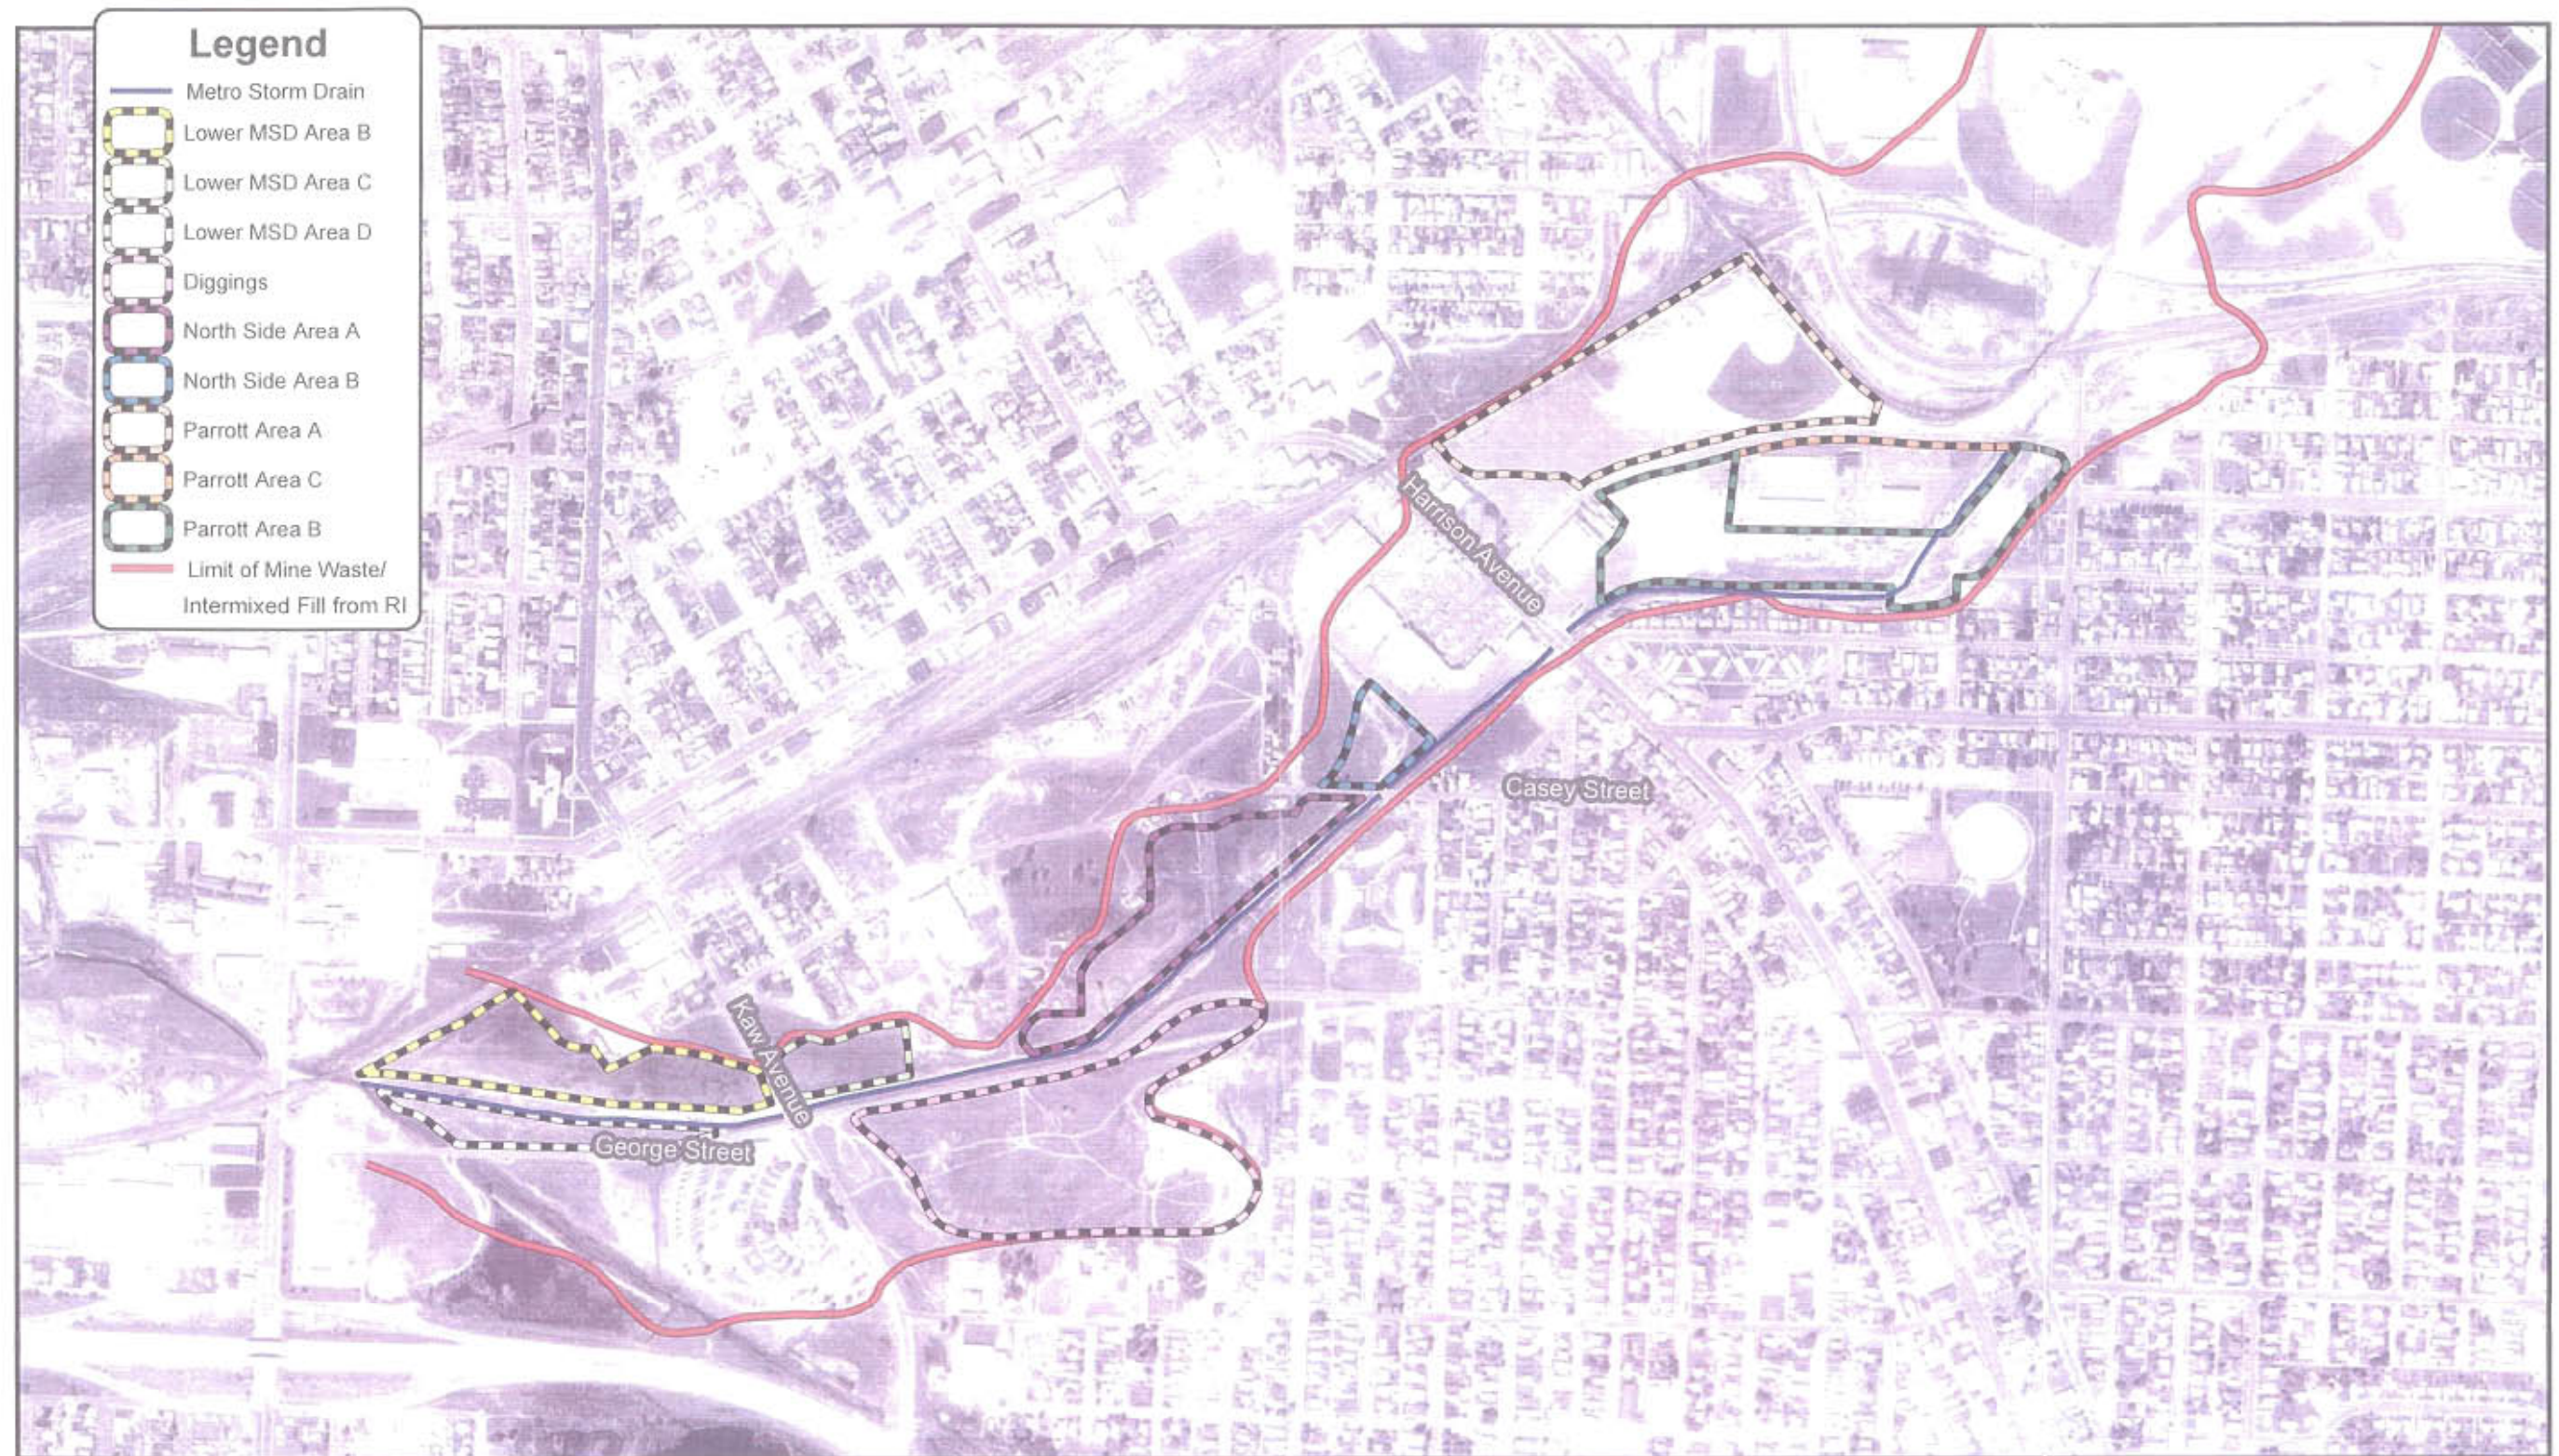
Figure 4. MSD Tailings
Boundaries
