QUALITATIVE ASSESSMENT OF HABITAT IN EIGHT TRIBUTARIES TO UPPER CLARK FORK RIVER

June 2009

**Dennis Workman,
Natural Resource Consultant
5449 Prospect Dr.
Missoula, MT 59808**

**Montana Natural Resource Damage Program
P.O. Box 201425
Helena, MT 59620**

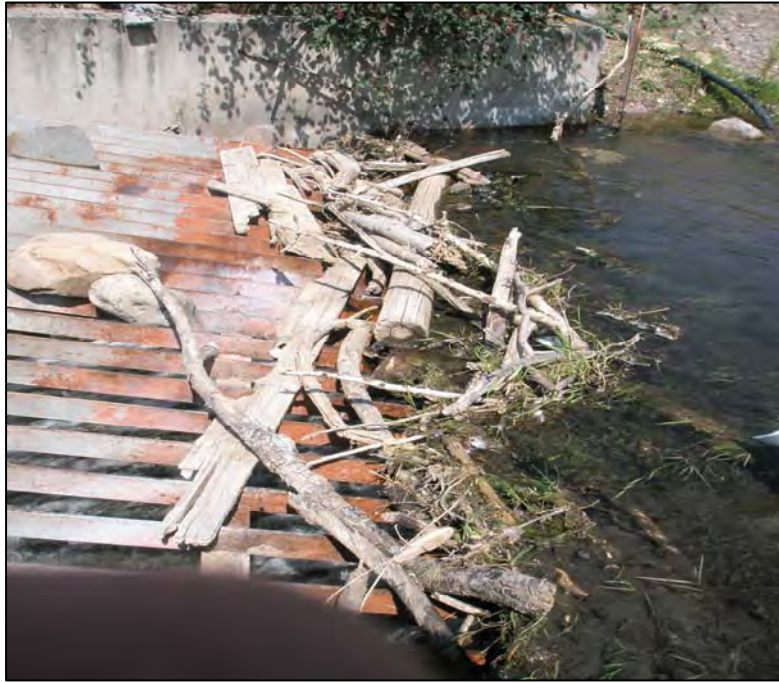
Photo C1 inlet of I-90 culvert steep apron under grate

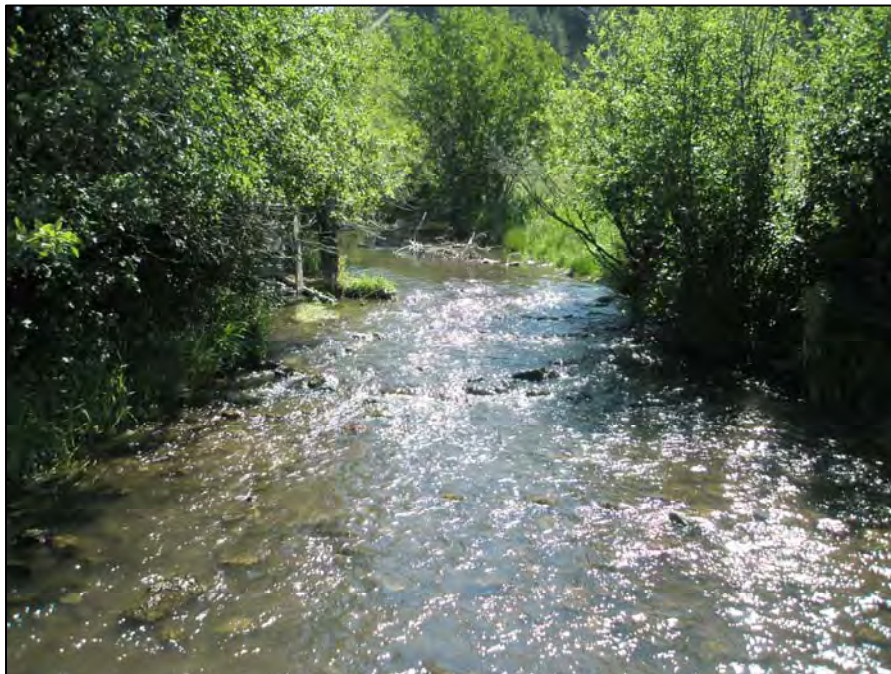
Photo C4 habitat in heavily wooded section

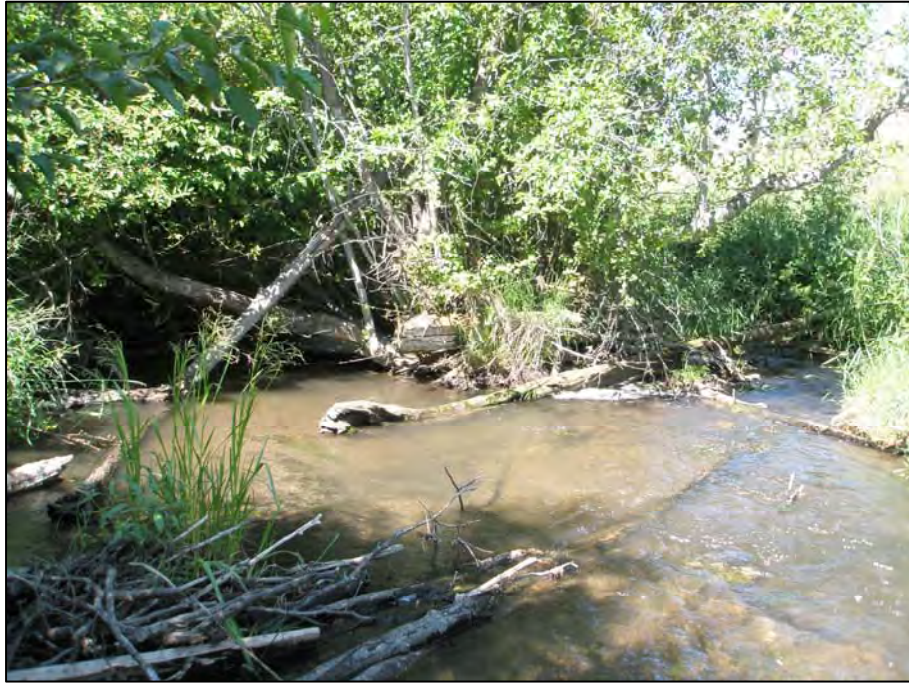
Photo C5 habitat in heavily wooded section

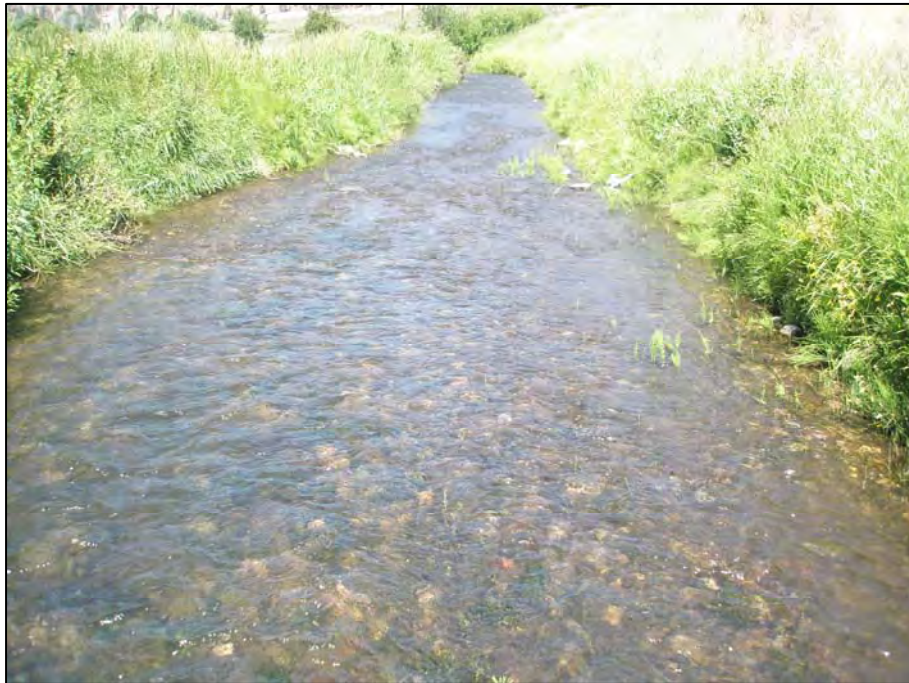
Photo C6 habitat in section with grasses

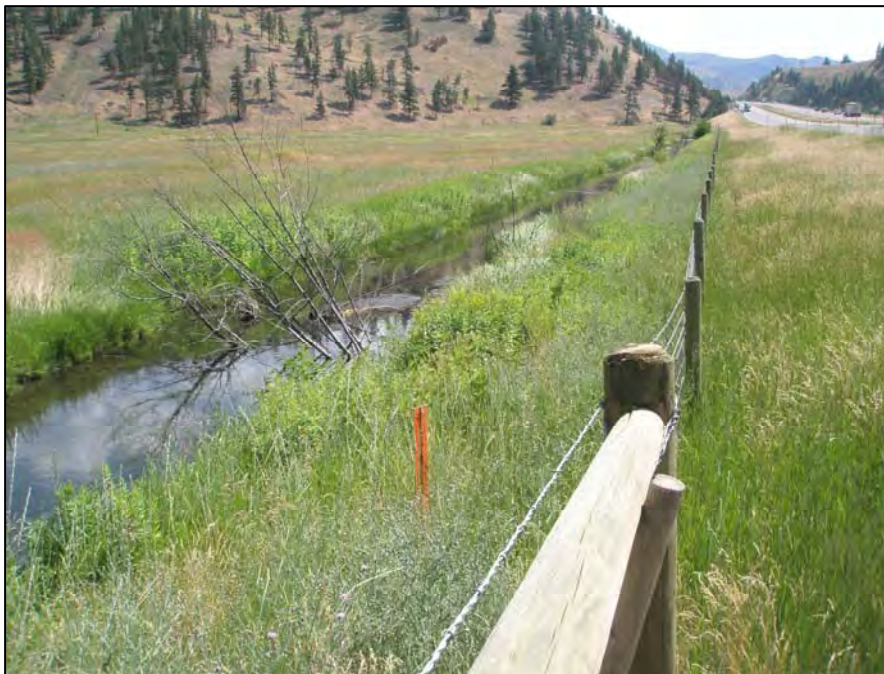
Photo C8 Cramer Cr north of I -90

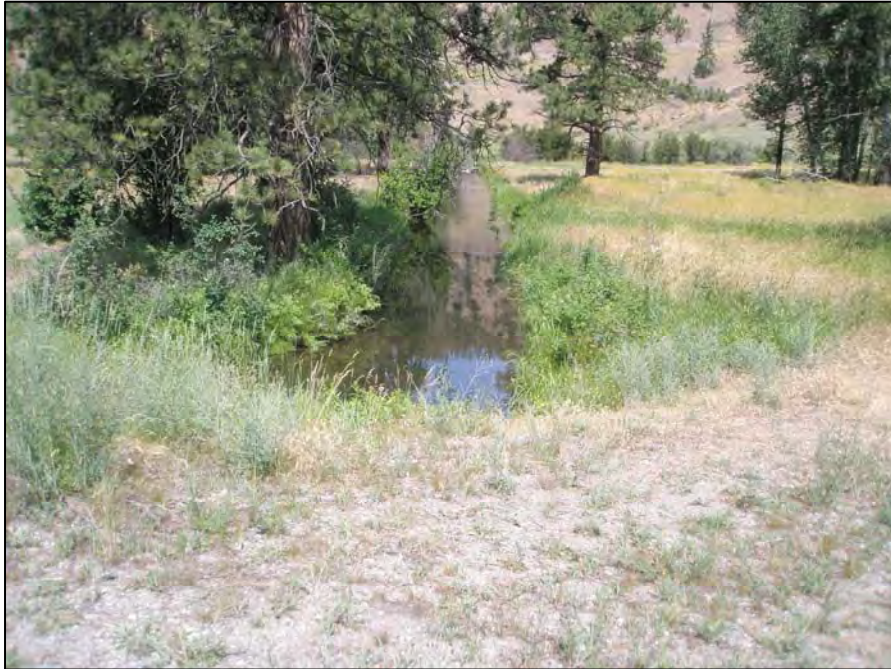
Photo C9 Cramer Cr. north of I-90 flowing toward pond

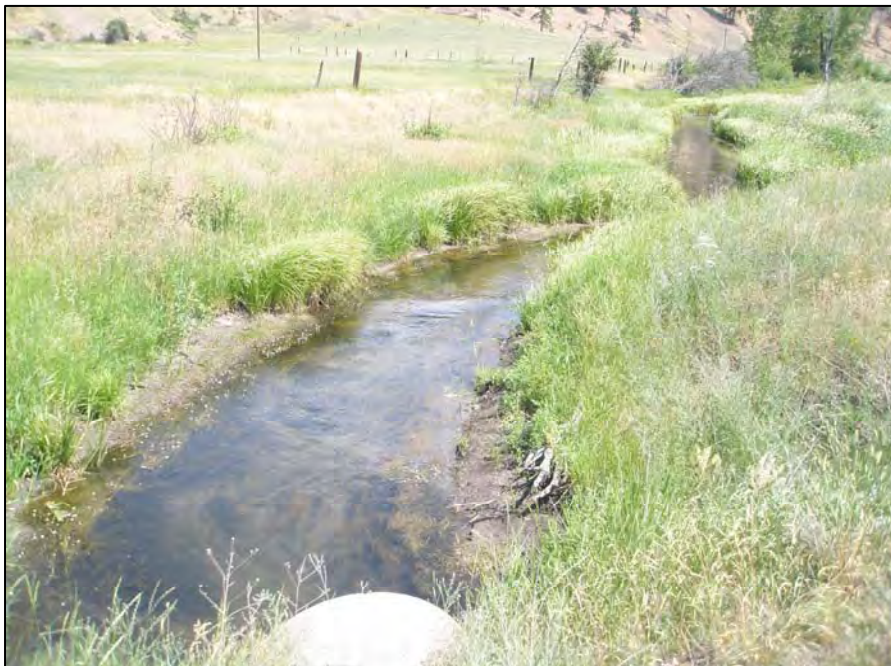
Photo C10 Cramer Cr north of I-90 flowing out of pond toward highway

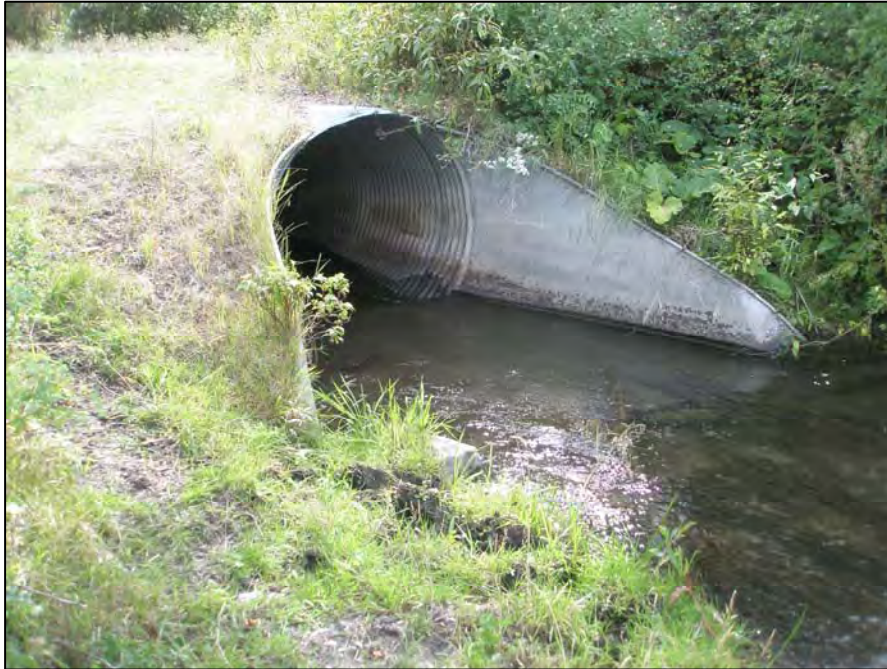
Photo C13 McFarland culvert inlet

1. Remove the old culvert and debris jam at the mouth (Reach 5) to facilitate fish passage (Photos C14 and C15).
2. Restore low gradient reach (Reach 4) from the river upstream to the MRL culvert (Photos C11 and C12). McFarland's culvert (Photo C13) may be set too high, creating a backwater during runoff and sediment accumulation in this reach.
3. Increase woody riparian vegetation on all reaches where wood riparian vegetation is lacking.
4. Explore water rights acquisition on this section of Cramer Creek.

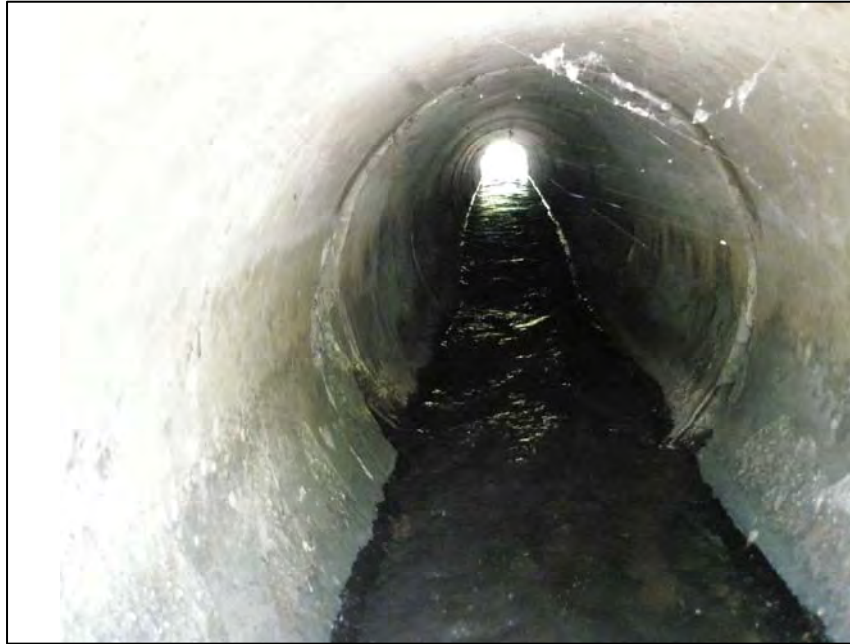
Photo C19 interstate culvert

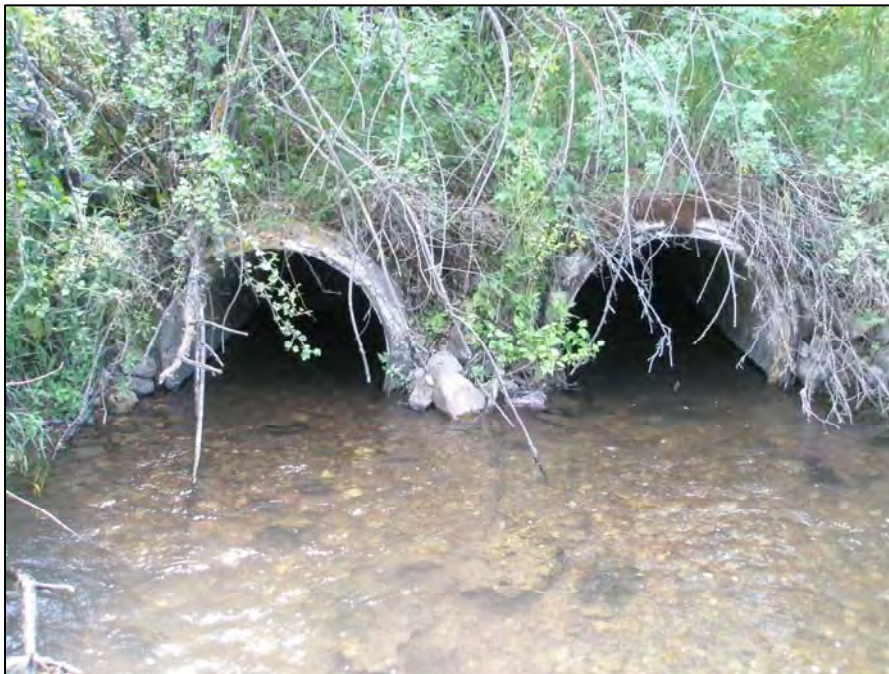
Photo C20 railroad culverts

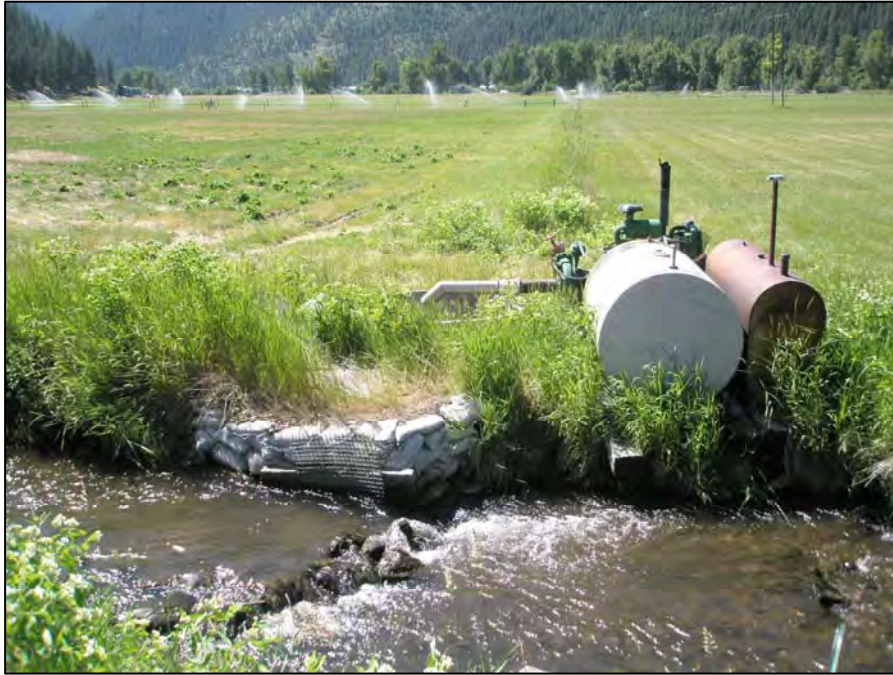
Photo C21 irrigation pump and check dam

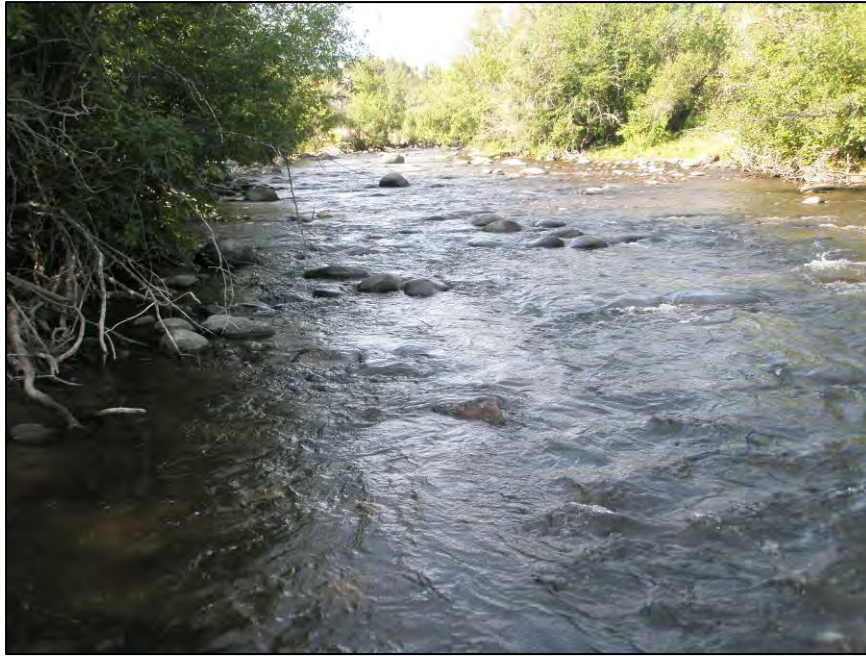
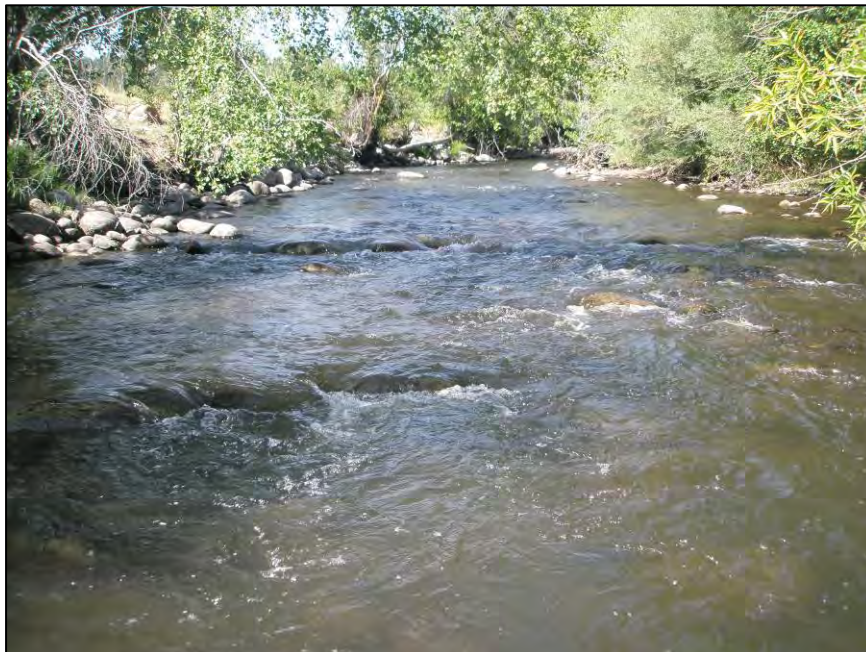
The channel from the Allendale Diversion to the highway was dominated by small to medium sized boulders and cobble. The banks were stable and lined with a mix of woody vegetation species, which provide some shading and a few undercut banks (Appendix D1, Photos 1 and 2). The railroad bridge, immediately upstream of the highway bridge, created a debris dam that has created a mid-channel island a short distance upstream (Appendix D1, Photo 3). There was no riparian fencing along either side of the reach and there was evidence of livestock accessing the creek (Appendix D1, Photo 4); however, the banks were stable and there was no sign of channel over-widening. Trout habitat consisted of pocket water around boulders and deep runs. Pools were in short supply in this reach.

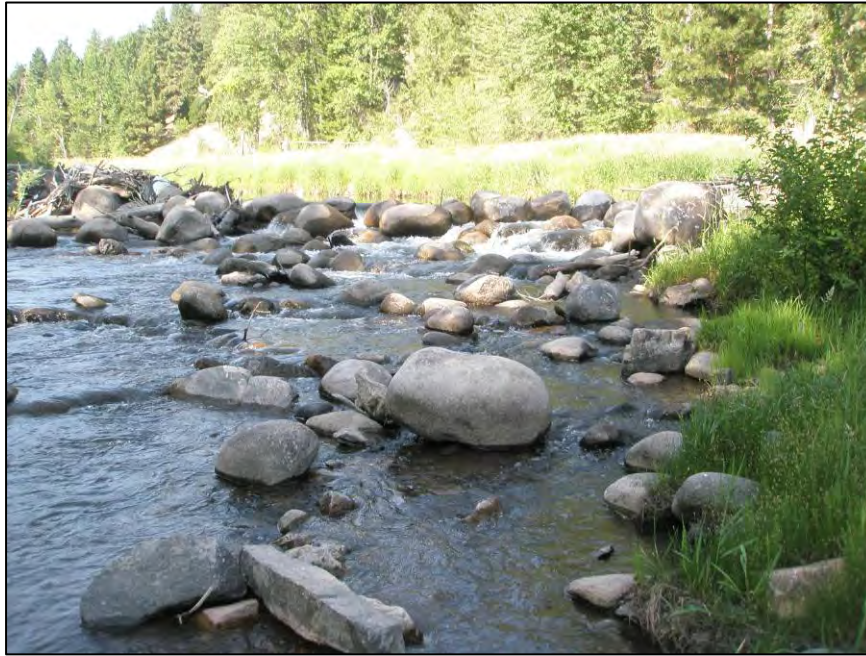
Photo 5

Reach 1 habitat and channel condition appeared to be relatively good (Appendix D1, Photo 9). The two large irrigation divisions are potential fish passage barriers; however, since

they are structures made of large rock they are porous and there could be ways for fish to get through or over them (Appendix D1, Photo 5). In spring runoff water apparently over tops them, as was evidenced by the woody debris collected on the top of the lower one, giving fish an opportunity for passage during that season (Appendix D1, Photo 6). The unscreened ditches they feed are potential entrapment hazards for fish. Fish passage and entrapment are the two most significant issues in this reach during good water years. Low flow could become an important issue in poor water years.

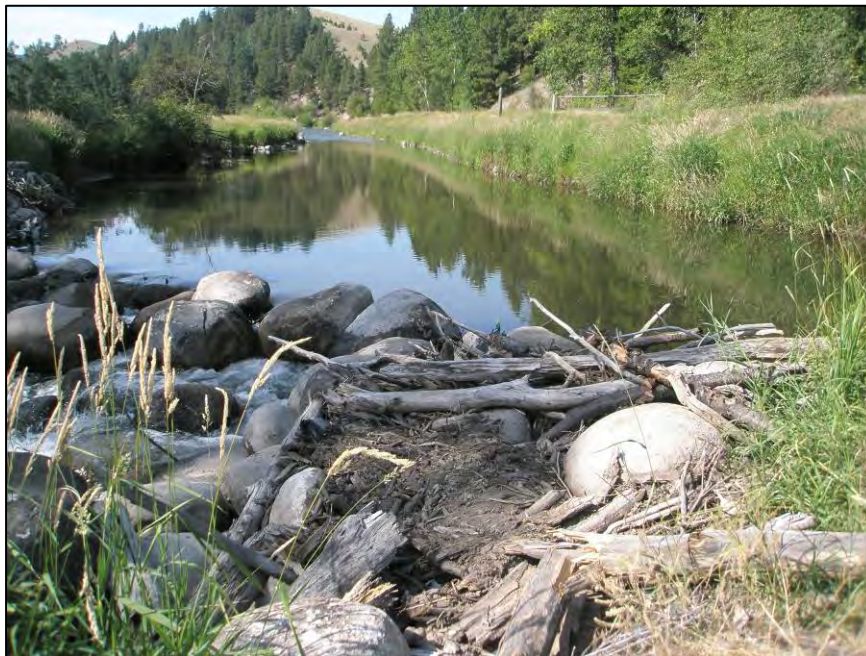
Photo 6

The creek channel between the two diversions was inundated by a long still pond created by the lower diversion (Appendix D1, Photo 6). Neither the Allendale nor the lower headgates had fish screens to prevent fish from being trapped in the canals (Appendix D1, Photo 7).

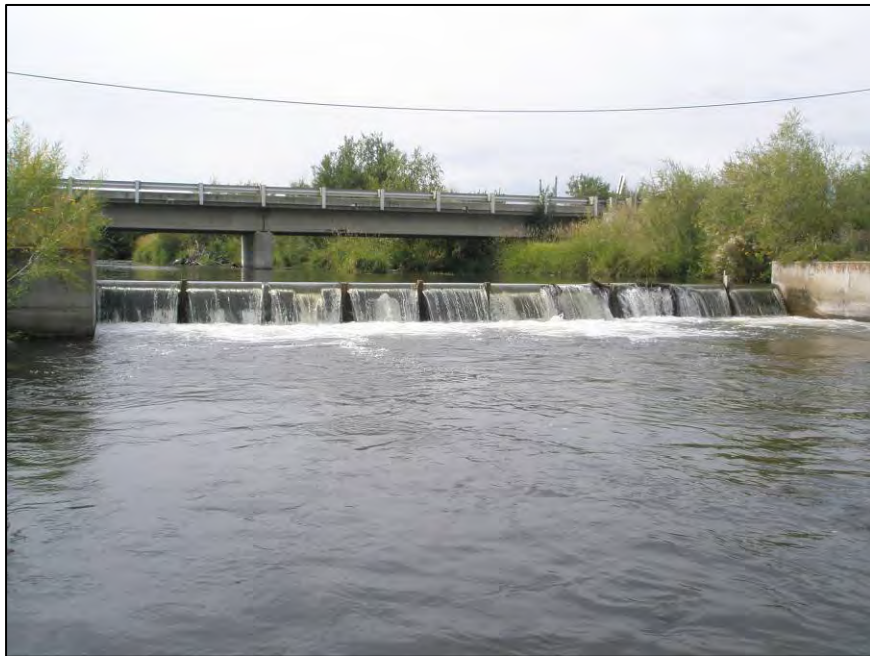
Photo 8

Seven diversions were located in this reach (Table D3). Immediately downstream of the Hall Bridge a concrete diversion dam crosses the creek (Appendix D4, Photos 8 and 9). This was a passage barrier not only for fish but also for anyone floating the stream during the irrigation season. There was a ditch going off each end of the diversion (Appendix D4, Photos 10 and 11). This structure had a concrete foundation with posts and planks that appeared to be removable (Appendix D4, Photo 9). Passage could be possible when the posts and planks are not in place. All of the other diversions in this reach used dikes made of streambed gravel to divert the water except one that used woven wire and fabric (Appendix D4, Photos 12 and 13). All ditches lacked fish screens, thus they all presented entrapment hazards for fish.

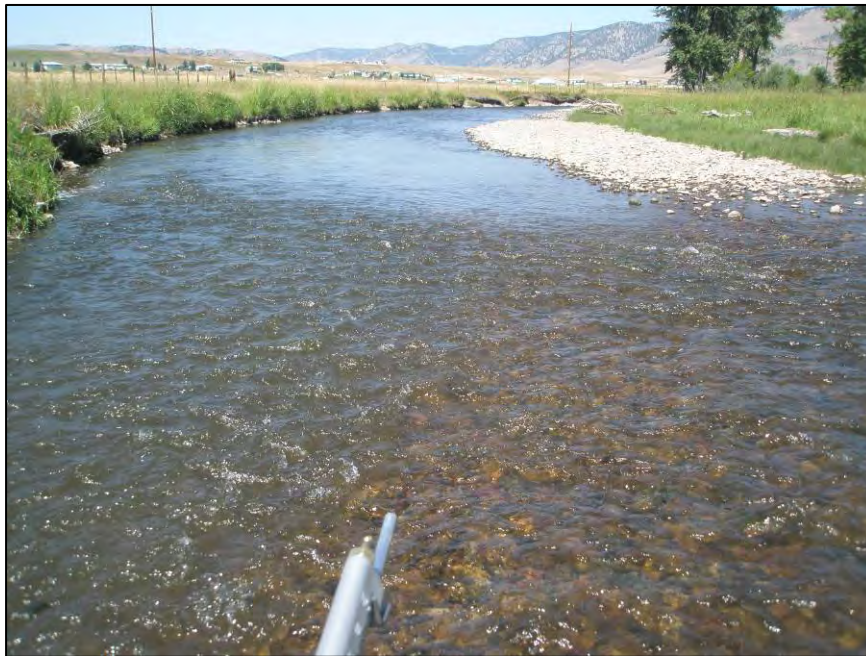
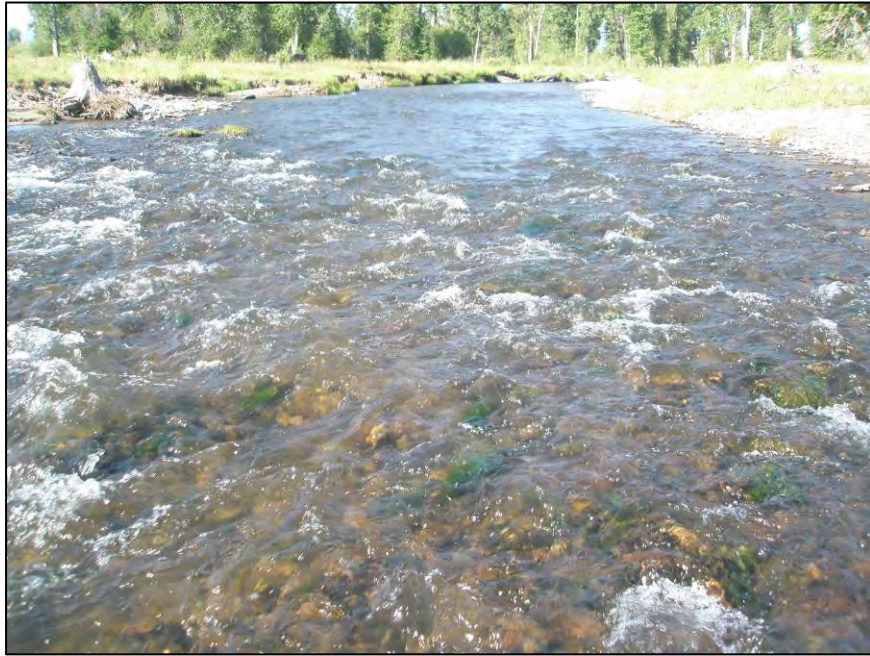
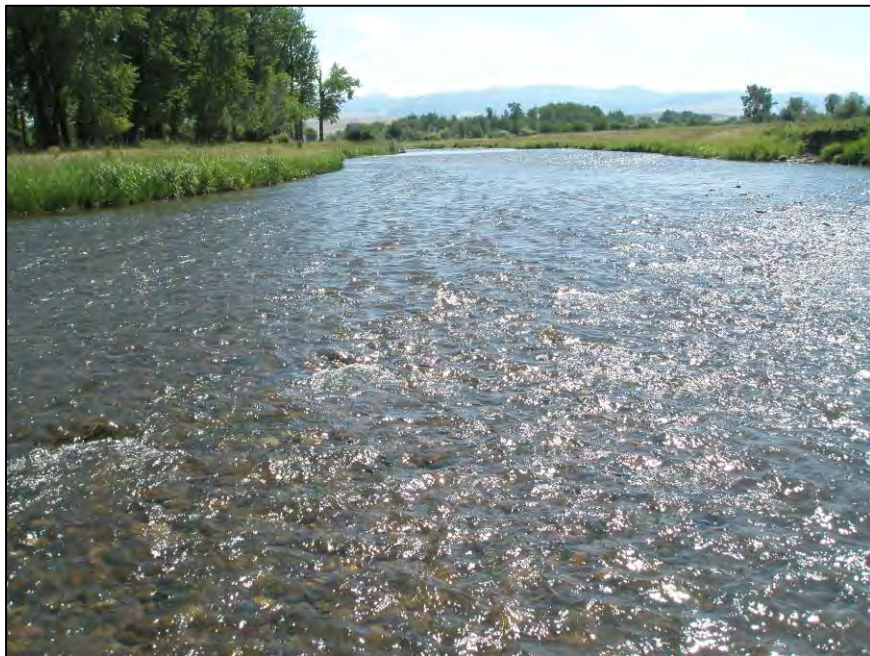
Throughout Reach 5 of Flint Creek, the stream bed composition was cobble, gravel and sand. Boulders and large cobble were no longer present. Habitat consisted of runs, riffles and pools with very few deep, high-quality pools (Appendix D5, Photos 4, 5, 6). The entire reach lacked woody riparian vegetation; however, streambanks were stable for the first 0.9 of a mile downstream from Mullan Road due to heavy cover of tall grass (Appendix D5, Photos 7, 8, 9). This portion of the reach was evidently fenced on both sides since there were no recent signs of livestock accessing the stream. Without the deep binding root mass of woody riparian vegetation there were few undercut banks. Without woody riparian vegetation there was no shading and no large woody debris in the reach except on a bend a short distance upstream of the mouth (Appendix D5, Photos 10 and 11).

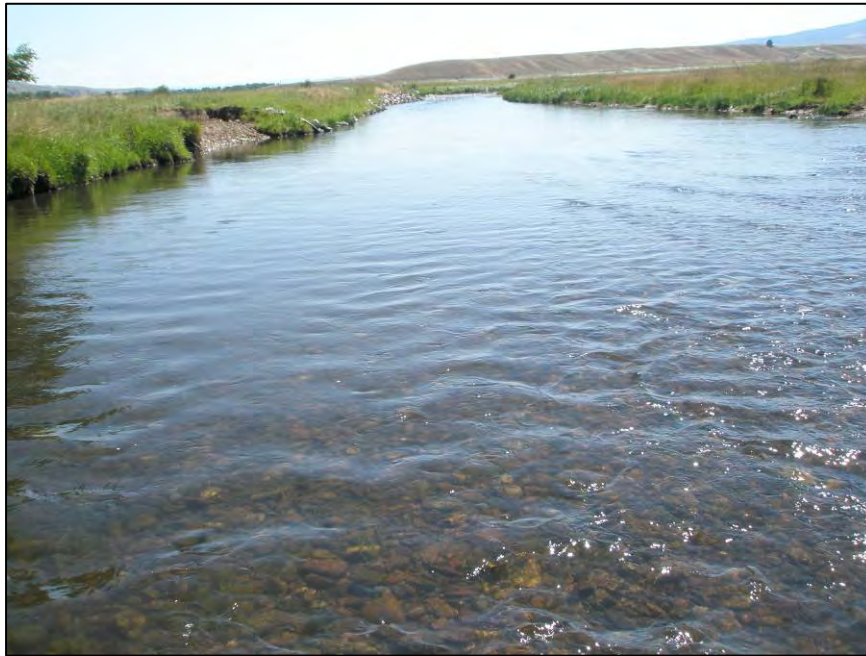
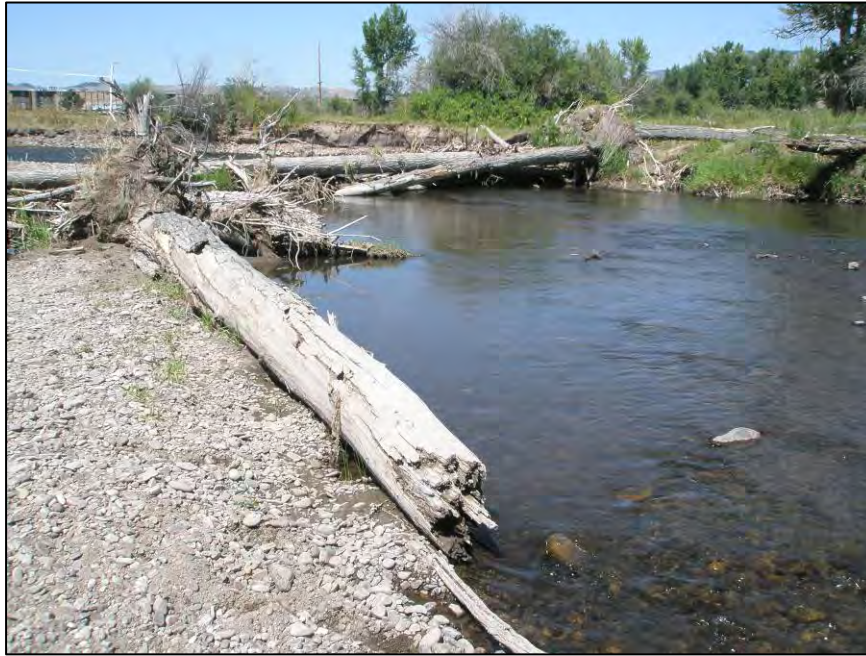
There was evidence of mechanical straightening in the lower mile of the reach that was probably done many years ago (Appendix D5, Photo 12 and 13). This, along with the lack of woody riparian vegetation, has resulted in over widening of the channel in the lower mile of the reach (Appendix D5, Photos 10 and 14). Livestock have access to the lower 1.6 miles, resulting in eroding streambanks and a lack of woody riparian vegetation.

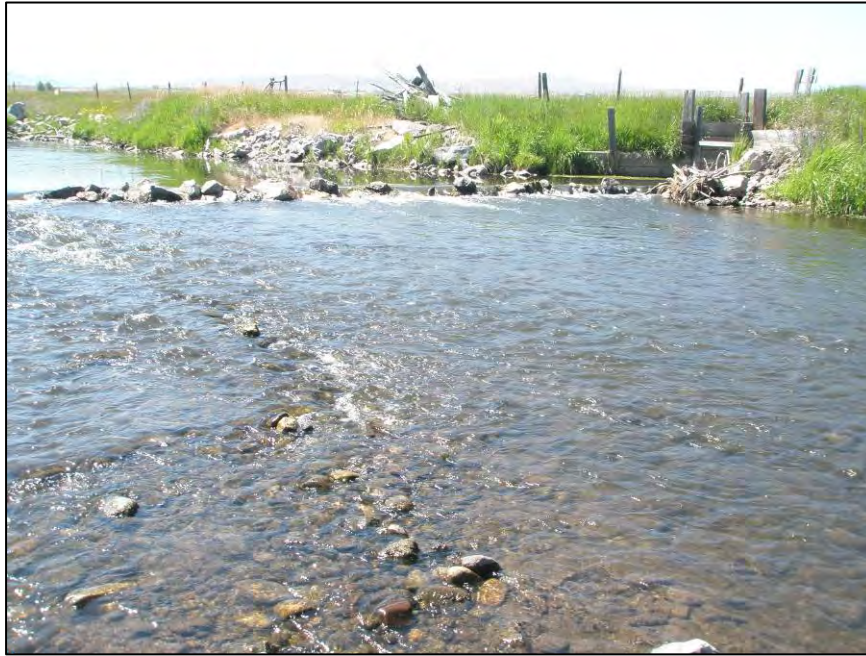
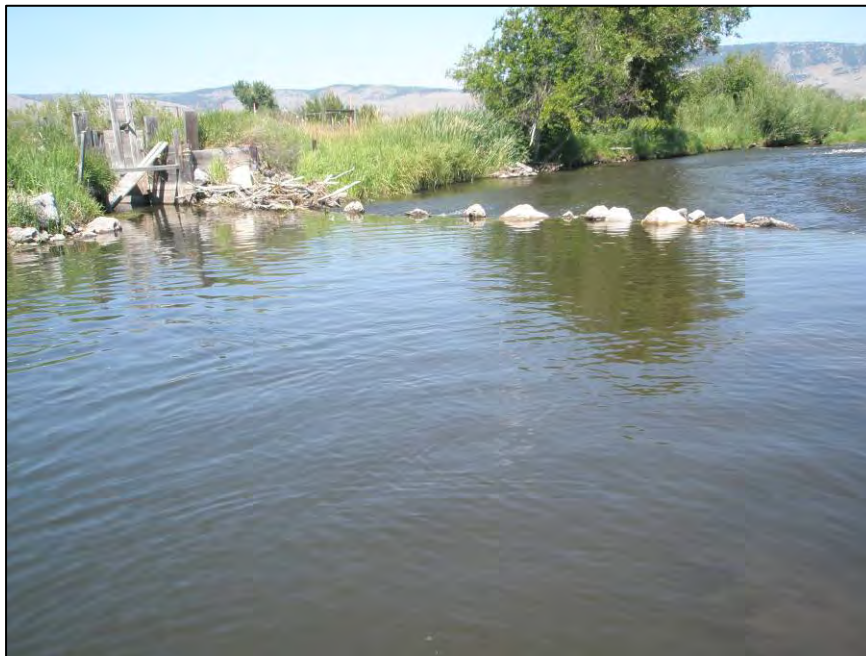
Only one diversion was found in Reach 5. It had a rock diversion dam and wooden headgate on the left bank approximately 0.7 mile downstream from Mullan Road (Appendix D5, Photos 15 and 16). At the time of the survey, it was diverting approximately 1 cfs. This diversion lacked a fish screen.

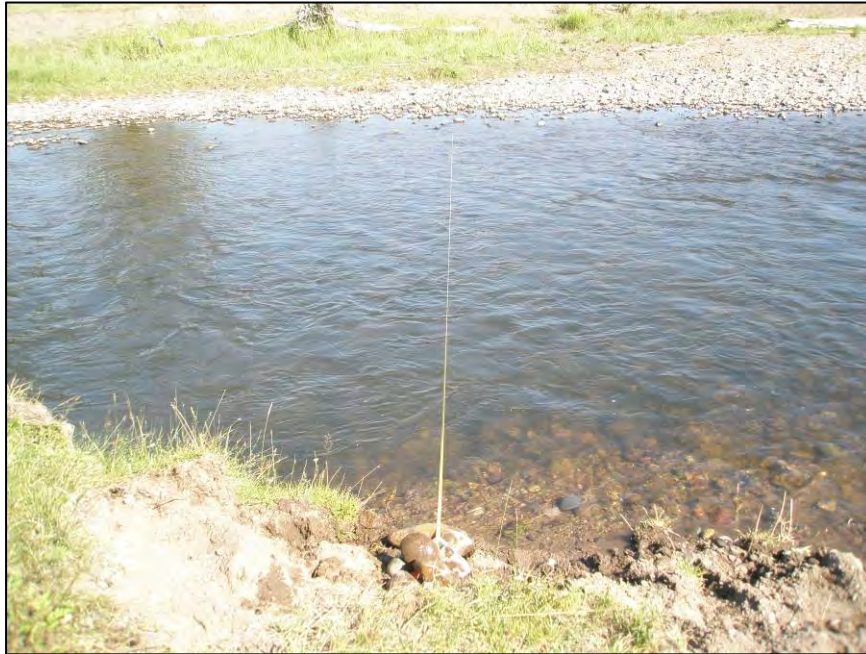
Photo 17

On the day of the survey, the USGS gage at Mullan Road measured 59 cfs, and at the mouth the flow was measured at 60 cfs (Appendix D5, Photo 17). Under these flow conditions habitat quality was fair but it would be poor under lower flow conditions.

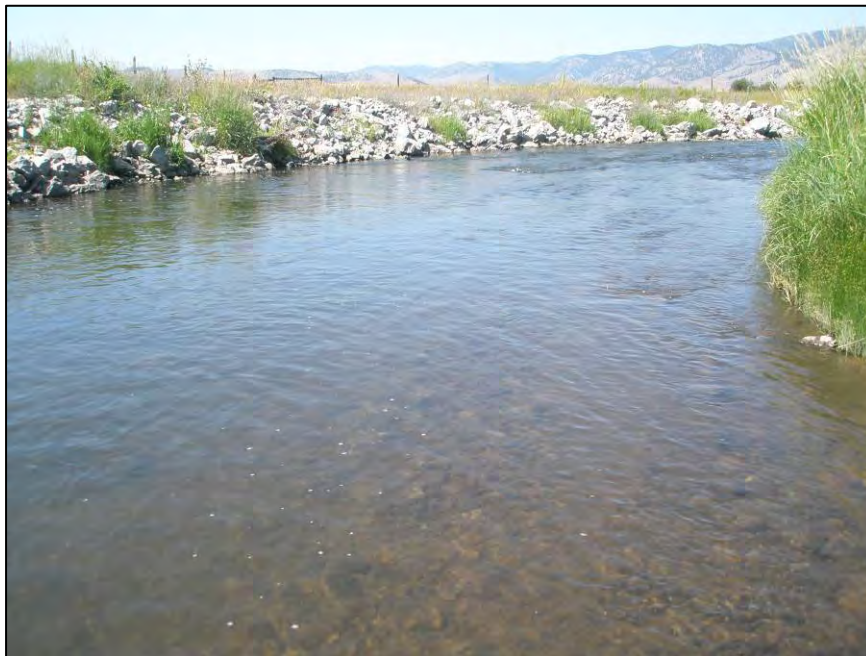
Photo 18

Reduced grazing pressure for the first 0.9 of a mile, downstream from the Mullan Road Bridge, the use of heavy grass cover and streambed-cobble rip-rap have improved channel stability and habitat conditions in this portion of the reach (Appendix D5, Photo 18). Although heavy grass cover improves channel stability, it does not provide the shade, deep binding root mass or other amenities that come with woody vegetation. In addition, the heavy grass cover could prevent the establishment of woody bank cover. Woody vegetation would require help to become reestablished in this portion of the reach. The entire reach will need some work to begin to restore it to a high quality habitat condition.

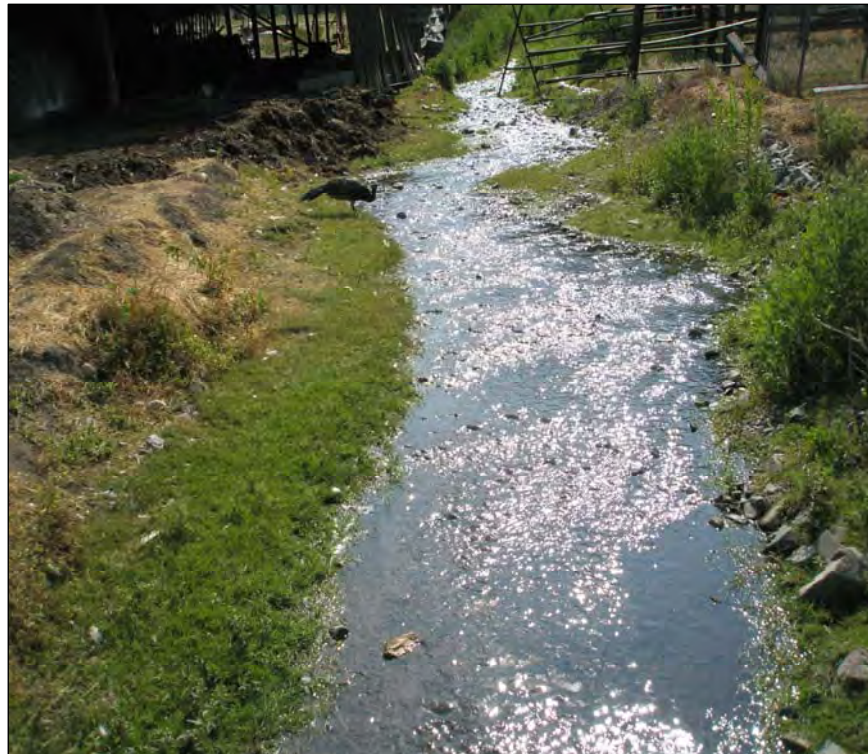
Photo E2. Gillespie Creek above barnyard bridge

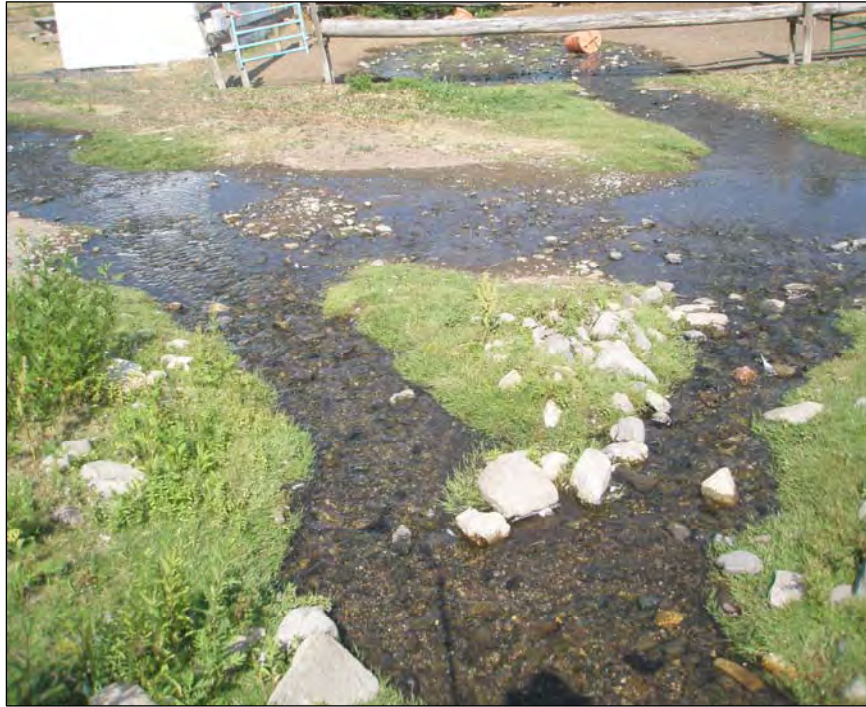
Photo E3. Gillespie Creek below barnyard bridge

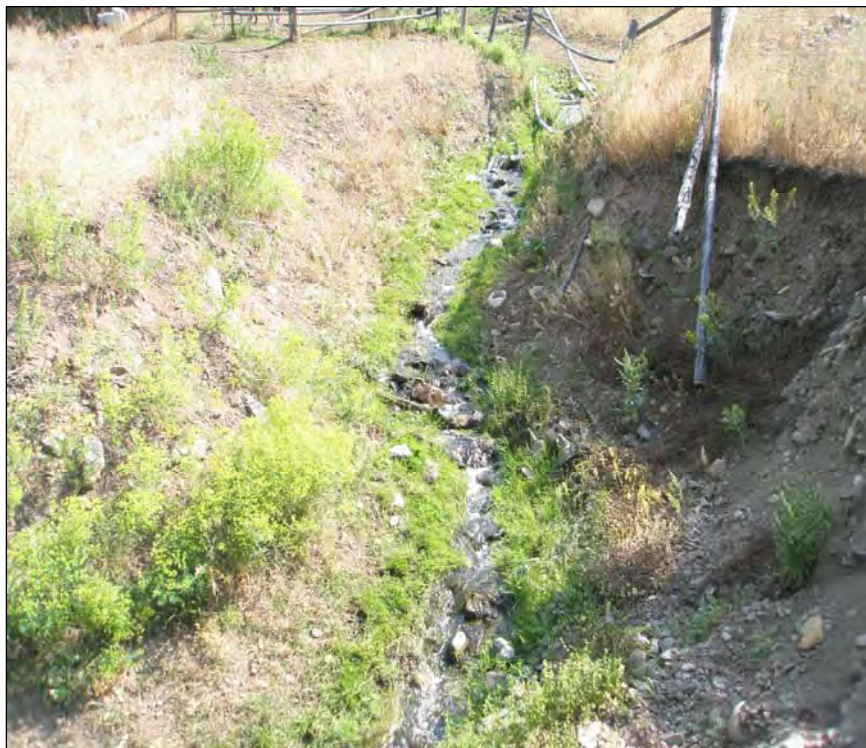
Photo E4. Gillespie Creek leaving barnyard

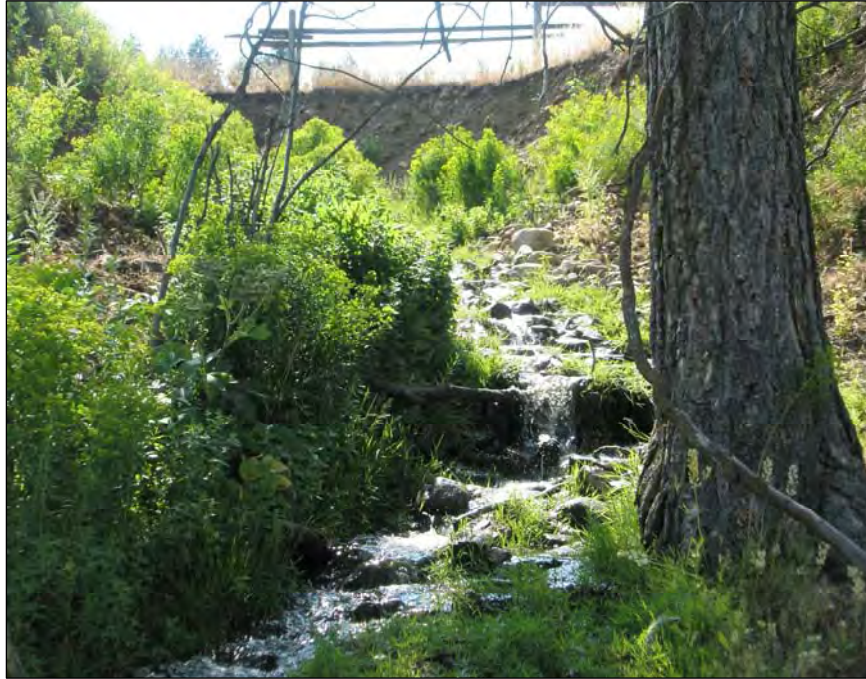
Photo E5. Gillespie Creek near base of bench

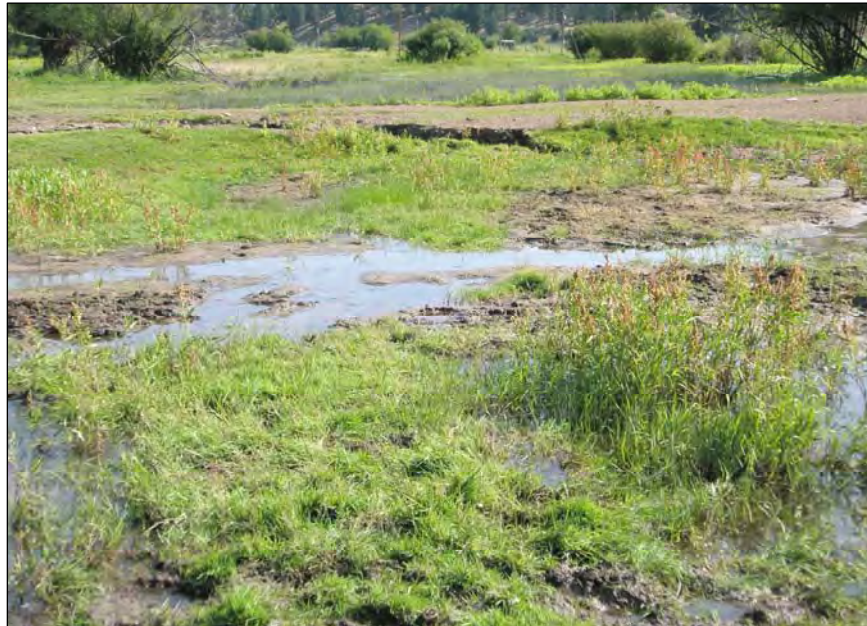
Photo E6. Gillespie Creek on the river terrace

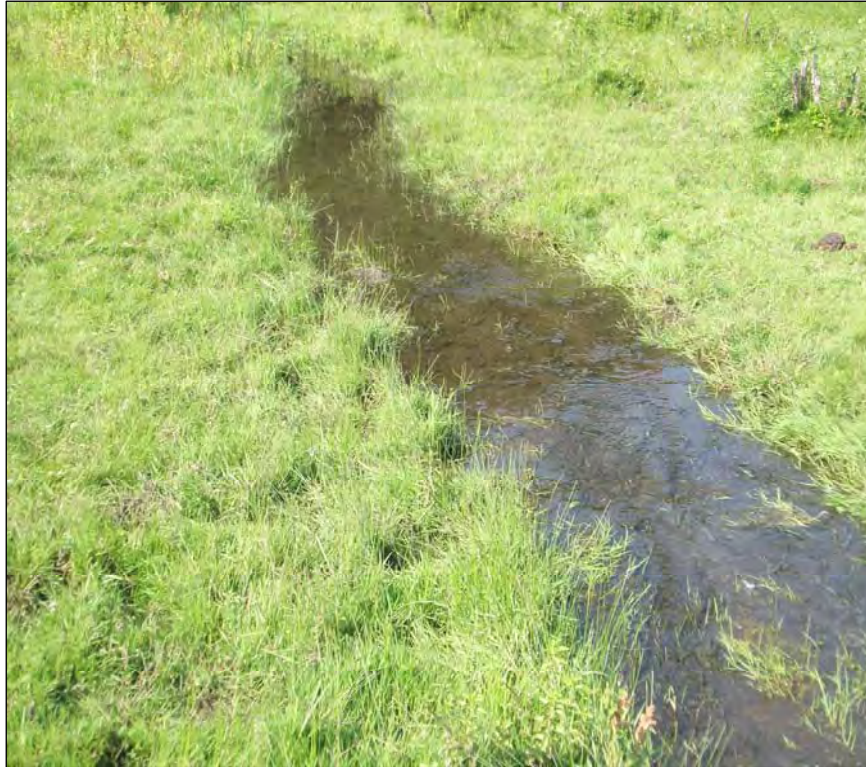
Photo E7. Gillespie Creek in old river channel

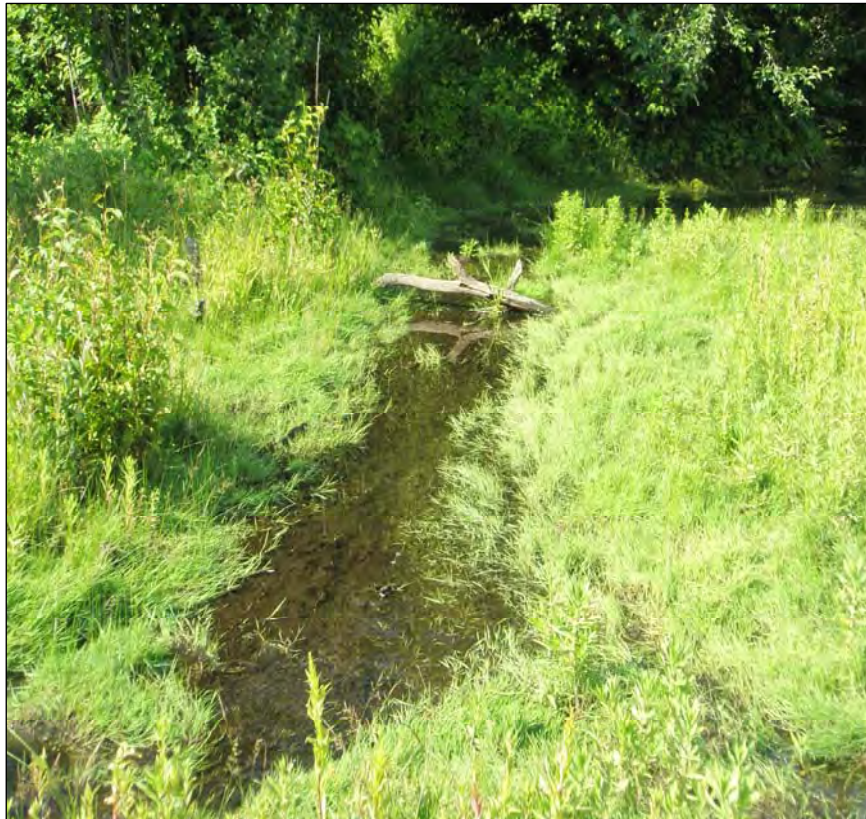
Photo E8. Gillespie Creek in old river channel

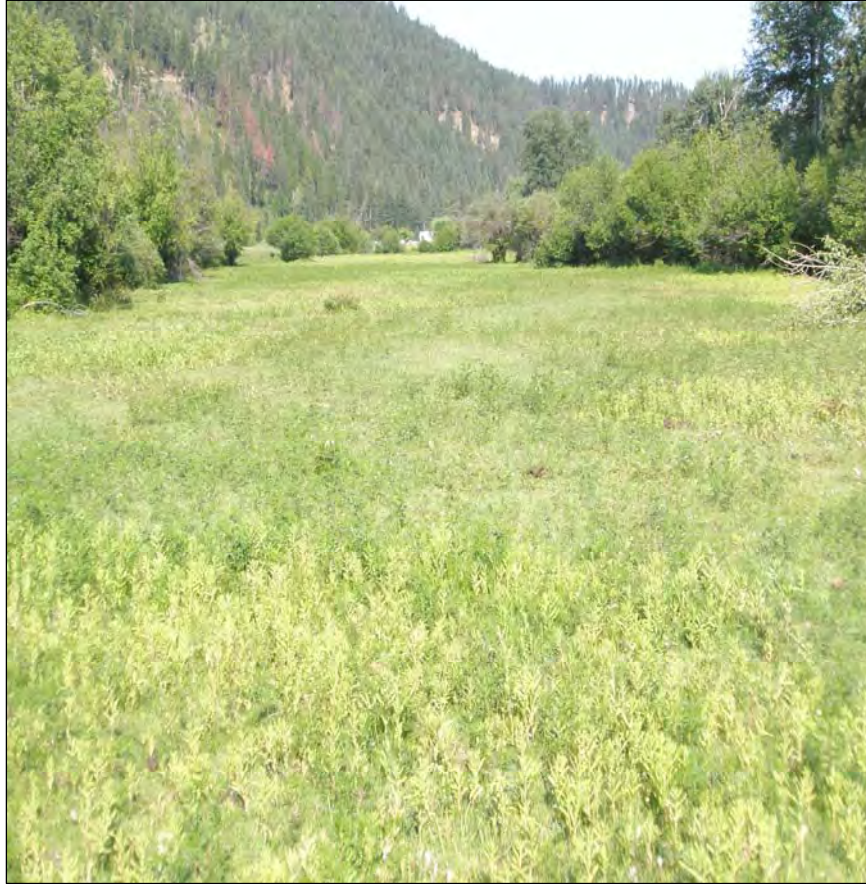
Photo E9. Old river channel that carries Gillespie Creek

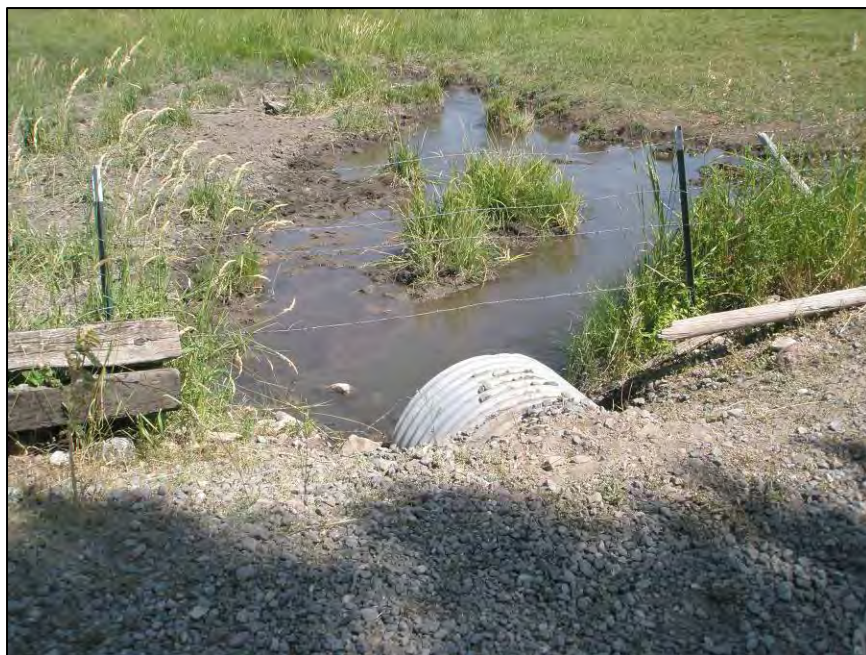
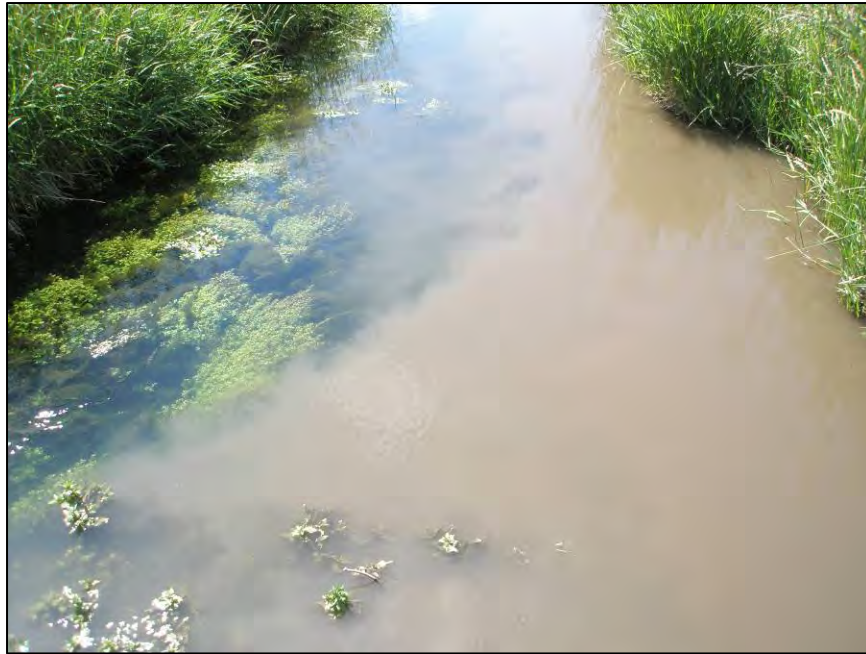
Photo F12

From the point that it leaves the mountains until it disappears in the large irrigation ditch, it flows through man-made ditches and channels. Upstream of I-90 it is in a ditch along either the east or west side of the hay field/pasture where there is very little woody riparian vegetation. Habitat quality is poor throughout the entire 1.8 miles of stream surveyed. Livestock have damaged the streambanks and created water quality problems (Photos F12 and F13).
