QUALITATIVE ASSESSMENT OF HABITAT IN EIGHT TRIBUTARIES TO UPPER CLARK FORK RIVER

June 2009

**Dennis Workman,
Natural Resource Consultant
5449 Prospect Dr.
Missoula, MT 59808**

**Montana Natural Resource Damage Program
P.O. Box 201425
Helena, MT 59620**

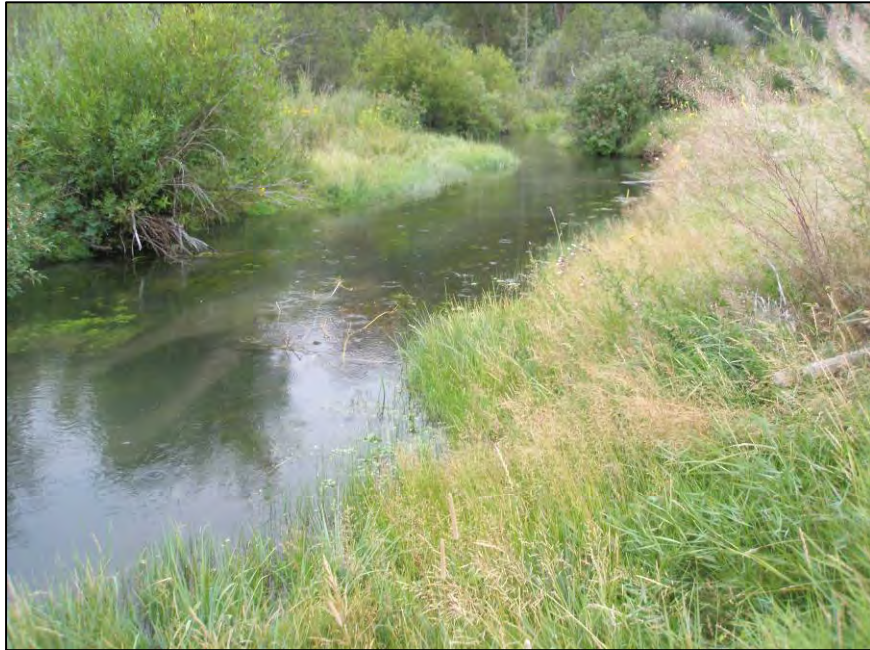
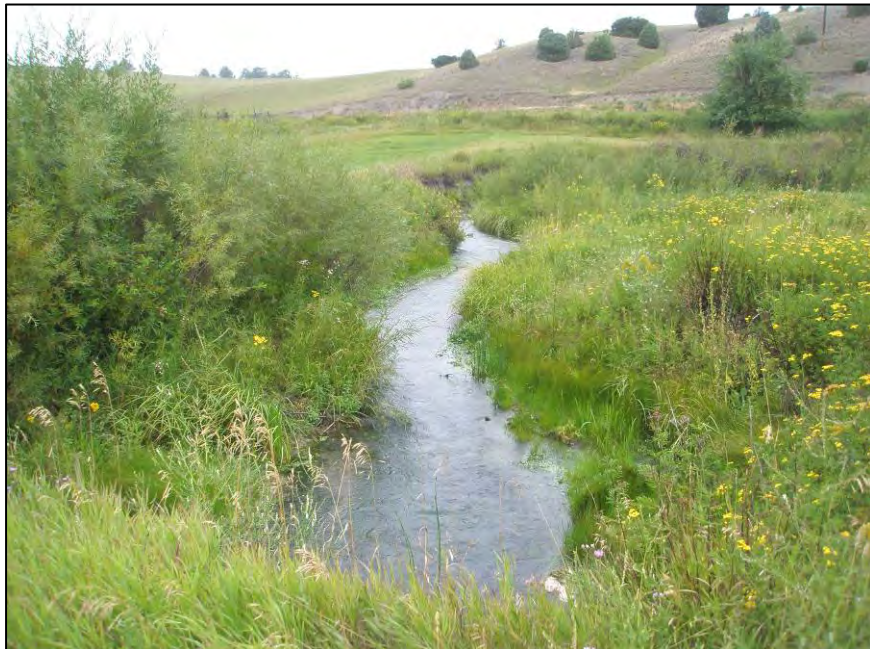
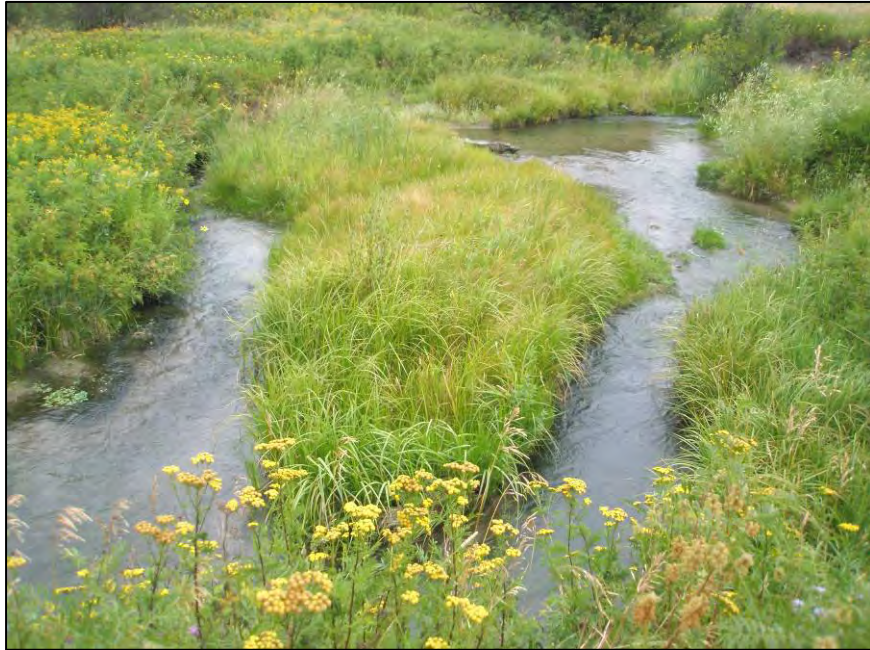
The stream channel was stable with good run and pool development, but riffles are in short supply (Photos I15, I16, I17). There were some undercut banks and some large woody debris creating excellent trout habitat (Photos I18, I19, I20). Fish of unknown species were observed in the stream during the survey. There were some signs of livestock accessing the stream, but not to the extent that it had damaged habitat or channel stability (Photos I21 and I22).

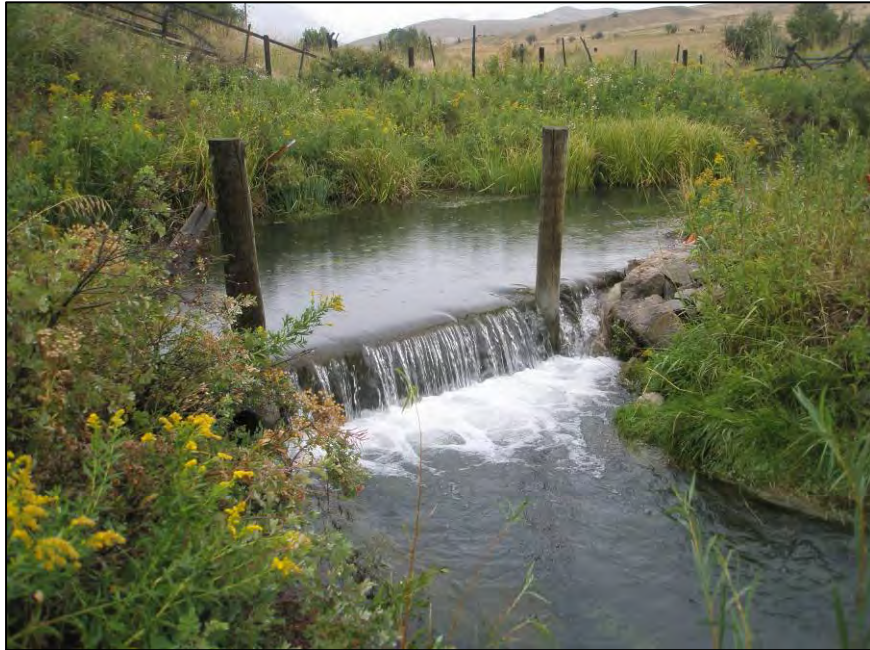
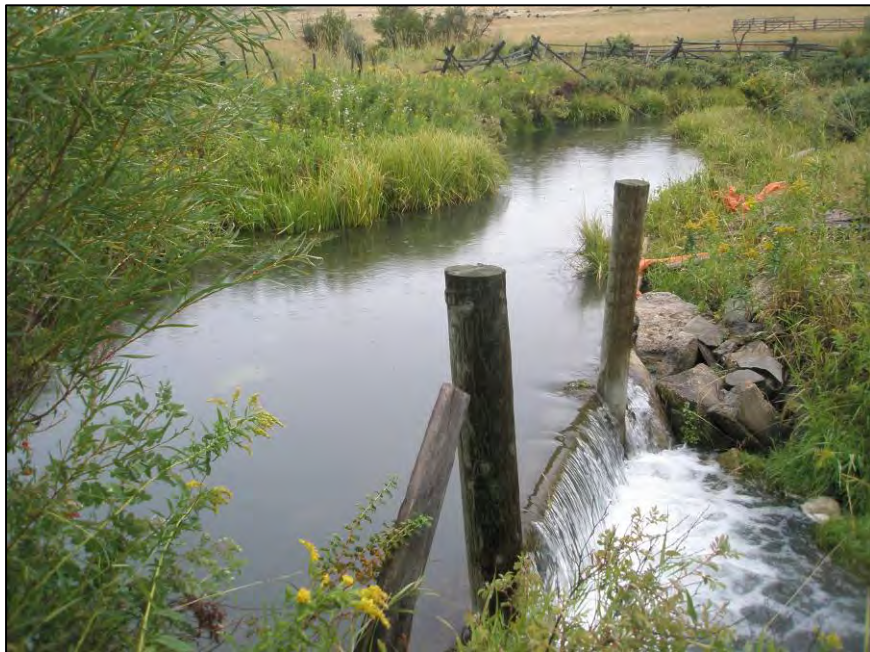
Only one irrigation diversion was found, and it was located at the head of the survey section (Photos I27 and I28). It feeds a ditch between the county road and the pasture/hay land east of the county road. After reaching the lower end of the pasture/hay land (0.5 miles) it turns west under the county road and irrigates land between the Interstate highway and the frontage road for about 1/2 mile. Any water left could enter a pond on the north side of I-90 approximately one-half mile east of the Phosphate exit. On August 27, 2008 flow in the ditch was 3.9 cfs as measured at a flume approximately 400 feet upstream from where the ditch turns west under the county road.

1. Given that the lower 1-½ miles of stream has good spawning habitat, no action relative to the seasonal fish barrier is recommended at this time.
2. Explore the ownership and value of the pond near the Phosphate exit as a potential fishery.
3. Water temperatures may be elevated and would need to be checked before making a major investment in improvement.
